## Garza Independence High School Site Summary

<b>Address</b>	1600 Chicon Street Austin Texas 78702
<b>Number of Permanent Campus Facilities</b>	5
<b>Original Year of Construction</b>	1939
<b>Total Campus Building Area (combined)</b>	46,233 SF

## Main School Building – BLDG-015A

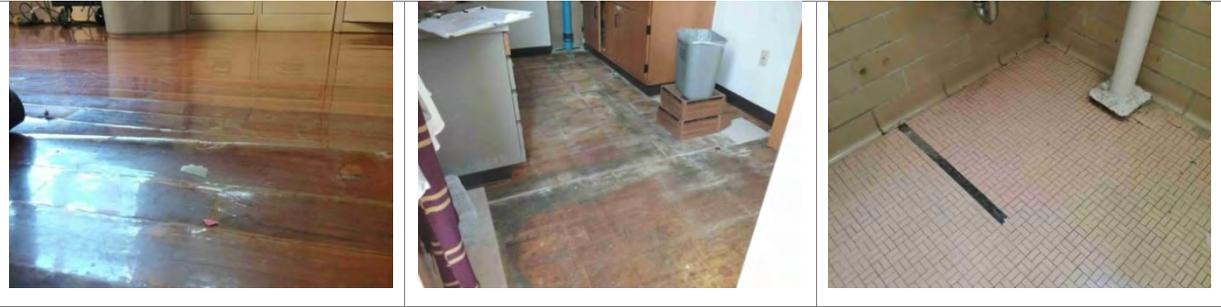
Interior Floor Finishes

System	Subsystem	Condition and Deficiency Overview	System Condition Rating
		<p>classrooms. The remaining 5% is vinyl stick-on flooring found in the gymnasium that resembles wood.</p> <p>The flooring was observed to be in average condition. The original wood floor was buckling in many places; room 105 in particular. The science labs have a shared common area, and the VCT tile was observed to be missing due to a wall repair. Tiles were missing in the cafeteria and gymnasium restrooms.</p>	
	Interior Ceiling Finishes	<p>About 85% of the interior ceilings are acoustical tile; 5% are 2-foot-square perforated tiles in the cafeteria; 5% are 1-foot-square perforated tiles in the weight room; and 5% is open corrugated metal deck on bar joists in the weight room. The ceiling appeared to be in average condition.</p> <p>The perforated stick-on ceiling tile in the cafeteria stage area, appeared to be very outdated and in poor condition. The tile was observed to be ripped, stained and yellowed.</p>	Average

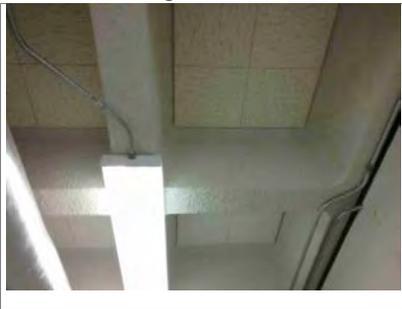
Interior Ceiling Finishes	Interior ceilings are 100% exposed structural concrete waffle pan with 12"x12" perforated acoustical tiles glued into the depth of the waffle structure for sound attenuation. According to building staff, the tile is suspected to be asbestos tile. The ceiling appeared to be in good condition.	Good
<b>Conveying</b>	System not present.		N/A
<b>Plumbing</b>	Plumbing Fixtures	The facility contains multiple plumbing applications that service one level, consisting of: public restrooms, staff restrooms, janitorial closets with service sinks, and classrooms with laboratory sinks.  These restrooms typically have wall-mounted vitreous china hand sinks with manual faucets or metering faucets, along with vitreous china, floor-mount/wall toilets with manual flushing valves, and vitreous china, wall-hung urinals in the male restrooms with manual flushing valves. There are also wall-mounted service sinks found in the janitorial closets.  The plumbing fixtures were observed to be in good condition.	Good

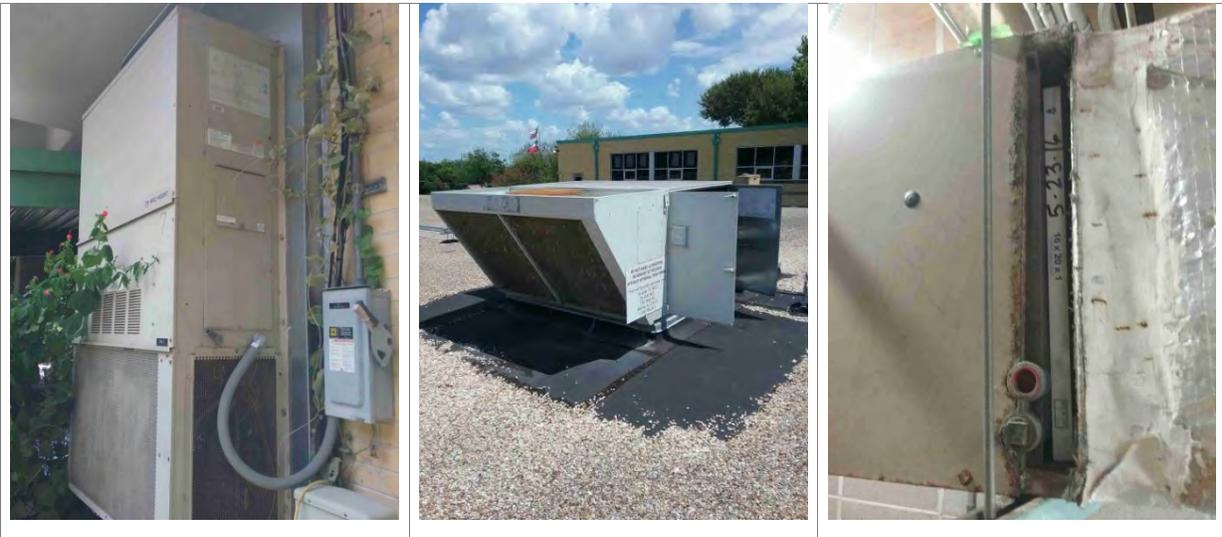
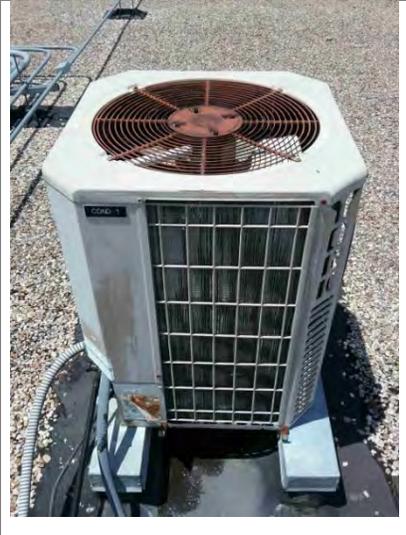
**Mechanical/HVAC System Deficiency Examples**

System	Subsystem	Condition and Deficiency Overview	System Condition Rating
	Domestic Water Distribution	The plumbing fixtures observed in this facility are not serviced by any heat-generating systems from the main mechanical room.  All associated plumbing distribution piping for this system appeared to be in good condition.	Good
	Other Plumbing	The facility is serviced by various area and equipment floor drains. The floor drains vary in size and typically have a flat metal drain cover equipped. The other plumbing system for this building was observed to be in good condition.	Good
<b>Mechanical/ HVAC</b>	<p>This building has multiple HVAC applications. The major mechanical equipment consists of through-wall-mounted, packaged heat pump systems that are attached to the external side of the building enclosure. There are also four roof top-mounted split packaged air conditioning units as well as six EFs.</p> <p>Sixteen (16) HVAC systems were assessed throughout the building. The refrigeration capacity of the units ranges from 2- to 10-TON.</p> <p>The HVAC equipment appeared to be in average condition. Many of the deficiencies observed were general aging of equipment, and enclosure and insulation damage due to exposure to the elements. Another widespread observed deficiency was the type of refrigerant used in the externally wall-mounted WSHPs; all of the observed heat pumps currently utilize an outdated refrigerant, type R-22. Additionally, the two 10-TON roof top AHUs (OAUs [outside air units] 1 and 2) were not in service because their respective electrical disconnect switches had been moved to the off position. Lastly, the fan coil unit (FCU 1) located in electrical room 300 had corrosion damage to the enclosure.</p>		Average

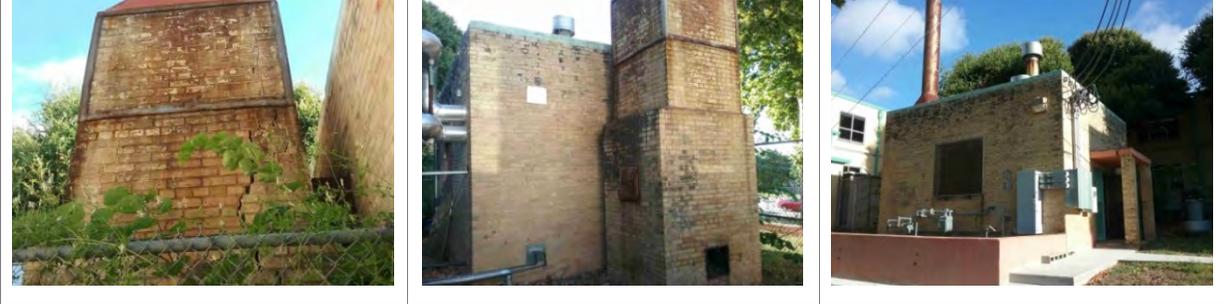
**Exterior Walls**

System	Subsystem	Condition and Deficiency Overview	System Condition Rating
<b>Exterior</b>	Exterior Walls	The mechanical building was built in 1939 and has a brick façade.  The exterior walls were observed to be in poor condition. All four sides were weathered and corroded. The brick chimney, which was no longer in use, was cracked, and the metal stack was extremely corroded.	Poor
	Exterior Windows	There is one exterior window located in the building that is no longer used.  The exterior window was observed to be in poor condition. It was broken and boarded up. Broken glass was evident, and the frame was corroded.	Poor
	Exterior Doors	The double doors are metal in a metal frame louvered at the bottom...  The doors were observed to be in poor condition and corroded.	Poor
<b>Roofing</b>	The building has a single-ply membrane roof without gutter or downspouts. The roofing appeared to be in average condition.		Average

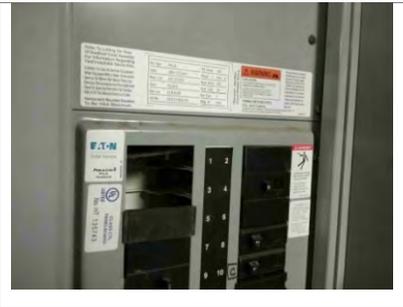
**Electrical Distribution**

<b>Electrical</b>	Electrical Distribution	The service enters the building from overhead pole-mounted transformers southeast of the boiler room and feeds a 1200A main switchboard. The main switchboard along with additional panelboards distributes power throughout the complex.  Panelboards were observed to be in good condition with the exception of BR2, which was missing breaker filler plates at locations 1 and 3.	Good
	Lighting	There does not appear to be any exterior lighting attached to the building. Suspended fluorescent fixtures are present on the interior of the building.  The lighting was observed to be in average condition. The lighting level was sufficient to view the equipment; however, additional illumination would be helpful for more detailed maintenance of the equipment.	Average
	Communications & Security	System not present.	N/A

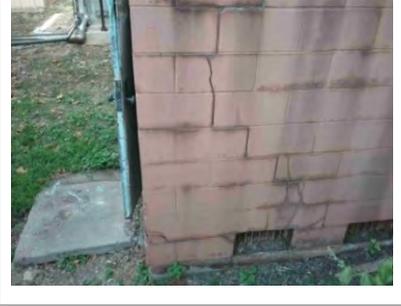
System	Subsystem	Condition and Deficiency Overview	System Condition Rating
<b>Exterior</b>	Exterior Walls	The storage building was built in 1939 and is constructed of CMU.  The exterior walls were observed to be in poor condition. The blocks were cracked, and there were open vents allowing water to enter into the top and bottom of the room.	Poor
	Exterior Windows	System not present.	N/A
	Exterior Doors	There is one door providing access to the structure. The one door is metal in a metal frame.  The exterior door appeared to be in very poor condition. It did not close and was corroded.	Poor
<b>Roofing</b>	The roof is constructed of concrete.  The roofing was observed to be in poor condition and very aged.		Poor
<b>Interior Construction</b>	Interior Walls	The walls are constructed of CMU.  The interior walls were observed to be in poor condition. The walls were cracked, and water was infiltrating into the interior.	Poor

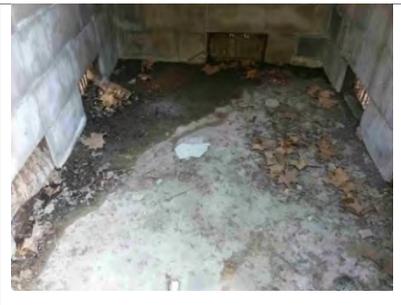
System	Subsystem	Condition and Deficiency Overview	System Condition Rating
<b>Interior Finishes</b>	Interior Wall Finishes	System not present.	Poor
	Interior Floor Finishes	The floor is an unfinished concrete slab. The floor was observed to be in poor condition. The slab was wet and cracked	Poor
	Interior Ceiling Finishes	The ceiling is unfinished concrete. The ceiling finishes were observed to be in poor condition. It was chipped, and aggregate was exposed.	Poor
<b>Conveying</b>	System not present.		N/A
<b>Plumbing</b>	Plumbing Fixtures	System not present.	N/A
	Domestic Water Distribution	System not present.	N/A
	Other Plumbing	System not present.	N/A
<b>Mechanical/ HVAC</b>	System not present.		N/A
<b>Fire Protection</b>	Fire Alarm	System not present.	N/A
	Fire Protection/ Suppression	System not present.	N/A
<b>Electrical</b>	Electrical Distribution	The underground conduit is mainly for lighting in the building. The conduit appeared to be in average condition. Certain sections of conduit were not completely buried.	Average

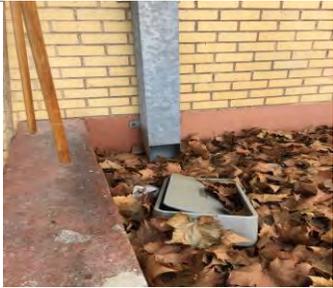
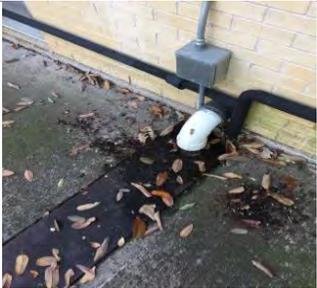
Site Drainage

Clogged downspout	Clogged condensate drain

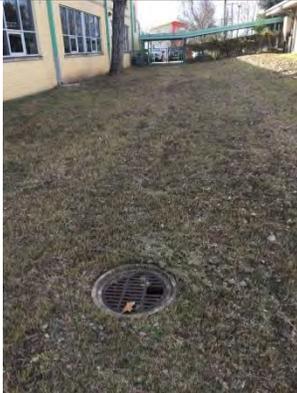
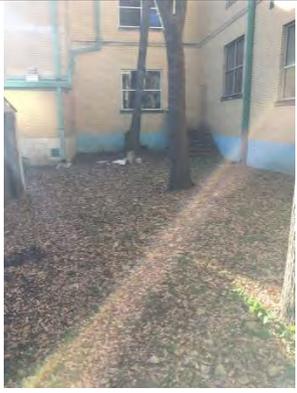
Courtyards	<p>The courtyard system is in poor condition. Courtyard A in the</p>	Poor

System	Subsystem	Condition and Deficiency Overview	System Condition Rating
		<p>north area has three portable buildings, a solar panel, and a fenced area for raising chickens. Courtyard B between the two main buildings has poor drainage. Courtyard C, south of the main buildings, has a detention tank leading to a detention pond for raising fish. The walkway edge is broken. All yards are filled with fall leaves.</p> <p>Courtyards Deficiencies:</p> <ul style="list-style-type: none"> <li>• Poor drainage in Courtyard B</li> <li>• Broken walkway in Courtyard C</li> </ul>	
	Landscaping	<p>The landscaping system is in poor condition. Overgrown vegetation in courtyard is blocking the sidewalk on the east side of the building.</p> <p>Landscaping Deficiencies:</p> <ul style="list-style-type: none"> <li>• Overgrown shrubs on fencing</li> <li>• Overgrown shrubs blocking sidewalk</li> <li>• Fallen branches and leaves are throughout the landscaped area.</li> </ul>	Poor

Poor Drainage	Leaves clogging area drains.

1. Courtyard B, regrade for proper drainage.
2. Courtyard C, repair walkway.
3. Remove leaves.

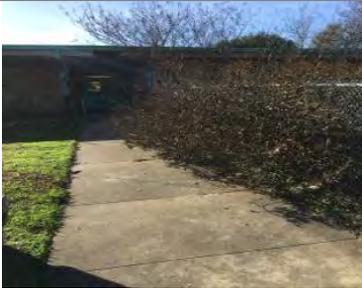
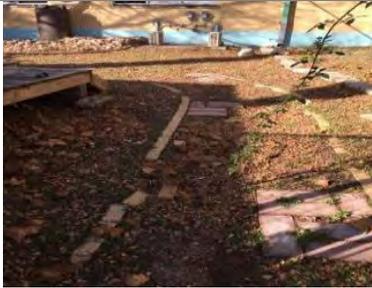
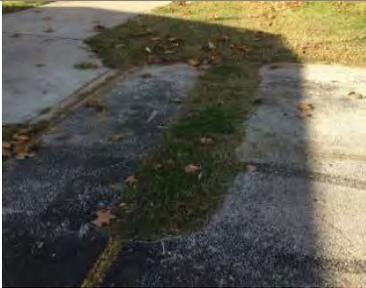
Landscaping

Overgrown vegetation on fencing blocking sidewalk	Branch blocking sidewalk entrance to Courtyard C	Grass eroding pavement in Staff Parking Lot B

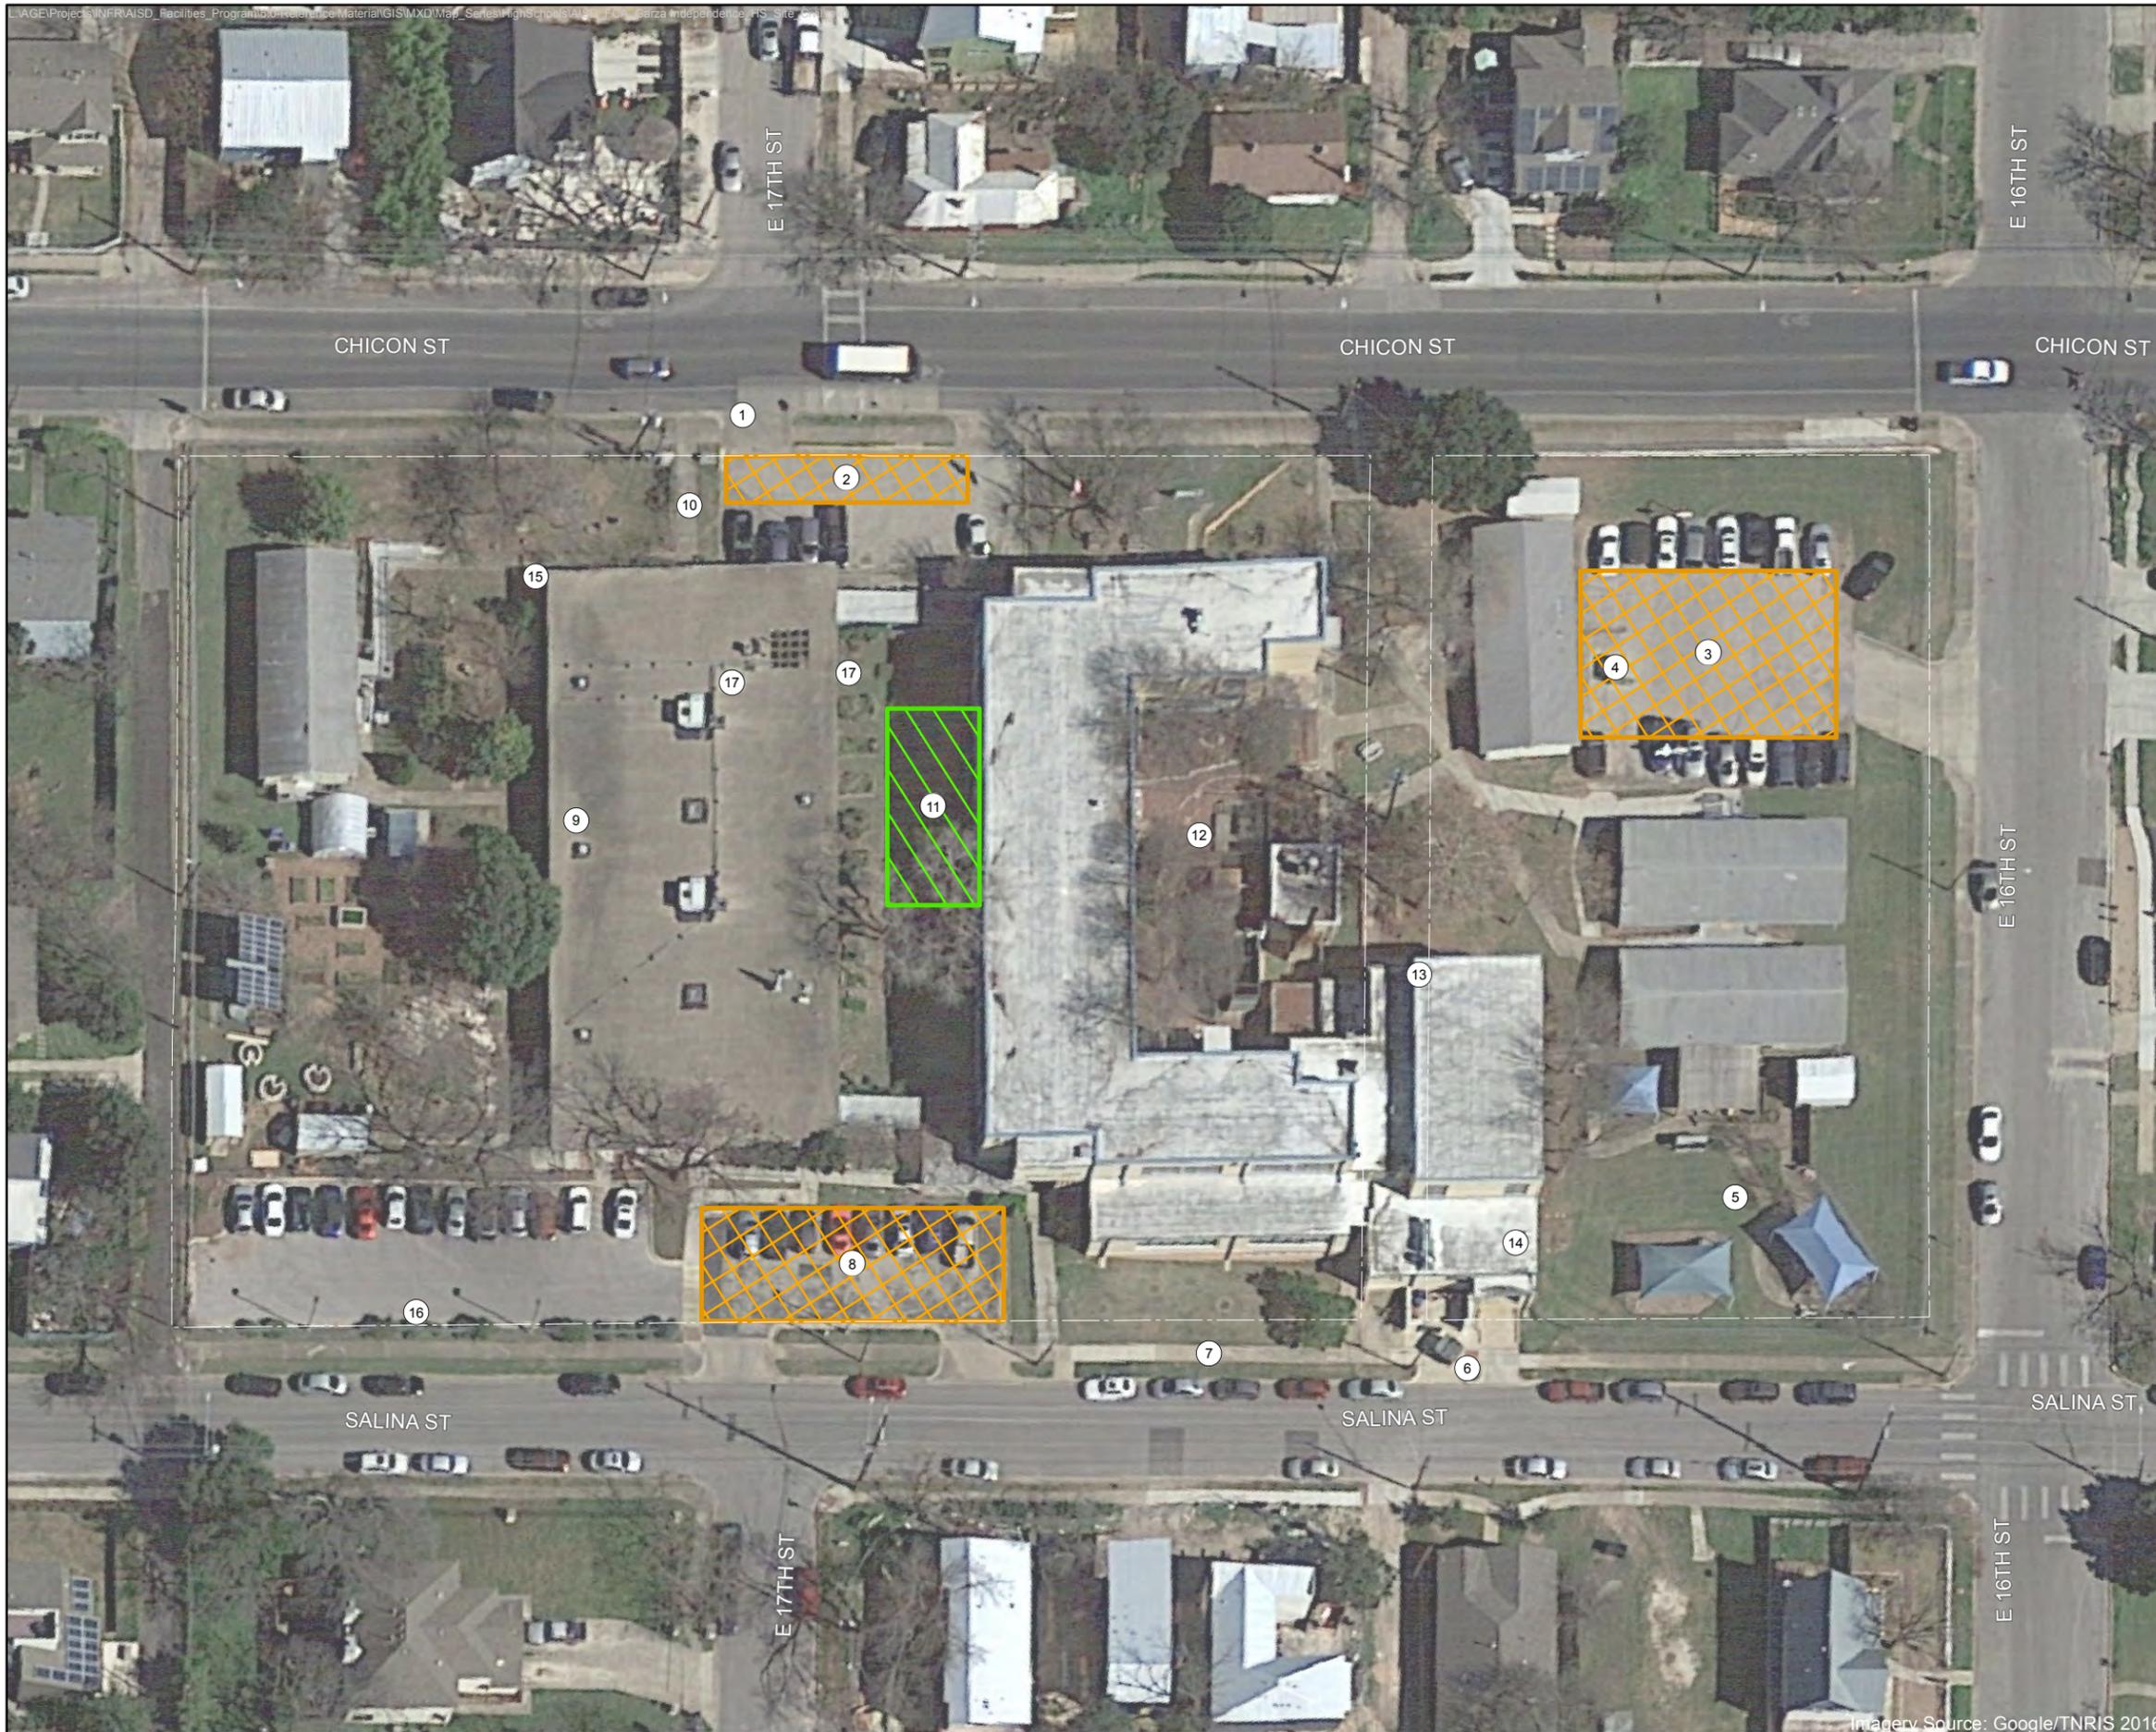
1. VISITOR PARKING LOT A HAS POTHOLE 5' X 5'.
2. VISITOR PARKING LOT A HAS TIGHT CRACKS, RAVELING, STRIPING FADED. NEED PARKING LOT LIGHTING.
3. STAFF PARKING LOT B SEVERE RAVELING, WEED OVERGROWN INTO PAVEMENT. NEEDS RECONSTRUCTION.
4. DUMPSTER IN PARKING LOT DOES NOT HAVE CONCRETE SLAB OR APPROACH.
5. LOW POINT IN PLAYSCAPE, REGRADE FOR PROPER DRAINAGE. WALKWAY HAS PESTHOLE AND CRACKS.
6. DUMPSTER SITS ON SIDEWALK.
7. PEDESTRIAN PAVING BROKEN.
8. STAFF PARKING LOT C2 HAS CRACKS, RAVELING, FADED STRIPING AND PATCH.
9. CONDENSATE DRAIN PATH CLOGGED.
10. SIDEWALK BLOCKED BY OVERGROWN SHRUBS.
11. COURTYARD B NEEDS REGRADE FOR PROPER DRAIN.
12. COURTYARD C WALKWAY BROKEN, FILLED WITH FALL LEAVES AND BRANCHES.
13. DOWNSPOUT DRAIN PATH CLOGGED.
14. BROKEN EXTERIOR WALL, REINFORCED STEEL EXPOSED.
15. ERODED SIDEWALK PANEL.
16. OVERGROWN SHRUBS ON FENCE.
17. BROKEN SIDEWALK.

1. Visitor Parking Lot A, repair pothole and crack seal.
2. Staff Parking Lot B, reconstruct paving.
3. Staff Parking Lot C2, repair crack seal sealcoat.

1. Replace cracked sidewalk panels.
2. Add soil to eroded edge of sidewalk.

1. Repair clogged downspout and drain path.

1. Repair walkway.
2. Regrade for proper drainage.
