Johnson High School (LBJ) & Liberal Arts and Science Academy (LASA) Site Summary

Main School Building – BLDG-014A

Theater Building – BLDG-014B

Site/Civil Assessment

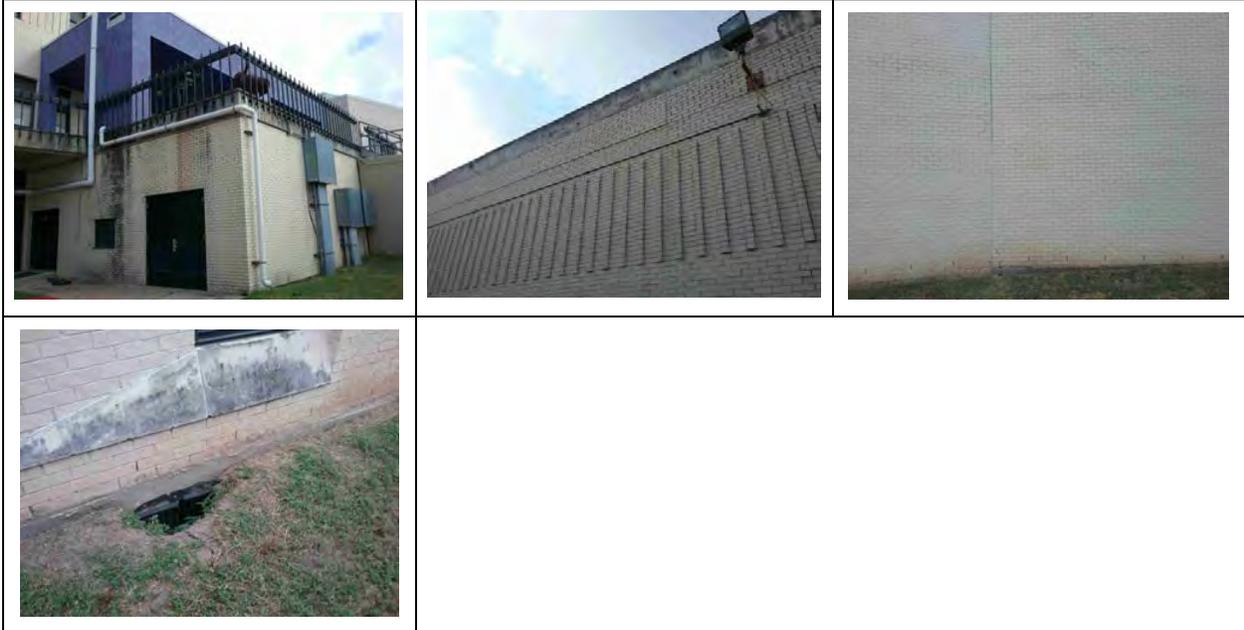
System	Subsystem	Condition and Deficiency Overview	System Condition Rating
Exterior	Exterior Walls	<p>The exterior of the building consists of a brick facade with stone accents at the canopies and windows. The upper walls at the gymnasium are clad in metal panels.</p> <p>The exterior walls were observed to be in average condition. There were signs of structural movement at the gymnasium. In several areas, the brick was offset horizontally from the brick below. This appeared to be at the line of the roof structure. The exterior wall system appeared to be operating as designed with the possible exception of age related issues, building movement, and physical damage such as damaged stone panels and holes in the brick facade. Exterior sealants needed replacement. Assessment of drainage should be done to ensure water flows around the building rather than through the crawl space.</p>	Average
	Exterior Windows	<p>The exterior windows consist of single pane glazed units in single hung frames constructed of aluminum. Units sit on stone accents or above extended system, which includes an infill panel below the window system. There are a number of windows with hollow metal frames.</p> <p>The exterior windows were observed to be in poor condition. The age of the windows and the mechanisms were such that the sealant at of the original windows is in the process of failure and requires re-caulking. It was observed that the spring mechanisms in the single hung</p>	Poor

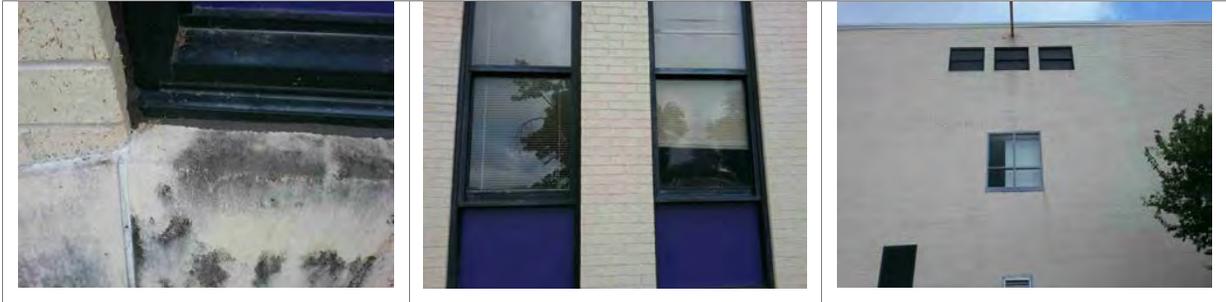
Exterior Windows

System	Subsystem	Condition and Deficiency Overview	System Condition Rating
		<p>mechanisms have failed and require repair. A significant number of the glass panes have been replaced with acrylic that has aged and clouded as a result of exposure to ultraviolet light reducing their utility. At all glazing , the sealant and stops are in the process of failing and need to be repaired and/or resealed, which appeared to be true for 85% of the windows. On the east side of the building, the hollow metal frame of the window located in the percussion room of the band area is rusting. This window system appeared to be in need of repair and/or replacement.</p>	
	Exterior Doors	<p>The door systems are limited to hollow metal doors in hollow metal frame systems. Typically, the hardware is original to the installation. There are doors that have their knuckle hinges replaced with continuous geared hinges. Main window lights in doors and adjacent to doors have been replaced acrylic. Doors have been painted and repainted.</p> <p>The exterior doors were observed to be in average condition. The thickness of the paint was affecting the operation of the doors. It was observed that the doors at the entry from the courtyard were not closing do to rubbing from paint and sagging. At the penthouse, it appeared that the door is hanging by one hinge. On the west facade south facing entry, the door appeared to be missing working hardware. In at least one case, exiting gates appeared to be out of compliance with ADA (American with Disabilities Act) requirements.</p>	Average

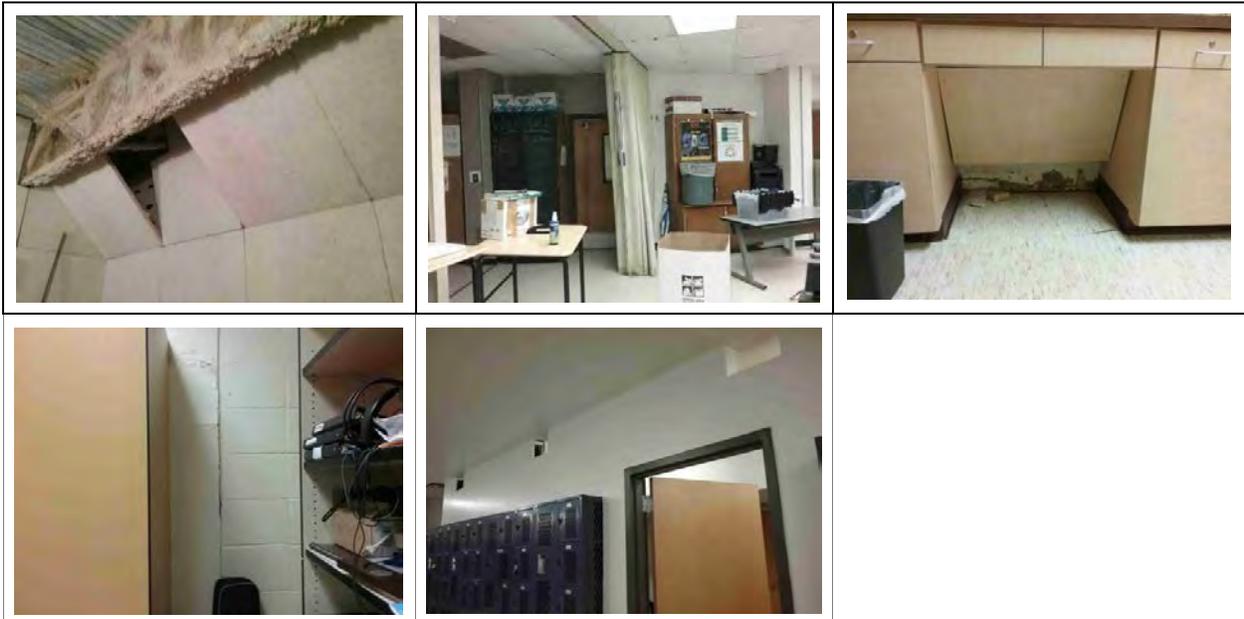
Interior Walls

System	Subsystem	Condition and Deficiency Overview	System Condition Rating
		<p>The interior walls appeared to be in average condition. In the training area of the athletic section, which appeared to be an addition, joints between gypsum board wall systems and CMU (concrete masonry unit) were opening. In mechanical areas, the sound mitigation material installed as part of the wall system was observed to be falling off the wall. Gymnasiums contained louvered openings that have been partially covered but still allow moisture and untempered air into the gymnasiums. Water infiltration that damaged the wall system was noted. Cracking at CMU wall systems was observed in the gymnasium and varsity locker room. Wood construction was observed in the male locker room. This appears to be a code violation. The use of accordion doors appears to have been abandoned on the second floor. The access to the walk-in freezer and refrigerator is inadequate for movement of material from the loading dock to the walk-in units. The CAC and Principal Sheila Henry reported that the basement classroom areas have hole in the walls, potentially due to rodents.</p>

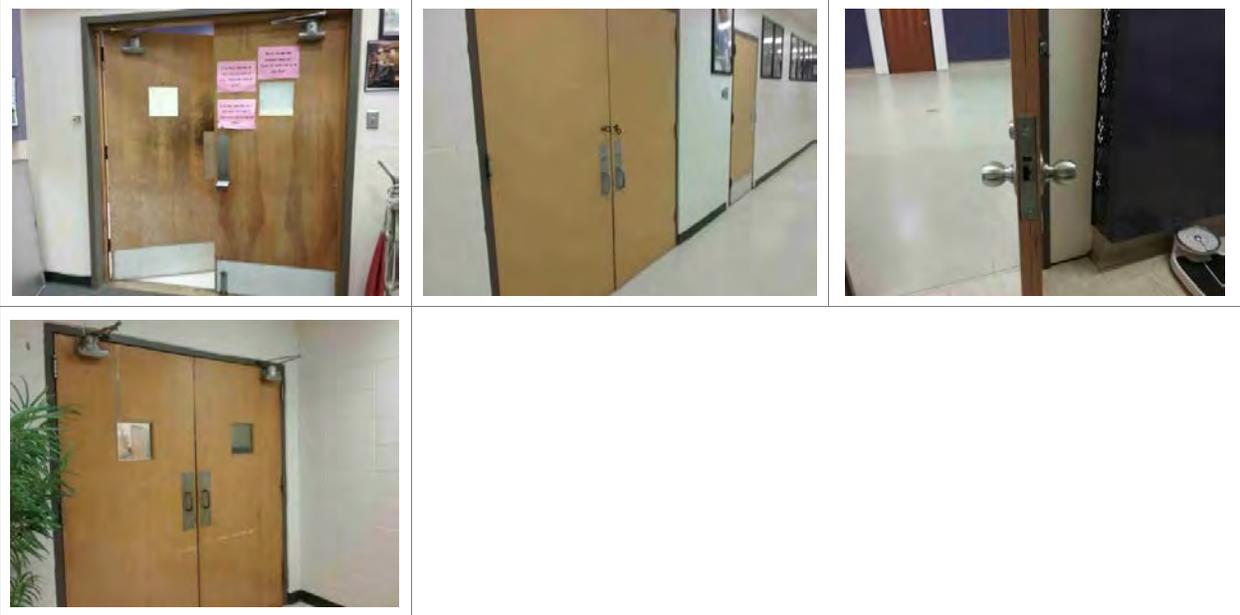
Interior Doors	<p>Interior doors are typically solid core wood doors with veneer set in hollow metal door frames. Mechanical spaces typically have hollow metal doors in hollow metal frames.</p> <p>The interior doors appeared to be in average condition. Except for individual door issues, the wood doors in the older parts of the building were observed to have veneer damage and wear. The most egregious of those issues were severe damage to or missing veneer. In certain instances, "security" equipment had been installed on doors. This usually took the form of large eye bolts attached to the door(s). These are problematic from a code standpoint and were present on emergency exit doors.</p>	Average
	Interior Specialties	<p>Metal lockers are present in corridors, kitchen staff areas, coaching offices, and in locker rooms.</p> <p>The lockers appeared to be in average condition and had been freshly painted in the last couple of years. Student lockers will need to be cleaned of the layers of paint and recoated electrostatically in five years.</p>	Average

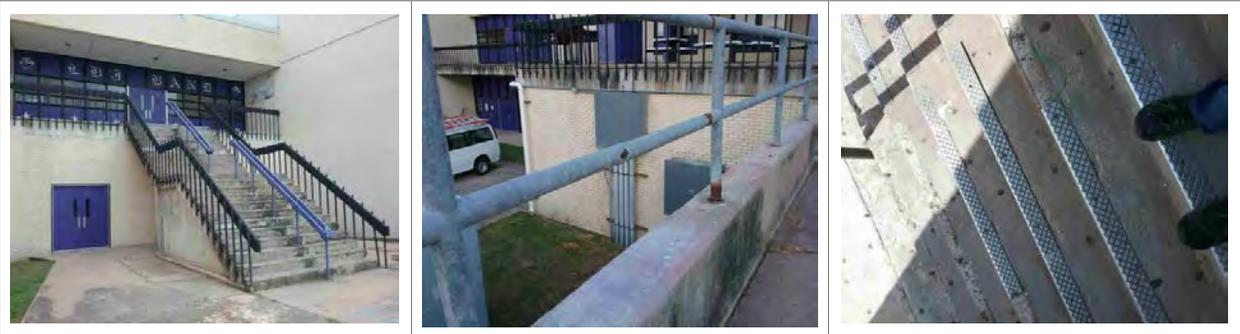
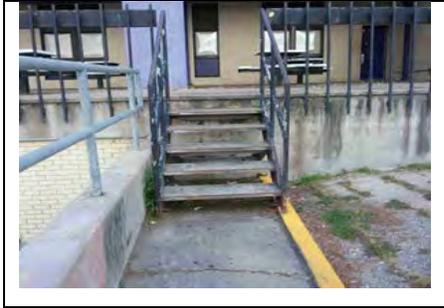
System	Subsystem	Condition and Deficiency Overview	System Condition Rating
Stairs	Exterior Stairs	<p>Exterior stairs are limited to the east side of the building and are cast in place concrete with inset anti-slip nosing. In one instance, the stair is a metal frame with concrete treads.</p> <p>These exterior stairs appeared to be in poor condition. This rating is based on the presence of trip hazards in the form of damaged nosing pieces that are raised. Other stairs rated in poor condition did not have current code compliant guard rails or balusters. Rusting was noted at guardrails and handrails. The metal frame stair was not resting on the ground but was incorrectly cantilevered off the building.</p>	Poor
	Interior Stairs	<p>Interior stairs are concrete. They are equipped with inset metal anti-slip nosing and metal handrails. Given the construction of the stairwells and the stairs, the stairs appeared to be in average condition, but not in immediate need of repairs.</p>	Average

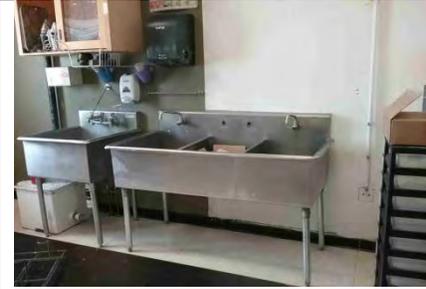
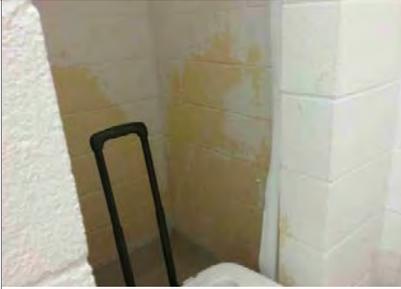
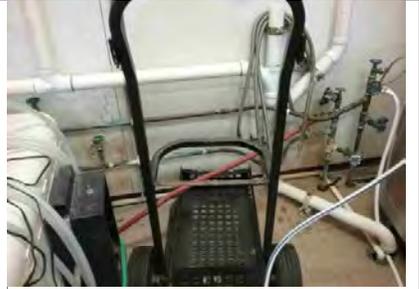
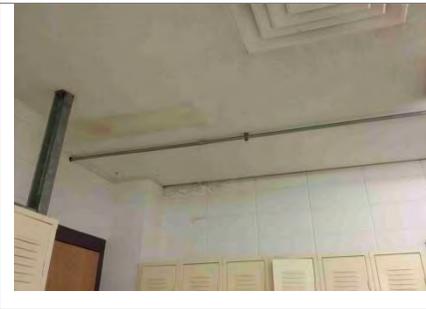
Interior Finishes	Interior Wall Finishes	<p>Finish systems are limited to paint, ceramic tile, and transite panels. Do to the age of the building, the paint systems are in need of constant maintenance.</p> <p>The interior wall finishes were in average condition. Issues observed included water damage from sinks against gypsum board rather than a water resistant surface. There appeared to be damage from leaks and constant use.</p>	Average
	Interior Floor Finishes	<p>VCT (vinyl composite tile) is found throughout the building along exposed concrete in mechanical and shop areas and carpet in the library and some administration areas. Strip wood flooring is installed in the gymnasium.</p> <p>The interior floor finishes appeared to be in average condition. VCT was noted as damaged from variation in the substrate in corridors and a storage area. VCT was noted as lifting or moisture damaged in the dance room, the choir room. The choir room VCT issues were located on the riser system suggestion moisture infiltration underneath. Carpet at the library was observed as lifting or stained.</p>	Average

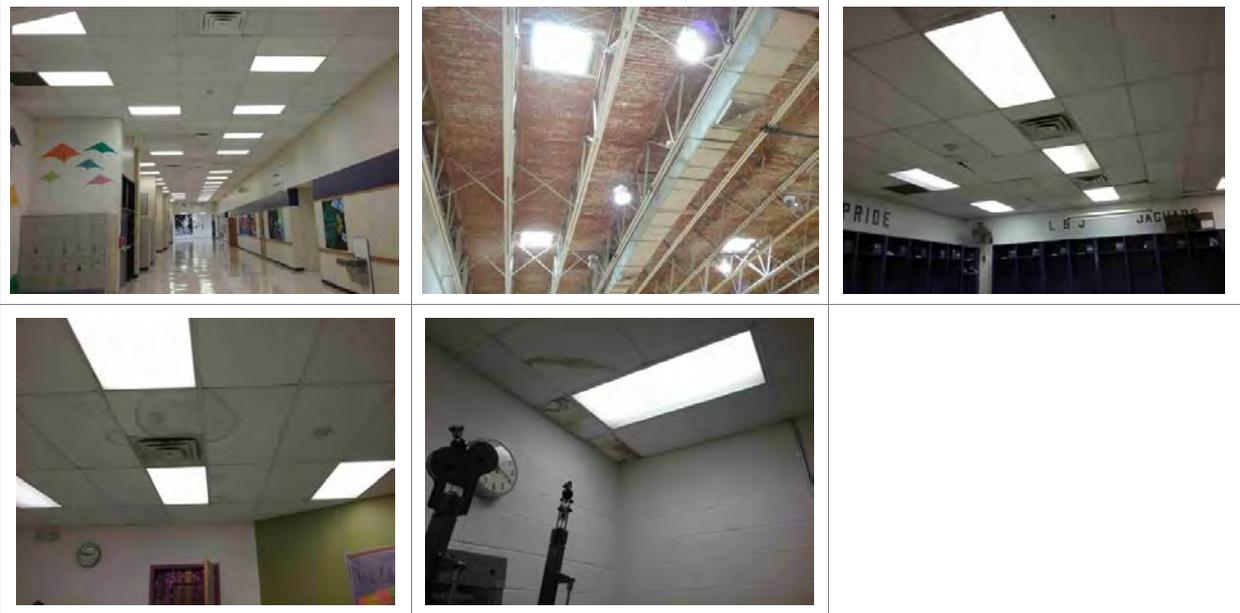
Interior Ceiling Finishes

System	Subsystem	Condition and Deficiency Overview	System Condition Rating
		<p>restrooms, or maintenance areas.</p> <p>The interior ceiling finishes are in average condition. The ceiling tile on the first floor was observed aged and worn. Ceiling tiles were water damaged on the first and second floors from roofing or plumbing leaks.</p>	
Conveying		<p>The building is equipped with two passenger elevators to service two levels.</p> <p>These two elevators were reported in the interview summary to be original, both had maintenance issues, and both are at the end of their design service life span. The elevator adjacent to the gymnasium has been reported to fail.</p>	Poor
Plumbing	Plumbing Fixtures	<p>The building has public restrooms for males and females, students, and separate staff restrooms located throughout the facility. These restrooms have vitreous china hand sinks in counters with manual faucets, along with vitreous china, floor-mount/wall toilets with manual flushing mechanisms, and vitreous china, wall-hung urinals in the male restrooms with manual flushing mechanisms. There are service sinks found in the janitorial closets, and water coolers located throughout the facility, typically near the public restrooms. The restroom plumbing fixtures were observed to be in good condition as the fixtures were typically aged but still operational. The building also includes other specialty locations with plumbing fixtures, including a kitchen for the school cafeteria, art classrooms, locker rooms, and home economics/life skills classrooms.</p> <p>Most fixtures in the restrooms were in serviceable condition but were dated with the campus and are inefficient. The large compartment sinks in the robotics/shop area as well as the art classrooms were stained and contain debris but were still operational. The showers in the male and female locker rooms had significant corrosion, and cracking was present in the shower pans in the female locker rooms. It was reported from the interview that there were leaking faucets in the locker rooms.</p>	Average

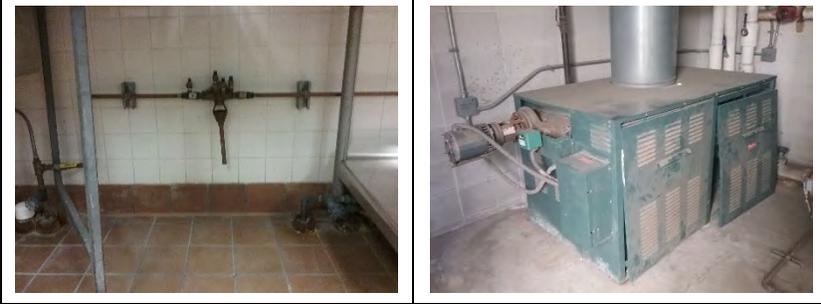
Domestic Water Distribution

System	Subsystem	Condition and Deficiency Overview	System Condition Rating
		<p>lack of hot water during dish wash cycles.</p> <p>The domestic water distribution system was observed to be in average condition. The hot water for the gym showers is served by a boiler and two storage tanks of approximately 500 gallons each. This boiler was beyond its service date and show significant signs of rust and heat exchanger degradation. The condition of the storage tanks was not apparent since they are wrapped in insulation that appears to be in serviceable condition. There was evidence of repairs within the system and a need existed for additional repairs of corroded piping and fittings. The CAC and Principal Stacia Crescenzi reported that the female locker room has water temperature issues (fluctuations between hot or cold).</p> <p>Distribution piping observed in the crawl space adjacent to the central plant had areas with leaking valves and torn/missing insulation.</p>

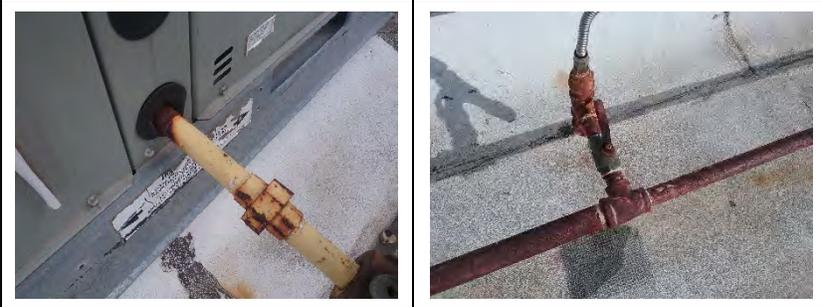
Other Plumbing	<p>The roof drains are equipped with metal grate covers to prevent debris from entering the drainage system.</p> <p>The roof drains were observed to be in good condition. It was observed that the roof drainage for the two-story part of the building is collected in the crawl space. This piping in the crawl space has been recently replaced, and there was a concern as to how the piping is supported from the first floor structure. The gas piping on the roof was rusted.</p>	Average
Mechanical/ HVAC		<p>The major mechanical equipment consists of indoor modular AHUs (air handling units) located primarily in mechanical crawl spaces, mechanical mezzanines, or penthouses. The AHUs are served by a central chilled water plant with two 500-TON chillers and complimenting cooling towers. In addition, there are several packaged RTUs (roof top units) that serve isolated areas such as the cafeteria, kitchen, administration areas, and male and female locker rooms.</p> <p>It was observed that there are 11 AHUs ranging in a capacity from 7,000 CFM (cubic feet per minute) to 27,000 CFM. These AHUs are arranged as constant volume multi-zone dual deck configurations and were replaced in 2005.</p> <p>Most AHUs in this location were in good condition and showed very little corrosion due to the highly humid environment. The discharge and return air duct for many of the units were showing significant corrosion due to sweating and age. There was damage to a few of the AHUs ductwork that needs immediate repair. The AHU serving the kitchen (AHU-KIT) had large quantities of dirt and debris built up on the fan side of the cooling coil. This could lead to the buildup of mold on the interior of the unit.</p>	Average

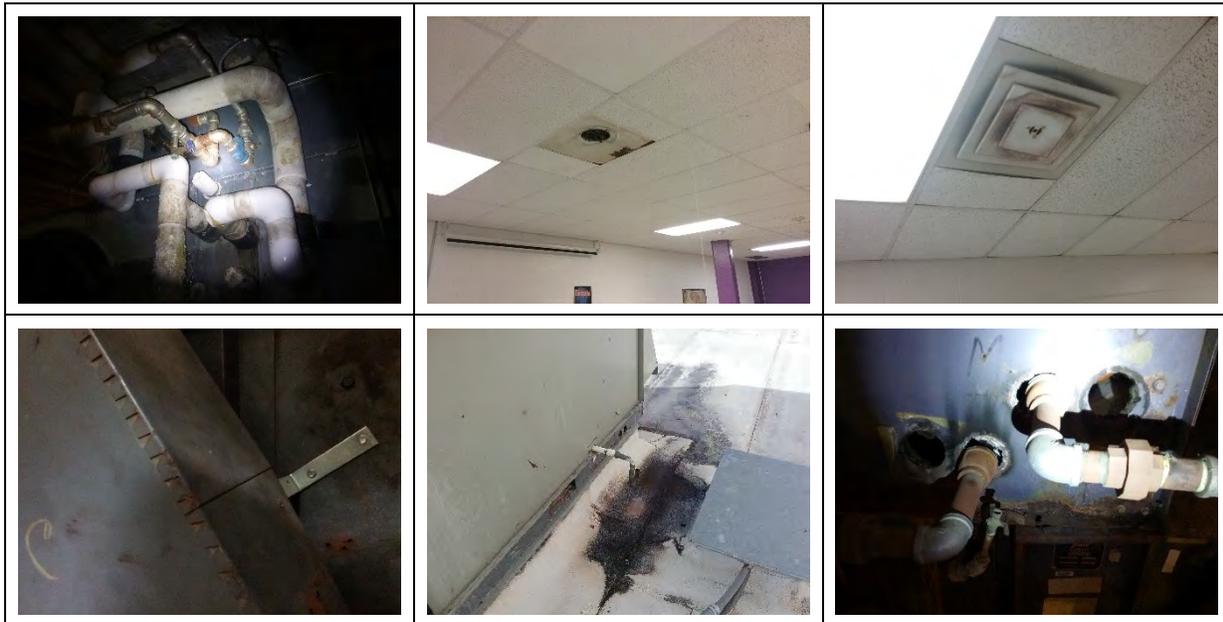
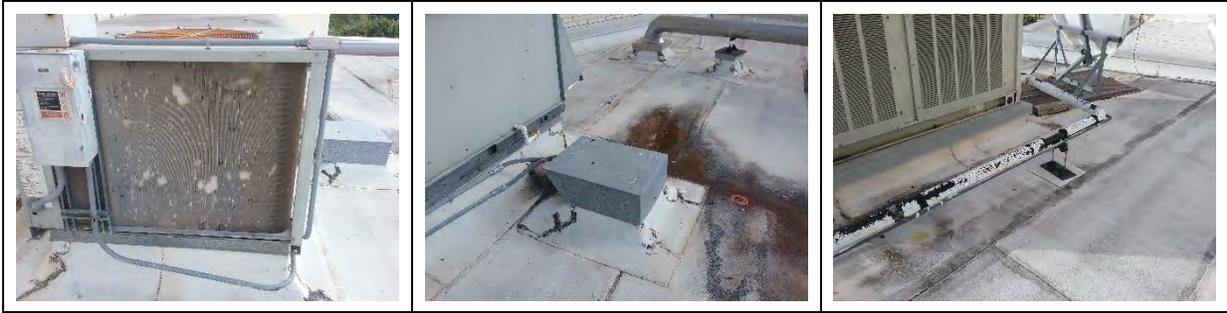
System	Subsystem	Condition and Deficiency Overview	System Condition Rating
		<p>The four AHUs located in the gymnasium penthouse were recently replaced within the last five years, appeared to be in good condition, and did not show evidence of deficiencies at this point.</p> <p>There are two mezzanines in the area of the band hall, and an additional mezzanine in the gymnasium area where there are six AHUs in place. These AHUs are all original to the school and exhibited large amounts of corrosion through each unit resulting in significant leakages in each of the AHUs.</p> <p>The two RTUs on the roof to the south of the gymnasium were aged past their service date and had damage on the condenser coil. These two units also utilized R-22 refrigerant.</p> <p>The three RTUs in the administration roof area were installed in 2005 (estimated) and were in good condition. Since these units are recent units, they utilize R-410a. A deficiency noted was associated with a rupture in the drain line of which was draining directly onto the roof creating a slip and fall hazard as well as mold risk.</p> <p>There are two RTUs serving science classrooms 158 and 156. These two RTUs similar to the gymnasium RTUs were aged passed their design service life and had significant hail damage on their condenser coils.</p> <p>The supply, return, and exhaust air diffusers throughout the campus are of differing ages, but mostly original and were showing significant rust and corrosion. There were diffusers that have been disassembled and/or removed.</p> <p>The cooling towers appeared to have been replaced recently and were in good condition. There appeared to be scaling on the fill. The chiller condenser water system uses a Dolphin system for water treatment. The chillers were installed in 1999. Both chillers appeared to be in working order. The heating water boilers were installed in 2005 (estimated). The boilers appeared to be in good working order and were operating. A deficiency associated with this system was with corroded piping associated with the expansion tanks and air separators.</p> <p>The chilled, heating, and condenser water systems all use inline pumps. The pumps appeared to have been replaced and all had signs of significant design service life age and several motor changes. In addition to the age and apparent service of the pumps, the installation of the pumps was not in keeping with manufacturer's recommendations for pumps of this type. The existing pumping scheme was constant volume with 3-way valves.</p> <p>It was reported during the survey that the vent hoods did not properly draw air. It was also reported that the thermostat for the kitchen unit was not properly located and does not allow the unit to operate correctly.</p>

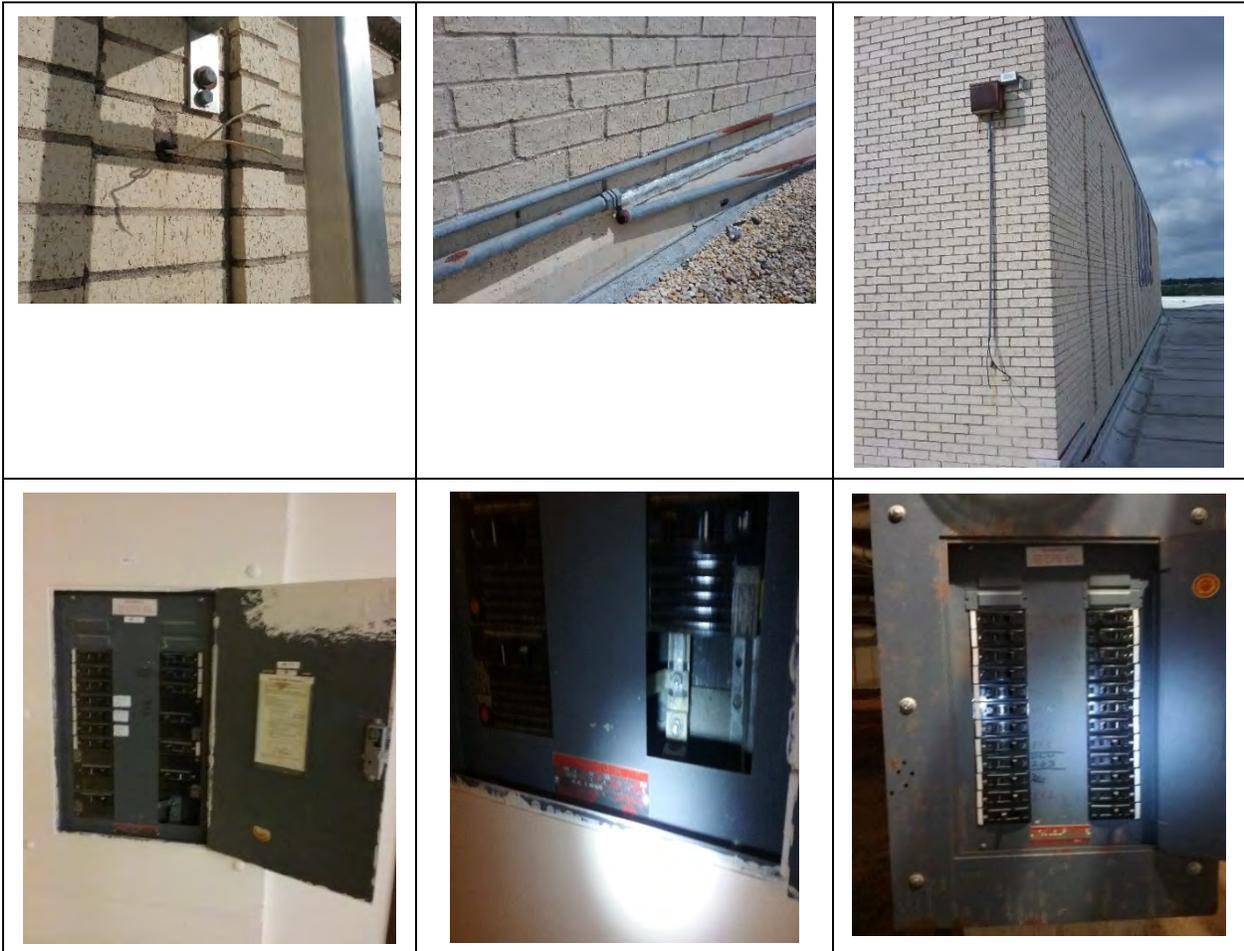
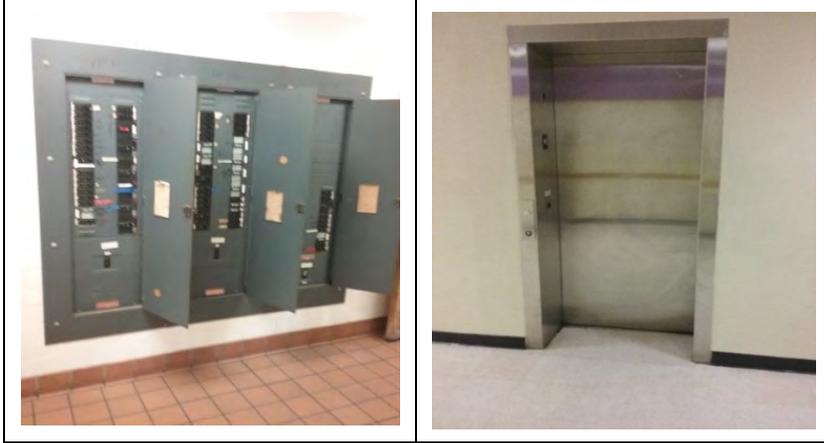
System	Subsystem	Condition and Deficiency Overview	System Condition Rating
	Fire Protection/ Suppression	System not present.	N/A
Electrical	Electrical Distribution	<p>The electrical service enters the building from the 277/480-volt 4000-amp main switchboard located on the exterior near the service transformer. The service feeds transformers and high-voltage panelboards, which are located in various electrical rooms throughout the building. There are distribution panels rated at 480-volt that feed lighting and mechanical equipment then utilize step-down transformers to 120/208-volt secondary, which feeds power to 120/208-volt panelboards.</p> <p>The electrical distribution equipment appeared to be in good condition. Panelboard PP-11 in the library was unlocked, circuit breaker covers were missing, and the bussing was exposed behind the circuit breaker board. This condition could be considered a life safety hazard as it was accessible to students near the book shelves. It was reported in the interview minutes that the kitchen was underpowered. It appeared that the three section panelboard PP1-1 was in average condition although aged and out of date. Crawl Space panelboard CS-3, near the center of the space, appeared to be in average condition although signs of rust corrosion were observed. On the roof, there were various wires exposed near the access ladder as well as unsupported conduits separated and hanging from the wires. It was observed there was an abandoned conduit and Belden cable.</p> <p>The building does not have a lightning protection system.</p>	Average

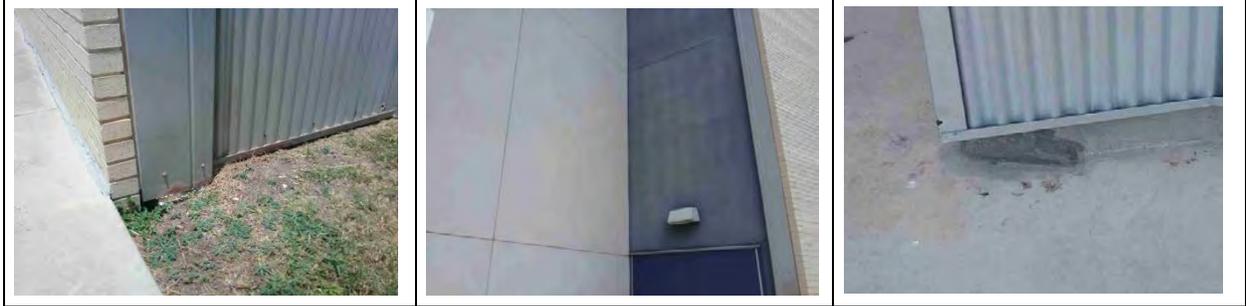
System	Subsystem	Condition and Deficiency Overview	System Condition Rating
Exterior	Exterior Walls	The exterior of the building consists of a variety of brick, corrugated metal panels, and stucco. The exterior walls are in average condition. Deficiencies observed included cracking in the stucco systems on the south side of the building. At the south east corner of the building, there is a small corner window in the ground that has formed. The exterior sheathing contacted the ground and could attract moisture and pests into the building. Exposed rebar was observed at the west side of the building.	Average
	Exterior Windows	Exterior windows are aluminum storefront system at the front lobby. It appeared to be functioning as intended and is in good condition.	Good
	Exterior Doors	Exterior doors are aluminum storefront system, hollow metal or roll up doors. The doors were observed to be in poor condition because the exit doors off the auditorium do not function as intended for emergency exiting. These doors do not swing all the way open due to a conflict with the sidewalk. In addition, the school uses the exit vestibule for storage and does not maintain the space. This results in a life safety hazard.	Poor

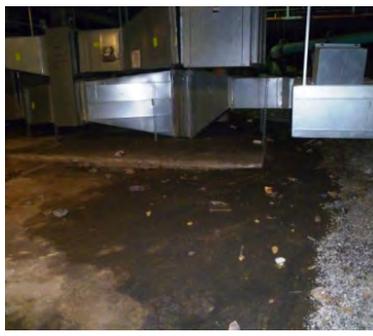
Damp soils in crawl space

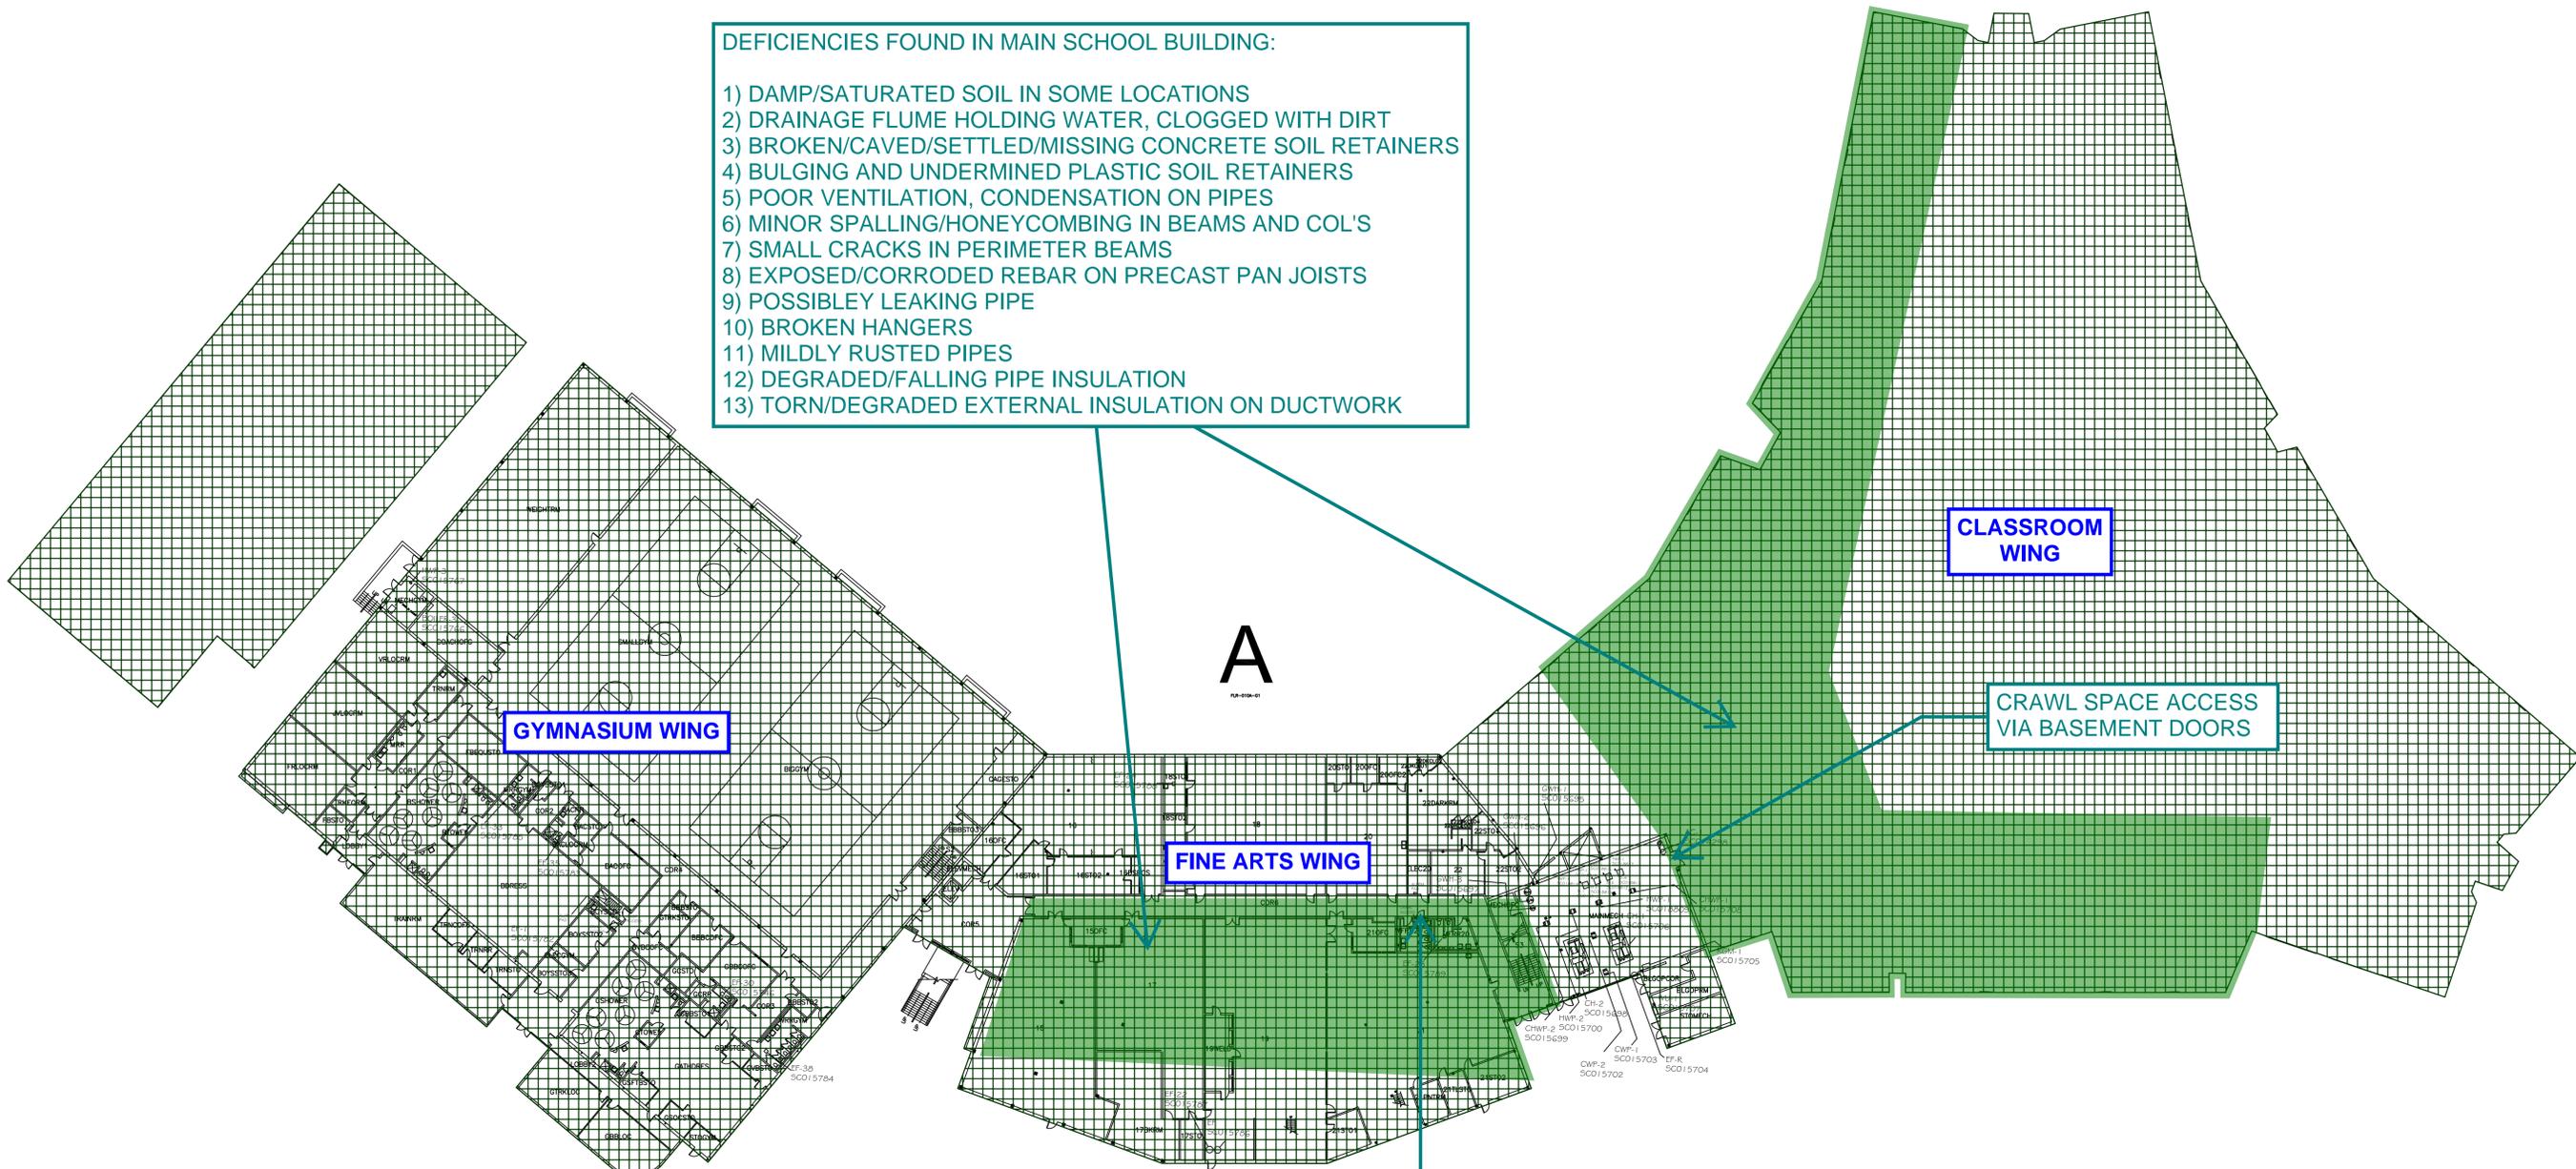
- DEFICIENCIES FOUND IN MAIN SCHOOL BUILDING:**
- 1) DAMP/SATURATED SOIL IN SOME LOCATIONS
 - 2) DRAINAGE FLUME HOLDING WATER, CLOGGED WITH DIRT
 - 3) BROKEN/CAVED/SETTLED/MISSING CONCRETE SOIL RETAINERS
 - 4) BULGING AND UNDERMINED PLASTIC SOIL RETAINERS
 - 5) POOR VENTILATION, CONDENSATION ON PIPES
 - 6) MINOR SPALLING/HONEYCOMBING IN BEAMS AND COL'S
 - 7) SMALL CRACKS IN PERIMETER BEAMS
 - 8) EXPOSED/CORRODED REBAR ON PRECAST PAN JOISTS
 - 9) POSSIBLY LEAKING PIPE
 - 10) BROKEN HANGERS
 - 11) MILDLY RUSTED PIPES
 - 12) DEGRADED/FALLING PIPE INSULATION
 - 13) TORN/DEGRADED EXTERNAL INSULATION ON DUCTWORK

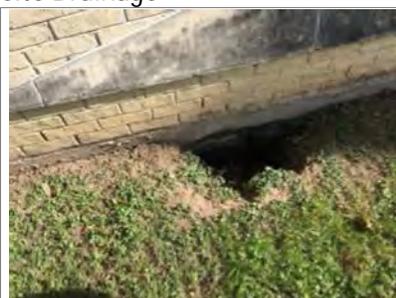
Pest holes

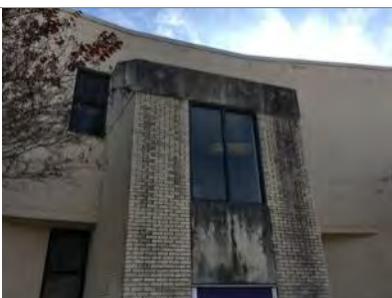
Water runs off the side of building

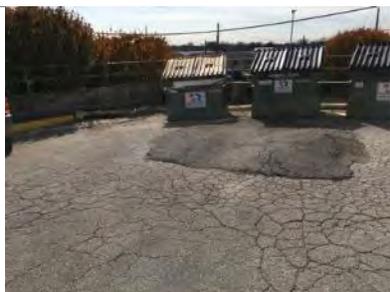
Dumpsters not on concrete

20. THERE IS A POSSIBLE LEAK IN THE WATERLINE.
21. THE AREA INLET NEEDS TO BE REGRADED TO MAINTAIN POSITIVE DRAINAGE.
22. THERE IS NOT A CONCRETE PAD UNDER AND/OR IN FRONT OF THE DUMPSTERS.

1. Repair pavement around dumpsters and place on concrete pad, with approach pad.

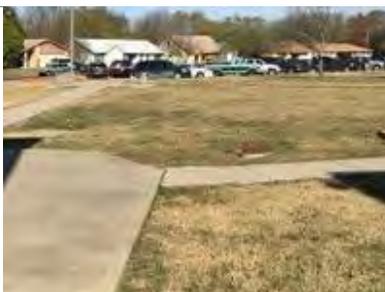
Regrade inlet

1. Investigate and fix potential leak in the front of school
2. Remove outdoor water fountain.
3. Regrade area around area inlet to maintain positive drainage.
4. Install fiberglass grease sampling enclosure.

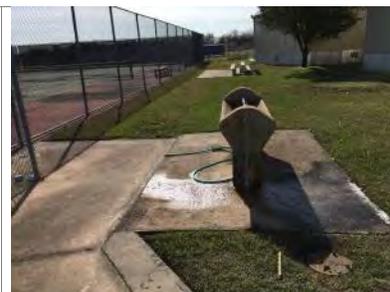
Outdated water fountain

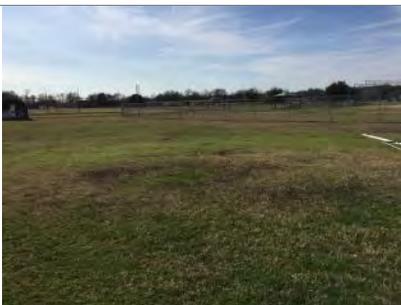
Low spots throughout field

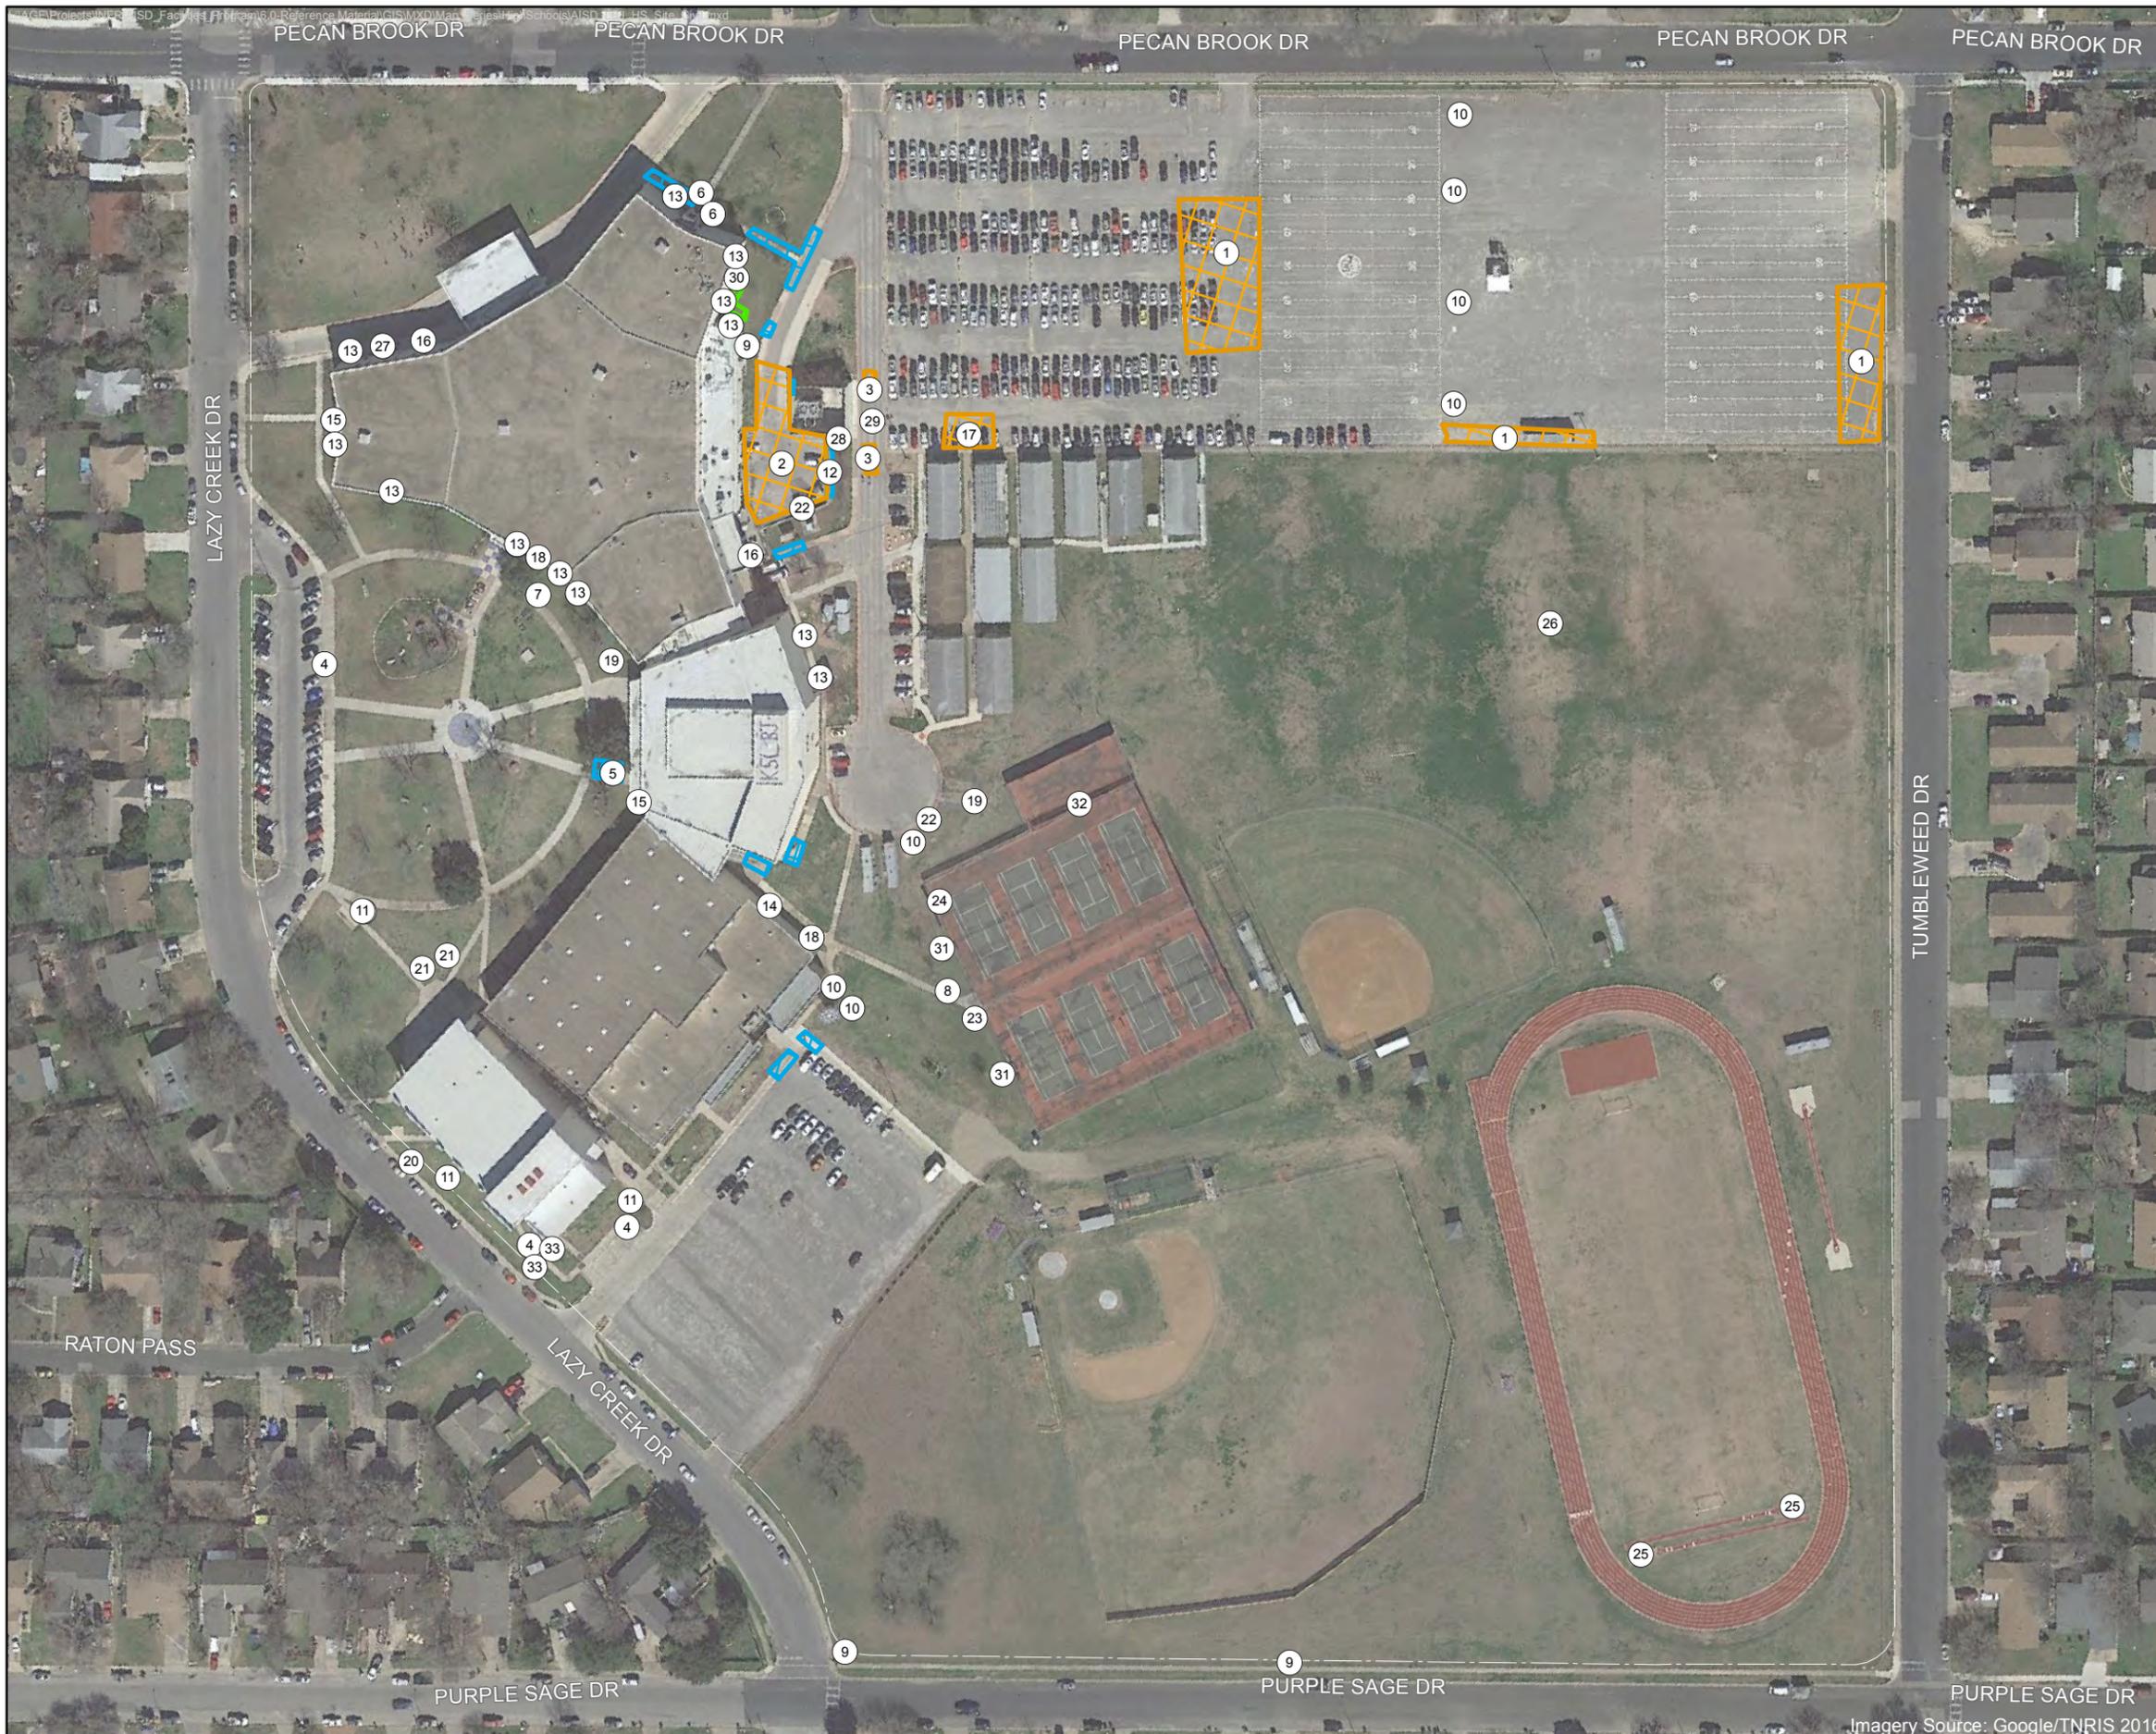
1. THERE IS RAVELING IN THIS AREA.
2. THERE IS ALLIGATOR CRACKING IN THIS AREA.
3. THERE IS A POTHOLE IN THIS AREA.
4. THE CONCRETE PAVEMENT IS BROKEN.
5. THE SIDEWALK IS BROKEN/HEAVING/SUNKEN IN.

9. THE FENCE IS BENT AND/OR BROKEN IN NEED OF REPAIR.
10. AREAS OF MATERIAL/DEBRIS/CONCRETE NEED TO BE REMOVED.
11. BIKE RACK
12. THE RETAINING/LANDSCAPE WALL IS DAMAGED.

17. THIS AN AREA OF KNOWN FLOODING ISSUES. (OBSERVED OR REPORTED)
18. THE IRRIGATION BOX IS MISSING A COVER.
19. THERE ARE LOW SPOTS THAT NEED TO BE FILLED IN.

33. DAMAGED HANDRAIL
