McCallum High School Site Summary

Address	5600 Sunshine Drive Austin, TX 78756
Number of Permanent Campus Facilities	8
Original Year of Construction	1953
Total Campus Building Area (combined)	265,022 SF

Main School Building – BLDG-005A

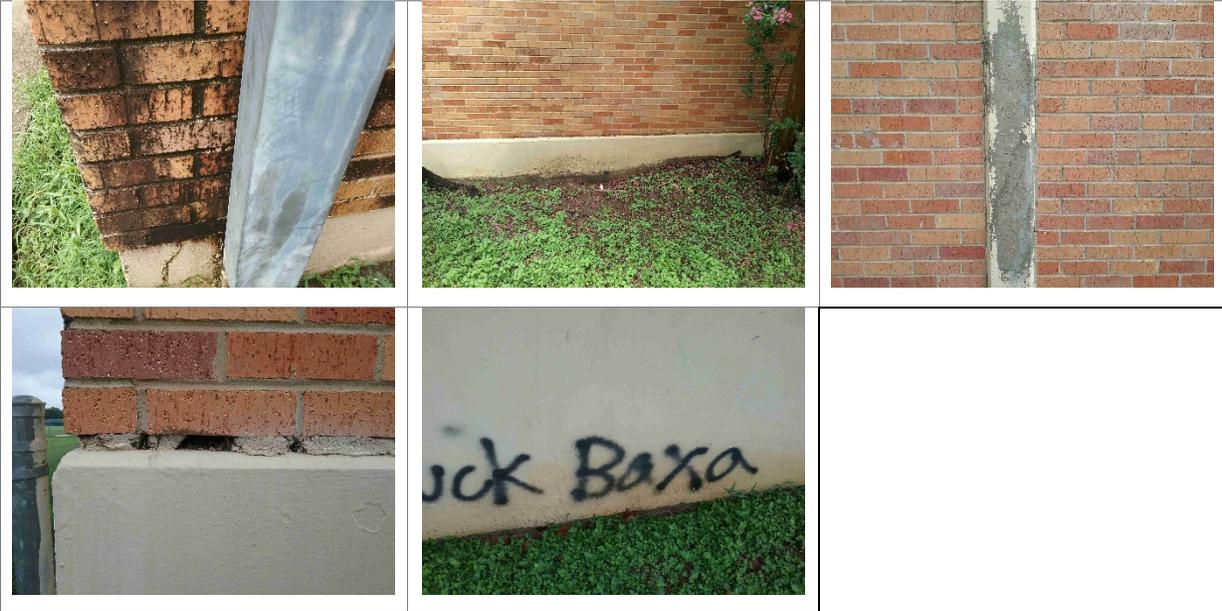
System	Subsystem	Condition and Deficiency Overview	System Condition Rating
Exterior	Exterior Walls	The exterior walls of the building are comprised of brick. The exterior walls were observed to be in good condition with a few minor issues. Discoloration was observed on the exterior walls. Soil erosion was observed in many areas at grade adjacent to the building foundation. The paint was worn off of some concrete pilasters in the courtyards. Deteriorated mortar was observed at the base of the brick wall. Graffiti was observed on one exterior wall.	Good
	Exterior Windows	The exterior windows are comprised of a single-pane glazing set in aluminum frames. The top half of each window is infilled with an opaque acrylic panel. The windows were observed to be in poor condition. Many of the windows were observed to have deteriorated sealant. Many holes and broken window panes were observed in the 100-wing. One set of exterior windows in the 100-wing corridor was pulling away from the wall opening. The wall was also damaged or unfinished. One pane had a half-inch gap between the pane and frame. Organic growth was observed on the exterior of the windows from the inside of room 125. Organic growth was also observed between many window panes and their frames. The library windows were in good condition. Peeling paint was observed on the concrete lintel above one storefront system. The metal lintels above the exterior	Poor

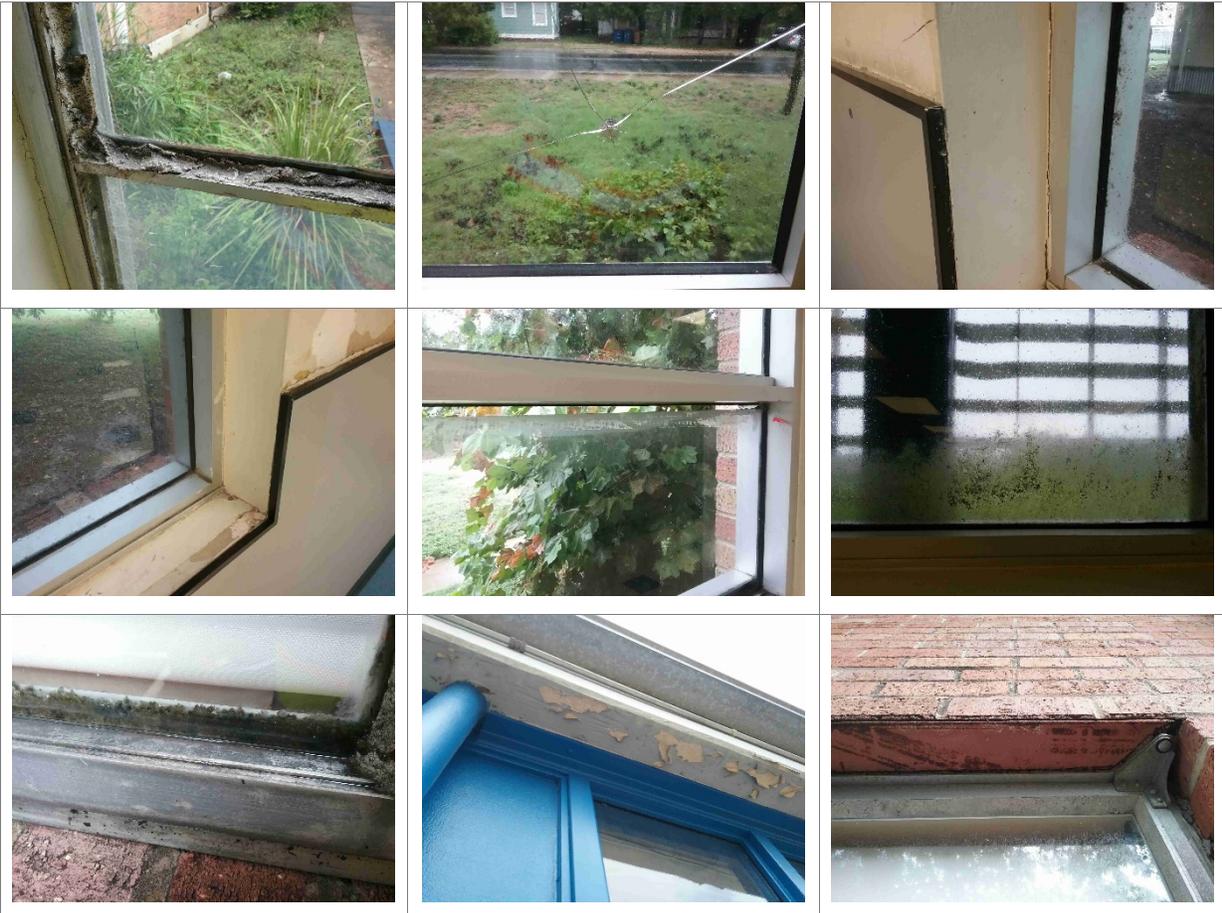
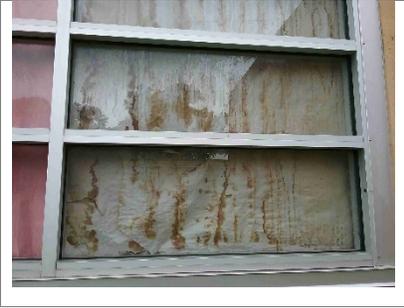
Exterior Windows

System	Subsystem	Condition and Deficiency Overview	System Condition Rating
		windows were aged. Evidence of water infiltration was observed through the windows in the 100-wing. Rooms 128, 126, and 135 were specifically observed to be affected. It was reported that rainwater leaked into the windows in rooms 108, 134, 136, 136A, 138, and the Special Ed office.	
	Exterior Doors	The exterior doors are half glazed, metal doors in metal frames with side lites and transom windows. The doors and frames were observed to be worn at areas of high use. The middle framing component was observed to be extremely scratched on many exterior doors.	Average
Roofing		<p>There is a modified bitumen roof with a white coating covering about a quarter of the building. This same roof acts as the floor of the roof penthouses. There is another newer, modified bitumen roof with a white coating covering about a third of the building. Additionally, there is a built-up roof system covering half of the building. It is topped with a granular cap sheet.</p> <p>The older modified bitumen roof membrane was observed to be very aged. Cracks and torn seams were present. Excessive ponding was observed on the roof, and corresponding leaks were observed in the interior of the school building. The white coating was almost completely deteriorated, and the remainder was very aged from sun exposure. Blisters and uneven surfaces were also observed on the roof. The roof was assessed the day after a rain event. The modified bitumen floors of the roof penthouses were flooded. Corrosion and rust were prevalent on all equipment supports.</p> <p>Deterioration was also observed on the newer modified bitumen roof membrane. The white coating was still intact, except in certain isolated areas. Leaks were also observed on the interior of the building underneath this roof. The metal panel siding adjacent to the modified bitumen roof had worn paint finishes. Dimpling was also observed in the roof surface. An entire segment of the roof (segment A-42) was flooded as there was only one blocked roof drain serving the area.</p> <p>The built-up roof was in poor condition as ponding was prevalent on the roof surface and leaks were present within the interior of the school. Vegetation and debris were observed around many roof drains, blocking the flow of water.</p>	Poor

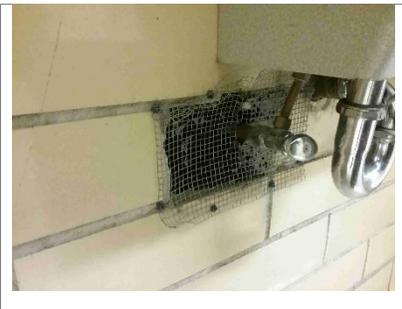
Interior Construction	Interior Walls	<p>The interior walls are comprised of ceramic-faced masonry units and metal studs covered with drywall and are accented by clerestory windows throughout the corridors. The kitchen walls are constructed of ceramic-faced masonry units.</p> <p>A portion of the masonry block was observed to be broken under a water fountain in the corridor. The kitchen walls were observed to be in good condition.</p>	Good
	Interior Doors	The interior doors are comprised of half-glazed wood doors in wood frames. Wood doors in metal frames also	Average

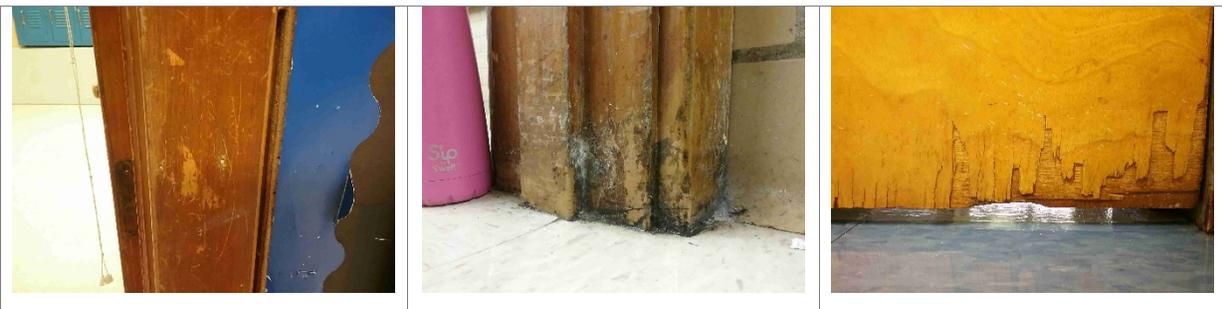
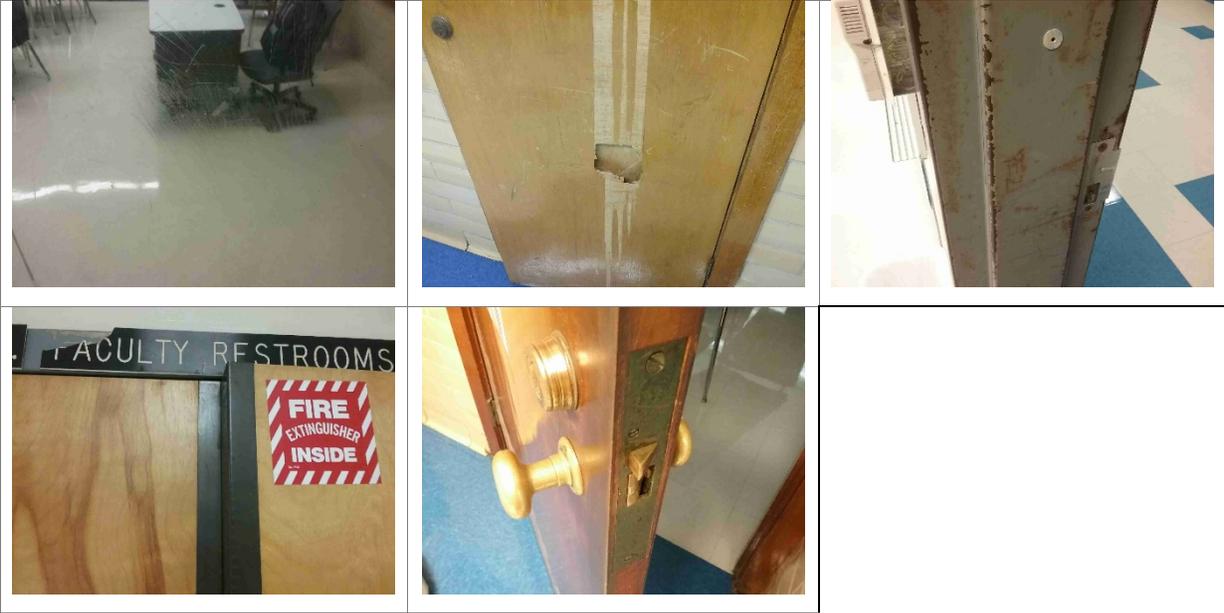
Interior Doors

System	Subsystem	Condition and Deficiency Overview	System Condition Rating
		<p>exist, and these doors have narrow wired lites. The remaining service doors and corridor doors are metal in metal frames.</p> <p>The doors were observed to be in average condition with worn finishes at typical areas of high use. The wood frames and doors were often damaged. A hole was observed in one door. Some of the vision glazing was scratched. The metal frames were observed to have scratched finishes. The doors to the electrical equipment room and to room 123 in the 100-wing were not plumb and would not shut. The hardware on the door to room 126 was stuck and would not deploy the latch.</p>	
	Interior Specialties	<p>There are recessed, painted metal lockers in the corridors.</p> <p>The lockers were observed to have worn finishes. Some lockers were missing hardware.</p>	Average
Stairs	Exterior Stairs	<p>A series of exterior stairs provides access to the exterior doors. They are concrete stairs with metal nosings and metal handrails.</p> <p>The exterior stairs were observed to be in average condition as many of the stair nosings were broken; both concrete and metal. A concrete stair was observed to be separating from the stairs beneath it. The paint on the handrails was also worn.</p>	Average

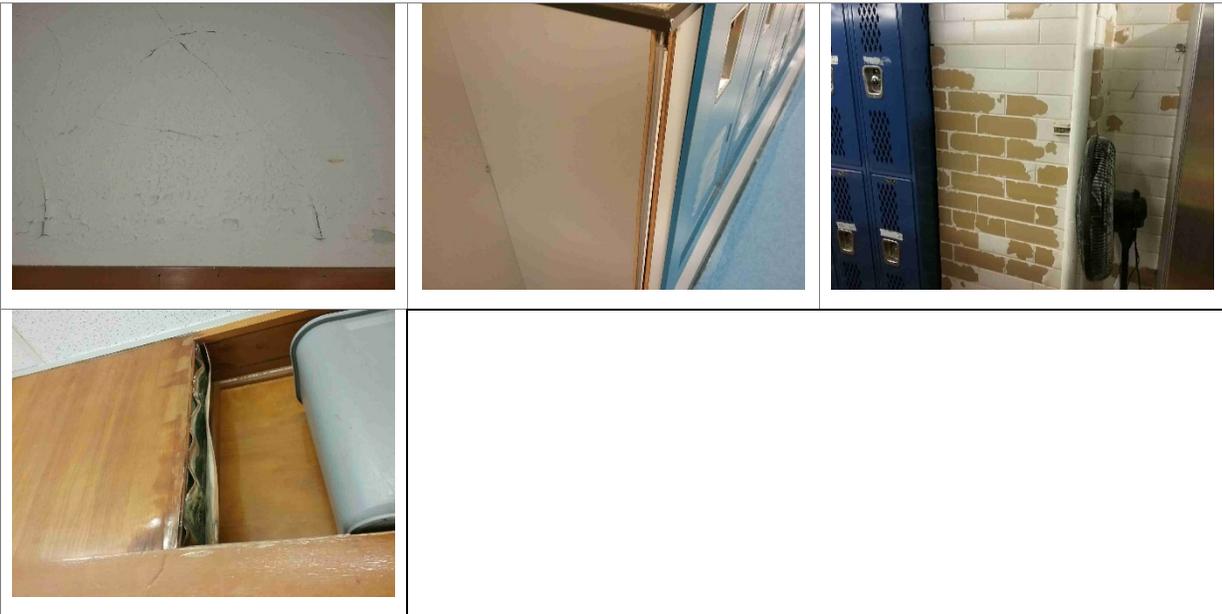
Interior Stairs	System not present.	N/A
Interior Finishes	Interior Wall Finishes	<p>The interior walls are finished with unpainted ceramic masonry units, painted masonry units, painted drywall, painted plaster, and extensive wood paneling throughout the corridors and classrooms. Where drywall exists in the corridors, a damage-resistant paneling system acts as a wainscot. The kitchen walls, constructed of ceramic-faced masonry units, are left unfinished. The locker rooms are finished with painted masonry units and painted plaster.</p> <p>The wood paneling was observed to be in good condition both in the corridors and in the classrooms except at one water-damaged location. Crackling paint was observed on some of the drywall classroom walls. Some of the wainscot was damaged. The paint in the locker rooms was in poor condition.</p>	Average
	Interior Floor Finishes	The floors are finished with linoleum tiling, ceramic tile in the restrooms, carpet in the administration wing, and wood flooring on the stage and gymnasium floors.	Average

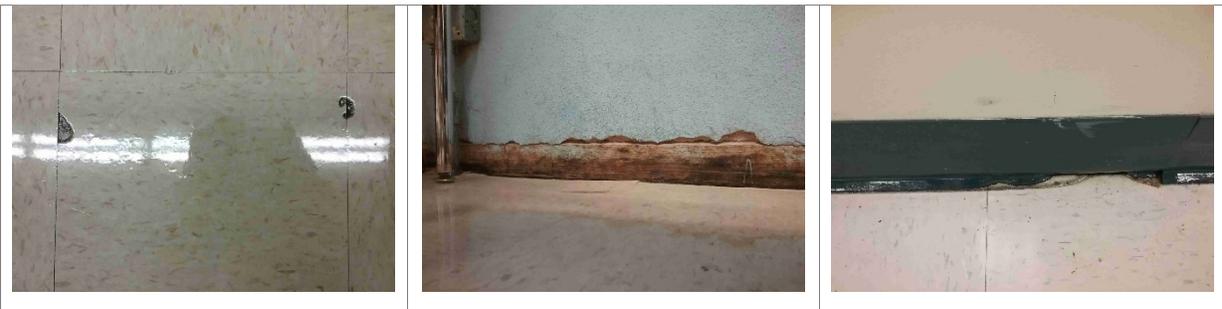
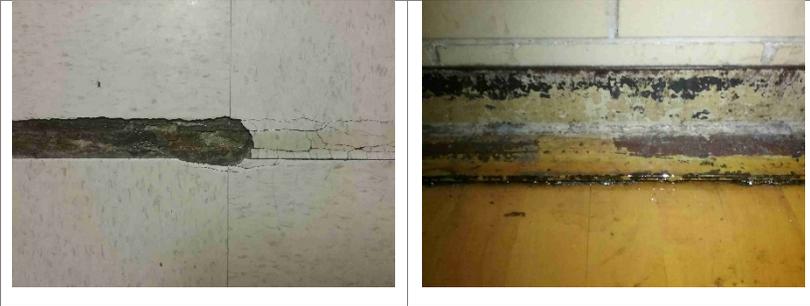
Interior Floor Finishes

System	Subsystem	Condition and Deficiency Overview	System Condition Rating
		<p>Rubber wall base is also present on drywall walls. The kitchen floor is finished with ceramic tile.</p> <p>Chipped and broken linoleum tiles were observed. The English office was missing a wall base. Much of the rubber base was dented and damaged in the classrooms. The kitchen floor was in good condition. The cafeteria floor was in good condition. The linoleum tile floor outside of the gymnasium was unwaxed with many broken tiles. The gymnasium floor was in good condition. The wall base in the small gymnasium was in poor condition, very aged and discolored.</p>	
	Interior Ceiling Finishes	<p>The interior ceilings are finished with ACT (acoustic ceiling tile) in the corridors, library, cafeteria, and classrooms, and the restrooms are ceiled with drywall. The kitchen is ceiled with lay-in moisture resistant tiles. The gymnasium is ceiled with lay-in panels.</p> <p>The ceiling finishes were observed to range from good to failing condition. Popped ceiling tiles and chipped ceiling tees were observed throughout the corridors. Water-damaged tiles were also observed in the corridors and classrooms of the 100-wing (rooms 114, 113, and 141 and corridors C2, C6, and C9). Mold was observed on the ceiling in the C2 corridor. The cafeteria ceiling was in good condition, except for some torn ACT tiles and slight water damage at a structural kicker. The kitchen ceiling was in good condition. The ceiling grid in corridor C8 was tilted and askew. The gymnasium ceiling was in failing condition as every ceiling panel was torn on the surface. The small amount of lay-in ACT tiles in the middle of the gymnasium were observed to have mismatched tiles. The ceiling of the small gymnasium was in good condition.</p>	Average

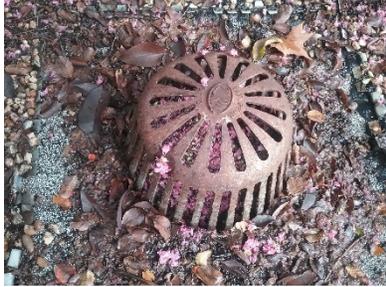
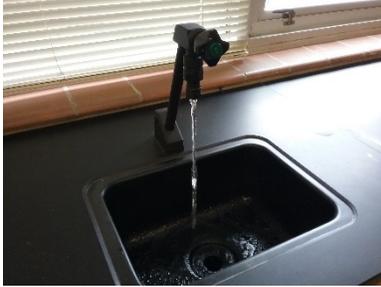
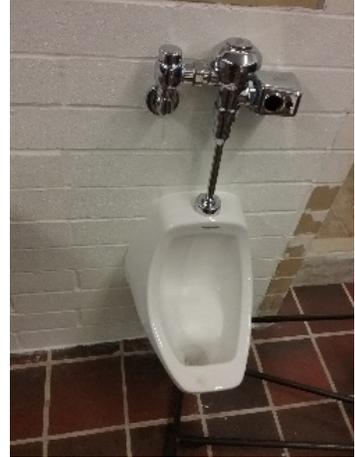
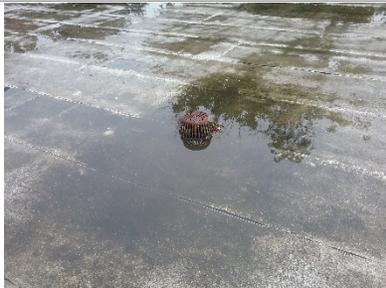
System	Subsystem	Condition and Deficiency Overview	System Condition Rating
		<p>The restroom plumbing fixtures were observed to be in good condition as the fixtures were typically aged but still operational.</p> <p>The building has other specialty locations with plumbing fixtures, including a kitchen for the school cafeteria and home economics classrooms. These plumbing fixtures were observed to be in good condition.</p> <p>Several of the urinals in the male locker room had new automatic flush valves. It was observed that it took several flush cycles to fully flush the contents of the urinal. No water closets were observed to have new flush valves.</p> <p>There was a single-compartment sink in room 161 that was not draining at the time of observation.</p> <p>There was a science sink in room 143 that did not appear to have adequate flow through the faucet.</p>	
	Domestic Water Distribution	<p>All of the plumbing fixtures are serviced with domestic cold water. There are GWHs (gas water heaters) within the kitchen space, and several additional EWHs (electric water heaters) are located within janitorial closets.</p> <p>The domestic water distribution system observed in the building appeared to be in average condition. The GWHs in the kitchen area were aged and showing signs of wear. The remaining EWHs were observed to be in good condition.</p> <p>It was observed that it took several minutes to obtain warm water in the home economics classroom.</p>	Average

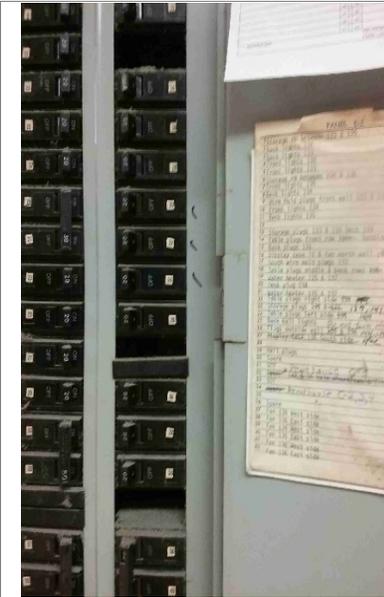
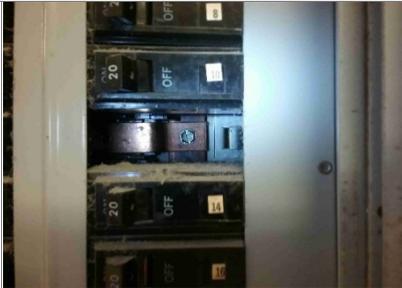
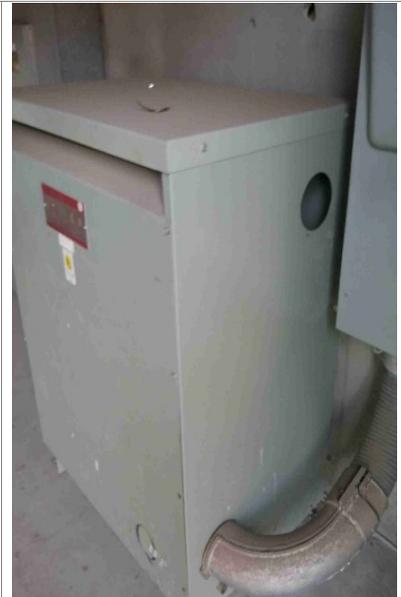
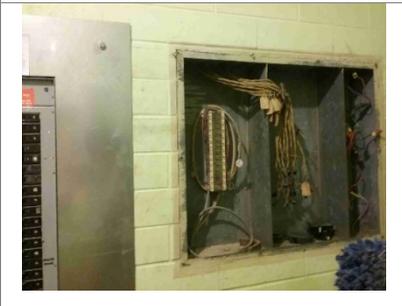
Electrical Distribution

System	Subsystem	Condition and Deficiency Overview	System Condition Rating
		<p>The electrical distribution equipment was observed to be in average condition. Facility staff reported that the kitchen panelboard R no longer had spare capacity to accommodate future loads. They also reported that the teachers' lounge microwave caused frequent circuit breaker trips. Panelboard G-2 in corridor C9 was missing circuit breaker covers. In room CC155, abandoned electrical enclosures being used for telephone and electrical junction boxes were exposed with no covers. In electrical room ELEC130, the 150KVA transformer had an open hole.</p> <p>The building does not have a lightning protection system.</p>	
	Lighting	<p>The building exterior lighting consists of HID (high-intensity discharge) light fixtures located along the entire perimeter. The interior lighting consists of 2'x4' fluorescent recessed troffers and 1'x4' surface mounted fluorescent light fixtures.</p> <p>The facility staff reported that the exterior lighting was inadequate along the eastern wall outside the small gymnasium.</p> <p>The interior and exterior lighting appeared to be in good condition. There were exit signs present in the building that appeared to be in good working condition.</p>	Good

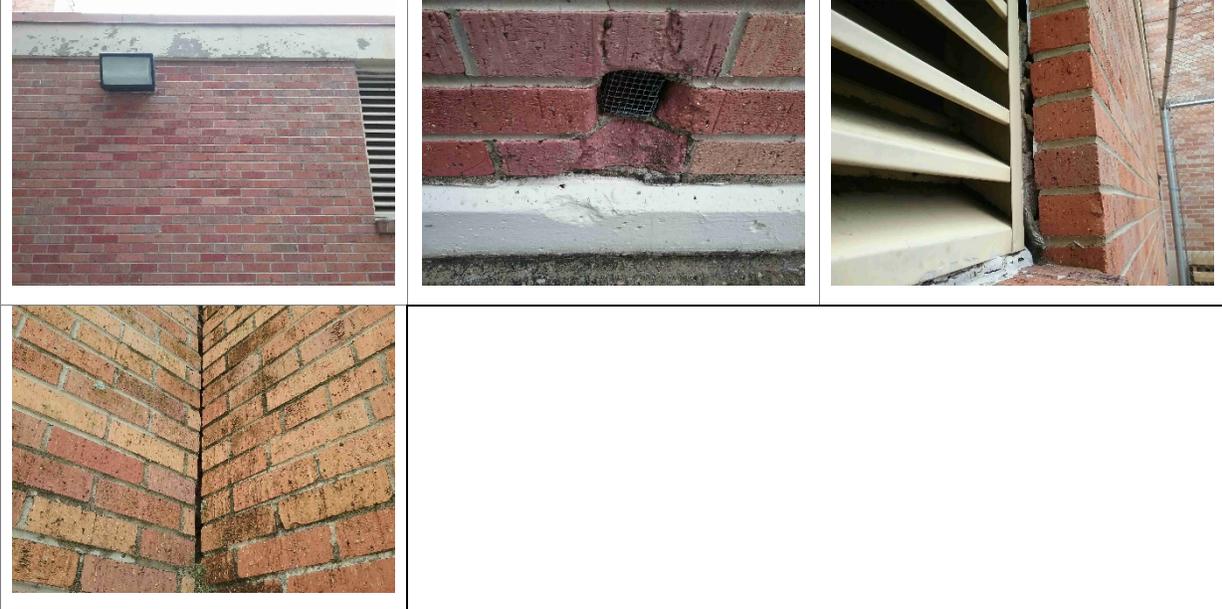
System	Subsystem	Condition and Deficiency Overview	System Condition Rating
Exterior	Exterior Walls	<p>The exterior walls of the mechanical building are clad with brick. There is a painted concrete beam at the top of the walls.</p> <p>The wall was observed to be in average condition with chipped paint on the concrete and a few broken bricks. The sealant around the louvers was aged and deteriorated, exposing a gap between the brick wall and the interior wythe. The boiler stack was separating from the mechanical building wall.</p>	Average
	Exterior Windows	System not present.	N/A
	Exterior Doors	<p>There is one main entrance to the mechanical building. This entrance is comprised of metal double doors with transom windows. The remaining service doors are also metal.</p> <p>The condition of the exterior doors varied. The main entrance doors were observed to have a corroded metal frame and bent weather stripping. One pane of the transom windows above the door had been replaced with acrylic glazing. The acrylic material was observed to have been damaged.</p>	Average

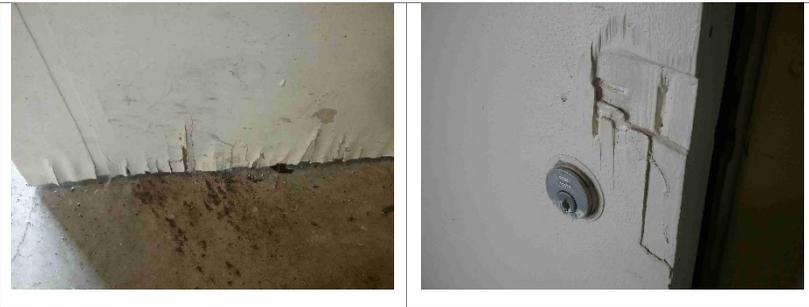
System	Subsystem	Condition and Deficiency Overview	System Condition Rating
		because significant cracks were observed both between the bricks and through the bricks.	
	Interior Doors	There is one interior door in the building leading to the restroom. The door is wood in a wood frame. The door was observed to be in poor condition with excessive water damage at the base. Some wood was also observed to be chipped from the door.	Average
	Interior Specialties	System not present.	N/A
Stairs	Exterior Stairs	System not present.	N/A
	Interior Stairs	There is one set of concrete stairs in the interior of the building providing access from ground level to the sunken finish floor of the building. The stairs were observed to be in good condition with no visible damage.	Good
Interior Finishes	Interior Wall Finishes	The interior of the building is painted. The interior finish was observed to be in average condition. Chipped paint was observed. Many cobwebs were observed.	Average

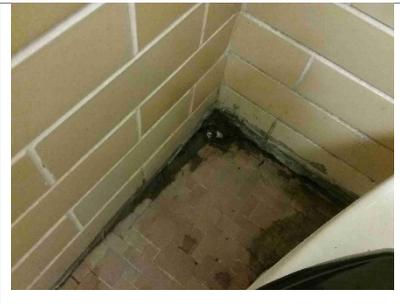
Interior Floor Finishes	The majority of the floor finish in the building is concrete. There is a small restroom in the building which is floored with linoleum tile. The concrete floor was observed to be in good condition, but the linoleum restroom floor was aged and dirtied at the corners.	Average
	Interior Ceiling Finishes	The ceiling is finished with metal panel. Rust was observed on the ceiling support tees across the entire room. Cracks were observed on many of the ceiling panels.	Poor
Conveying	System not present.		N/A
Plumbing	Plumbing Fixtures	The building has one restroom for staff located in the facility. This restroom has a vitreous china wall-mounted lavatory, along with vitreous china floor-mount toilets with manual flushing mechanisms. The restroom plumbing fixtures were observed to be in average condition as the fixtures were typically aged but still operational.	Good

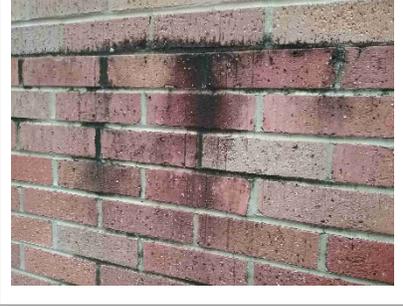
System	Subsystem	Condition and Deficiency Overview	System Condition Rating
Exterior	Exterior Walls	The exterior walls are brick. Very small amounts of discoloration were observed on the exterior walls.	Good
	Exterior Windows	The exterior windows consist of fixed windows in aluminum frames. The glazing is single-pane. The metal lintels on the exterior windows were aged and rusting.	Average
	Exterior Doors	The exterior doors are comprised of half-glazed, painted, metal double doors set into a system of side lites and transom windows. The finishes on the exterior doors were worn in typical places. Water leakage was observed at the threshold of the exterior doors leading to the dance studio.	Average
Roofing	The roof was inaccessible at the time of assessment due to weather conditions. It was not assessed, but very little water damage was observed inside the building. Soil erosion was noted at the downspouts terminating at grade.		Average

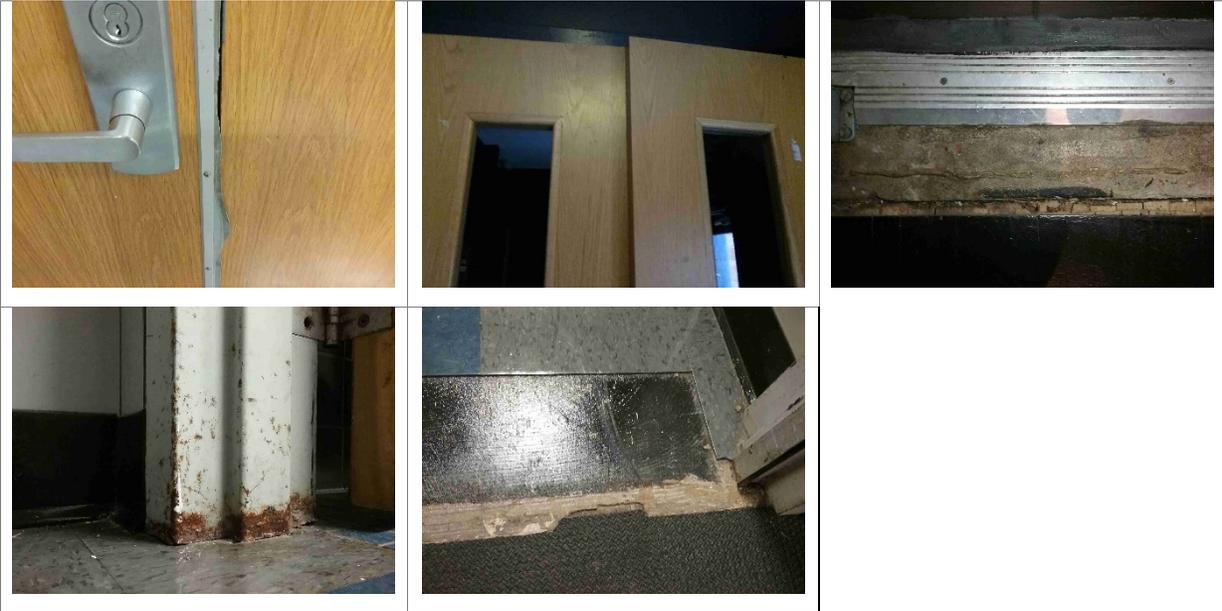
Interior Construction	Interior Walls	The interior walls are comprised of metal stud construction finished with drywall. Interior walls were observed to be in good condition with no deficiencies observed beyond the finishes.	Good
	Interior Doors	The interior doors are wood with metal frames. They have narrow lites and metal kickplates. The threshold sealant on the theater door was observed to be pulled out of place. The doors leading to the dance studio and band room were wood double doors.	Average

System	Subsystem	Condition and Deficiency Overview	System Condition Rating
		They were not plumb and were difficult to close. The threshold exiting the stage doors was incomplete, causing a half step between flooring materials. The restroom door frames were rusted at the bases. The door to the classical guitar classroom was missing a threshold.	
	Interior Specialties	System not present.	N/A
Stairs	Exterior Stairs	System not present.	N/A
	Interior Stairs	System not present.	N/A
Interior Finishes	Interior Wall Finishes	The interior walls are finished with painted drywall and FRP (fiber-reinforced plastic) panels acting as a wainscot. Interior wall finishes were observed to be in average condition with various deficiencies. Some of the wall finish was poorly patched, and some of the wall finish was broken at thresholds and corners. Much of the walls were observed to be scratched and dented. Drywall was ripped from many different corners.	Average

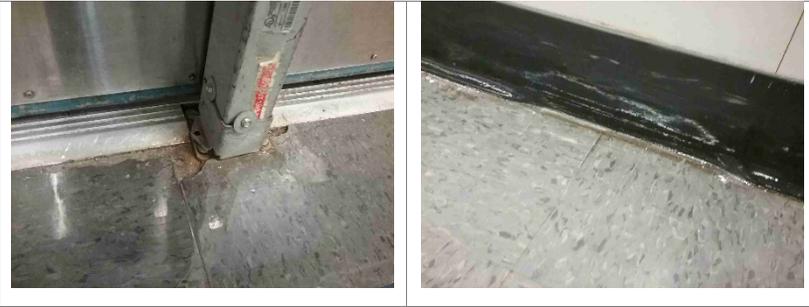
Interior Floor Finishes	The interior floor is finished with linoleum tile and rubber wall base. The theater aisles and offices are finished with carpet. The stage and dance studio floors are wood. The dance studio also has a rubber sheet layer taped to the floor. The restrooms have ceramic tile floors. Some linoleum tile was observed to be broken, especially near door thresholds. Additionally, a small area of rubber base was dented into the wall.	Average
	Interior Ceiling Finishes	The interior ceiling is finished with ACT (acoustical ceiling tile) and drywall with adhered acoustical panels. A portion of the drywall soffit in a music room was observed to be very damaged by water. Dripping water was observed at the time of assessment. Some of the ACT was torn or popped out of place. Some of the adhered acoustical panels in the entryway were discolored and possibly water-damaged at the edges.	Average

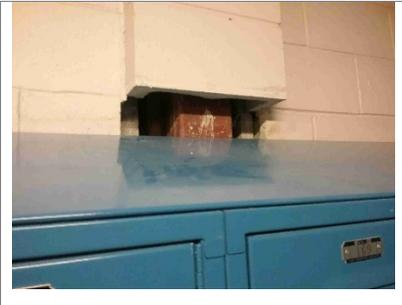
Interior Construction	Interior Walls	The interior walls are constructed of CMU (concrete masonry unit) up to 11 feet. Above that, they are constructed with metal studs and drywall to deck. The building was undergoing major renovations at the time of assessment. The interior walls were in good condition with little damage. The CMU walls of the old dance changing room were observed to expose the structure behind the wall.	Good

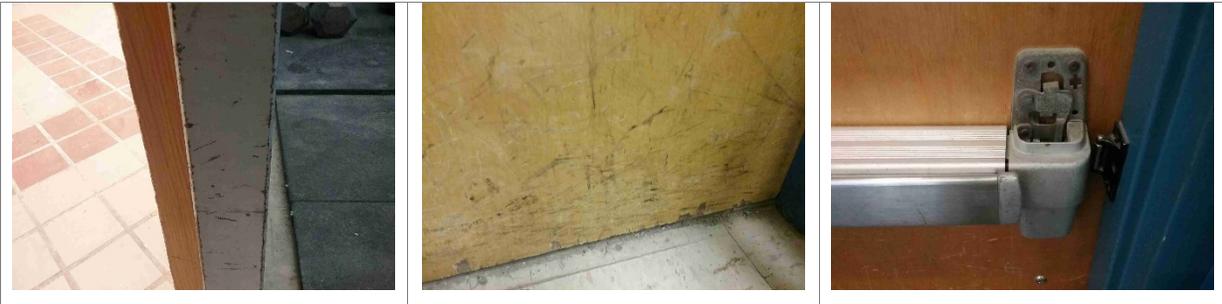
System	Subsystem	Condition and Deficiency Overview	System Condition Rating
	Interior Doors	<p>The interior doors are wood doors in metal frames.</p> <p>The interior doors were observed to be in good condition with slight wearing on the door frames as is typical of use. The wood on some doors was scratched from use as well, and one door was observed to have broken panic hardware.</p>	Good
	Interior Specialties	<p>There are metal athletic lockers throughout the facility.</p> <p>The new lockers were observed to be in good condition, but the old lockers had corroded finishes.</p>	Average
Stairs	Exterior Stairs	<p>The exterior stairs of the building are concrete and provide access to various service doors. The handrails are painted metal.</p> <p>The stairs were observed to be in average condition with noticeable wear and tear; the anti-slip nosings were excessively damaged at every step. The handrails were also observed to be in average condition with worn paint.</p>	Average

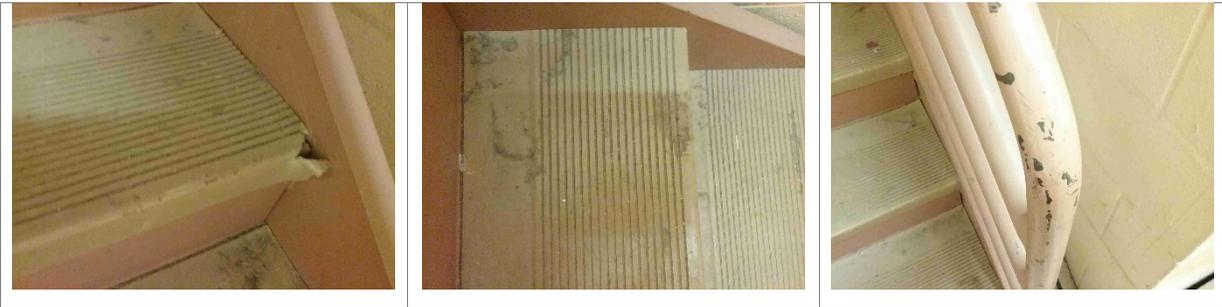
Interior Stairs	<p>There is one staircase inside the building, providing access to the mezzanine. The stairs are metal and finished with rubber treads. The handrails are painted metal.</p> <p>Many of the treads had damaged rubber, and all of the treads had stained, dirty rubber. The paint on the handrails was observed to be worn away.</p>	Average
Interior Finishes	Interior Wall Finishes	<p>Both the CMU and drywall walls are painted. There is wood molding highlighting the connection of the two materials. The shower rooms are finished with glazed ceramic tile.</p> <p>The wall finishes were observed to be in good condition with typical scuffs and small chips off the paint. Wear and tear were not noticeable on the majority of wall finishes. The interior of the janitorial closet was more stained than any other area of the building. The finish on one wall in the old male dressing room was damaged from water.</p>	Good

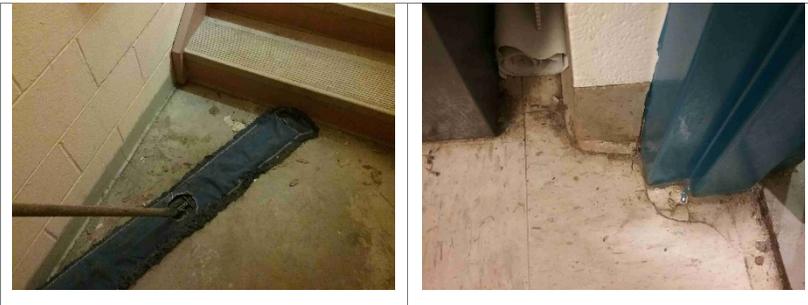
Interior Floor Finishes	<p>The interior floors are finished with a variety of materials, including ceramic tile, linoleum sheeting, and wood. The weight room floor is covered with athletic rubber tile.</p> <p>The building was undergoing major renovations at the time of assessment. Though construction-related debris was common on the floor finishes, the floor of the janitorial closet was observed to be especially littered.</p>	Good

System	Subsystem	Condition and Deficiency Overview	System Condition Rating
		The floor in the coach's office was observed to be aged with small chips in the material.	
	Interior Ceiling Finishes	<p>The ceilings in the building are finished with wood wool panels and lay-in water-resistant ceiling tiles. The restrooms and locker rooms are ceiled with painted drywall.</p> <p>The building was undergoing major renovations at the time of assessment, and many of the ceiling tiles had been removed for access. The ceilings were observed to be in good condition. The paint finishes on the new shower room and old dance changing room ceilings were peeling. The ceilings of the old dance shower room and JV football shower room were falling in from water damage.</p>	Average
Conveying	System not present.		N/A
Plumbing	Plumbing Fixtures	<p>The building has several locker rooms. These rooms typically have vitreous china hand sinks in counters with manual faucets, along with vitreous china, wall-mounted toilets with manual flushing mechanisms.</p> <p>The building was under construction at the time of assessment, and the areas containing plumbing fixtures were not able to be observed.</p>	N/A

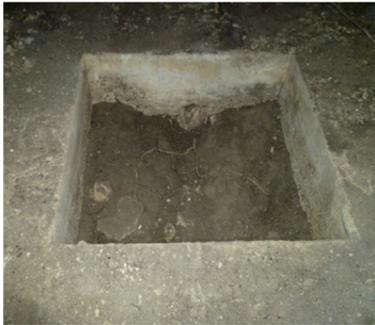
Water infiltrating crawl space from outside perimeter of building

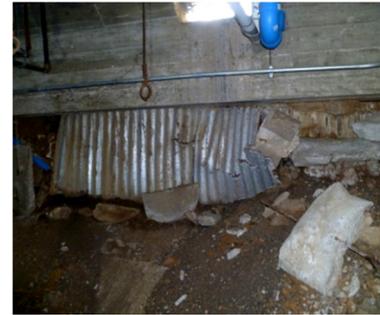
Failing soil retainers, major soil intrusion at perimeter

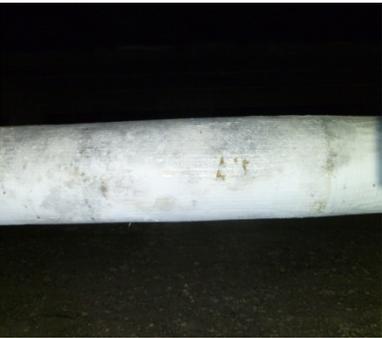
<p>Mild pipe insulation mold</p>

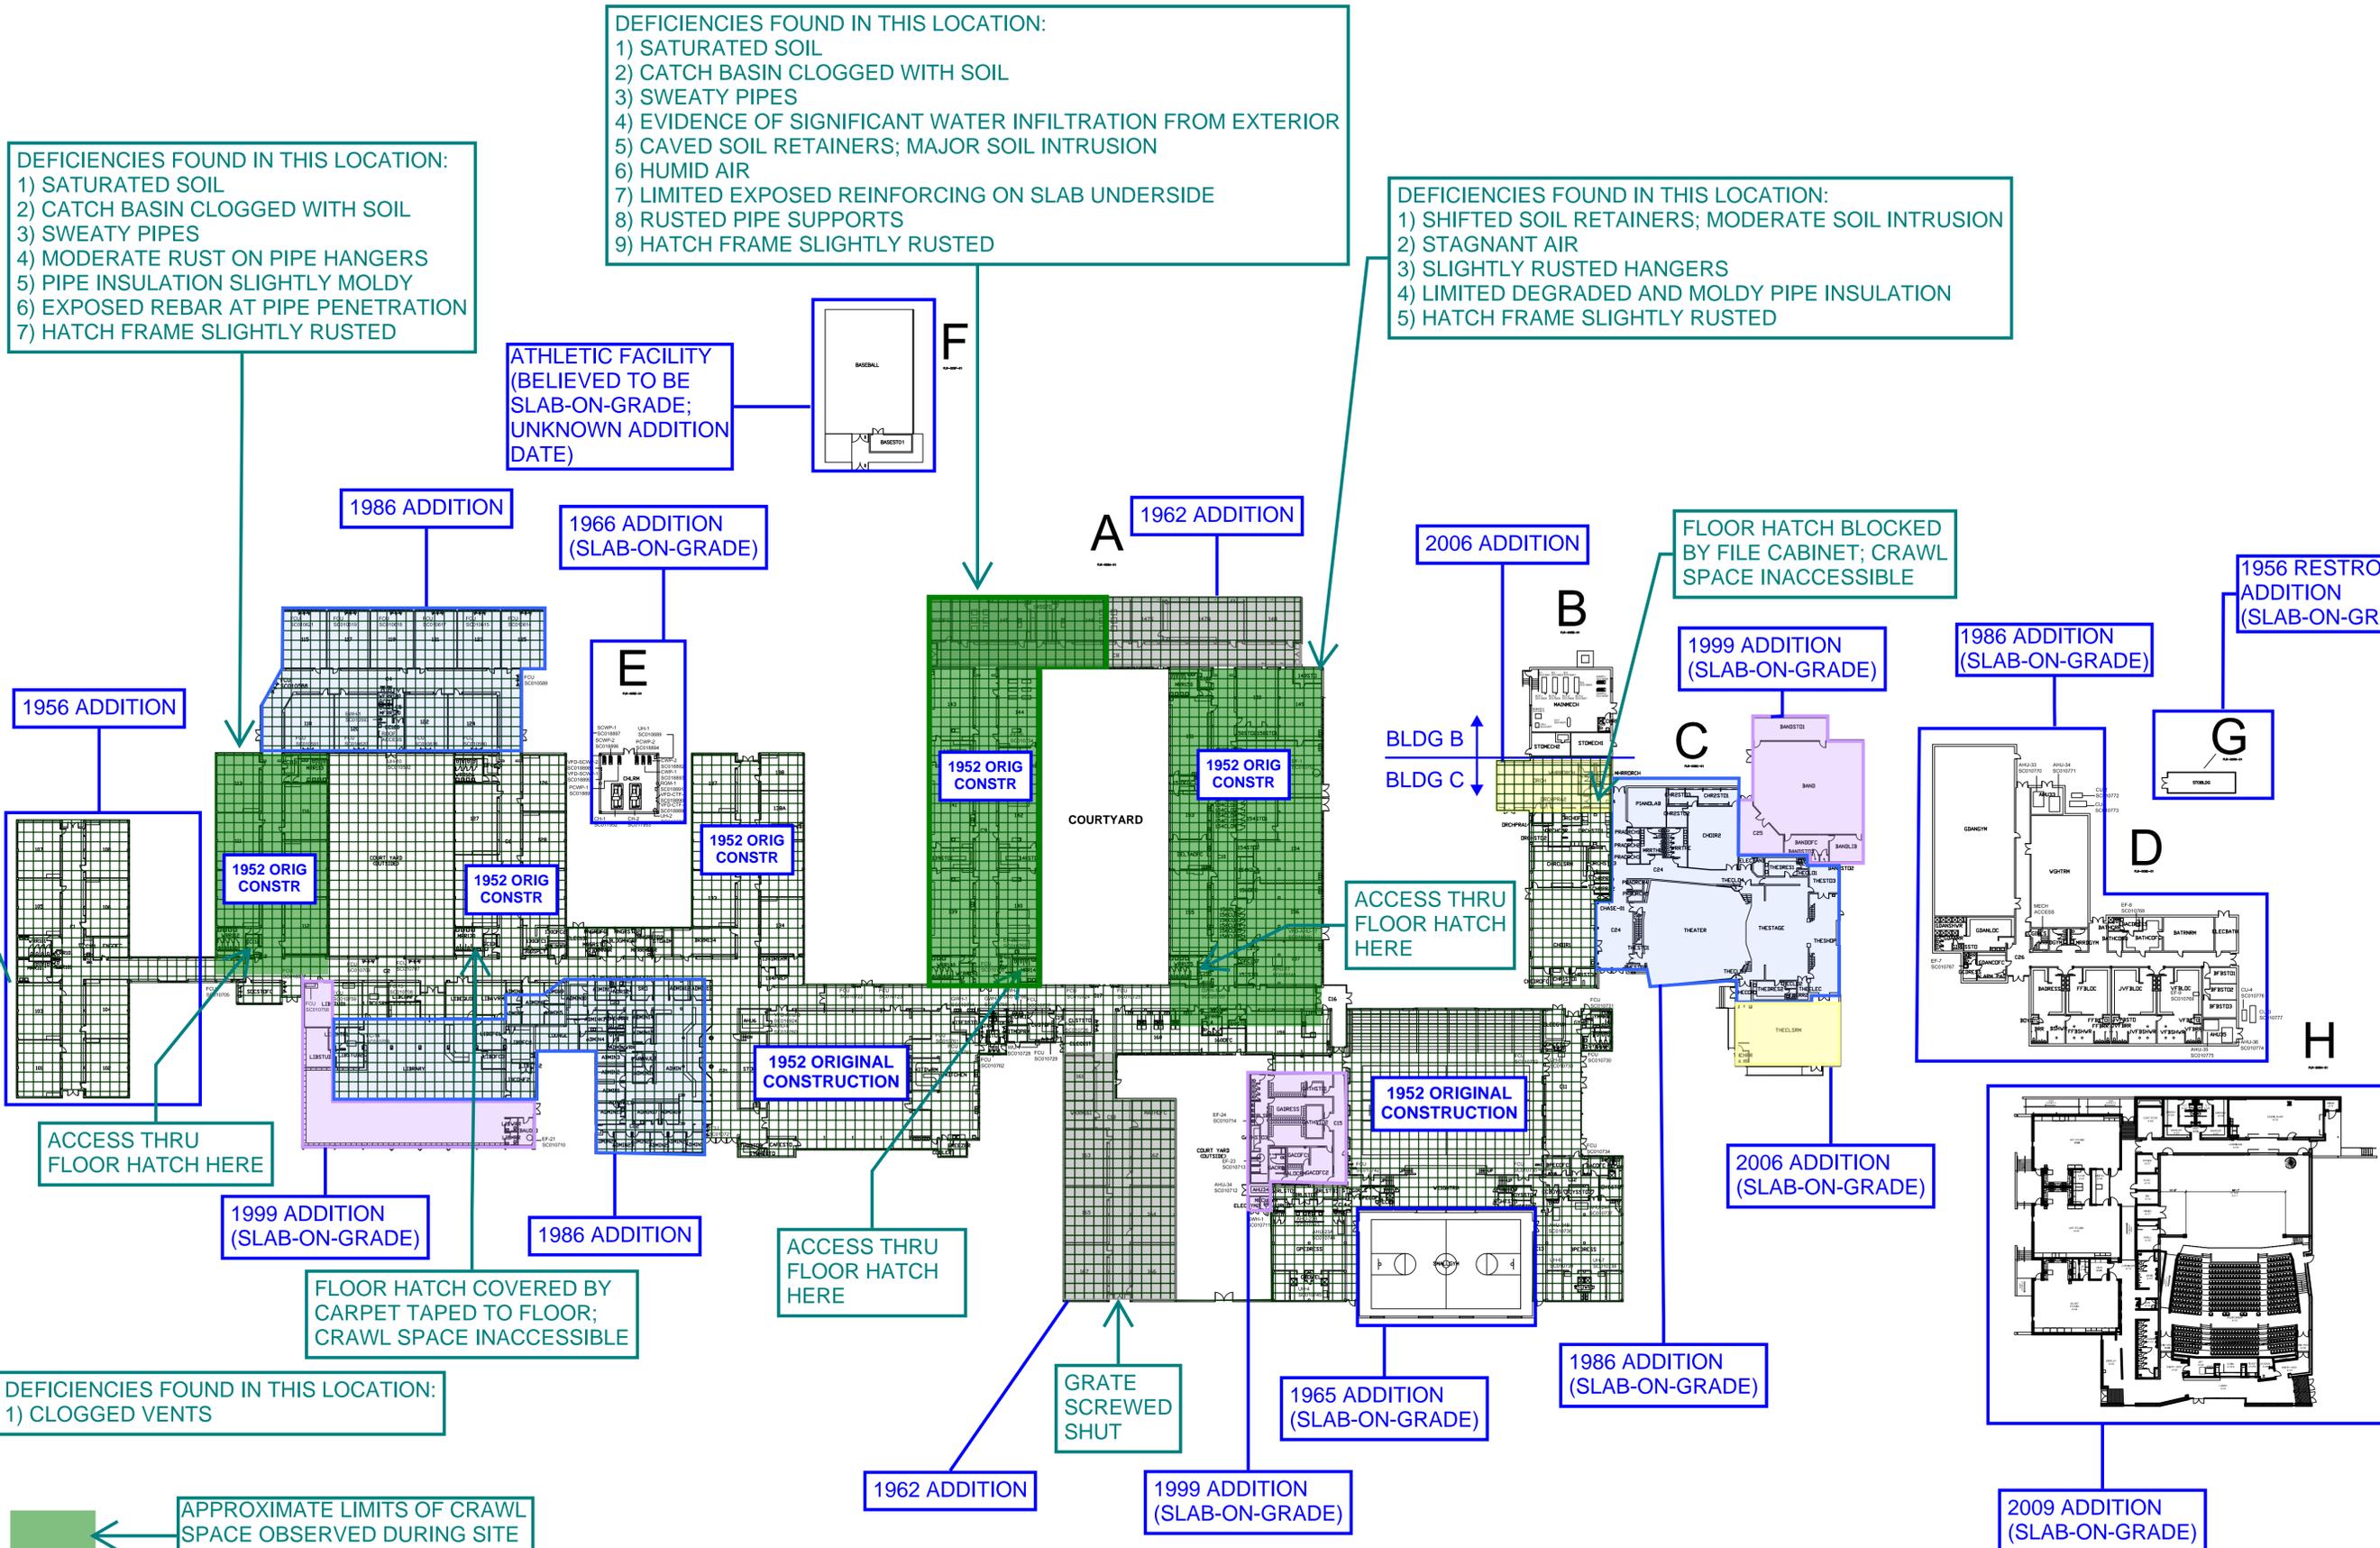
DEFICIENCIES FOUND IN THIS LOCATION:
 1) SATURATED SOIL
 2) CATCH BASIN CLOGGED WITH SOIL
 3) SWEATY PIPES
 4) EVIDENCE OF SIGNIFICANT WATER INFILTRATION FROM EXTERIOR
 5) CAVED SOIL RETAINERS; MAJOR SOIL INTRUSION
 6) HUMID AIR
 7) LIMITED EXPOSED REINFORCING ON SLAB UNDERSIDE
 8) RUSTED PIPE SUPPORTS
 9) HATCH FRAME SLIGHTLY RUSTED

DEFICIENCIES FOUND IN THIS LOCATION:
 1) SHIFTED SOIL RETAINERS; MODERATE SOIL INTRUSION
 2) STAGNANT AIR
 3) SLIGHTLY RUSTED HANGERS
 4) LIMITED DEGRADED AND MOLDY PIPE INSULATION
 5) HATCH FRAME SLIGHTLY RUSTED

DEFICIENCIES FOUND IN THIS LOCATION:
 1) CLOGGED VENTS

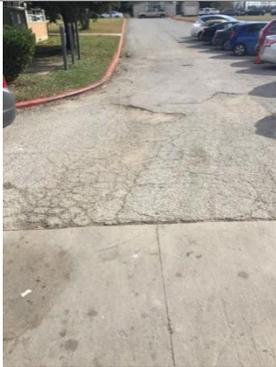
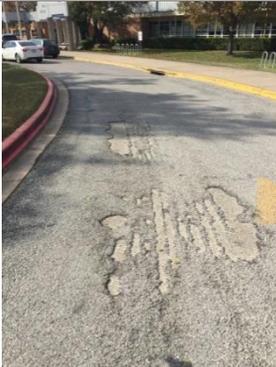
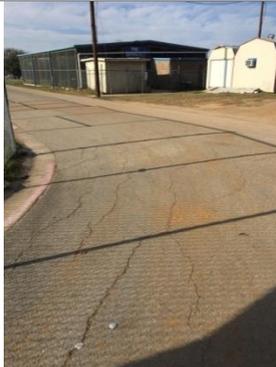
Roadways

Parent drop off road potholes and alligator cracking	Parent drop off road delamination	Baseball road longitudinal cracking

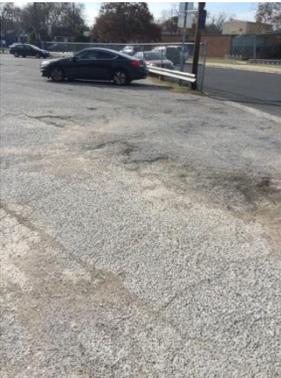
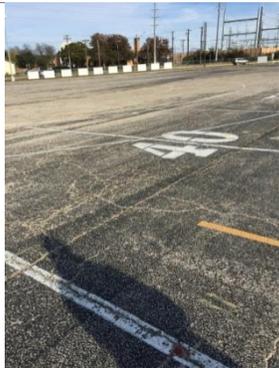
Parking Lots

Service/mechanical road, low pavement near manhole.	P3 raveling, potholes patches	P5 longitudinal cracking and alligator cracking old sealcoat

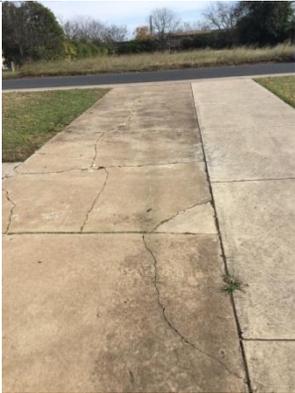
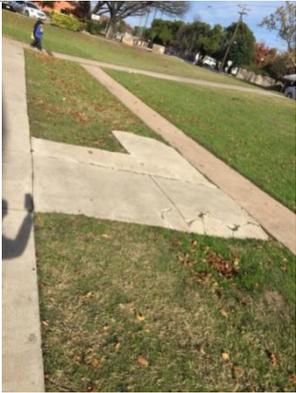
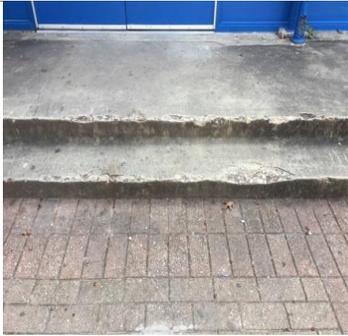
Pedestrian Paving

<p>Broken sidewalk to replace</p>	<p>Broken sidewalk to remove</p>	<p>Stairs, chipped concrete</p>

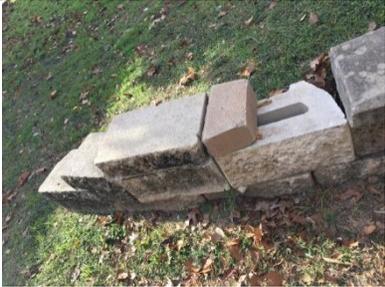
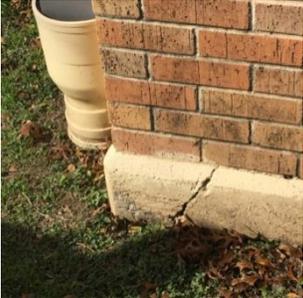
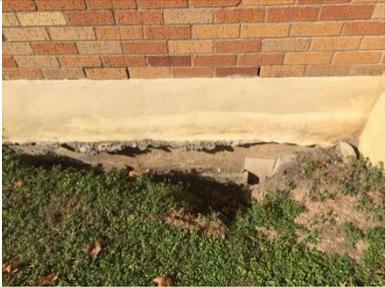
Site Development

<p>Broken retaining wall</p>	<p>Broken foundation corner</p>	<p>Pest holes (6+) on exterior of building</p>

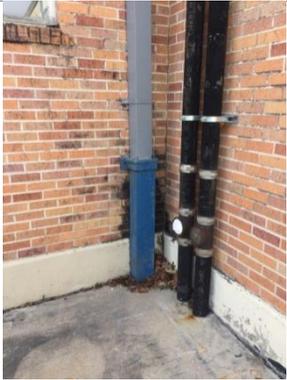
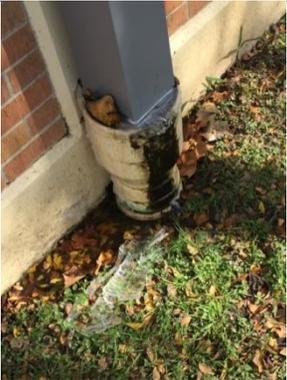
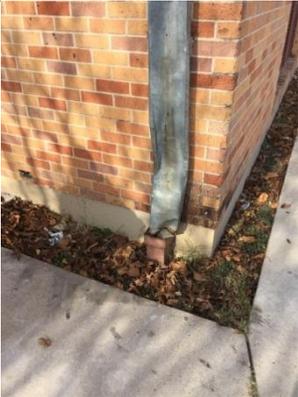
Site Drainage

<p>Clogged Downspout</p>	<p>Clogged Downspout</p>	<p>Broken Downspout</p>

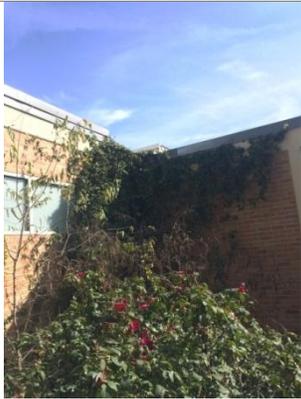
Courtyard/Landscaping

Overgrown vine in the interior courtyard	Grass worn in performance area	Sidewalk overgrown by primrose jasmine

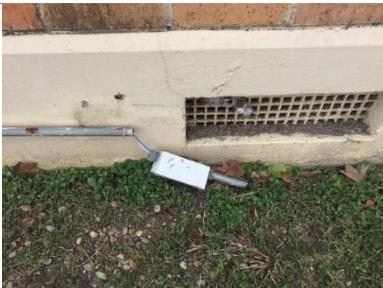
Storm Sewer and Other Site Utilities

Storm sewer infiltration	Broken electrical conduit for perimeter light	HVAC valve releasing water onto fence.

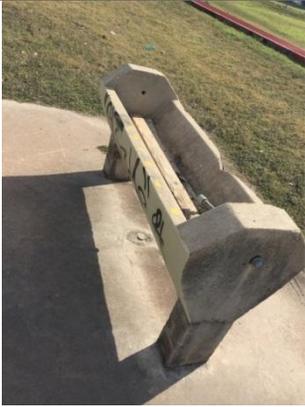
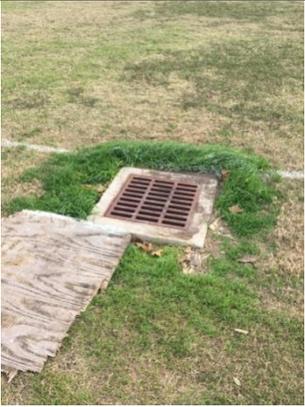
Football Field

<p>Remove fountain at football field</p>	<p>Drainage inlet needs backfill at football field</p>
