Reagan Early College High School Site Summary

Address	7104 Berkman Drive Austin, TX 78752
Number of Permanent Campus Facilities	9
Original Year of Construction	1965
Total Campus Building Area (combined)	253,072 SF

Administration Building – BLDG-006A

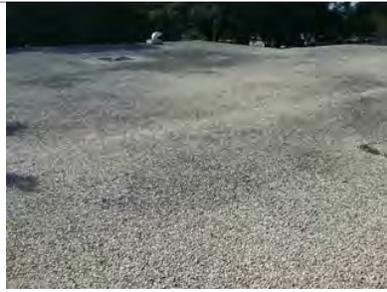
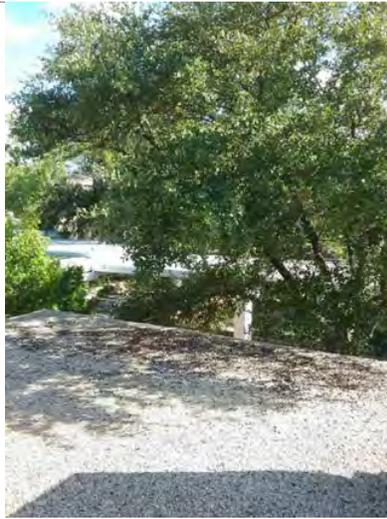
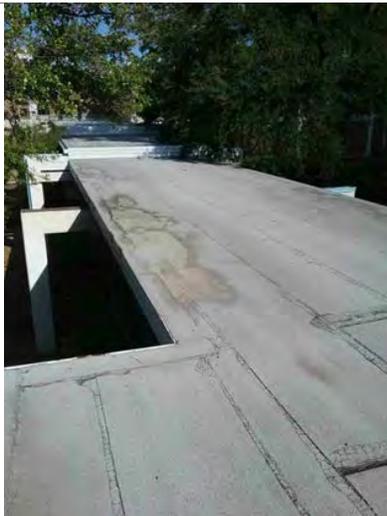
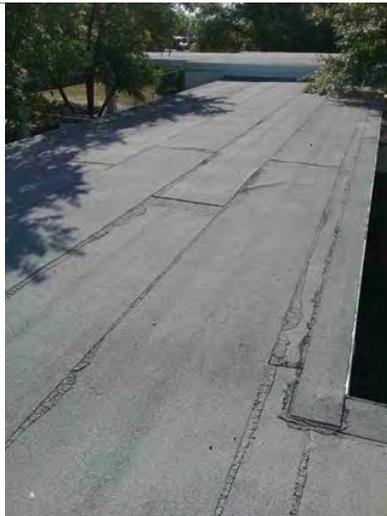
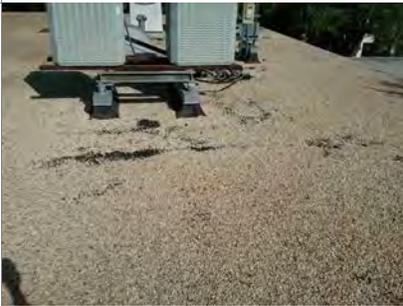
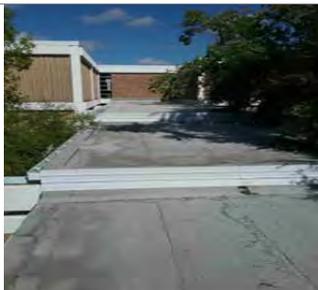
Roofing Deficiency Examples

System	Subsystem	Condition and Deficiency Overview	System Condition Rating
		<p>The following deficient conditions were observed on the main building roof surface: evidence of ponding water, cracked asphalt scuppers, cracked sealant, debris build-up, and bald spots resulting in the exposure of the asphalt membrane. The roof trim and metal flashing materials were observed to be in average condition. It should be noted that there were no reported active leaks in occupied spaces within the building at the time of the assessment.</p> <p>The following deficient conditions were observed on the walkway canopy roof surfaces: evidence of ponding water, blisters, spider cracking, and cracked sealant. The trim and metal flashing was observed to be cracked and aged. The gutter and downspout system serving the walkway canopies was observed to be insufficient as wide-spread corrosion and peeling paint was observed on the canopy's metal framing system. It also appeared that water frequently cascaded out of the gutter system onto the pedestrian sidewalks located below the canopies. It was also observed that the top of the concrete beam system supporting the canopy structure was spalling in several areas due to exposure to the elements. Julie Vetter, AISD Construction Management, reported that the concrete beam system that supports the canopy has more wide spread issues. All walkway canopies appear to have structural integrity issues. Gaps can be seen from the exterior and within the courtyard stairs area. Two concrete beam systems have already been replaced due to these issues.</p>

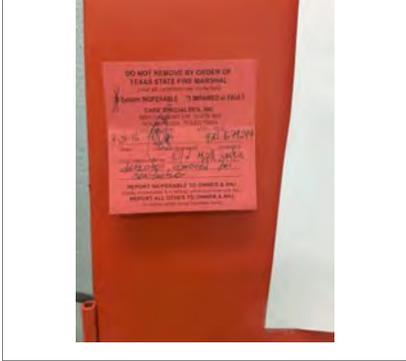
System	Subsystem	Condition and Deficiency Overview	System Condition Rating
		<p>Panel) for the entire campus. All other buildings (with the exception of the Auto Mechanics, Theater & Band Hall building) report to this FACP. The building has initiation and annunciation devices such as audio/visual devices, visual only, pull stations, heat and smoke detectors. The system is manufactured by Silent Knight (by Honeywell). The system was observed to be in good condition, (there was no functional testing performed) There is a State Fire Marshal tag dated 07/31/15 on the FACP stating "Old Mall smoke detectors removed for construction". Tag states "system inoperable". The tag also states that the tag can only be removed by a State of Texas Fire Marshal. The panel display showed "All Systems Normal" during the assessment site visit. It does not appear that there is a campus wide "Mass Notification System", and the Audio/Visual devices appeared not to be voice capable. School personnel stated that the Fire Alarm monitoring system does not report correctly to the AISD Service Center and that all the buildings are not programmed in the system.</p>

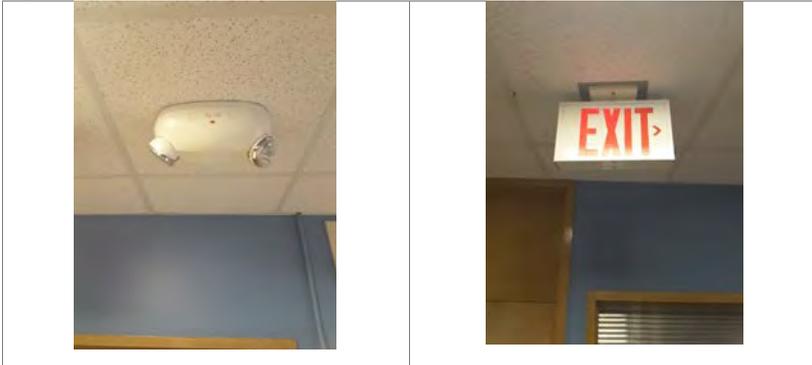
Lighting

System	Subsystem	Condition and Deficiency Overview	System Condition Rating
		<p>When a sampling of exit signs and emergency lighting units test switches were engaged, there was no illumination. All lighting is controlled via toggle switches...</p>	
	<p>Communications & Security</p>	<p>There is a Gemini security panel including surveillance cameras in the building. There is a public address system with ceiling mounted speakers.</p> <p>There appeared to be a new telecommunications systems rack. The Wi-Fi devices also appear to have been recently installed.</p> <p>All the communications and security system appeared to be in good condition with no observed or reported deficiencies.</p>	<p>Good</p>

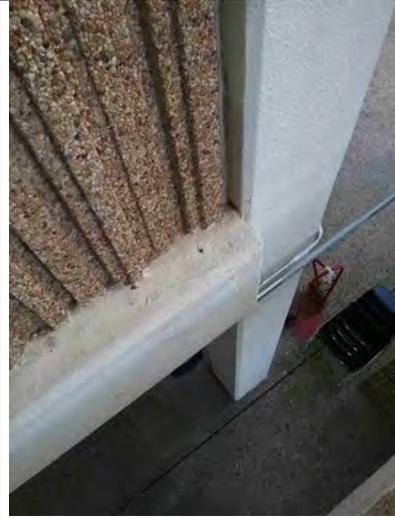
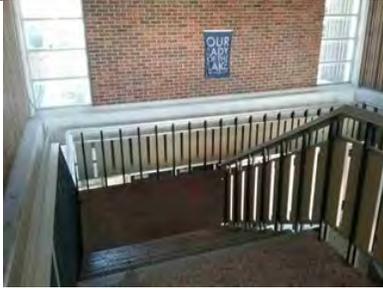
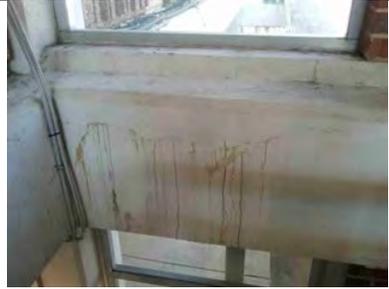
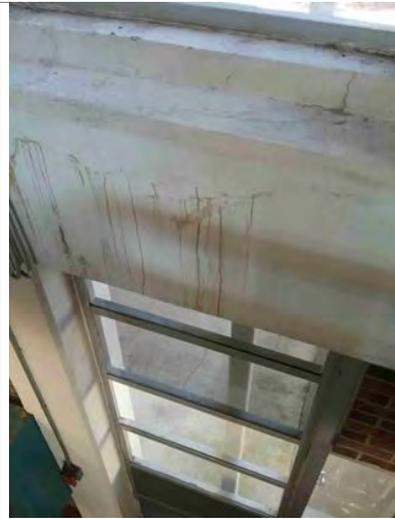
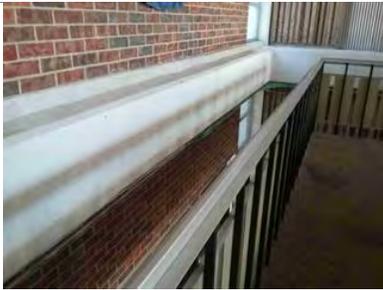
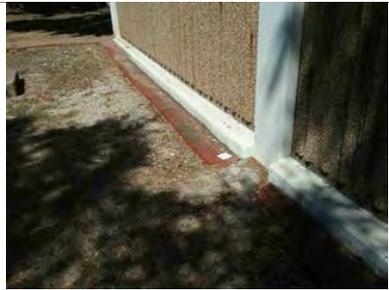
Exterior Walls

System	Subsystem	Condition and Deficiency Overview	System Condition Rating
		<p>Occasional minor rust spots were present on 5% of the external aggregate-coated concrete wall panels. The joints of the exterior wall with the foundation were dirty and degraded throughout the building, as were the joints of the building to sidewalks.</p> <p>The reinforced concrete beams of the balcony near the elevator were cracking horizontally near their top and their interface with other beams and columns.</p> <p>The makeshift brick apron adjacent to the foundation on the northwest below adjacent to roof B-02 appeared problematic as it was likely permeable since the brick joints were not sealed and it had settled and drained towards the foundation.</p>	
	Exterior Windows	<p>The exterior windows consist of single-pane glazing units with aluminum frames and vertical sliders spring-loaded with four sections of glass</p> <p>The units were in average condition given their service age. No leaks were reported by facility staff. Sealant was degraded from 50% of the windows on their inside and throughout their outside. The lower painted aluminum panels of 50% of the windows were faded. Room 235 has a missing window latch so it would not stay shut due to the window's spring loading. In 15% of the windows, glass panels had been replaced with acrylic, of which about 30% was heavily worn and scratched. 60% of window blinds were missing or broken. The windows were rated average as they have exceeded their expected design service life, broken and missing blinds, and acrylic panel fading. Some damage existed in windows adjacent to the entry way doors that may be attributable to possible structural issues similar to those in Building H New Mall or other causes.</p>	Average

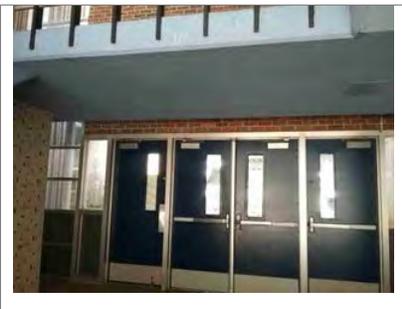
Exterior Doors	<p>Exterior doors are steel in metal frames with partial glazing in the doors and glazing on either side of the set of doors. This glazing varied as about 70% glass and 30% acrylic.</p> <p>The doors appeared to have been recently recoated. 10% of the glazing in the doors was heavily scratched or worn limiting safety visibility, and about 15% glazing adjacent to the entrances had scratched panels. The exterior doors' condition was average due to the glazing condition at the entrances and service age of the entrance door and window subsystems.</p>	Average

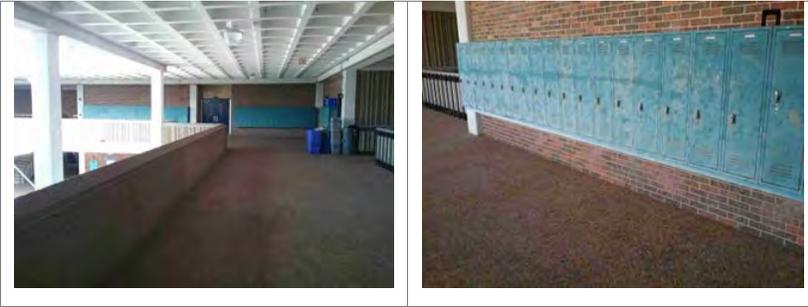
System	Subsystem	Condition and Deficiency Overview	System Condition Rating
		structurally and functionally sufficient. The sliding folding partitions in the staff offices are old, but are in good condition.	
	Interior Specialties	<p>Steel lockers are present on both floors in the courtyard and sheltered by the courtyard roof. They are painted and mounted either to the brick veneer or to the ground level floor.</p> <p>Lockers with greater exposure to the sun or precipitation had more weathered paint and undercarriage. The tops of 80% of the lockers had dust and debris accumulation, and appeared to be dented down at each unit by ongoing precipitation accumulation or other loading, possibly by books. About 60% of them had rusty tops. Some appeared to be wearing well without dents or excessive wearing due to use or abuse.</p>	Average
Stairs	Exterior Stairs	<p>Two flights of stairs with one landing of polished reinforced concrete steps are present at each of the four entrances.</p> <p>The polishing of the concrete was worn in the most highly trafficked areas. The step treads were worn, slippery, and chipping near the treads and on the steps creating a slipping hazard, especially when wet. About 10% of the area of the landings had spalling and 10% has delamination occurring, which provided a tripping hazard. Spalling was present at the top of the stairs. The landings may reach the end of their expected design service life within the next couple of years. Some landings had minimal cracks in them, whereas one of the landings had a center cracking running across its bottom and up its sides. The stairs were in average condition with worn treads creating a life safety issue.</p>	Average

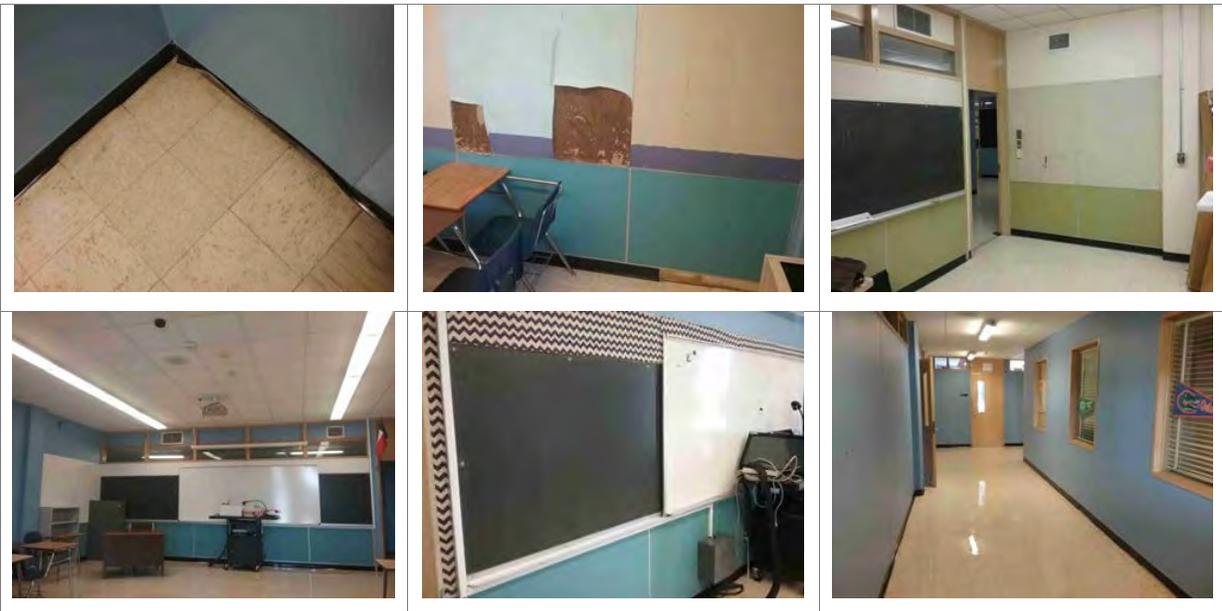
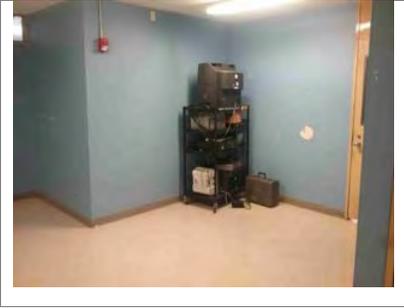
Interior Stairs	A fixed aluminum roof access ladder is present in the janitorial room. It was in good condition.	Good
Interior Finishes	Interior Wall Finishes	<p>Interior wall finishes include paint on the interior of the exterior CMU walls, paint on the gypsum board of the interior walls, chalkboards, marker boards, vinyl panels, painted vinyl panels, bulletin boards, and vinyl covered bulletin boards, and rubber/plastic base boards that were sometimes painted.</p> <p>Some interior base boards needed repair due to tearing, marking, stains, worn out glue, or repainting. Some corridor walls had paint that needed touch up. The painted vinyl finished walls in many of the corridors and the vinyl panels underneath many of the blackboards</p>	Average

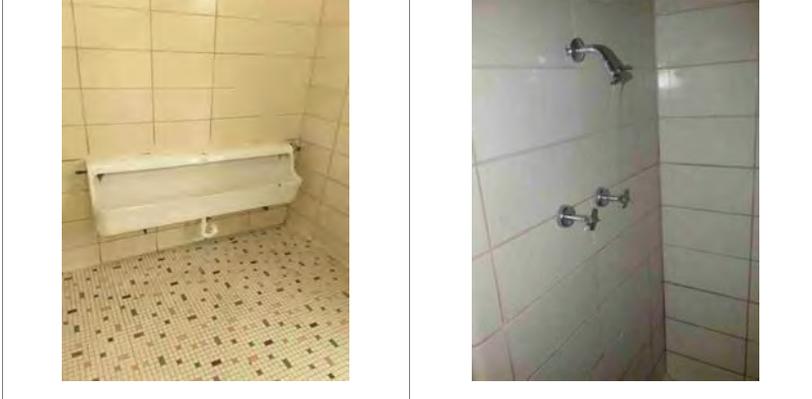
System	Subsystem	Condition and Deficiency Overview	System Condition Rating
Plumbing	Plumbing Fixtures	<p>The facility has male and female restrooms for public use, male and female locker rooms with restroom facilities, and staff restrooms.</p> <p>The restrooms utilize vitreous china fixtures throughout with manual faucets and flush valves. The hand sinks are in-counter mounted while the toilets and urinals are wall-mounted fixtures. The locker rooms also have group style showers with stainless steel fixtures.</p> <p>The facility also has water coolers, typically near the restrooms, and mop sinks at the janitorial closets.</p> <p>The plumbing fixtures were all functioning properly but are nearing the end of their expected design service life.</p>	Average
	Domestic Water Distribution	<p>All of the plumbing fixtures are serviced with hot water from multiple small GWHs (gas water heaters) and EWHs that were located throughout the buildings</p> <p>The water heaters were replaced in recent years and were in good condition.</p>	Good

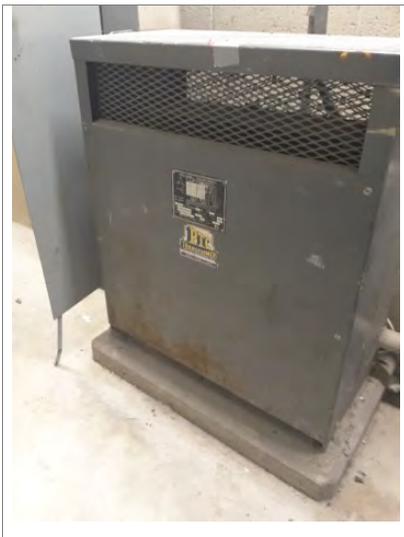
System	Subsystem	Condition and Deficiency Overview	System Condition Rating
Electrical	Electrical Distribution	<p>The Boiler Room contains GH4 which houses the main 600-amp circuit breaker for the entire building. This and the other main electrical distribution equipment are in good condition.</p> <p>MCCA located in the Boiler Room is only utilized as overcurrent protection for four HVAC pieces of equipment.</p> <p>There is one original transformer located in the Electrical Equipment room (located between the various locker rooms) that was very rusted and corroded, it was in poor condition.</p> <p>There is electrical equipment that is original to the building, it was in average condition.</p> <p>There is a section of roof where lightning protection is installed, the grounding conductors were aged and in average condition.</p>	Average
	Lighting	<p>The building's exterior lighting consists of HID luminaires mounted under the canopy and on all the exterior walls. The gymnasiums all have HID luminaires and they were in good condition. The rest of the interior spaces had fluorescent T8 luminaires, also in good condition. One of the gymnasiums had an exit sign missing its face.</p>	Good

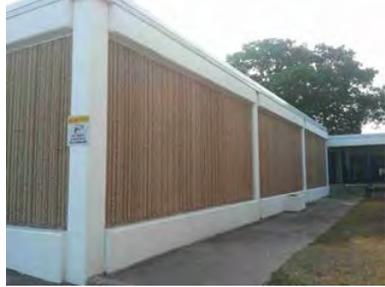
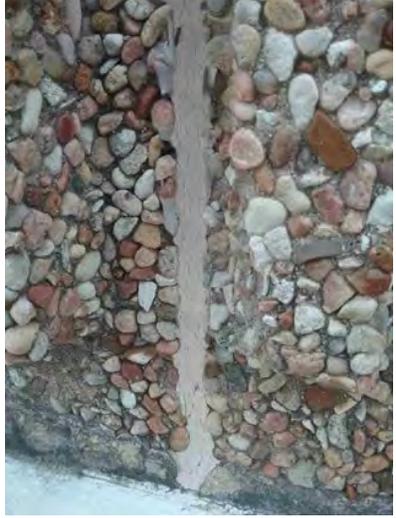
System	Subsystem	Condition and Deficiency Overview	System Condition Rating
Exterior	Exterior Walls	The exterior of the building consists of painted reinforced concrete beams and columns with prefabricated concrete panels coated with aggregate. The exterior walls were in average condition. Wall joints and sidewalk joints were deteriorated.	Average
	Exterior Windows	The exterior windows consist of single-pane glazing units with aluminum frames and vertical sliders spring-loaded with four sections of glass. This single-pane design was aged, although the units were in average condition. The windows were rated average because of their broken and missing blinds, panel fading and age.	Average
	Exterior Doors	Doors are metal in metal frames. Some are partially glazed. A linked steel roll-up door is present near the east entrance. The entry doors were well-coated to protect from typical weathering.	Good

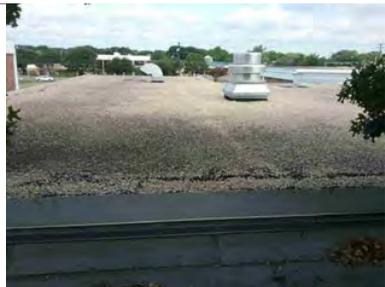
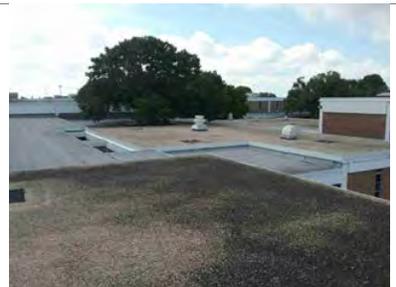
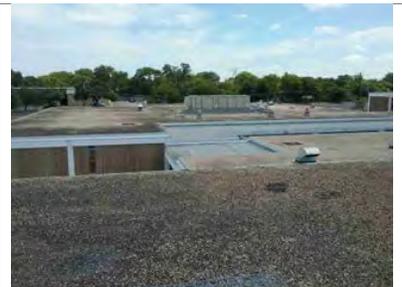
Roofing Deficiency Examples

Roofing	The roof material covering the building varies between built-up asphalt with a granular topping on the main portion of the building and modified bitumen on the entrance and covered walkway canopies. The covered walkway canopies are constructed of concrete columns, beams and steel and aluminum framing. The roofing systems covering the building were observed to be in poor condition. Active or historical leaks were observed in the building and on the bottom side of the covered walkway canopies. The following deficient conditions were observed on the main building roof surface: evidence of ponding water, cracked asphalt scuppers, cracked sealant, debris build-up, and bald spots resulting in the exposure of the asphalt membrane. The roof trim and metal flashing materials		Poor

System	Subsystem	Condition and Deficiency Overview	System Condition Rating
		<p>were observed to be in average condition.</p> <p>The following deficient conditions were observed on the walkway canopy roof surfaces: evidence of ponding water, blisters, spider cracking, and cracked sealant. The trim and metal flashing was observed to be cracked and aged. Gutters and downspouts on the canopies were not present. It was also observed that the top of the concrete beam system supporting the canopy structure was spalling in several areas due to exposure to the elements. Tree branches overhung above the covered walkway canopies contributing greatly to debris and water accumulation and subsequent accelerated weathering.</p>	
Interior Construction	Interior Walls	Interior walls are predominantly painted gypsum board on wooden or aluminum framing, finished wood paneling, painted CMU, or painted vented CMU. Some minor water damage to the drywall adjacent to the door entering the locker room was observed.	Good

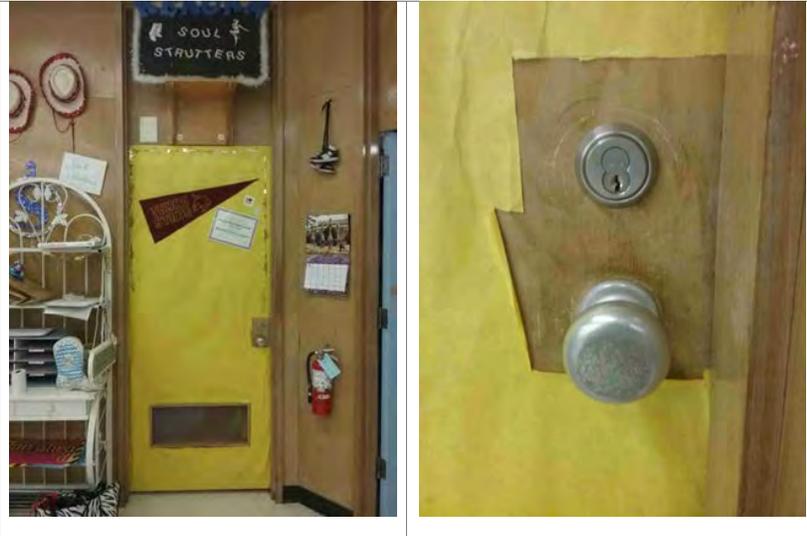
Interior Doors	Interior doors are wood with wooden frames. Interior door finishes were highly worn and scuffed.	Average
	Interior Specialties	Painted steel lockers are present in a room. The tops of the lockers were rusted and needed repainting. The lockers were aged. The lockers may or may not have been mounted to the wall.	Average
Stairs	Exterior Stairs	System not present.	N/A
	Interior Stairs	System not present.	N/A
Interior Finishes	Interior Wall Finishes	The interior of the building has acoustical wall panels at the top on the south side concrete block exterior or interior wall on the north and south sides and wood paneling on the west side. The interior finishes were dated but appeared to be in functional condition. Some paint was scuffed and chipped from walls, especially on corners. Much of the wood paneling was delaminating from the walls and could cause a safety hazard.	Average
	Interior Floor Finishes	The predominant floor finish is VCT tile. The VCT was highly worn and absent in a room that had a crawl space hatch. Some of the base boards were loose and peeling.	Good

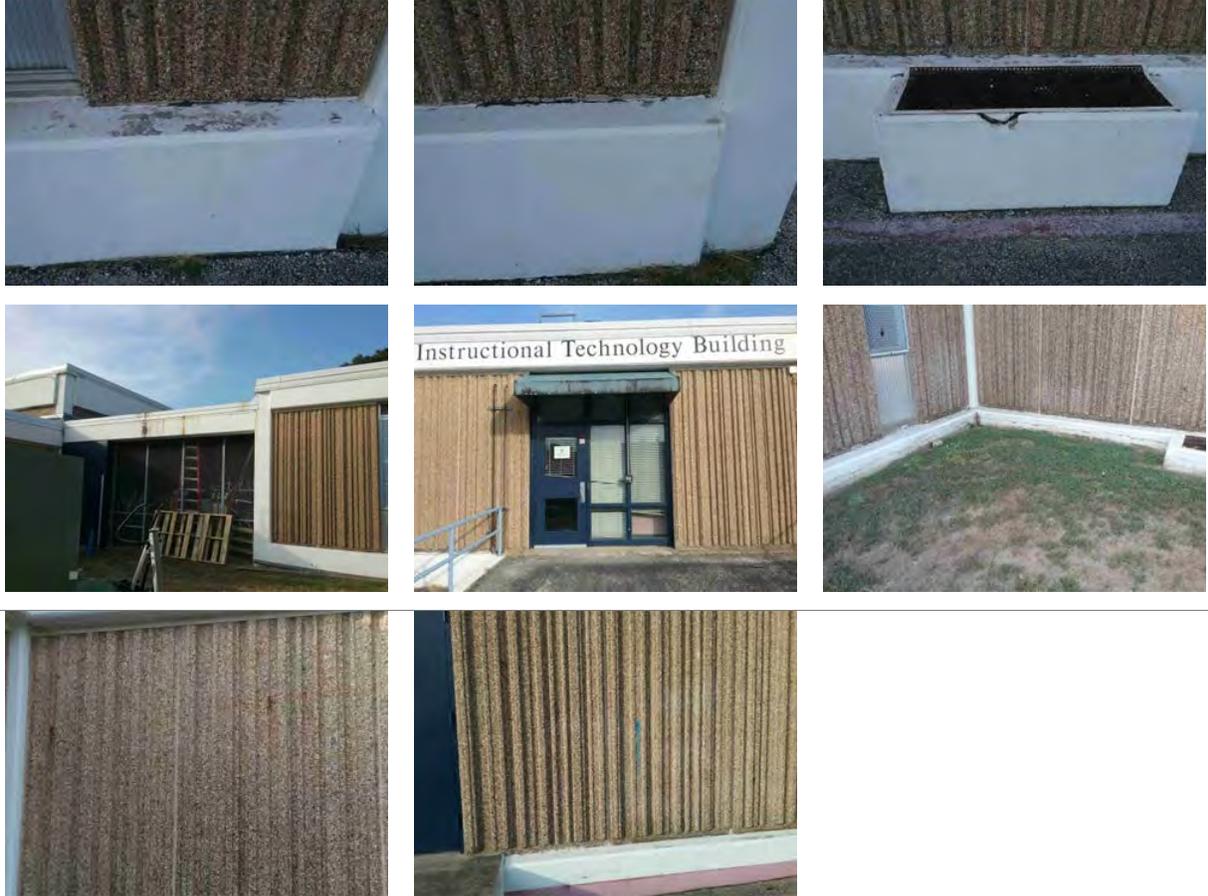
System	Subsystem	Condition and Deficiency Overview	System Condition Rating
Exterior	Exterior Walls	<p>The building is one story. The exterior facade is a mix of exposed aggregate precast panels with a vertical pattern or brick veneer inset into concrete frames created by the foundation columns and beams at the roof line. The rear elevations away from the common areas have a taller concrete wall at the base. The top of the precast panels appear to be held in place with steel angles located at the top of the panels. The building is predominantly the precast panel facade. The Art and ROTC entrances have a glazed brick finish in the doorways.</p> <p>The exterior walls were observed to be in good condition with several very minor deficiencies. The precast panels had some minor rust stains and had one spot of blue paint on the exterior. The paint was and has been peeling off of the concrete structure, and at some point the concrete had been repainted but the previous paint layers were not stripped prior to repainting. The bottoms of the precast panels have chipped and have been repaired with what appears to be mortar, and the angles that hold the panels in place were observed to have minor rusting in some locations. The paint on the top concrete grade beam is continuing to peel and needs to be repainted. The concrete around the base is also being stained by some of the rusting security covers on the windows. Around the rear and side of the building, near the cafeteria, there appeared to be some tar like substance, possibly roofing that had run down</p>	Good

System	Subsystem	Condition and Deficiency Overview	System Condition Rating
		<p>the face of the concrete. The exterior foundation is pitted with what appeared to be some minor non-structural cracks.</p>	
	Exterior Windows	<p>The exterior windows consist of single pane glazing in aluminum frames and single panel glass in passage door sidelites. The window frames match the height of the precast panels and are split into several sections. The bottom panel of the window is a metal panel that looks like louvers with vertical slats and the top panel is a solid flat plate. Painted wire mesh covers glass on nearly half of the building for security purposes.</p> <p>Overall the condition of the windows was good considering the age of the system, but the overall average condition rating was based on their age. Some windows mesh covers showed signs of rusting. Rust staining from mesh covers was staining the window frames below the covers and the concrete wall below.</p>	Average

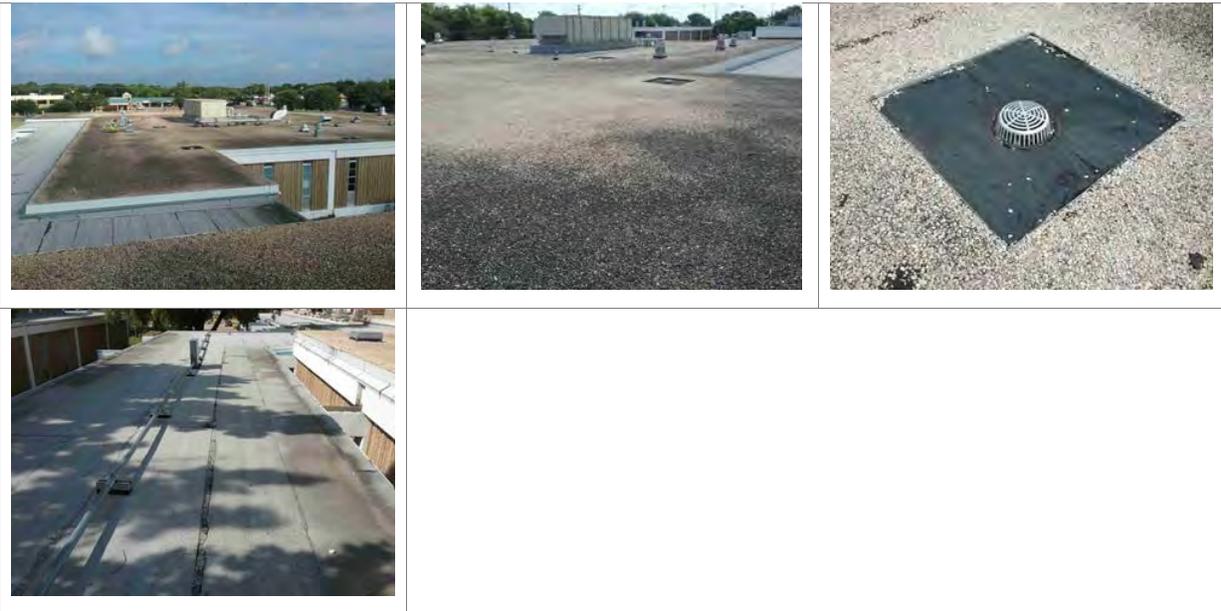
Roofing Deficiency Examples

System	Subsystem	Condition and Deficiency Overview	System Condition Rating
		<p>The following deficient conditions were observed on the walkway canopy roof surfaces: evidence of ponding water, blisters, spider cracking, and cracked sealant. Tree branches overhung the covered walkway canopies contributing greatly to debris and water accumulation and subsequent accelerated weathering. The trim and metal flashing was observed to be cracked and aged. Gutters and downspouts on the canopies were not present. It was also observed that the top of the concrete beam system supporting the canopy structure was spalling in several areas due to exposure to the elements.</p>	
<p>Interior Construction</p>	<p>Interior Walls</p>	<p>The interior walls are framed partition walls, CMU walls and brick walls. No issues were found on the walls other than finishes. No holes or cracking was observed in the walls. One portion of the wall had a crack above one corner of the door typical of settlement cracks; however, the wall was most likely not structural, therefore the crack was considered cosmetic. In several areas of the building, rows of interior windows were between offices/work rooms and the main classrooms. One location has single pane glazing in wood frames. In the other locations there was glazing with security mesh in metal frames. Both sets of windows appeared to be newer construction. Some additional windows were found with similar conditions.</p> <p>Interior walls were observed to be in good condition with no significant deficiencies to report.</p>	<p>Good</p>

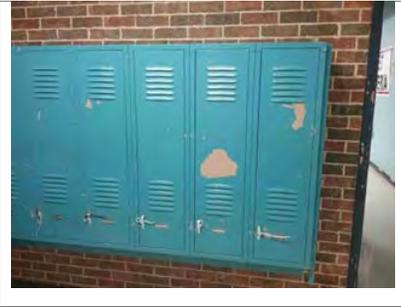
System	Subsystem	Condition and Deficiency Overview	System Condition Rating
	Interior Specialties	<p>Metal lockers occur on the inside and outside of the building. Lockers either had combination locks or were tied closed.</p> <p>The lockers were observed to be in average condition. The lockers on the exterior were observed to be worn and had locations showing signs of rusting and areas where the paint was missing. The lockers on the interior were observed to require a new painted finish as large sections of paint were missing and showed the previous paint layers below.</p>	Average
Stairs	Exterior Stairs	<p>Two sets of exterior concrete stairs and ramps occur on the exterior of the building providing access up to the building from the main plaza.</p> <p>The concrete stairs were observed to be in average condition as some previous damage has caused the corners of the stairs to be ground down at the corner likely due to wear, spalling or fractures. Some of the broken corners had not been repaired.</p>	Average

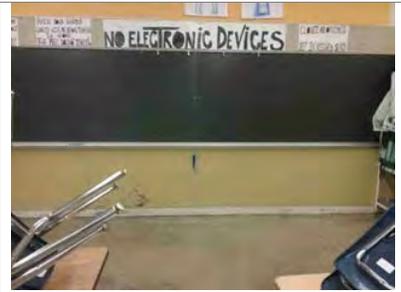
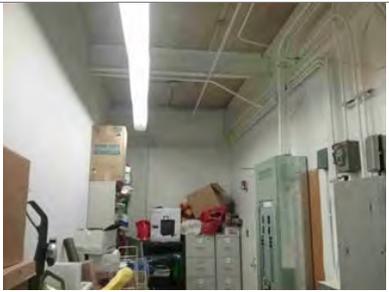
Interior Stairs	System not present	
Interior Finishes	Interior Wall Finishes	<p>Similar to the interior doors, due to the age of the building a condition rating of average was assigned. Several different interior remodels have modified the original finishes within the building. The remodels have created a multitude of different types and levels of finishes. Wall finishes include painted CMU, brick, painted non-textured drywall partition walls, polished colored brick, wood panels, and tile or painted CMU in the restrooms. One room in the JROTC training area has acoustical panels on the wall and one restroom has painted drywall for the wall finish rather than ceramic tile which was standard. This building contains the art room and some murals and other artwork have been painted on the corridor walls near the art room.</p> <p>The interior wall finishes were observed to be in average condition, where recent remodels have not taken place the deficiencies was more apparent which is why the finishes are rated average. Deficiencies observed included areas where new paint is required to repair damaged finishes. Some walls were observed to have irregular wall surfaces or were excessively dirty.</p>	Average

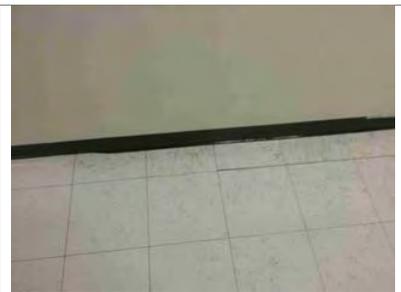
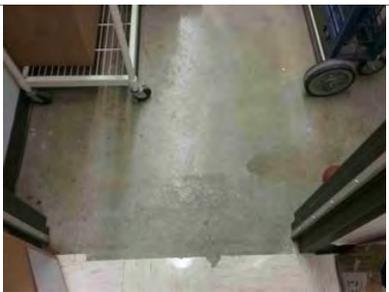
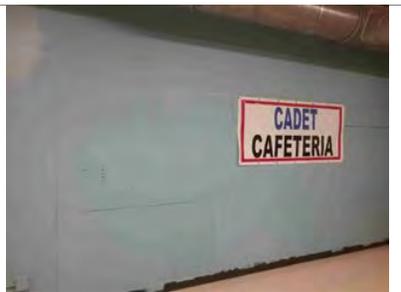
Interior Floor Finishes

System	Subsystem	Condition and Deficiency Overview	System Condition Rating
		<p>levels of finishes. The majority of the flooring is VCT in different colors and patterns. The VCT has recently been refinished. The restrooms have tile floors and the mechanical rooms have no finish and are exposed concrete. Rooms in the newly remodeled ROTC training area and offices have relatively new carpet. Rubber cove wall base is used throughout the building. All of the rooms were not accessible at the time of the site visit.</p> <p>The floor finishes were observed to be in overall good condition; over one third of the accessible portions of the building were observed to have recently replaced carpet. The condition of the VCT was in good condition and although some of the VCT is older it was observed to have been well maintained. The rubber cove wall base was in good condition, although several locations were observed where it has deteriorated or is not adequately attached to the wall. One broken VCT was observed adjacent to a service space.</p>

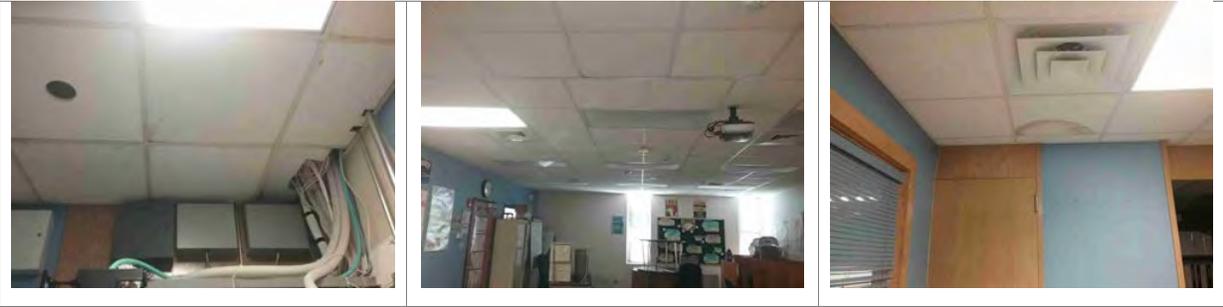
Interior Ceiling Finishes	<p>Three types of ceiling finishes were observed in the building; ACT (acoustic ceiling tile), painted drywall, and exposed to structure. In the areas exposed to structure a fibrous board covered the roof decking so it was not visible. The acoustical grid was a mix between 2' x 2' and 4' x 4'.</p> <p>The condition of the ceiling tiles was observed to be average. The ceiling tiles range from old worn and stained to new. The newer ceiling panels in one room had an offset grid such that in the middle of the room the grid was offset. Some panels with stains were visible and some were very dirty. No sagging panels were observed in this building.</p>	Average
Conveying	System not present.		N/A
Plumbing	Plumbing Fixtures	<p>The building has student and staff restrooms. The staff restroom was remodeled in recent years and has vitreous china fixtures including a wall-mounted sink and floor mounted toilet. The plumbing fixtures use manual faucets and flush valves.</p> <p>The student restrooms are similar to the facilities throughout the rest of the campus and have in-counter mounted sinks with manual faucets, floor mounted toilets with manual flush valves, and wall-mounted urinals (male restroom only) with manual flush valves.</p> <p>Overall the restrooms were functioning well and were observed to be in good condition.</p>	Good

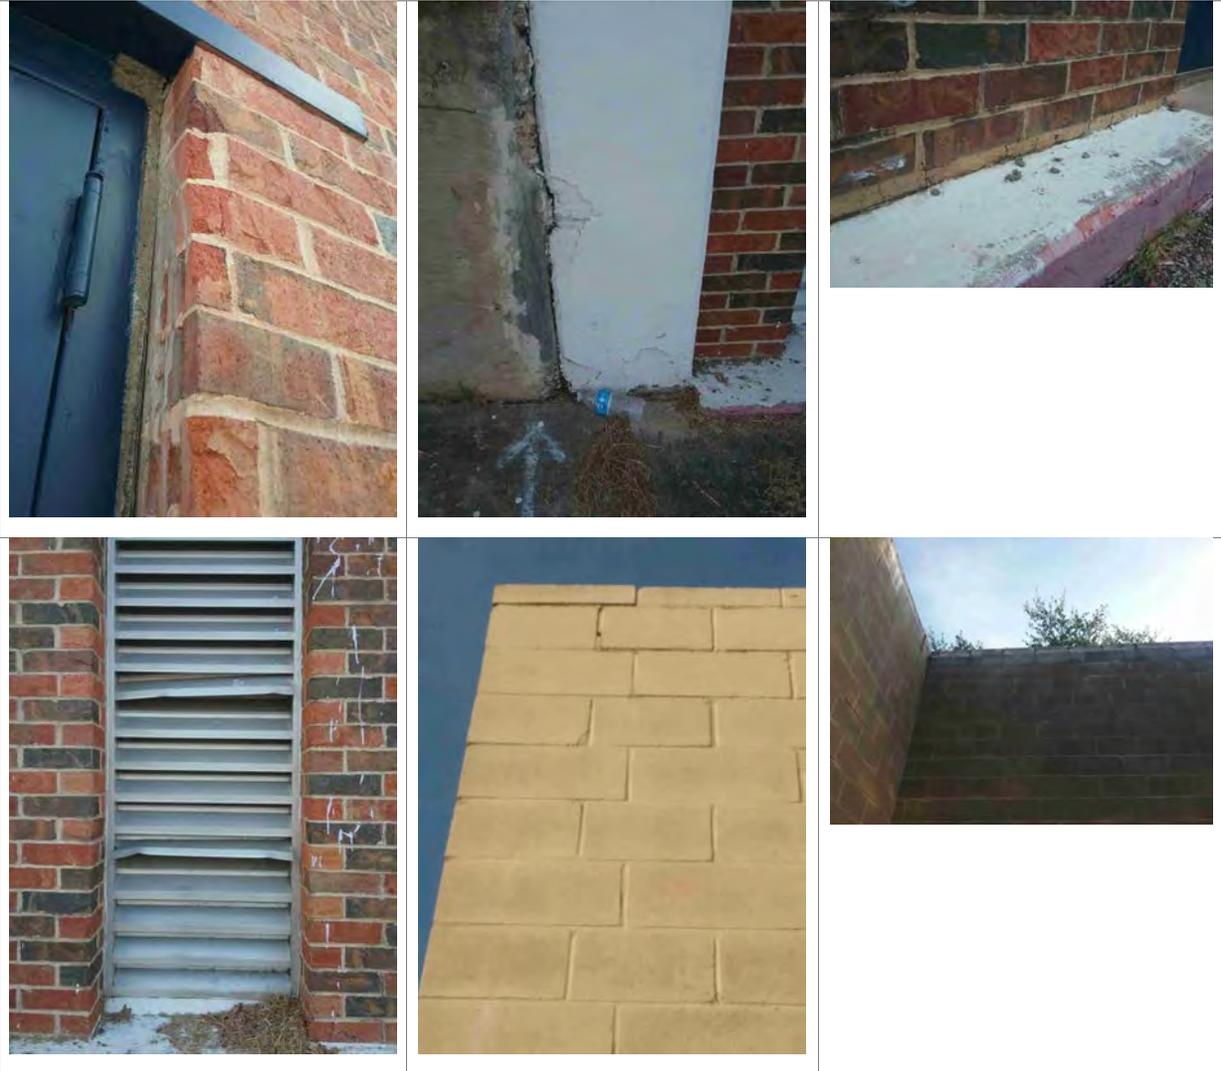
System	Subsystem	Condition and Deficiency Overview	System Condition Rating
Exterior	Exterior Walls	<p>The Mechanical Building includes two independent structures; the main building and the cooling tower enclosure. The main building is a concrete framed structure with structural CMU walls and brick exterior face. The cooling tower enclosure is CMU block wall with sections of chain-link fencing that together create a perimeter enclosure, or screen, for the cooling towers. The main building has a concrete slab and houses the chilled water and heating hot water equipment, while the cooling tower enclosure has a raised concrete foundation supporting two cooling towers and houses no other equipment.</p> <p>The exterior enclosure walls of the two structures are in average condition showing signs of degrading grout, brick and expansion joints.</p>	Average
	Exterior Windows	<p>The exterior windows at the mechanical building are single-pane with steel frames and have sections of glass that are approximately 1.5'x4'.</p> <p>The windows are aged and damaged at both of the facilities entries and are in poor condition.</p>	Poor

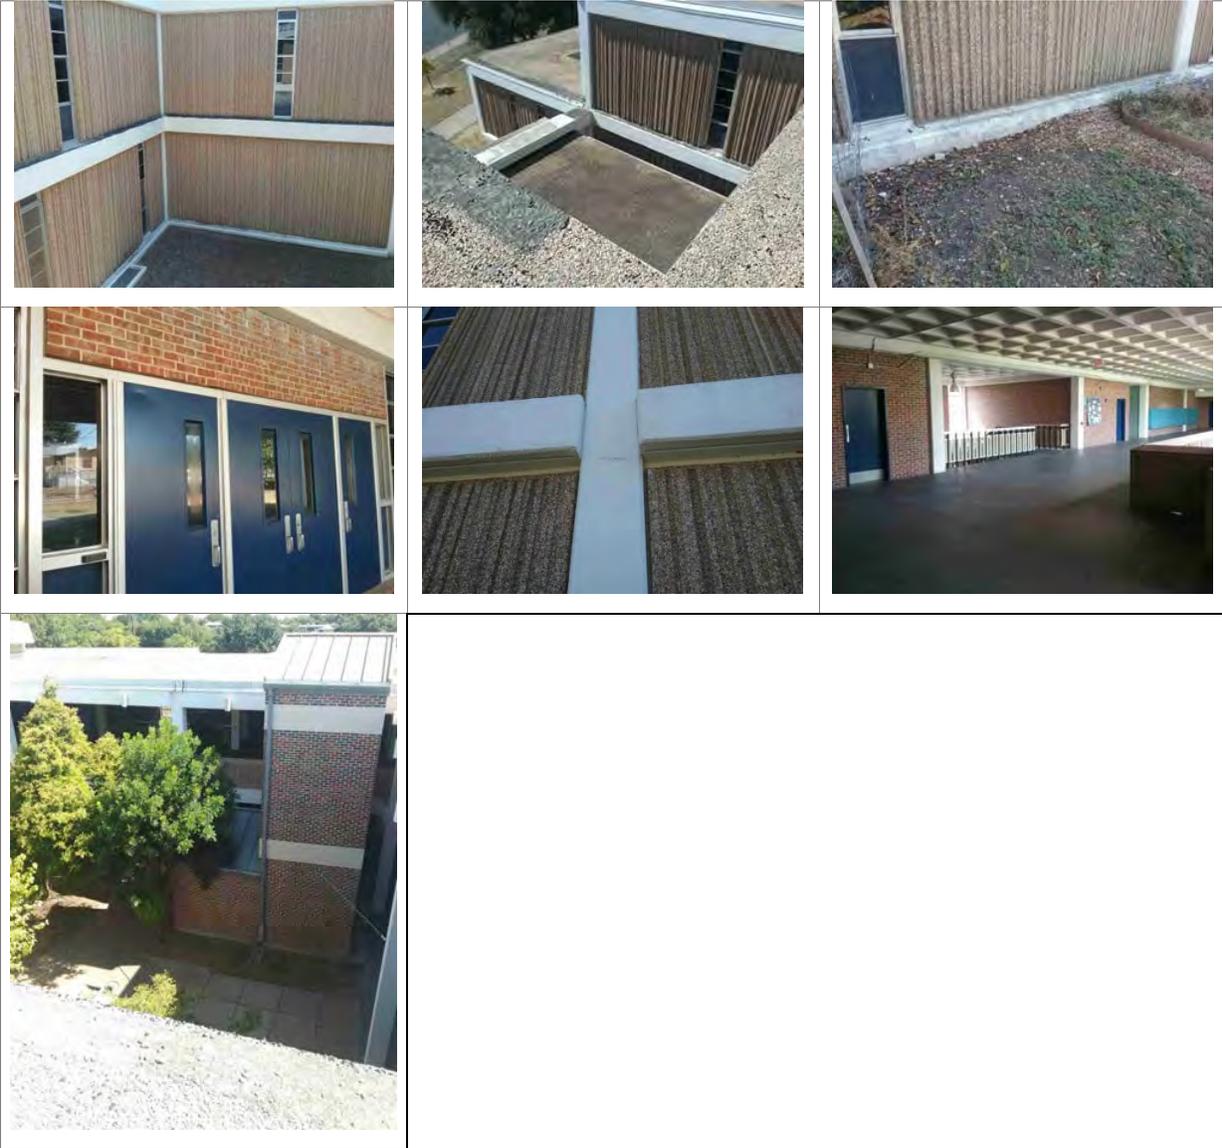
System	Subsystem	Condition and Deficiency Overview	System Condition Rating
Exterior	Exterior Walls	<p>The exterior of the building consists of painted reinforced concrete beams and columns with brick veneer panels at entrances, above entrances, and facing the interior outdoor courtyard or prefabricated concrete panels coated with aggregate on the exterior of the building.</p> <p>Debris and possible biological growth had degraded the coating of some beams and columns and their joint sealants with some walls, which are especially present on the northeast and southwest areas. Rare occasional small cracks existed in five percent or less of the area of beams. The (large) lintel of entrance awning H-10 is rusted and joint sealant degraded. The north east wall junction of a column and beam has rebar possibly bulging out for six to eight inches in length. The paint was peeling on the northeast wall beams and appeared to weather more frequently than those of the rest of the building. The grout at the bottom of the elevator shaft and elevator mechanical room was dirty, weathered, and eroded. A south staircase wall beam was cracking at the joint of the stairs and column. Another beam by the southwest stair is cracking laterally at its top. Sealant was degraded for much of the joint of the brick veneer walls facing the interior outdoor courtyard and the sidewalk or balcony.</p> <p>Water was leaking out of an approximately a one and one-half inch diameter hole in the soil in the yard south</p>	Good

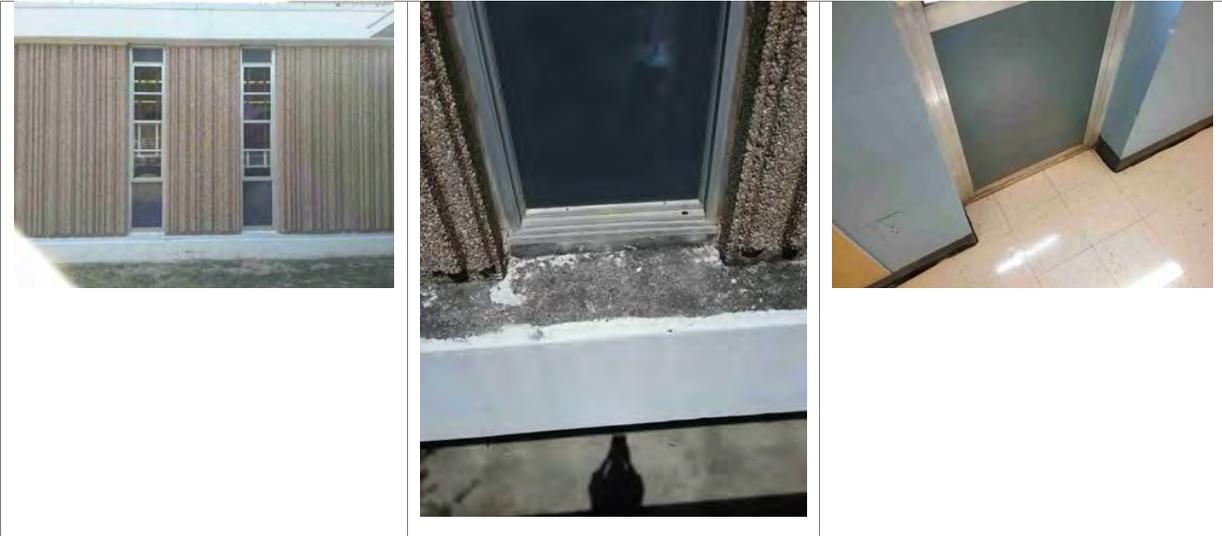
System	Subsystem	Condition and Deficiency Overview	System Condition Rating
		of the intersection of covered walkway canopies H-02 and G-05.	
	Exterior Windows	<p>The exterior windows consist of single-pane glazing units with aluminum frames and vertical sliders spring-loaded with four sections of glass.</p> <p>This single-pane design is aged, although the units were in average condition given their age. No leaks were reported by inquiry to facility staff. Sealant was degraded from 50% of the windows on their inside and outside. The lower painted aluminum panels of 50% of the windows were faded. In 15% of the windows, glass panels had been replaced with acrylic, of which about 30% was heavily worn and scratched. 60% of blinds were broken or missing. The windows were rated average because of their broken and missing blinds, panel fading and age.</p>	Average
	Exterior Doors	<p>Exterior doors are steel with partial glazing in the doors and glazing on either side of the set of doors. This glazing varied as about 70% glass and 30% acrylic.</p> <p>The doors appeared to have been recently recoated. 10% of the glazing in the doors was heavily scratched or worn limiting safety visibility, and about 15% glazing adjacent to the entrances had scratched panels. Facility staff reported that one of the doors at the main entrance on the southwest side was worn enough where it could be yanked open if pulled hard even when locked, but the door of concern could not be identified. This could not be verified during the observation even with staff assistance. The exterior doors condition was rated as average because of the glazing condition of the entrances and age of the entrance door and window subsystems.</p>	Average
