Reagan Early College High School Site Summary

Address	7104 Berkman Drive Austin, TX 78752
Number of Permanent Campus Facilities	9
Original Year of Construction	1965
Total Campus Building Area (combined)	253,072 SF

Administration Building – BLDG-006A

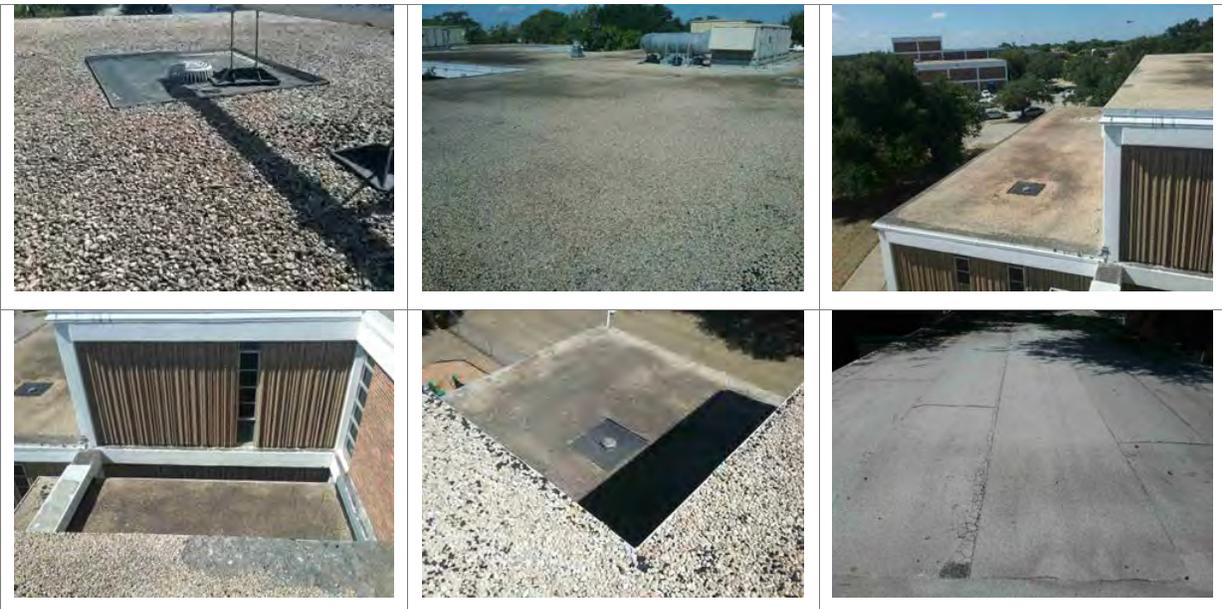
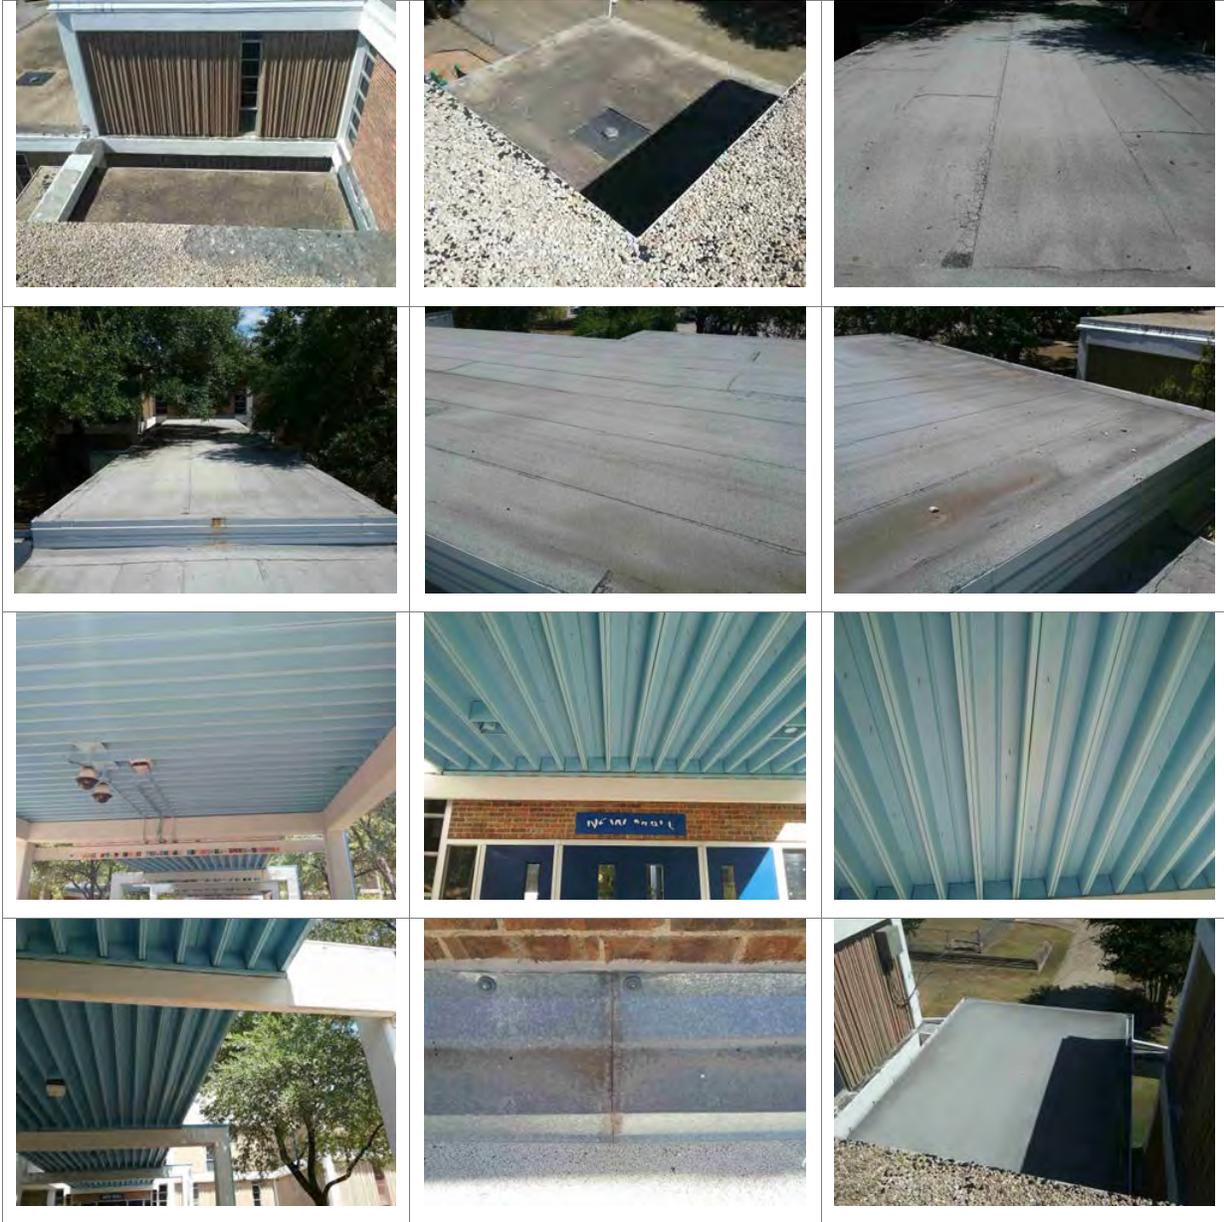
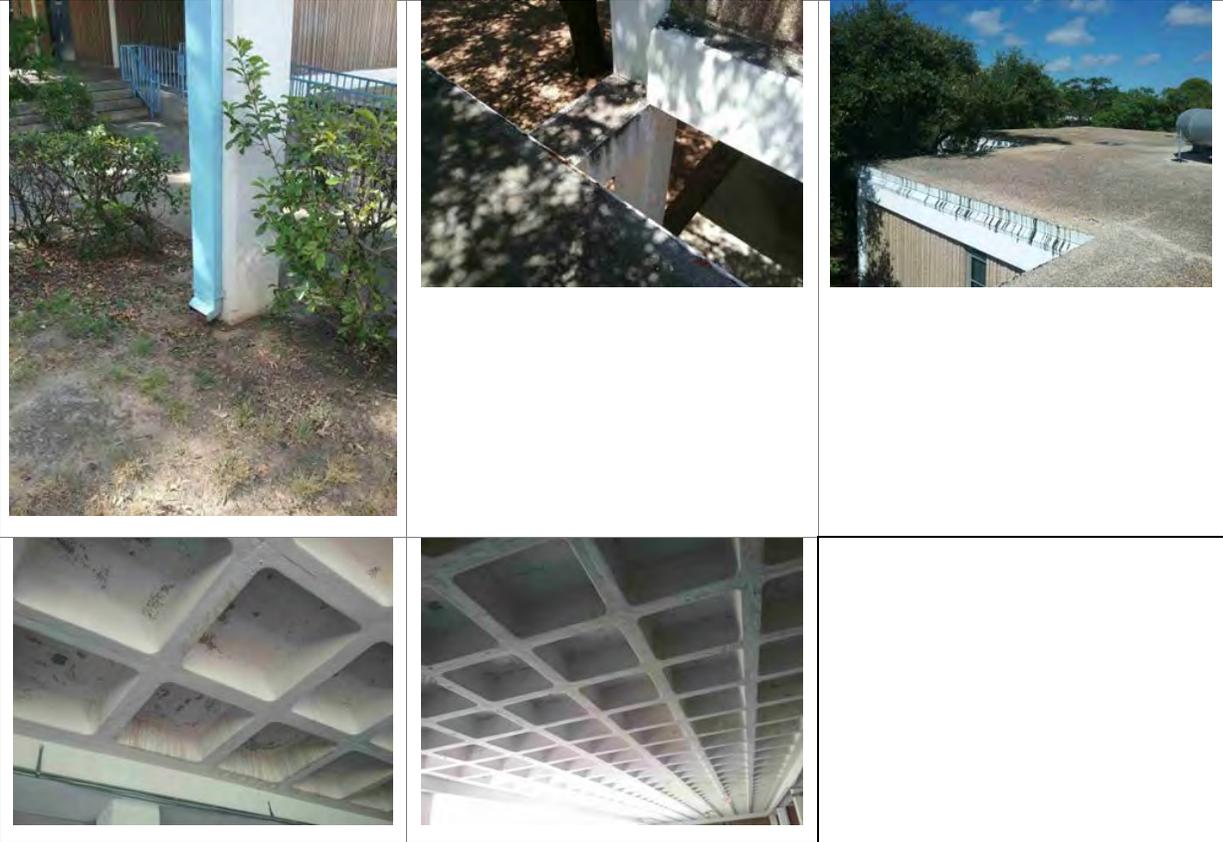
Roofing Deficiency Examples

Roofing	<p>The roof material covering the building is constructed of various materials. The main portion of the building is covered with built-up asphalt and granular topping while modified bitumen is found on the entrance and covered walkway canopies. The covered walkway canopies are constructed of concrete columns, beams and metal framing.</p> <p>The roofing systems covering the building were observed to be in poor condition. The following deficient conditions were observed on the main building roof surface: evidence of ponding water, cracked asphalt scuppers, cracked sealant and joints, debris build-up, and bald spots resulting in the exposure of the asphalt membrane. The roof trim and metal flashing materials were observed to be in average condition. Gravel and debris was present in some of the gutters of the built-up asphalt covered entrance awnings. It should be noted that there were no</p>		Poor

System	Subsystem	Condition and Deficiency Overview	System Condition Rating
		<p>reported active leaks in occupied spaces within the building at the time of the assessment.</p> <p>The following deficient conditions were observed on the walkway canopy roof surfaces: evidence of ponding water, blisters, spider cracking, and cracked sealant. The trim and metal flashing was observed to be cracked and aged. Gutters were not observed to be present at the canopies, but periodic downspouts were observed. It appeared that there was a lack of controlled roof drainage of water off of the canopy surface. Some canopy flashing and trim joints were cracked, rusted, and weathered likely because of debris and excessive walkway canopy storm water runoff.</p>	
<p>Interior Construction</p>	<p>Interior Walls</p>	<p>Most interior walls are painted gypsum board on wood or aluminum framing, though around 15% are painted CMU. Interior glass, wood-framed windows are present in each quarter classroom corridor's teacher office's walls adjacent to the corridors on each level of the building.</p> <p>The interior walls had a condition rating of average because of their age and finishes, though they were functionally sufficient.</p>	<p>Average</p>

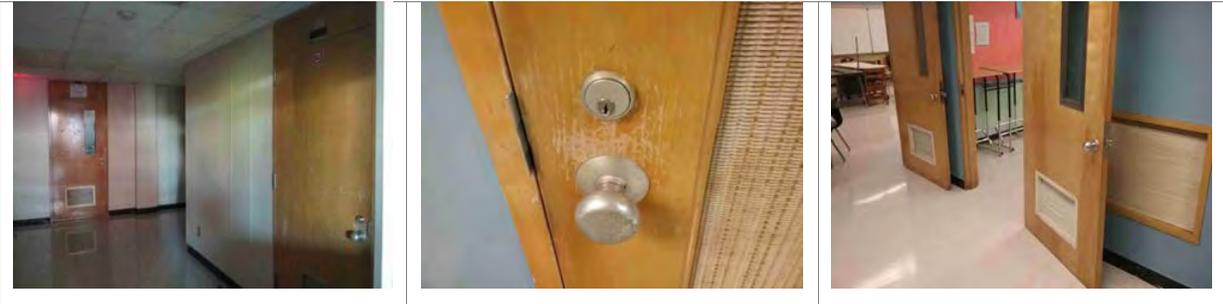
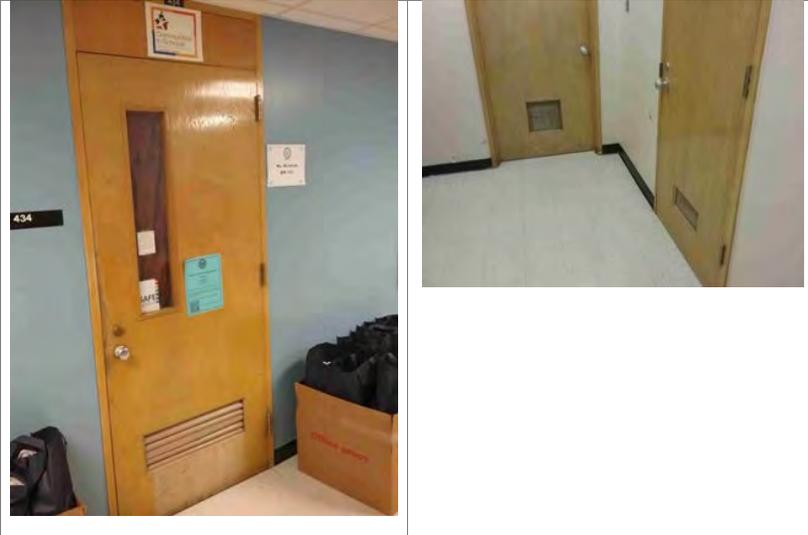
Interior Doors

<p>Interior Doors</p>	<p>Interior doors are solid wood in wood frames. 90% are partially glazed with glass, reinforced glass, or acrylics. Louvers are present in the bottom half of some doors for mechanical, storage, and special use rooms along with 60% of classrooms. Sliding folding partitions are present in the staff office of each classroom corridor.</p> <p>Overall, 85% of the interior door hardware was worn, especially in the corridor of rooms 410 to 414. The office door in the corridor of rooms 421-424 was jammed by the bottom of its door frame in contact with the door frame and possibly the floor and would not open at all, despite the door flexing minimally. The finish of 75% of doors were aged, dated, and heavily worn as indicated by scratches, wear, tape and adhesive wear marks, though most doors remain structurally and functionally sufficient. The sliding folding partitions in the staff offices are old, but were in good condition.</p>	<p>Average</p>

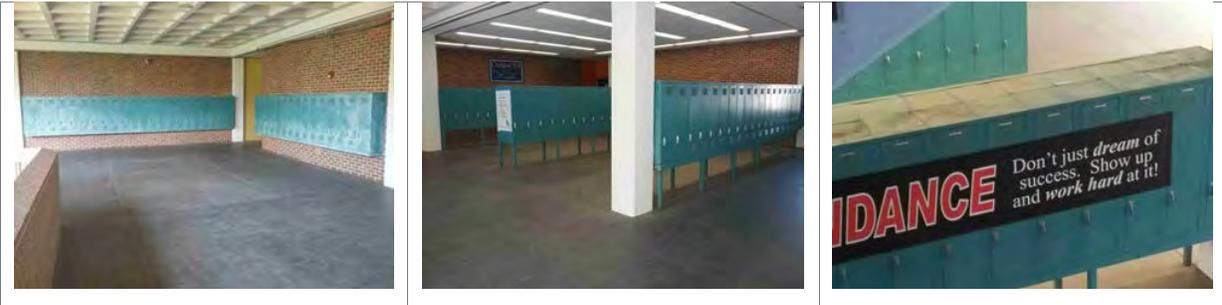
Interior Specialties

System	Subsystem	Condition and Deficiency Overview	System Condition Rating
		ongoing precipitation accumulation or other loading, possibly by books. About 60% of them had rusty tops. Some appeared to be wearing well without dents or excessive wearing due to use or abuse.	
Stairs	Exterior Stairs	<p>Two flights of stairs with one landing of polished reinforced concrete steps are present at each of the four entrances. The polishing of the concrete was worn in the most highly trafficked areas.</p> <p>The step treads were worn, slippery, and chipping near the treads and on the steps and are presently creating a slipping hazard, especially when wet. The landings had a high presence of spider web cracks in 50% or more of their area. About 10% of the area of the landings had spalling and 10% had delamination occurring, which provided a tripping hazard. The landings may near the end of their useful design service life within the next couple of years.</p>	Poor

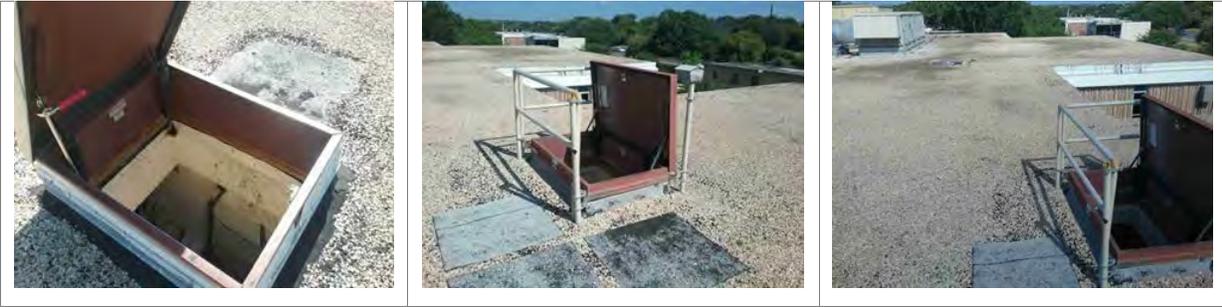
Interior Stairs	<p>A fixed steel roof access ladder is present in the janitorial room. A fixed aluminum step ladder (stairs) is present in a separate roof access room. The step ladder roof access hatch railing is fiberglass reinforced plastic (FRP).</p> <p>The roof hatch access ladder in the janitorial room was not of sufficient height to safely access the roof through the hatch; however, a stair ladder existed at another nearby hatch in another nearby roof access room. The FRP roof hatch railing of the roof access step ladder was severely weathered, splintered, broken, weak, unsteady, and missing pieces. The condition rating was poor because of the conditionally obsolete roof access railing for the fixed aluminum roof access step ladder and the insufficient height of the fixed steel roof access ladder.</p>	Poor
Interior Finishes	Interior Wall Finishes	<p>Interior wall finishes include paint on the interior of the exterior CMU walls, paint on the gypsum board of the interior walls, chalkboards, marker boards, vinyl panels, painted vinyl panels, bulletin boards, and vinyl covered bulletin boards, and rubber/plastic base boards which were sometimes painted.</p> <p>Some interior base boards needed repair due to tearing, marking, stains, worn out glue, or repainting. Some corridor walls had paint that needed touch up. The painted vinyl finished walls in many of the corridors and the vinyl panels underneath many of the blackboards</p>	Average

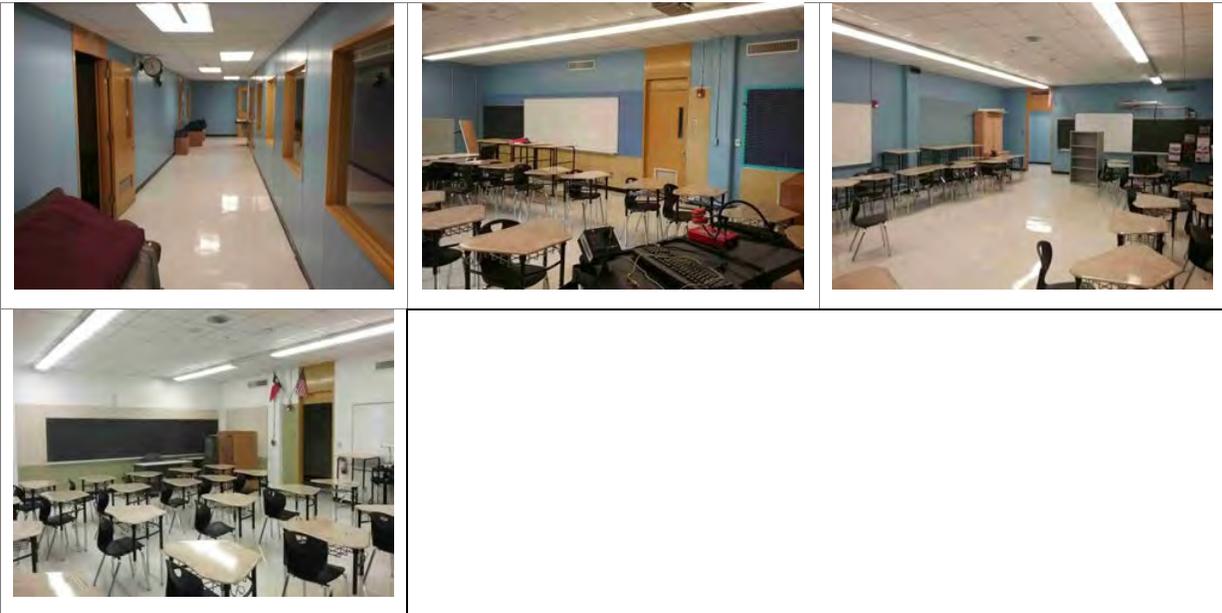
Interior Wall Finishes

System	Subsystem	Condition and Deficiency Overview	System Condition Rating
		were in good condition, especially give their age., The recent repainting of most of the interior corridors, and the relatively overall average condition of the wall finishes, the interior wall finishes were rated as average.	
	Interior Floor Finishes	<p>The ground floor adjacent to the interior outdoor courtyard finish is polished reinforced concrete slab. The balcony floor finish is polished reinforced concrete. The interior conditioned space corridor and classroom floor finishes are 8"x8" VCT, with about 10% of the VCT being replaced by 12"x12" VCT.</p> <p>The balcony had excessive spider web cracking, worse and larger in corners and worse near each its corners and at each set of stairs in. Minor water damage indicated by stained and buckled tiles was observed in the exterior corners of classrooms 420-440 due to either current or historical water penetration.</p>	Average

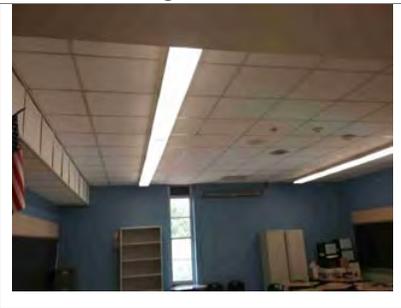
Interior Ceiling Finishes	<p>The ceilings are 2' x 2' suspended ACT tiles inside the condition spaces, and exposed painted waffle slab reinforced concrete in the unconditioned open corridors surrounding the courtyard.</p> <p>The ceiling tiles of the classrooms 440-444 corridor had older ceiling tiles than the other corridors in the buildings, probably by five to seven years. When the tiles were used in a vertical application in an enclosure of a utility conduit in the building, they were often warped.</p>	Good
Conveying		<p>The building is equipped with a hydraulic passenger elevator to service two levels. The elevator was noted as having a maximum weight capacity of 2100 lbs. This elevator was observed to be in good condition as a recent inspection certificate issued within the last year, as required, was visible. The school personnel stated that the elevators were original to the building, the equipment within the machine room shows a manufacture date of 1999.</p>	Good

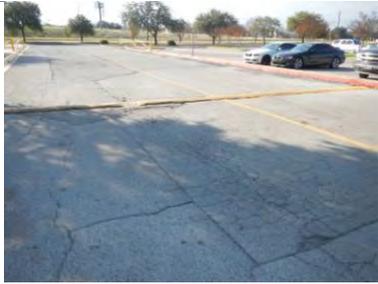
Longitudinal and alligator cracking	Transverse and longitudinal cracking	Drainage damage

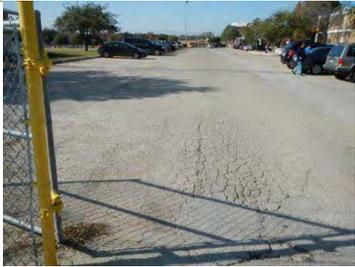
Alligator cracking	Damaged utility patch	Overgrown grass and erosion

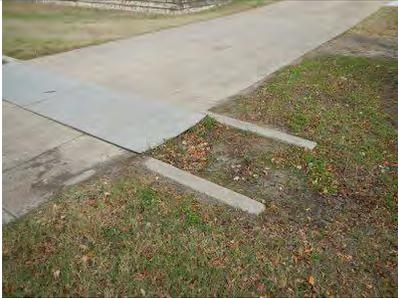
Clogged drainage cut	Wood bridge

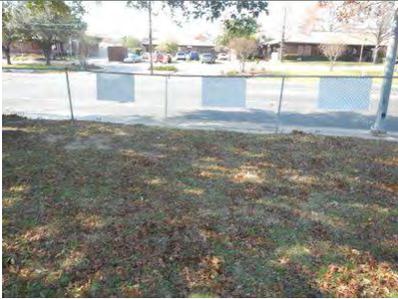
Bent fence	Uncovered crawl space

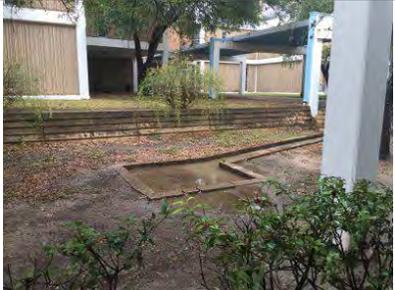
Clogged flume and area inlet	Erosion against building	Condensate does not tie to underdrain

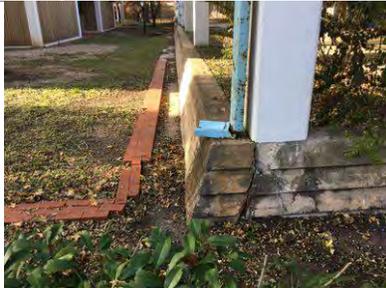
Damaged Downspout	Inadequately sized inlet	Damaged and inadequately sized inlet

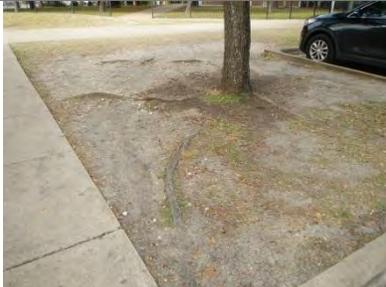
Re-sodding needed	Overgrown tree	Broken/Abandoned Irrigation

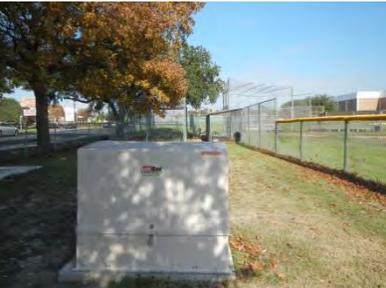
Fiberglass Grease Sampling Enclosure Found	Dumpster needs concrete pad and approach	Low spot and damaged irrigation

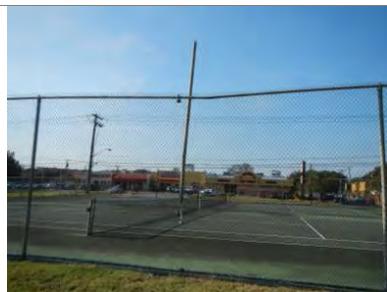
Tennis court fencing needs repair

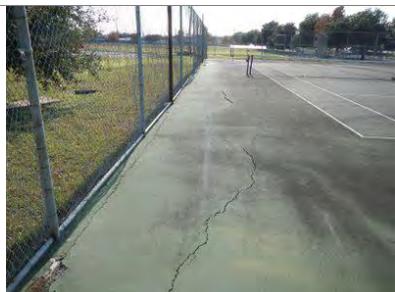
Tennis court cracks

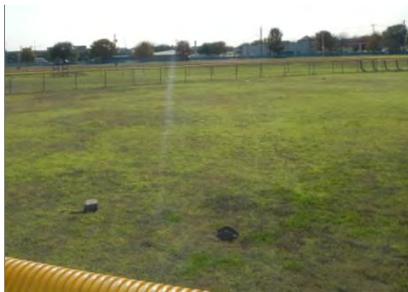
Missing irrigation box covers

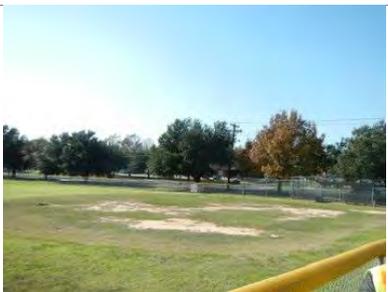
Worn softball field

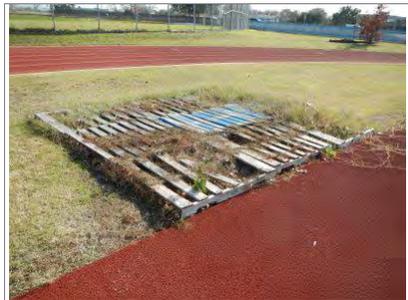
Area of material needs to be removed

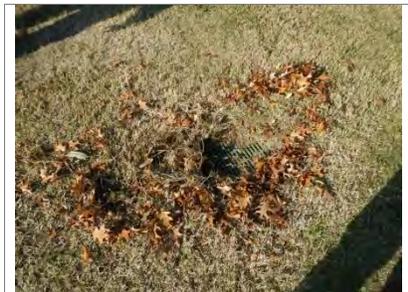
Area inlet needs to be uncovered

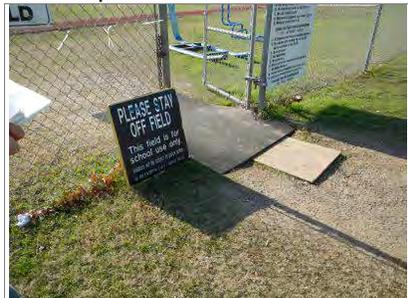
Refill and compact walkway

1. Fix broken pipe.
2. Refill and compact walkway.
