Bedichek Middle School Site Summary

Address	6800 Bill Hughes Road Austin, Texas 78745
Number of Permanent Campus Facilities	3
Original Year of Construction	1972
Total Campus Building Area (combined)	133,942 SF

Introduction

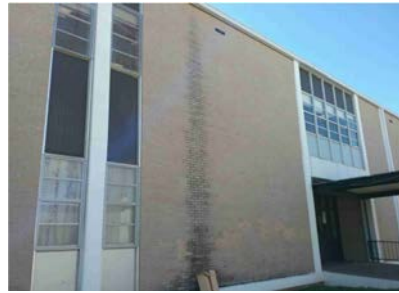
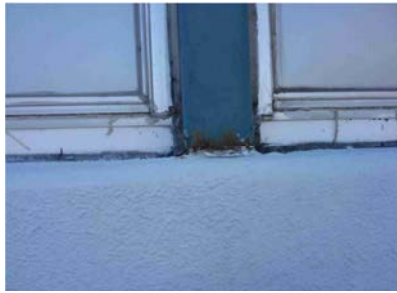
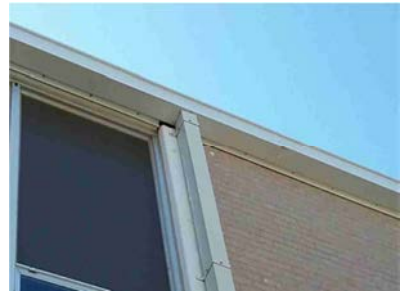
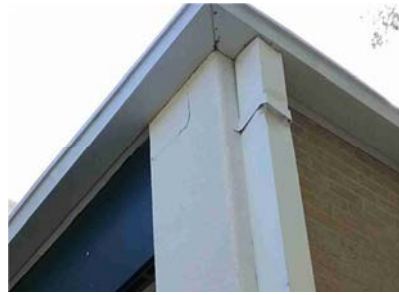
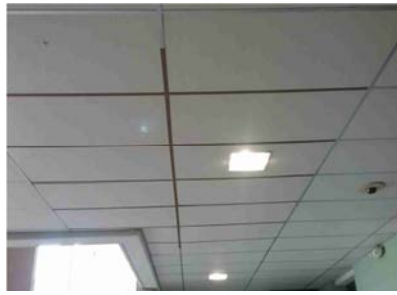
System	Subsystem	Condition and Deficiency Overview	System Condition Rating
Exterior	Exterior Walls	<p>The exterior walls are primarily brick with exposed concrete and steel structural elements. Exposed steel is found primarily at window systems and canopies.</p> <p>The exterior walls were observed to be in average condition. Rusting steel columns were observed at the cafeteria and window system on the west side of corridor C6. An open joint between a concrete column and the roofing system was observed outside the same C6 corridor and a cracked concrete column was observed on the south side of the building. Walls were stained from uncontrolled run-off from the roof due to a lack of gutters or gutters being bypassed. In the vein water control, an abandoned pond was observed between BLDG-054A and BLDG-054C.</p>	Average
	Exterior Windows	<p>Windows are a combination of older single-glazed, aluminum, single-hung window units; older aluminum storefront type systems; and newly installed single-glazed, aluminum, single-hung window units. Approximately one quarter of the window units are recently replaced or are in the process of being replaced.</p> <p>The exterior windows were observed to be in average condition. There were jambs observed without sealant. The larger window installations at the cafeteria and the west exit of corridor C6 had failing sealants in the window system and at the joint between other building</p>	Average

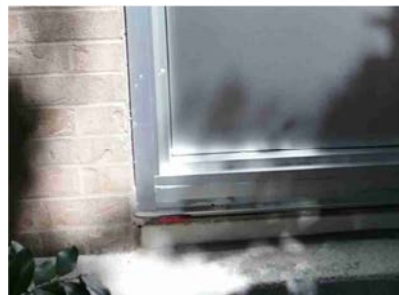
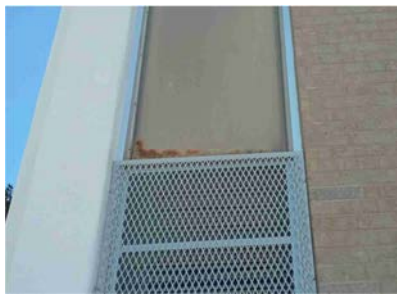
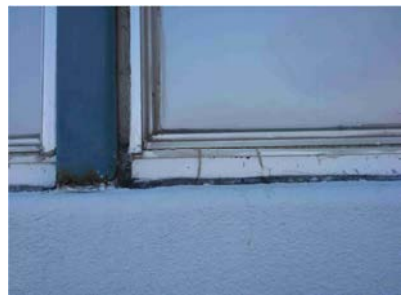
Exterior Windows

System	Subsystem	Condition and Deficiency Overview	System Condition Rating
		elements in the window system. In the 130 wing a spandrel panel in the window system was observed to be rusting. It was reported that the windows leak.	
	Exterior Doors	<p>Exterior doors are hollow metal doors set in hollow metal frames. Door systems typically include glazing in the doors; sidelights, and transoms. Some mechanical rooms have louvers set in the metal doors. A rolling door/security grill is located outside of the kitchen area.</p> <p>The exterior doors were observed to be in average condition. All doors exhibited finish damage in the form of aged chalky finish, peeling paint, or physical damage. Two doors were missing. Two locations had rust on the frame or louver. Panic hardware was observed as being damaged in two locations. A roll-up door covers an exit way, creating a hazard when the building is occupied. Some glass panes appear to have been replaced with acrylic glazing.</p>	Average

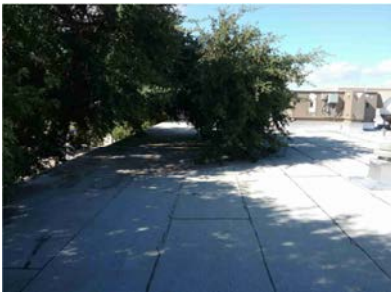
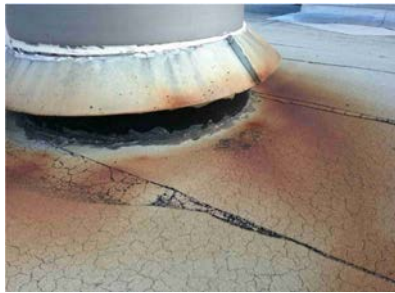
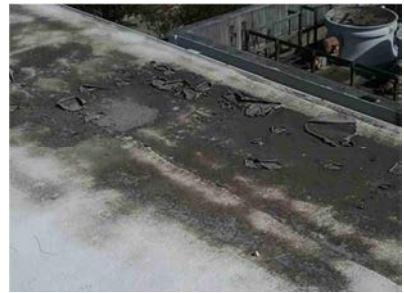
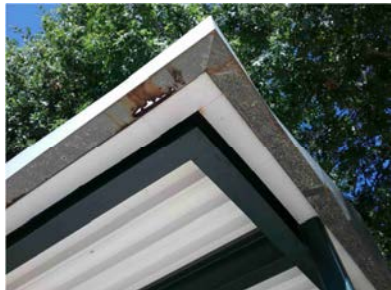
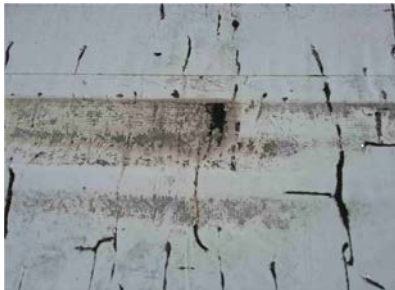
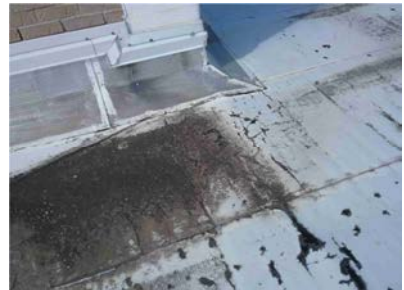
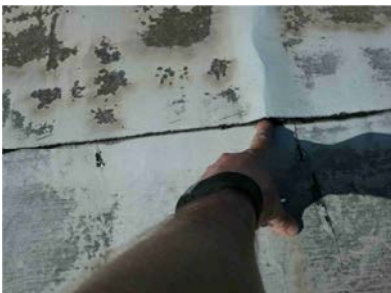
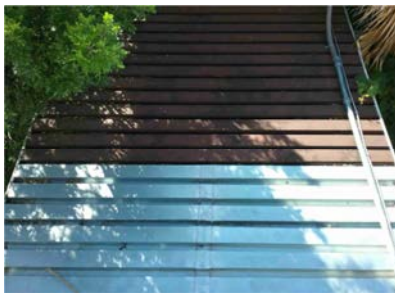
Roofing Deficiency Examples

Roofing	<p>Roofing systems include two versions of a modified bitumen installation, older EPDM (ethylene propylene diene terpolymer) type roofing, built-up construction, a cast in place concrete roof, and two types of metal roofing. The two types of modified bitumen include an installation with the typical granule-coated cap sheet and another with a foil-backed membrane coating the cap sheet. The metal roofing includes a low sloped folded/box corrugation installed on canopies covering walkways on the east side and in the courtyard and a standard corrugated metal panel on the west side installed on a steep slope system.</p> <p>The modified bitumen roofs with the foil-backed covering were observed to be in poor condition (sections A10 through A13). The District reported that this product is part of a warranty claim that is being pursued with the manufacturer of the product. On this product a large blister, ripping of the foil-backed covering, ponding, adhesion issues, and damage to the system were noted. The modified bitumen with the granule-coated cap sheet was observed to be in average condition (sections A05 and A16). Older repairs, ponding, aged roofing sealant, peeling, and trees touching the membrane were observed on this portion. The EPDM type system on the canopies covering the entrances on the east side of the building appeared to be aged (sections A08 and A09). Gutters for these sections were rusted through. The low slope metal roofing was observed to be in average condition (section A18). The portion on the east side of the building connecting to BLDG-054C appeared rusted. The concrete roof was observed to be in good condition (section A15). The steep sloped metal roof was observed to be in good condition (sections A01 through A04). The built-up roof section was observed to be in average condition (section A14). Roof areas A06, A07, and A17 did not exist. It was observed that the gutter and downspout systems may be undersized. Leaking was reported in the cafeteria and administration area. Damaged ceiling tiles inside the building indicated leaks in the roofing systems.</p>		Average

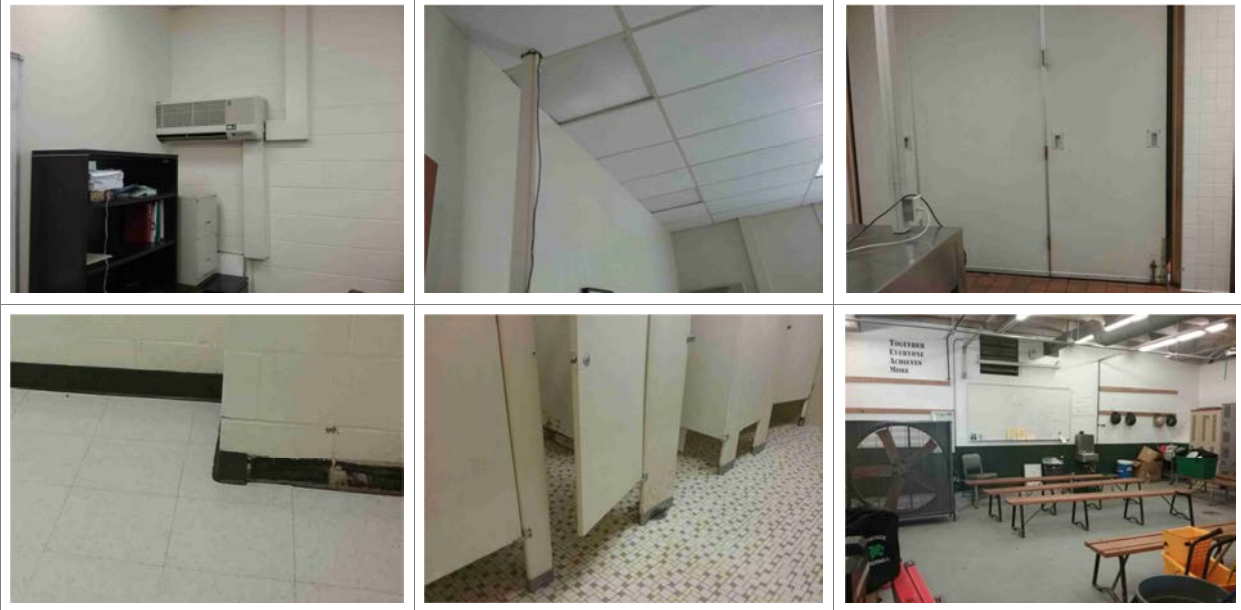
System	Subsystem	Condition and Deficiency Overview	System Condition Rating
Interior Construction	Interior Walls	<p>Interior wall systems are typically painted concrete masonry units (CMU) and gypsum board wall assemblies. Operable partitions are installed in the kitchen. In rooms 101 and 102 a partition is used to subdivide each room.</p> <p>The wall systems were observed to be in good condition. The new partition in rooms 101 and 102 was constructed to bisect the wall-mounted HVAC (heating, ventilation, and air conditioning) unit and any lighting in the suspended ceiling system. The millwork paneling installed above the stage in the theater appeared to be detaching from the wall. The operable partitions in the kitchen were noted to be rusting and had failed gaskets. Cracks in the CMU wall systems were noted in rooms 256 and 257, with the crack in 257 being horizontal and slightly offset. The field house room adjacent to the main mechanical room was observed as possibly not compliant for occupancy due to deficiencies in occupant load and exiting and fresh air circulation. Toilet partitions in one restroom were significantly rusted.</p>	Good

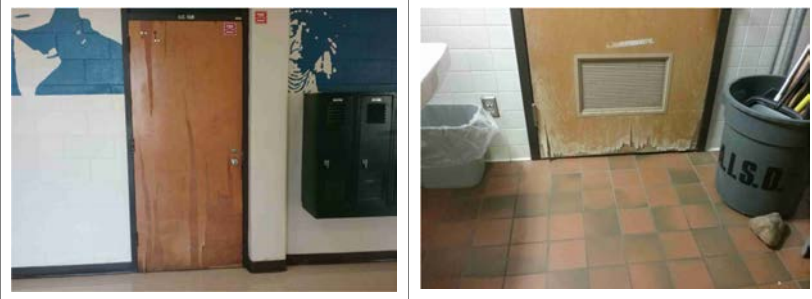
Interior Doors	<p>Interior doors are solid core with wood veneer door slabs set in hollow metal frames. Most of the hollow metal frames are a welded type, while a limited number are slip on sectional frames. There are a limited number of hollow metal doors inside the facility.</p> <p>The interior doors were observed to be in poor condition. The doors appeared to be original to the facility. Damage observed was primarily to the veneer applied to the solid wood core, but issues with rubbing at jambs and non-functional hardware were encountered as well.</p>	Poor
	Interior Specialties	<p>Half-height metal lockers are wall-mounted in the covered exterior corridors or in the basement field house. In addition, lab case work in an older section of the building is constructed of composite wood products with metal supplementary support and lab chemical-resistant tops.</p> <p>The lockers were observed to be in average condition. The finish on the lockers was observed to be aged and chalky. The lab case work in rooms 130, 131, and 133 was observed to be in poor condition. Conditions observed included veneer damage and substantive wear and tear. The lab case work in room 151 had water staining.</p>	Average

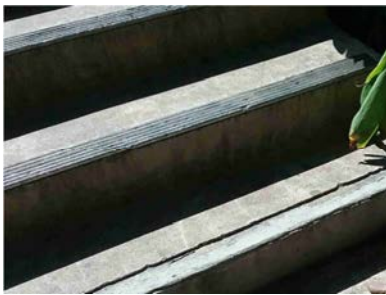
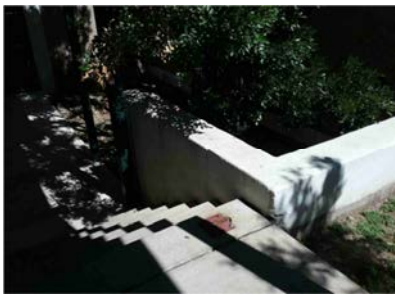
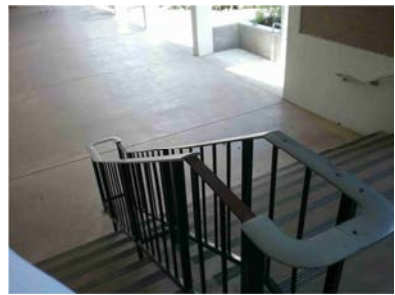
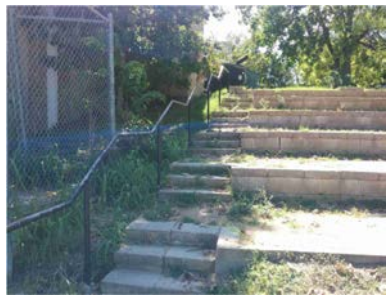
System	Subsystem	Condition and Deficiency Overview	System Condition Rating
Stairs	Exterior Stairs	<p>In most cases, exterior stairs are cast in place concrete with square tube metal railings coated in a paint finish system. These stairs have integral anti-slip nosing pieces. Railings within the covered walkway have steel lower sections with an aluminum handrail mounted on top or aluminum handrail in a wall-mounted configuration. One set of stairs is constructed of CMU set on sloping grade with a metal pipe railing.</p> <p>The exterior stairs were observed to be in average condition. All anti-slip nosing pieces were reported as worn to the point of not providing any resistance. These nosing pieces were observed to be damaged and worn throughout the facility. All railings were reported as failing and requested to be replaced. In many locations the aluminum handrail was noted as having sections missing. In one case the railing was missing altogether. At some exterior exits the railings were observed to have handrails that do not meet current code or accessibility requirements. The stair system constructed of CMU was noted as having uneven treads.</p>	Average

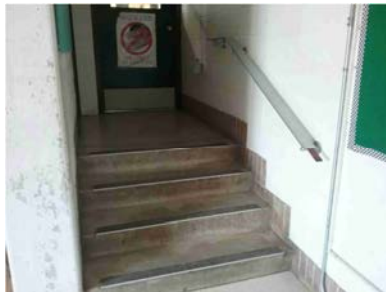
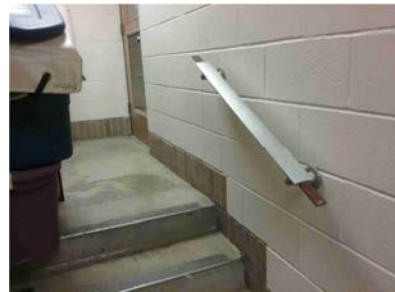
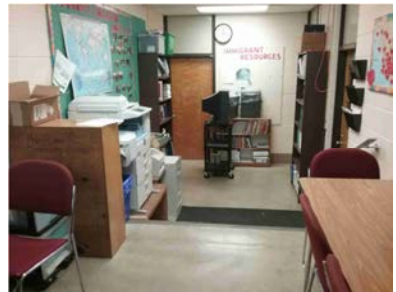
Interior Stairs	<p>Interior stairs are located in the 140 wing of the building and at the two stages. The stairs are cast in place concrete with wall-mounted, aluminum handrails.</p> <p>The interior stairs were observed to be in average condition. The railings were observed to be missing sections or damaged. Anti-slip nosing pieces were observed to be worn and ineffective. In the 140 wing it appeared that an exit way was being used as an office space, possibly creating a hazard in the facility. It was reported that there is not an accessible route to room 141OFC due to risers and stairs. It was observed that there is no accessible route to the choir room (141) and its support spaces. The wood structure at the stage does not have railings.</p>	Average
Interior Finishes	Interior Wall Finishes	<p>Interior wall finishes are primarily paint systems or vinyl wall covering over gypsum board partitions, cast in place concrete, or CMU. The restrooms and the kitchen include a mixture of painted gypsum board and ceramic tile. A limited number of rooms and areas have wood paneling. Many of the finish systems are aged or original to the building.</p> <p>The interior wall finishes were observed to be in good condition. Deficiencies noted with the vinyl wall covering in the 200 wing included physical damage and adhesion</p>	Good

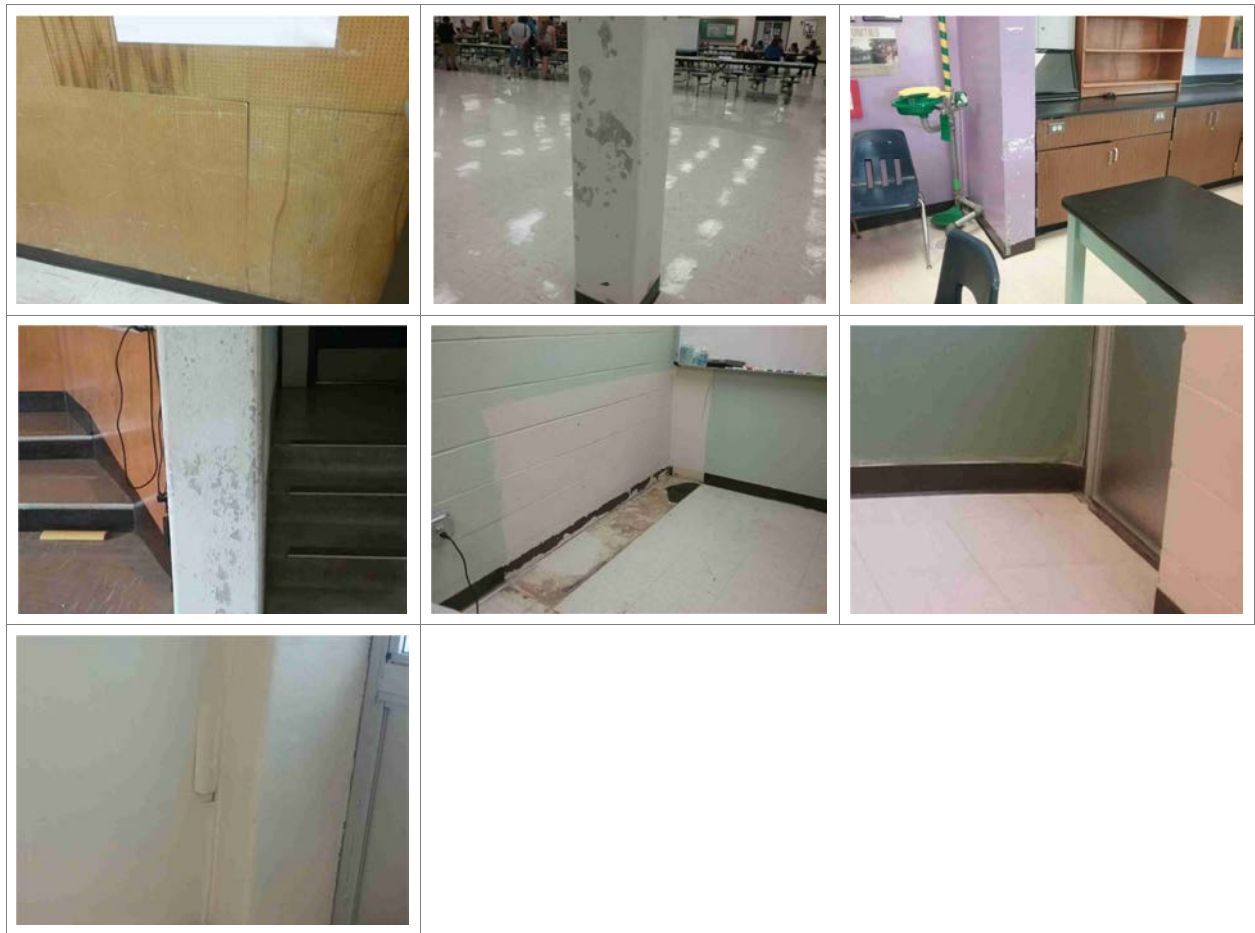
Interior Wall Finishes

System	Subsystem	Condition and Deficiency Overview	System Condition Rating
		loss with the substrate. Paint systems were either damaged or failing. Concrete surfaces in particular were observed as having paint condition issues. At the cafeteria the acoustic wood paneling around the stage was observed to be separating from the substrate. Other wood paneling had ghosting from previously installed products. It was not clear whether this wood paneling meets a Class A fire rating as may be required by this building or whether that was applicable at the time of construction. In room 154 raw gypsum board was visible where millwork was removed.	
	Interior Floor Finishes	<p>Interior floor finishes include vinyl composite tile (VCT), strip wood flooring at the stages, quarry tile in the kitchen, and carpet.</p> <p>The floor finishes in the building were observed to be in average condition. The VCT in the building was reported as lifting and haphazardly replaced. This appeared to be in keeping with the District's practice of replacing missing tiles with the color on hand rather than attempting to match the adjacent tiles. The campus staff requested that all VCT be replaced. Condition issues for the VCT included lifting, physical damage, and cracking. Substrate condition issues were noted. The VCT in the 200 wing had the largest percentage of deficiencies. The VCT in room 141 on the risers was also noted as lifting and the pattern of the lifting and wear suggested moisture underneath and movement of the structure supporting the floors. The removal of millwork or furniture uncovered damage to the VCT in the form of staining or dirt encased in wax build-up. The wood flooring systems on the two stages appeared to be in poor condition. The urethane coatings were observed as peeling and damaged. Carpet observed in the facility appeared to be newer and was in good condition.</p>	Average

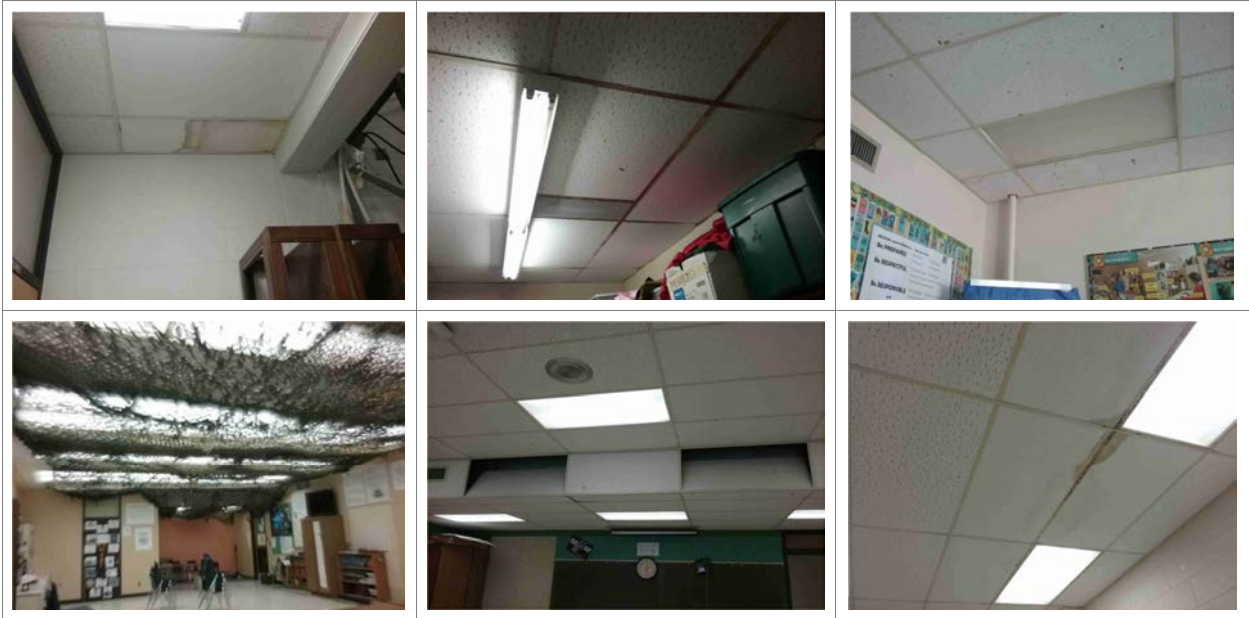
System	Subsystem	Condition and Deficiency Overview	System Condition Rating
	Interior Ceiling Finishes	<p>The ceiling systems are a 2'x4' suspended ceiling system with limited amounts of gypsum board ceilings as accents.</p> <p>The interior ceiling finishes were observed to be in poor condition. Areas of recent remodeling were in good or excellent condition but this was in a limited area. Ceiling tiles were observed with water damage, physical damage, improper installation, humidity damage, and aging. These conditions appeared in the 100, 130, 140, 150, and 200 wings along with the cafeteria area. Ceiling grid and HVAC system register systems were observed with rust. The tiles with issues observed were in all areas of the building except for the administration areas, the 190 wing, and the library. In room 154 camouflage netting was observed attached to the ceiling grid.</p>	Poor
Conveying	<p>This building has an elevator that serves two floors.</p> <p>No inspection certificate was found, but the elevator appeared to be in good condition.</p>		Good

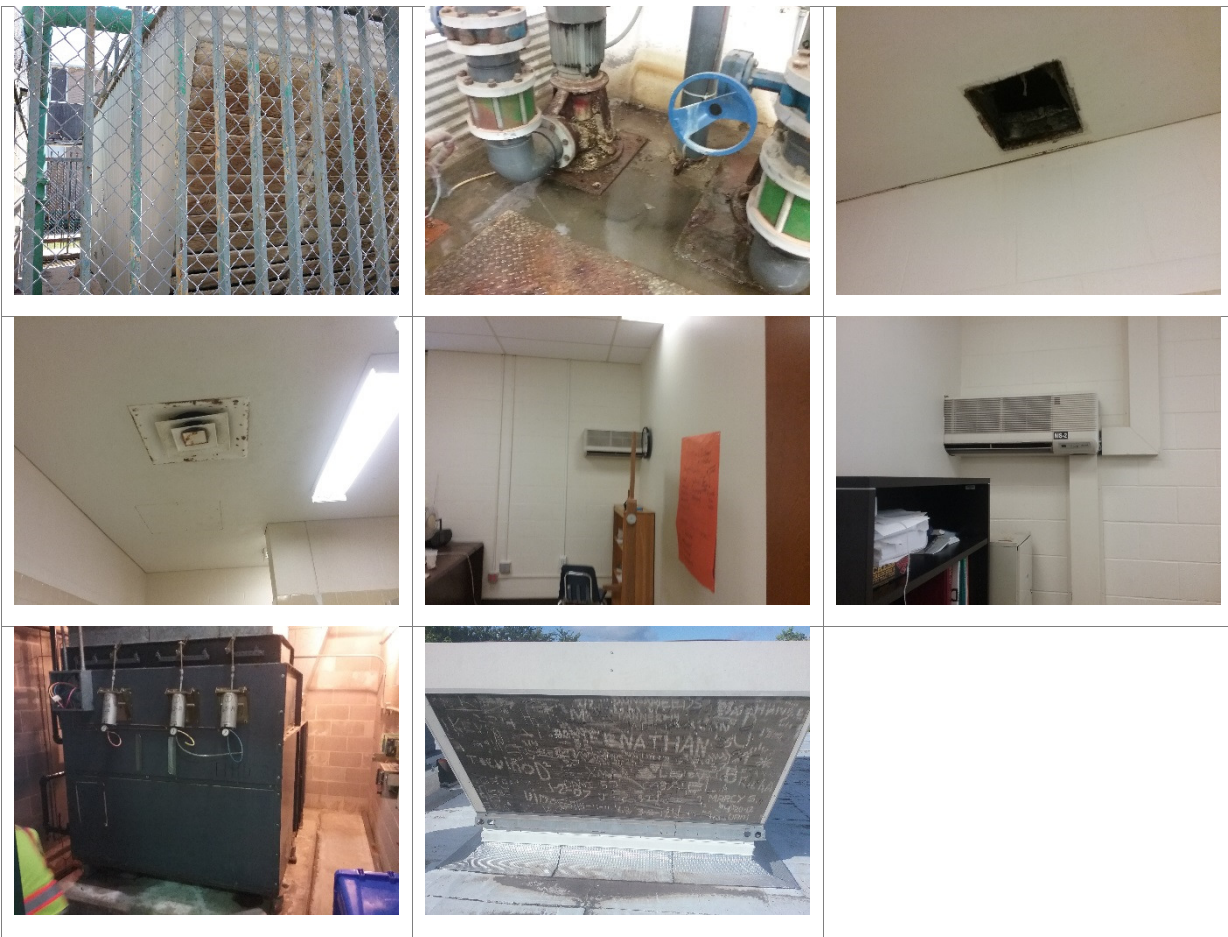
Mechanical/HVAC System Deficiency Examples

System	Subsystem	Condition and Deficiency Overview	System Condition Rating
Mechanical/ HVAC	<p>The major mechanical equipment consists of indoor chilled/hot water single zone AHUs (air handling units), an air cooled chiller, and gas fired heating water boilers. In addition, there are two outside air units (OAUs) that are roof mounted. All AHUs are either located in mechanical closets or on the roof. The mechanical closets are located along the outside border of the courtyard. The cooling tower is a built-up tower of metal and wood.</p> <p>With the exception of AHU-5, the AHUs located in mechanical closets exceed their typical design service life by more than 10 years. AHUs located on the roof were recently replaced and were observed to be in excellent condition. The diffusers in the classroom areas were observed to be in average condition. The diffusers and grilles in the restrooms from the courtyard are highly corroded and some have been removed from service. The chillers are approaching the end of their typical design service life. The chillers do not appear to have had any heavy maintenance performed. Chilled water and heating water pumps appeared to have been well maintained but were approaching the end of their typical design service life. The condenser water pumps had several leaks and appeared to have had heavy and continual maintenance. The boilers have exceeded their typical design service life but appeared to have been well maintained. The cooling tower was degrading and showed signs of excessive use. There are three mini-split systems in the area of room 130. An apparent remodel has put a wall in the middle of two of the units. The system is rated as poor due to the large quantity of equipment approaching or in excess of their typical design service life.</p>		Poor

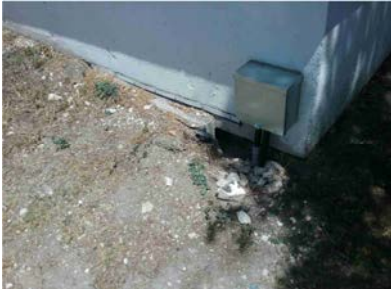
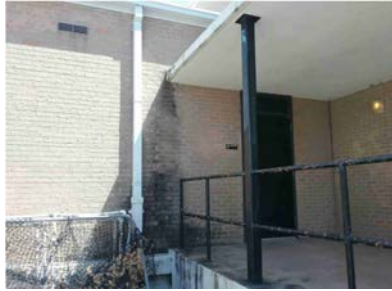
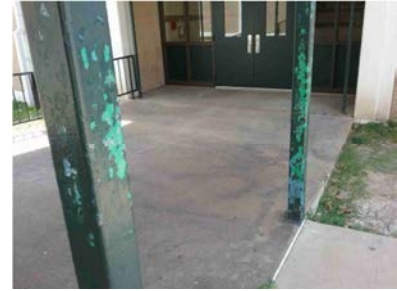
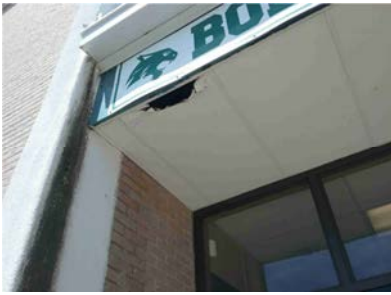
System	Subsystem	Condition and Deficiency Overview	System Condition Rating
Exterior	Exterior Walls	<p>Exterior walls are primarily brick with exposed concrete and steel structural elements. Exposed steel is primarily used in canopies covering walk ways.</p> <p>The exterior walls were observed to be in average condition. Deficiencies noted relate to the uncontrolled run-off of water from the roofing systems as a result of failure or omission, holes at grade leading under the building, and damage to brick work from graffiti removal. Uncontrolled run-off from the roof was noted as having damaged the suspended ceiling tile soffit system on the south side of the building. Gymnasium equipment supports and attachments on the exterior were observed as rusting. In the big gymnasium, the exterior wall appeared to have moisture issues as evidenced by the damage to the paint system and mineral buildup on the inside surface of the exterior wall. This takes the form of minerals leaching out of the grout and damage to the paint systems.</p>	Average

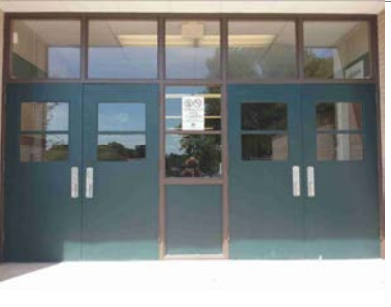
System	Subsystem	Condition and Deficiency Overview	System Condition Rating
	Exterior Doors	<p>Exterior doors are hollow metal doors set in hollow metal frames. There is acrylic glazing installed in some doors, sidelights, or transoms.</p> <p>The exterior doors were observed to be in average condition. The paint systems on the doors were noted as being aged and chalky. Some doors were observed as sagging in their frames, did not appear to affect the functioning of the doors.</p>	Average
Roofing	<p>Roofing systems include two versions of a modified bitumen installation, PVC (polyvinyl chloride), a cast in place concrete roof, and two types of metal roofing. The two types of modified bitumen include an installation with the typical granule-coated cap sheet and another with a foil-backed membrane coating the cap sheet. The metal roofing includes standing seam metal panel systems and a standard corrugated metal panel on the west side installed on a steep slope system.</p> <p>The roof system was observed to be in poor condition. Leaks are reported in the new band hall (room 404) and in the small gymnasium. The modified bitumen with the foil-backed covering is in poor condition (sections B05, B06, B08, B14, and B15). The District reported that this product is part of a warranty claim that is being pursued with the manufacturer of the product. On this product ripping of the foil-backed covering, ponding, adhesion issues, and damage to the system were noted. The modified bitumen with the granule-coated cap sheet was observed to be in average condition (sections B02 and B12). Older repairs, ponding, aged roofing sealant, and damage were all observed on these sections. The PVC on the upper roof sections was observed to be in average condition. (Sections B01 and B03). Ponding, ripples in the cap sheet, and previous repairs were observed on these surfaces. The concrete roof was observed to be in good condition (sections B04 and B11), but run-off from the roof was observed to be directed toward the building and appeared to be staining the building. The steep sloped metal roofs were observed to be in good condition (sections B13 and B16).</p>		Poor

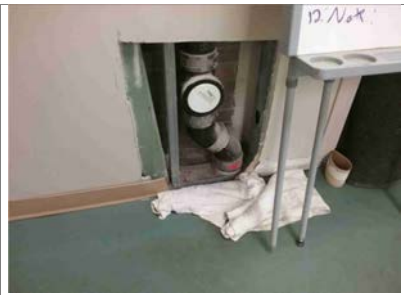
Interior Construction	Interior Walls	<p>Interior wall systems are typically painted CMU and gypsum board wall assemblies.</p> <p>The interior wall construction was observed to be in good condition. One deficiency observed in room 415 was a large hole cut in the wall system to access a rain water leader.</p>	Good
	Interior Doors	<p>Interior doors are solid core with wood veneer door slabs set in hollow metal frames. There are a limited number of hollow metal doors inside the facility.</p> <p>The interior doors were observed to be in good condition. Double door configurations did not close all of the way due to sagging on the door panels in the frames. The door in room 404 was observed rubbing the floor and damaging the VCT.</p>	Good

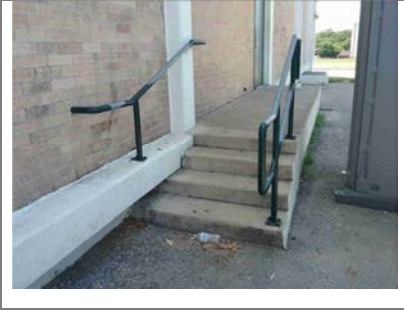
System	Subsystem	Condition and Deficiency Overview	System Condition Rating
	Interior Specialties	Metal lockers are in the locker rooms. The metal lockers were observed to be in excellent condition.	Excellent
Stairs	Exterior Stairs	All exterior stairs are comprised of cast in place concrete with metal pipe railings. The exterior stairs were observed to be in average condition as a result of the failing railing finish. Railings were noted as having peeling and damaged paint	Average
	Interior Stairs	System not present.	N/A
Interior Finishes	Interior Wall Finishes	Interior wall finishes are paint over gypsum board partitions or CMU. The restrooms include a mixture of painted gypsum board and ceramic tile. The interior wall finishes were observed to be in good condition in part due to the areas that have been remodeled or updated recently. The large gymnasium was observed as having two condition issues with the paint systems. The wall area above the bleachers on the north side was noted as having damaged paint likely from students picking at the wall finish. At other walls in the large gymnasium, the paint system at grout joints was observed to be falling and minerals were building up underneath the holes in the paint or under the paint itself.	Good

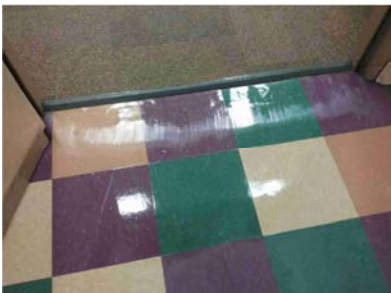
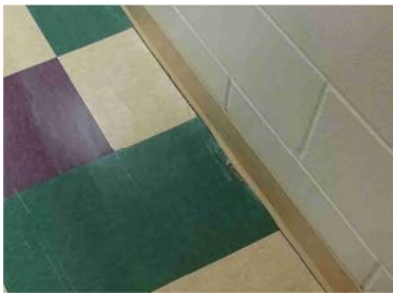
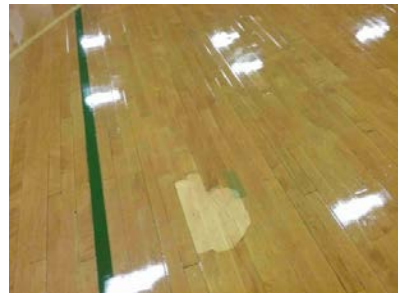
Interior Floor Finishes	Interior floor finishes include VCT, strip wood flooring at the gymnasiums, and ceramic tile in the restrooms and locker rooms. The interior floor finishes were observed to be in good condition. The VCT appeared to be newer but exhibited damage at the door that rubs on the floor in room 404 and in corridor C2. The wood flooring in the gymnasium was observed to be in poor condition. This assessment is the result of an inability to repair the main gymnasium where damage has occurred due to the presence of ACM (asbestos containing material) underneath and the condition of the urethane finish in the small gym.	Good

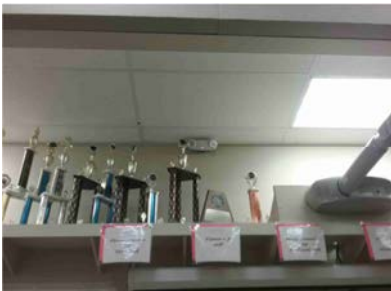
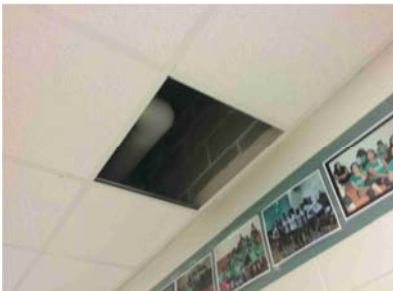
System	Subsystem	Condition and Deficiency Overview	System Condition Rating
	Interior Ceiling Finishes	Ceiling systems are a 2'x4' suspended ceiling system with limited amounts of gypsum board ceilings in restrooms or as accents. The gymnasiums include exposed structural systems and building elements. In one of the music areas wood fiber panels are installed. The ceiling finishes were observed to be in good condition. The two deficiencies noted were limited to the potential for future damage in room 404 as a result of roof leaks and a missing ceiling tile in corridor C16.	Good
Conveying	System not present.		N/A
Plumbing	Plumbing Fixtures	The building has individual restrooms for males and females, students, and separate staff restrooms located in the main hall of the facility. These restrooms have vitreous china hand sinks in counters with manual faucets, along with vitreous china, floor- and wall-mount toilets with manual flushing mechanisms, and vitreous china, wall-hung urinals in the male restrooms with manual flushing mechanisms. There is a service sink in the janitorial closet, and a water cooler in the main corridor. There are also male and female locker rooms. The restroom fixtures appeared to be in good condition. The showers in the locker rooms appeared to have corrosion on the shower heads and the drains. Due to the condition of the showers the system is rated as average.	Average

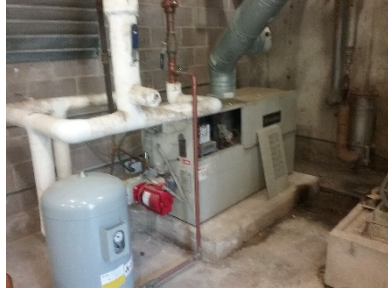
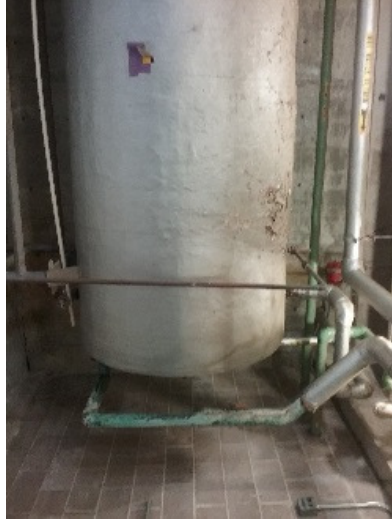
Domestic Water Distribution	The building is served from the main building. There is a domestic water boiler with separate storage tank and circulation pump in the basement mechanical room. The storage tank is insulated with no visible signs of leaks. The boiler appeared to be aged and in average condition. Piping at the storage tank was heavily corroded.	Average
	Other Plumbing	The roof drains are equipped with metal grate covers to prevent debris from entering the drainage system. The roof drains appeared to be in good condition.	Good
Mechanical/ HVAC	The major mechanical equipment consists of one boiler with pump, several roof-mounted chilled water air handlers, and several DX roof top units. Chilled water is provided from the central plant in the main building. The chilled water AHUs were new and in excellent condition. The DX RTUs were observed to be in average condition and approaching the end of their typical design service life. The diffusers and grilles in the facility were observed to be in good condition. RTU-2 is approaching the end of its typical design service life. The boiler and heating water pump were approaching the end of their typical design		Average

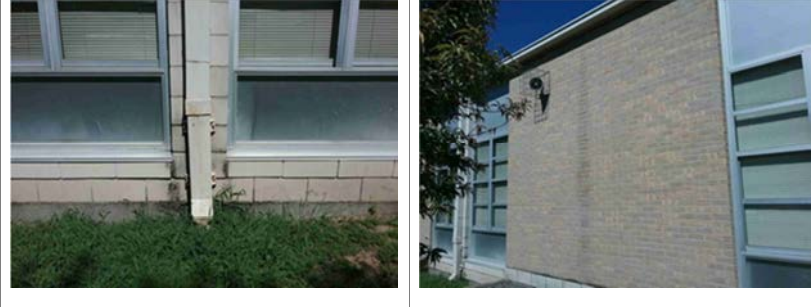
System	Subsystem	Condition and Deficiency Overview	System Condition Rating
Exterior	Exterior Walls	Exterior walls are primarily brick with CMU and metal panel accents and exposed steel. Exposed steel is at the canopy covering the walkway between buildings. The exterior walls were observed to be in good condition. The only deficiencies observed involved uncontrolled run-off from the roof systems and the resultant staining on the masonry.	Good
	Exterior Windows	Windows are single-glazed aluminum, single-hung window units with metal panel transoms and bottom panels. The window systems were observed to be in average condition. The interior window sills displayed substantive degradation likely due to water infiltration or condensation formed on the window systems during the winter months.	Average
	Exterior Doors	Exterior doors are hollow metal doors set in hollow metal frames. Typically these units contain window units. Some mechanical rooms have louvers set in the metal doors. The exterior doors were observed to be in good condition. The finish systems on the doors, frames, and louvers appeared aged and weathered. Rust was noted on the transom panel of the electrical room.	Good

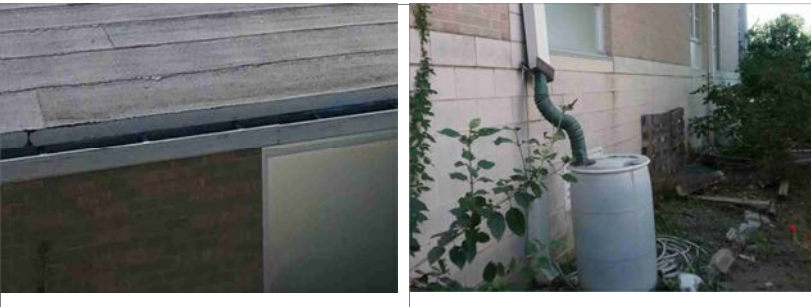
Roofing Deficiency Examples

System	Subsystem	Condition and Deficiency Overview	System Condition Rating
		The roof was observed to be in average condition. Staining on the wall, rust at the gravel stop observed from adjacent buildings, and water-damaged ceiling tiles were noted related to failed sealants or other portions of the roofing system. The rainwater collection system was also installed improperly.	
Interior Construction	Interior Walls	Interior wall systems are limited to gypsum board wall assemblies and CMU construction. The interior wall construction was observed to be in good condition. Two condition concerns were noted that are tangential to the walls themselves: In the male restroom, a clean-out cover plate was bent down exposing the interior of the CMU wall. The metal support leg for the countertop in the same restroom was missing an end panel and was rusting.	Good
	Interior Doors	Interior doors are solid core wood veneer door slabs set in hollow metal frames. All classroom doors have windows. The interior doors were observed to be in good condition with only minor surface finish issues.	Good

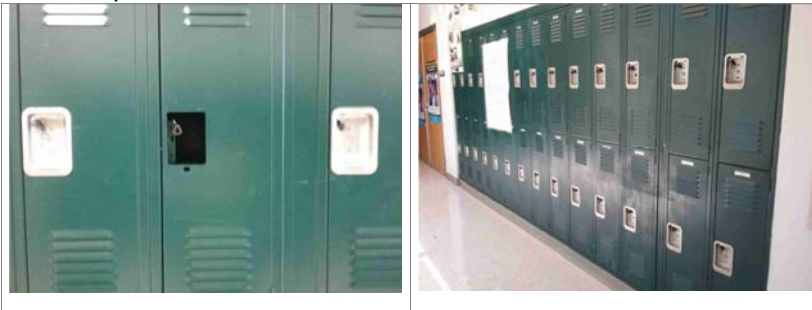
Interior Specialties	Metal lockers are installed in the corridor. These are in the form of double stacked half-height units. The lockers were observed to be in good condition. The surface finish of the lockers was a little aged and had wear and tear. One unit was noted as not having its hardware.	Good
Stairs	Exterior Stairs	System not present.	N/A
	Interior Stairs	System not present.	N/A
Interior Finishes	Interior Wall Finishes	Interior wall finishes are paint systems over gypsum board partitions or CMU. The restrooms include a mixture of painted gypsum board and ceramic tile. The interior wall finishes were observed to be in good condition. The outside corners of the gypsum board wall finishes were consistently worn in corridor C8. In one classroom, holes were noted in the gypsum board wall system from the removal of previously installed elements.	Good
	Interior Floor Finishes	Interior floor finishes include VCT and ceramic tile in the restrooms. The floor finishes were observed to be in good condition. Two condition issues were noted with the VCT. In corridor C8 some tiles were noted as cracking and in classroom 302 a few tiles were noted as stained.	Good

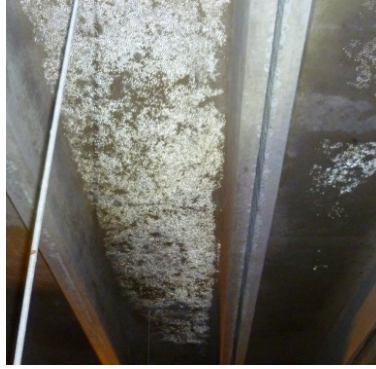
Condensation under slab

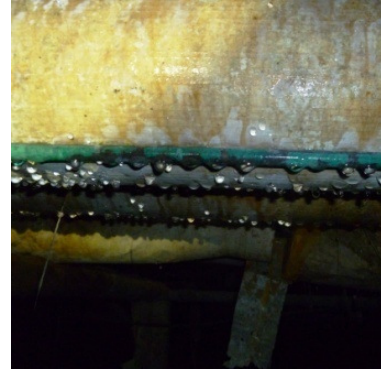
Sweating pipes

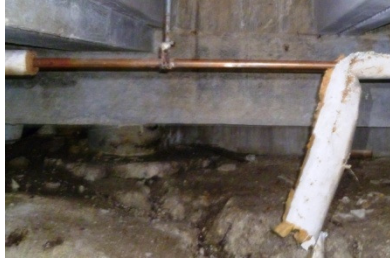
Fallen/degraded pipe insulation

3. Repair or replace any damaged or missing piping insulation as needed.
4. Address any equipment at all of the campus facilities that were noted with excessive noise/vibration by repairing the motor, changing the belt, or any other means to promote efficiency.
