Covington Middle School Site Summary

Address	3700 Convict Hill Road Austin, TX 78749
Number of Permanent Campus Facilities	3
Original Year of Construction	1986
Total Campus Building Area (combined)	173,867 SF

Introduction

Main School Building – BLDG-057A

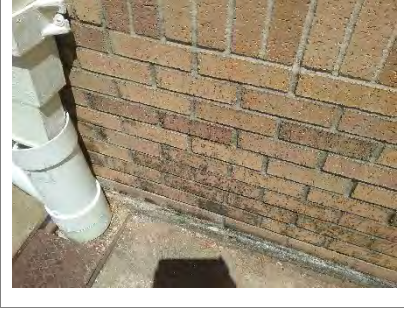
System	Subsystem	Condition and Deficiency Overview	System Condition Rating
Exterior	Exterior Walls	<p>The exterior walls are comprised of brick with a stone clerestory accent. A deep overhang on the courtyard side of the school is finished with plaster.</p> <p>The brick was observed to be in good condition with no visible signs of damage beyond slight discoloration from water. The plaster of the overhang was observed to be in good condition.</p>	Good
	Exterior Windows	<p>The exterior windows are single-pane in aluminum frames. They are semi-operable and set in horizontal bands.</p> <p>The windows were in good condition with the exception of several deficiencies. The exterior of the second-story windows was observed to be excessively dusty. The steel lintels on the first-floor windows were rusted and aged. It was reported that the bay windows at both stair landings leaked, but no signs of damage were observed. The operable windows were observed to function well.</p>	Good

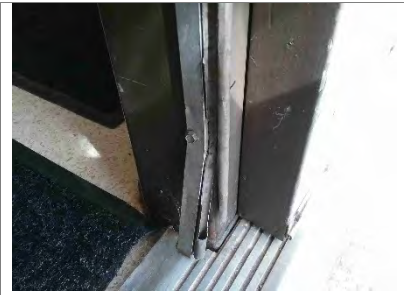
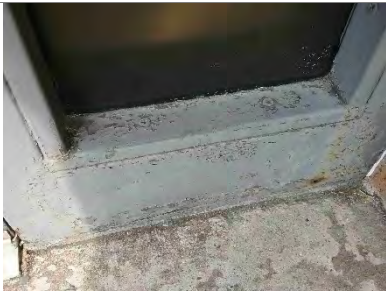
Exterior Doors	<p>The exterior doors are metal in metal frames with narrow lites. Many of the doors are arranged in pairs and set in a window system of transom windows and side lites.</p> <p>It was reported that the exterior double doors near rooms 118 and 115 did not close. The doors were observed to be closed, but the weather stripping was damaged. Multiple doors exhibited damaged weather stripping and aged and peeling exterior paint.</p>	Average

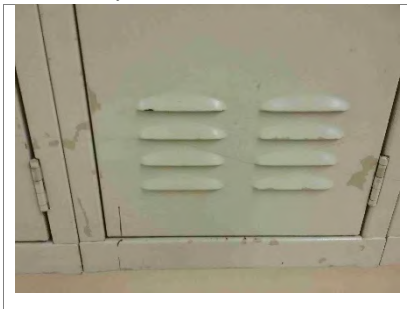
Interior Specialties	<p>There are wall-mounted metal lockers located in the corridors of the classroom wings.</p> <p>The lockers were observed to be in good condition with only minor signs of damage. Chipped paint was observed on some of the lockers.</p>	Good
Stairs	Exterior Stairs	System not present.	N/A
	Interior Stairs	<p>There are interior stairs in each wing of the building and in the main atrium. The stairs are constructed of concrete and are finished with linoleum sheeting and slip-resistant nosings. There is also a wood service stairway leading to a mechanical mezzanine by the gymnasium.</p> <p>The stairs were observed to be in average condition, as few instances of damage were observed. Some of the nosing material was chipped, and the paint on some of the top handrails was scratched. The wood of the service stairs was chipped, and the stair treads were uncomfortably shallow.</p>	Average

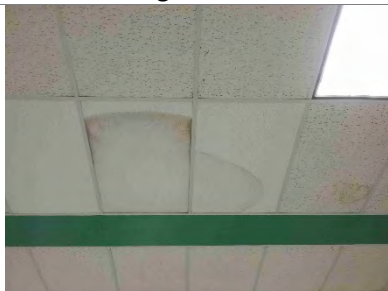
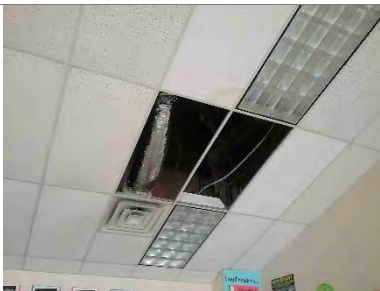
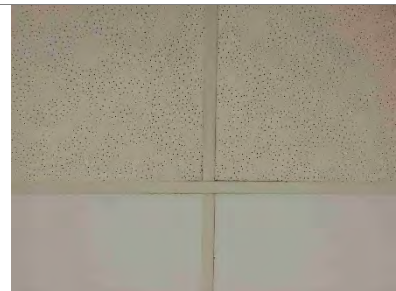
Interior Ceiling Finishes	<p>The building ceiling is finished ACT (acoustic ceiling tile) and painted drywall. The restroom ceilings are finished with painted drywall. The kitchen ceiling is finished with mismatched lay-in ceiling tiles. The gymnasium and adjacent corridor are finished with OSB (oriented strand board) panels.</p> <p>The interior ceiling finishes were observed to be in average condition. Water damage was observed on a few ceiling tiles, in areas including the east office and cafeteria. Some ceiling tiles were also observed to be bowing. Two ceiling tiles were missing from room 211. About half of the kitchen ceiling tiles were observed to be made of a pocked material. The kitchen ceiling tile tees were discolored and aged, and some of the tiles were dusty and dirty. The ceiling tiles in the corridors were aged and dingy. The OSB ceilings in the gymnasium and adjacent corridor were in poor condition; the material was observed to be aged and deteriorating. Some of the panels were replaced with other material.</p>	Average

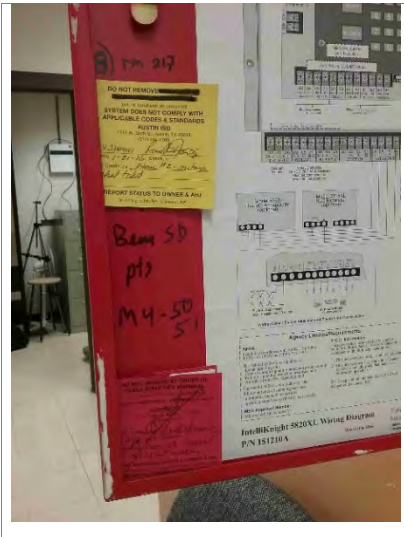
System	Subsystem	Condition and Deficiency Overview	System Condition Rating
		in the main mechanical room were observed to be in average condition. The condenser near the lounge area on the building exterior is aged and corroded.	
Fire Protection	Fire Alarm	<p>The building has a fire alarm system that consists of alarm and signaling devices such as horns/annunciators, strobes, horn/strobe combinations, pull stations, and detectors. The fire alarm system is controlled by a Silent Knight 5820XL control panel.</p> <p>The fire alarm system was in average condition. The fire alarm control panel appeared to be in poor condition, as several recent "failed" inspection tickets were observed posted on the inside of the panel door. However, the fire alarm end devices appeared to be in good condition.</p>	Average
	Fire Protection/Suppression	<p>The building does not have a fire suppression system. The building is protected by portable fire extinguishers placed throughout the facility.</p> <p>All observed portable fire extinguishers had inspection tags dated within the last year.</p>	N/A

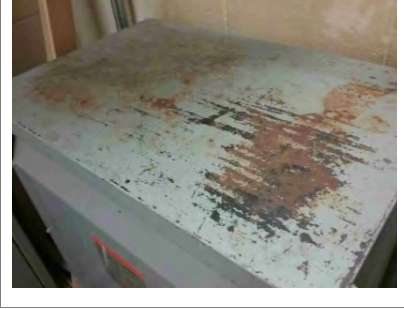
Electrical	Electrical Distribution	<p>The electrical service enters the building at the 277/480-volt 5000-amp main switchboard located in the main electrical room. It is a "six switch" rule switchboard, so there is no main breaker. The service feeds transformers and distribution panelboards located in various electrical rooms throughout the building. The building does not have a lightning protection system.</p> <p>The electrical distribution equipment appeared to be in average condition. About 15% of the electrical distribution equipment was observed with corrosion. Panelboard 'LV6' located in the cafeteria electrical room appeared to have missing breaker covers, and the bussing was exposed behind the breaker board. This condition could be considered a life safety hazard. It was reported that controls for bleachers in the gymnasium were not functional.</p>	Average
	Lighting	<p>The interior lighting consists of 2'x4' fluorescent-lensed fixtures and 2'x4' fluorescent parabolic fixtures. The parabolic fixtures are in the classrooms. The emergency lighting appears to be accomplished by emergency battery packs in select 2'x4' fixtures and incandescent emergency lighting units.</p> <p>The gymnasium lighting consists of HID (high-intensity discharge) low-bay light fixtures and 4'-long fluorescent strip lights with wire guards. There does not appear to be any emergency lighting in the gymnasium.</p> <p>The exterior lighting consists of HID and LED (light-</p>	Average

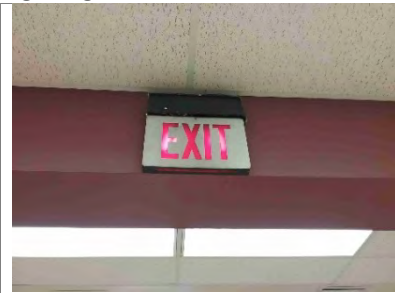
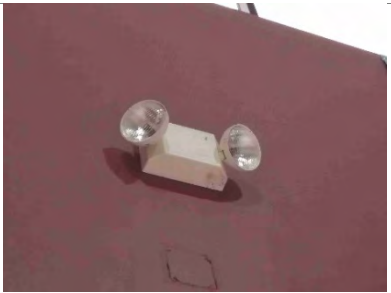
Lighting

System	Subsystem	Condition and Deficiency Overview	System Condition Rating
		<p>emitting diode) fixtures. There are some HID wall packs mounted on the building and in the courtyard.</p> <p>The lighting for the building appeared to be in average condition. Approximately 25% of the interior light fixtures and 10% of the exterior light fixtures appeared to be aged past their typical design service life. Observed deficiencies included inconsistent color temperatures and non-functional fixtures. The exit signs and lighting units present in the building appeared to be from the original construction. These appeared to be functional but showed considerable signs of wear and tear.</p>	
	Communications & Security	<p>There is a Gemini security system including surveillance cameras in the building. There is also a public address system. There is a digital clock system that appears to be from the original construction. The campus is equipped with telecommunication systems.</p> <p>The existing security system at the facility appeared to be good condition. Facility staff reported that additional cameras and card access points were needed at the campus, specifically at the main entrances and at the roof.</p> <p>According to facility staff, the public address system was aged and had reached the end of its typical design service life.</p> <p>Staff also stated the digital clock system was aged and had reached the end of its typical design service life.</p> <p>The main backbone equipment for telecommunications was located in an inaccessible room. Wi-Fi points were present throughout the campus and were in good condition.</p>	Average

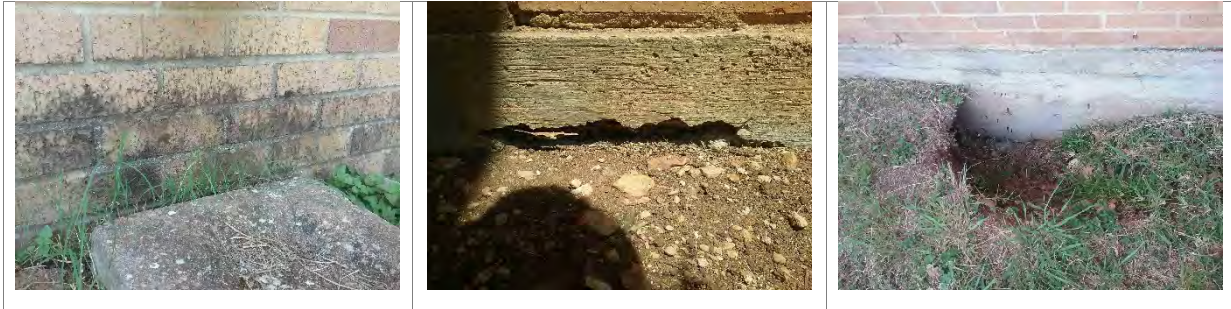
System	Subsystem	Condition and Deficiency Overview	System Condition Rating
Exterior	Exterior Walls	The exterior walls are finished with brick. The walls were in good condition with few instances of signs of deterioration. The exterior walls were observed to be discolored, and cracks in the concrete foundation walls were observed. Eroded soil was also observed in isolated spots.	Good
	Exterior Windows	The exterior windows are fixed single-pane windows in aluminum frames. The windows were observed to be in good condition with only small areas of damaged sealant.	Good
	Exterior Doors	The main entrance to the building is a set of two double doors, which are half glazed. There are two additional double doors at the end of the corridor, which have narrow lites. All exterior doors are painted metal. There are two fully glazed sliding doors at the west patio as well. The paint was observed to be peeling from the doors and frames. The sliding glass doors were observed to be in poor condition; the track had too much debris to be functional, and the tint on the doors was aged.	Average

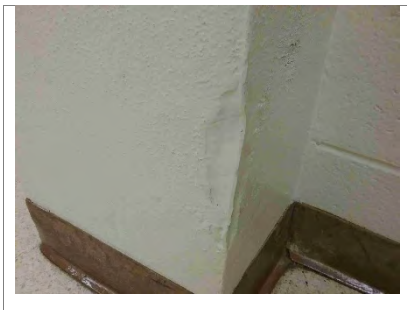
System	Subsystem	Condition and Deficiency Overview	System Condition Rating
Interior Construction	Interior Walls	The interior walls are constructed with CMU. Interior walls were observed to be in good condition with very few visible signs of damage. A portion of one pilaster was observed to be dented at the corner.	Good
	Interior Doors	The interior doors are metal in metal frames. The interior doors were observed to be in average condition due to use. Worn paint was observed on all doors and frames. One storage room door was observed to get caught on the floor.	Good
	Interior Specialties	System not present.	N/A
Stairs	Exterior Stairs	System not present.	N/A
	Interior Stairs	System not present.	N/A
Interior Finishes	Interior Wall Finishes	The interior walls of the building are painted, and wood wool acoustical panels are in most classrooms. The paint finish inside the building was observed to be in good condition. The majority of the wood wool acoustical panels were also in good condition, though the tan color was observed to create a dingy atmosphere. The wood wool acoustical panels in the band room were separating from the drywall ceiling.	Good

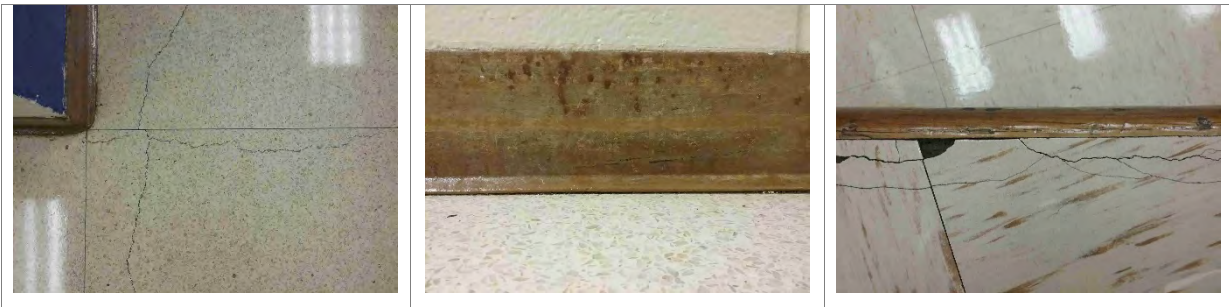
Interior Floor Finishes	The interior floor is finished with linoleum sheeting and carpet. The restroom floors are finished in ceramic tile. Cracks were prevalent in the flooring material, occurring every 8 feet. The rubber wall base was discolored and aged everywhere except the auditorium. The linoleum tile on the choir risers was cracked at the edge of each riser.	Average
	Interior Ceiling Finishes	The interior of the building is finished with ACT and painted drywall. The ACT was observed to be scratched, dented, and damaged from water.	Average
Conveying	System not present.		N/A
Plumbing	Plumbing Fixtures	This building consists of male and female public restrooms. The urinals are wall-hung, vitreous china. The toilets are also vitreous china, and the faucets are manual. The toilets and urinals have manual flush valves. The sinks are serviced with only cold water in this building. The fixtures in this building were in good condition. There were no observed water pressure issues, and all fixtures were fully functional.	Good

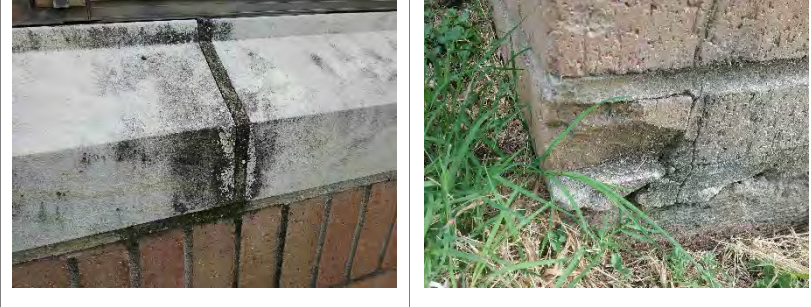
System	Subsystem	Condition and Deficiency Overview	System Condition Rating
Exterior	Exterior Walls	The exterior walls are comprised of brick. The exterior walls were in good condition with slight discoloration and a few instances of chipped brick.	Good
	Exterior Windows	The exterior windows are a series of partially operable fixed windows. They are single-pane and set in a metal frame. At the exterior of one auxiliary classroom, a double-pane window turns up to form a roof like a greenhouse. The exterior windows were observed to be in good condition with no visible signs of damage. The greenhouse-like windows were observed to be in poor condition due to excessive debris. The frames were rusted, and the panes were covered with calcium stains. The sealant was deteriorated. The CMU course just beneath the windows was observed to be splitting away from the CMU below.	Good
	Exterior Doors	There are two sets of exterior doors on opposite sides of the building. The door system is a double door with narrow lites set in a metal storefront system. There is one 6x8 manual overhead rolling door located in the woodshop classroom. The vertical weather stripping was bent on the exterior door. The overhead door appeared to be in average condition due to age, but evidence of leaking was observed around the door. It was evident that the door was not fully water tight.	Average

1. Clean the exterior of all windows, walls, and doors.
2. Refinish or repair damaged exterior doors and frames.
3. Replace all damaged weather stripping and sealant on doors and windows to remain.

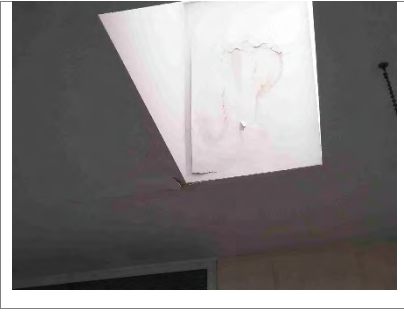
System	Subsystem	Condition and Deficiency Overview	System Condition Rating
Roofing	<p>The roof is standing seam metal. There are four skylights with deep insets above the south roof.</p> <p>The roof was inaccessible due to slope. Water damage was noted on the interior of the building, so it was assumed that the roof was in average condition. The skylights were observed to be in poor condition as the drywall finish around the skylights had much cracked and peeling paint. Water damage was observed at three of the skylights.</p>		Average
Interior Construction	Interior Walls	<p>The interior walls are comprised of CMU and metal stud with drywall construction.</p> <p>The interior walls were observed to be in good condition with very few visible signs of damage. The column in the corridor was dented at the base. A vertical crack was also observed in the wall near the exterior doors.</p>	Good
	Interior Doors	<p>The interior doors are wood in painted metal frames. The classroom doors have narrow lites.</p> <p>The interior doors were observed to be in average condition with typical scratched paint on the frames and worn wood near areas of high use. Some thresholds were observed to be skewed, creating a tripping hazard.</p>	Average

1. Assess the roofs of all buildings that show signs of interior water damage.

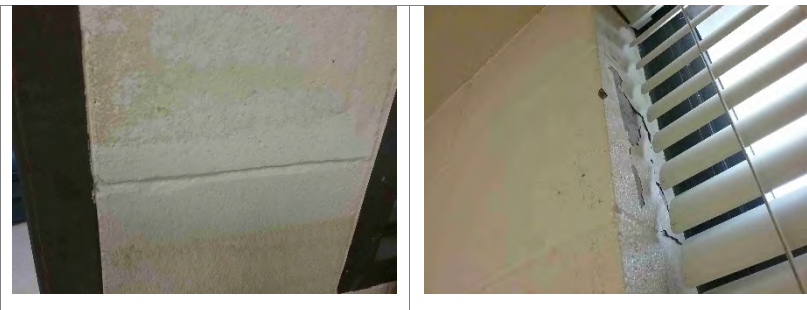
Interior Specialties	System not present.	N/A
Stairs	Exterior Stairs	System not present.	N/A
	Interior Stairs	System not present.	N/A
Interior Finishes	Interior Wall Finishes	<p>The walls are finished with soda drywall or painted CMU.</p> <p>The wall finishes appeared to be dingy, and some of the paint was observed to be peeling.</p>	Average
	Interior Floor Finishes	<p>The floor in the building is finished with linoleum sheeting, linoleum tile, and carpet tile, all with rubber wall base.</p> <p>Many large cracks were observed to cross the floor wall to wall, and the rubber base was very aged and discolored.</p>	Average

1. Replace damaged ceiling tiles and tees. Monitor and repair roof leaks as needed on all buildings to prevent further damage.
2. Replace damaged linoleum floor tile; investigate possible settling beneath cracked tiles.
3. Scrape peeling paint and repaint damaged finishes.
4. Replace all discolored, detached, or damaged rubber wall base.

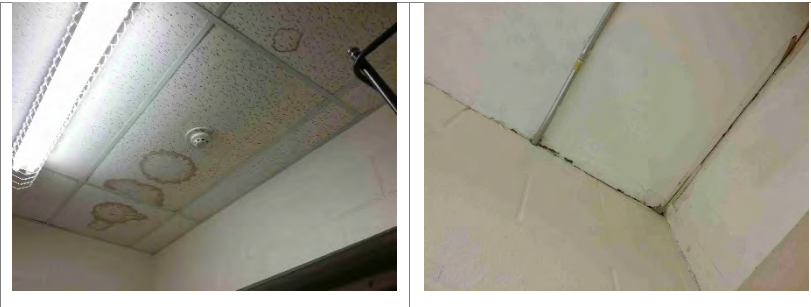
System	Subsystem	Condition and Deficiency Overview	System Condition Rating
	Interior Ceiling Finishes	<p>The building is finished with ACT throughout, except for the woodshop classroom.</p> <p>The interior ceiling finishes were in average condition. Water damage was observed on the ceiling tiles spanning the south side of the building and in the storage spaces of the woodshop classroom. Roof leaks were reported. Many tiles were observed to be askew or bowing. The drywall ceiling in the woodshop classroom was peeling away at the edges of the walls. Some of it was observed to be damaged from water intrusion near the overhead door.</p>	Average
Conveying	System not present.		N/A
Plumbing	Plumbing Fixtures	<p>A male restroom and a female restroom are next to the greenhouse. The fixtures are vitreous china. The toilets are floor-mounted with manual flush valves. The sinks in this building have manual turn handles.</p> <p>The plumbing fixtures appeared in good condition. The only noticeable issue was that the water pressure for the toilets was low. The toilets did not flush well, and it appeared that they would easily clog.</p>	Good

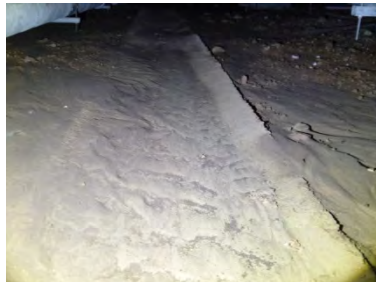
Drainage flume clogged with soil

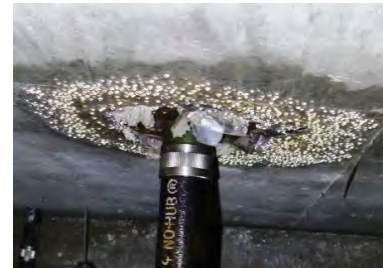
Condensation under slab

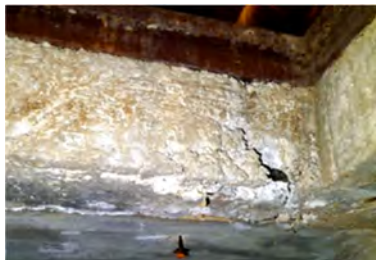
Poorly consolidated slab
