Fulmore Middle School Site Summary

Address	201 East Mary Street Austin, TX 78704
Number of Permanent Campus Facilities	4
Original Year of Construction	1911, 1980, and 2002
Total Campus Building Area (combined)	159,770 SF

Introduction

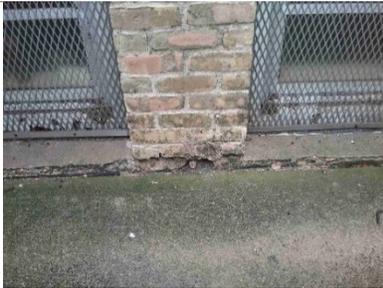
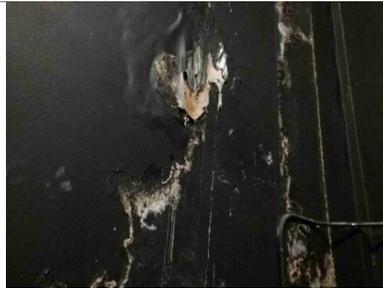
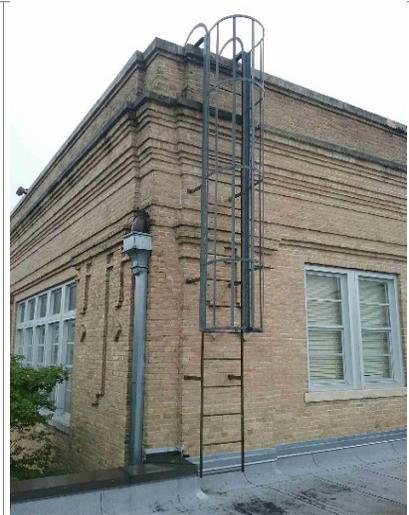
Exterior walls

System	Subsystem	Condition and Deficiency Overview	System Condition Rating
Exterior	Exterior Walls	<p>Exterior walls are entirely brick with limestone lintels above the first floor windows, at window sills, and at the parapet coping of the original portion of this building. Cement plaster panels are applied to the south wall of the newer west addition to the original building. Plaster soffits extend over the entries. A steel roof ladder is installed on the east side of the north wall at the second floor, which provides access to the third floor roof.</p> <p>The masonry was observed to be in average condition considering its age. Mortar and edges of the brick have deteriorated with age. The staff reported condensate leakage behind the theater stage and that this area is repainted annually. Damage to the inside of the south exterior wall was observed, although the cause of the damage could not be determined. The steel roof ladder appeared to be in average condition, but paint finish was failing. Concrete soffits appeared to be in good condition.</p>	Average

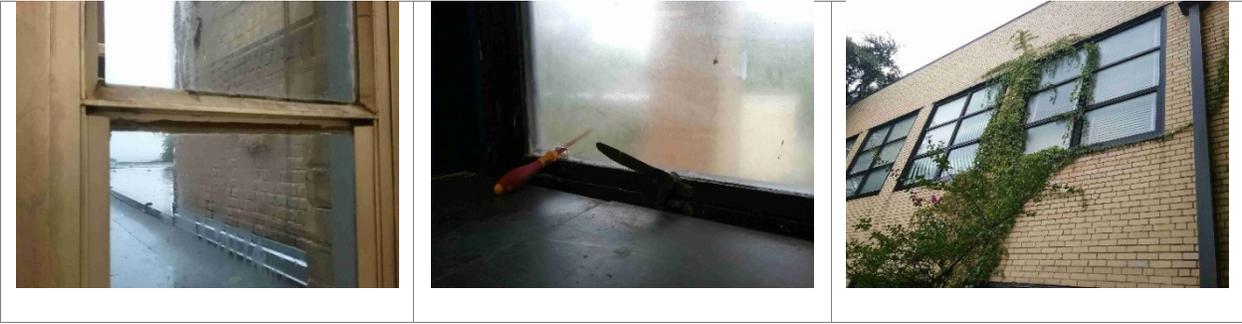
Exterior windows

Exterior Windows	<p>There are two types of windows installed in this building. Newer, clear anodized aluminum single-hung combination units have been retro-fit to openings in the original building. Painted aluminum awning combination units are installed elsewhere. Fixed storefront type windows of the same style are installed at the west stairwells and as clerestory windows above the library.</p> <p>The staff reported that the clerestory windows were leaking. Although it was raining during the assessment,</p>	Average

System	Subsystem	Condition and Deficiency Overview	System Condition Rating
		no leaking was observed. Some sashes were missing glazing seal. Cracked glass was observed in at least one of the units. Exterior sealant accessible to examination appeared to be in good condition. Vines had grown over a group of windows.	
	Exterior Doors	<p>West entrance doors are painted hollow metal in hollow metal frames set inside a painted, aluminum storefront. This storefront is installed the full height of the stairwell. The older, original north and south entry doors are painted hollow metal in hollow metal frames with sidelights and transom.</p> <p>All entry doors were in average condition. All lack weather-stripping. Lack of weather-stripping could account for the report by staff that water runs underneath the doors at stairwell S-1-1 during rain events.</p>	Average
Roofing	<p>There are two roof systems installed on this building. The highest two roof levels have a built-up system. These levels are internally drained and piped to leader boxes and downspouts located on the exterior wall, which in turn discharge to a below-grade drainage system. The lower roof levels have a modified bitumen system. The upper level of this system drains to a gutter on the east edge of the level. The gutter discharges onto the lower level through downspouts. The lower level is internally drained to below grade in the same manner as the built-up roof.</p> <p>The built-up system appeared to be the older of the two roof types. The ballast is absent from some of the surface and there is some ponding near a drain, which may indicate that there is little or no slope in the roof and/or the drain is clogged. The staff reported that the roofs leak in stairs S-4 and S-3. Ponding was observed near a drain adjacent to stair S-4 but no evidence was observed for cause of leaking into stair S-3. Utility supports on this roof were not properly seated. The modified bitumen system, utility supports, and roof associated sheet metal appeared to be in good condition. The staff reported that the gutter and downspouts are coming off of the building. There are obvious gaps in the downspouts, which may be an intentional attempt to allow for overflow of the system when drainage backup occurs. The staff believed that the library clerestory windows were leaking. Although thorough inspection of the windows was not possible, there was water ponding adjacent to the windows and therefore the roof could possibly be the source of the leak.</p>		Average

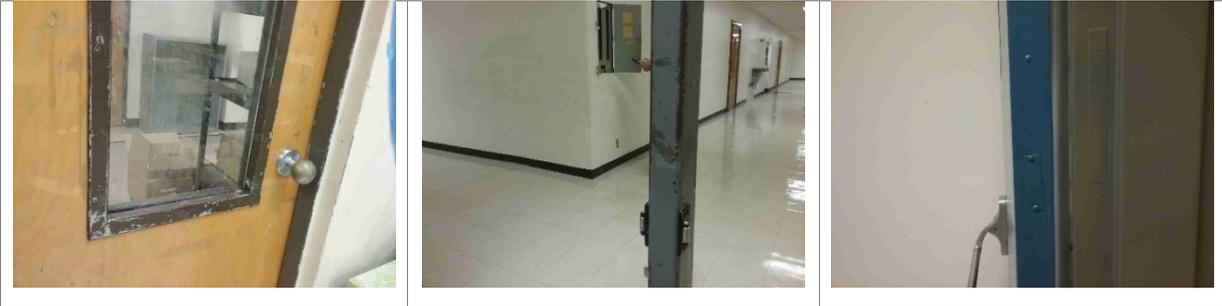
Interior Construction	Interior Walls	<p>Interior walls are either gypsum wallboard on conventional stud framing, masonry, or gypsum wallboard on masonry-backed furring, or plaster.</p> <p>The walls appeared to be in good condition.</p>	Good
	Interior Doors	<p>Stained solid core wood doors are installed in stained wood frames in the original portion of the building. Doors are typically stained solid core wood doors set in</p>	Average

System	Subsystem	Condition and Deficiency Overview	System Condition Rating
		<p>painted hollow metal frames in the newer portion of this building and in the renovated restrooms. Painted hollow metal doors set in painted hollow metal frames are installed at the stairs.</p> <p>Most door latch sets appeared to be worn. Doors were marred and the paint on frames was chipped. UL fire-rating labels were painted over.</p>	
	Interior Specialties	System not present.	N/A
Stairs	Exterior Stairs	<p>There is one set of exterior stairs and located at the bottom of the south stair well of the original building.</p> <p>Although old, this cast-in-place concrete stair appeared to be durable and average condition. The stairs did not have abrasive nosing or handrails.</p>	Average
	Interior Stairs	<p>There are four sets of exit stairs in this building. All of these stairs are built of cast-in-place concrete with embedded steel nosing and abrasive tread strips. The two east original building stairs have stained wood handrails, and stained wood capped plaster walls divide the stair runs. The two west end stairs are of similar construction but have terrazzo treads/risers, and painted steel pipe handrails. Smaller wood stairs with either stainless steel or painted steel handrails serve the theater stage.</p> <p>All stairs appeared to be in good condition.</p>	Good

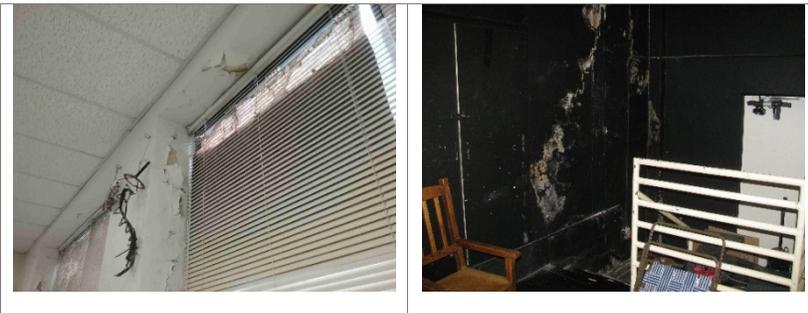
Interior Finishes	Interior Wall Finishes	<p>Paint is the predominant finish. The paint is either applied on plaster, gypsum wallboard, or concrete structure or over structural glazed tile. This includes the inside faces of the exterior walls. All restrooms have been renovated with full-height ceramic tile. The west brick facade of the original building forms the finish for the east wall of the library. Fabric-clad acoustic panels are installed on the upper theater walls.</p> <p>Finishes in the principal suite and the restrooms appeared to be in good condition, while all other finishes were average. Paint on the inside face of a west classroom exterior wall was observed to be peeling adjacent to the windows. Paint and substrate failure was also observed on the south, inside face of the theater stage exterior wall. It was suspected that both deficiencies were the result of moisture intrusion. Staff indicated that the stage wall is repainted annually.</p>	Average

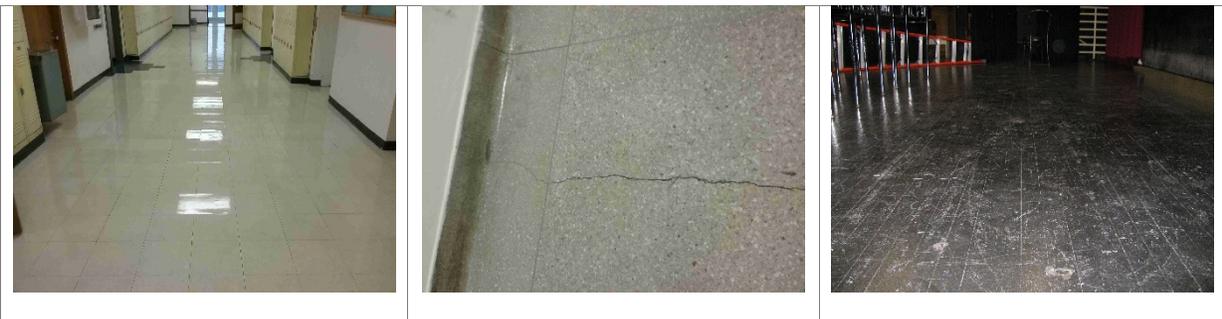
Interior Floor Finishes	<p>Resilient tile is installed in all classrooms, the nurse station, and the corridors of the original building. Terrazzo floor and wall base are installed in the</p>	Good

System	Subsystem	Condition and Deficiency Overview	System Condition Rating
		<p>corridors of the newer portion of the building. Carpet tile is installed in the library. Broadloom carpet is installed in the theater, principal suite, and common area of the counseling and nurse station. Newer porcelain tile is installed in the renovated restrooms. Painted plank wood flooring is installed at the theater stage. Ceramic tile cove units form the base in the newer restrooms. Wood base is installed in the stair intermediate landings and flanking the stair runs. Elsewhere resilient base is installed.</p> <p>All resilient tile and base as well as the stair wood base appeared to be in good, well-maintained condition, including the older tile in the original building. The original building tile could possibly contain asbestos as was also indicated by the staff. Cracks were observed in the terrazzo floors at different levels, yet cracking was not observed at the building exterior. The staff reported that the exterior should be inspected for cracking. All carpet appeared to be in good condition. Staff reported that the library carpet was new. The wood stage floor finish appeared to be scratched and chipped.</p>

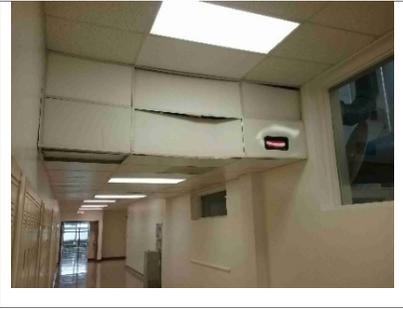
Interior Ceiling Finishes	<p>Painted gypsum board ceilings are installed in the restrooms and restroom vestibules. The bottom surface of roof panels are exposed to form the ceiling in the library. Elsewhere, a 2'x4' suspended lay-in ceiling grid system is installed throughout.</p> <p>It appeared that the restrooms were a part of a campus-wide restroom renovation and ceilings there appeared to be in good condition. The 2'x4' system was beginning to show age. The staff reported that all ceilings on campus were aged.</p>	Average
Conveying		<p>The building is equipped with a three-stop, 2,000-pound elevator located in corridor COR6 on the first floor. The mechanical equipment for the elevator is located within GSTO100. The inspection certification for the equipment is current.</p> <p>The building conveying system was observed to be in good condition. Faculty reported that the elevator is in good working condition.</p>	Good

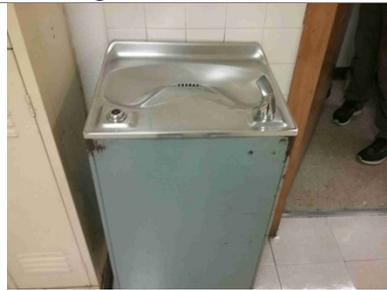
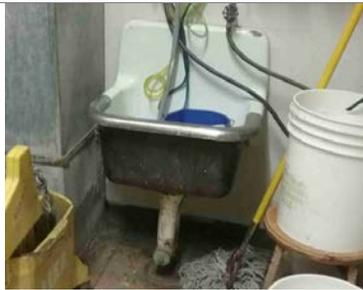
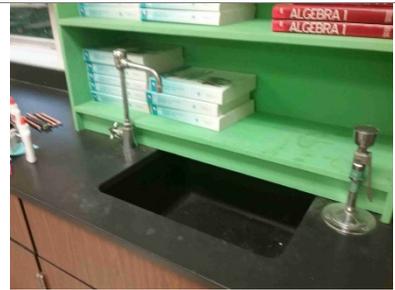
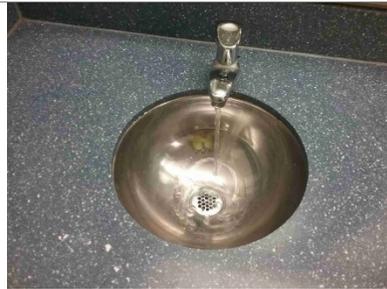
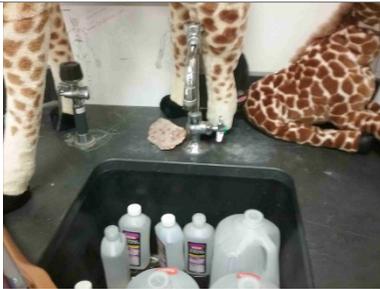
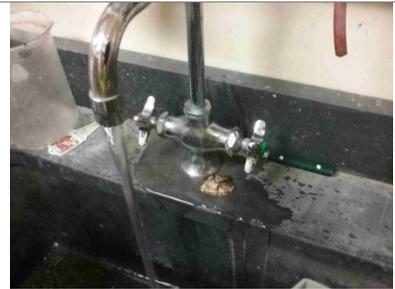
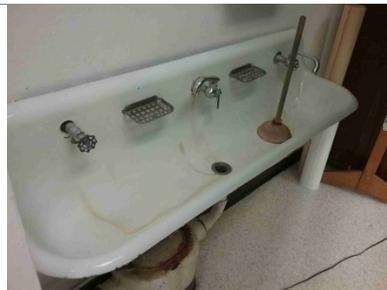
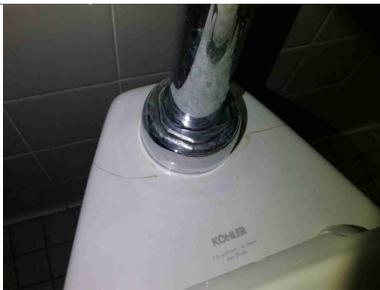
Plumbing Fixtures

System	Subsystem	Condition and Deficiency Overview	System Condition Rating
<p>Plumbing</p>	<p>Plumbing Fixtures</p>	<p>The building contains predominantly multi-use restrooms. Typical restrooms have floor-mounted vitreous china water closets with manual flush valves. Wall-hung vitreous china urinals with manual flush valves are located in the dedicated male multi-use restrooms. Restrooms contain under mount stainless steel sinks. A single-use restroom is in the nurse's office. Additionally personal use basin sinks are in LBOFC and GRPRM300. Stainless steel drinking fountains are in the corridors of the building. Science rooms on the second and third floor have resin basin sinks.</p> <p>Plumbing fixtures were in average condition showing minor signs of deterioration due to age. The janitorial mops sinks were in average condition, some showing signs of corrosion around the base. Sinks in GRR300, BRR200, and BRR100 were stuck in the on position. Sinks in rooms 112, 211, 301, 311, BRR300, BRR200, and BRR100 were observed to have no flow. One of the sinks in room 209 was observed to have low flow. The faucet on the sink in WKRM211 was observed to be leaking. Classroom 201 contains a triple faucet sink that was observed to be aged and the faucets were no longer attached well. One of the water closet fixtures in GRR200 was observed to have a cracked base.</p>	<p>Average</p>

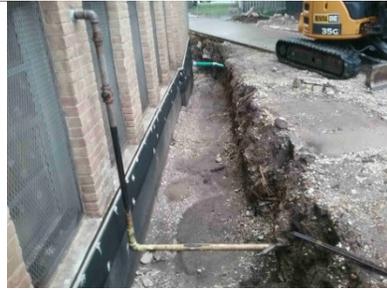
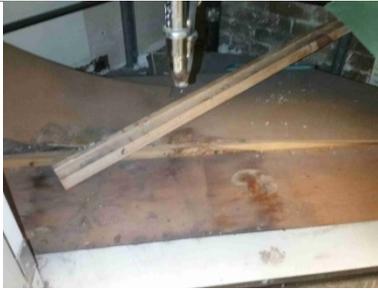
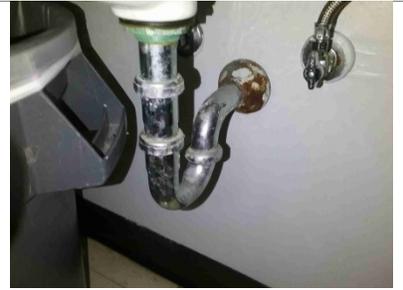
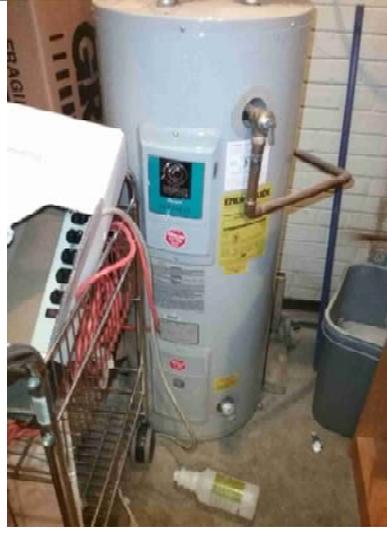
Domestic Water Distribution

<p>Domestic Water Distribution</p>	<p>A small water heater is observed to be in AHU1B (air handling unit 1B) to feed the nurse's office. No other water heaters are in the building. Domestic hot water is not supplied to the classroom plumbing fixtures.</p> <p>The water heater was observed to be aged and past its typical design service life but in average condition. Distribution plumbing was in average condition with minor signs of corrosion and deterioration with age. The sinks in rooms 303 and GRPRM300 had evidence of leakage underneath them. Construction onsite exposed previously buried distribution lines.</p>	<p>Average</p>
	<p>Other Plumbing</p>	<p>Other plumbing consists of floor drains in the restrooms, storm drains on the exterior and rooftop drains.</p> <p>Other plumbing was observed to be in average condition with signs of degradation associated with age. Grates over the roof drains were observed to be rusted. One of the storm drains was observed to have its grate clogged with debris.</p>	<p>Average</p>

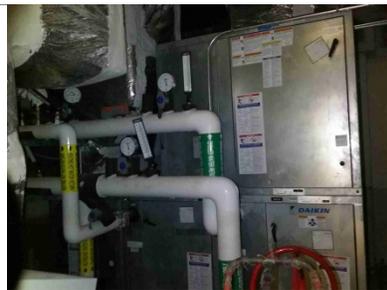
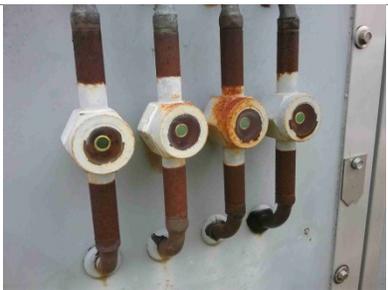
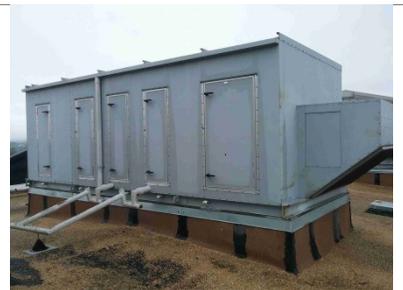
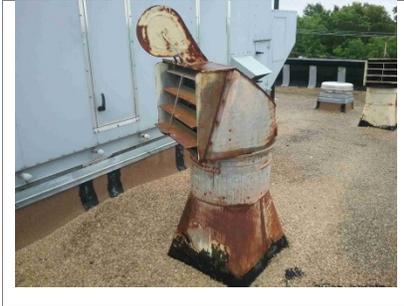
Mechanical/HVAC System Deficiency Examples

System	Subsystem	Condition and Deficiency Overview	System Condition Rating
Mechanical/ HVAC		<p>The building's HVAC (heating, ventilation, and air conditioning) system consists of heat recovery units, air handler units, fan coiled units and air conditioner condenser units. It is assumed the building receives additional cooling and heating from the chillers and boilers located outside building BLDG-043C. Various sized EFs (exhaust fans) and rotary vents feed the building.</p> <p>The AHUs on the floorplan in rooms 111 and 114 were not detectable; they were possibly in the ceiling but were unable to be assessed. AHUs were observed to be aged and past their typical design service life. Heat recovery HRU-2 was observed to have signs of corrosion and rust on the exterior. Heat recovery unit HRU-1 was observed to be making a loud vibrating noise during operation. Both heat recovery units had name plates that were significantly worn and hard to read information. Multiple air conditioning condenser units were observed to be using out of date refrigerant R-22 that is being phased out of use. It was reported in the facility interview that there are issues with heating controls in the building. In ceiling fan coiled units in room 111 appear to be working well. Rooftop rotary vents are extremely aged and rusted. EFs were observed to be aged and reaching the end of their typical design service life.</p>	Average

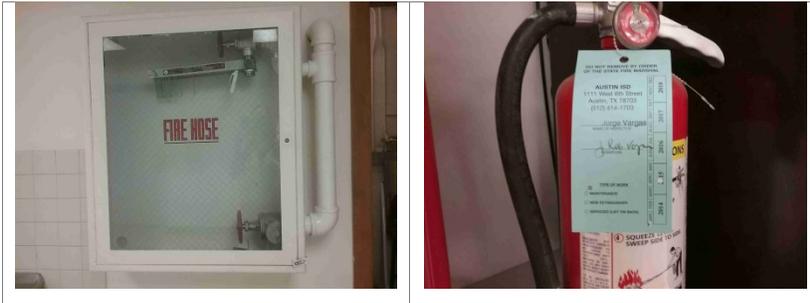
Fire Protection/Suppression

Fire Protection	Fire Alarm	<p>The building has a fire alarm system that consists of alarm and signaling devices such as strobes, horn/strobe combinations, pull stations, and detectors.</p> <p>The fire alarm system was observed to be in good condition. No deficiencies were observed during the assessment.</p>	Good
	Fire Protection/ Suppression	<p>A fire suppression system is not present for the building. Fire hose cabinets exist on each floor but fire hoses were not stored inside them. Fire extinguishers are present throughout the building.</p> <p>The fire extinguishers were observed to be in average condition. The fire hose cabinet on the third floor contained a fire extinguisher that was out of date on its annual inspection. Fire hose cabinets on the first and second floor did not contain a fire extinguisher. The fire extinguishers in rooms 108, 114, 207, 301, 303, 305, AHU3A, GSTO100, and COR6 were observed to be out of date on their annual inspection.</p>	N/A

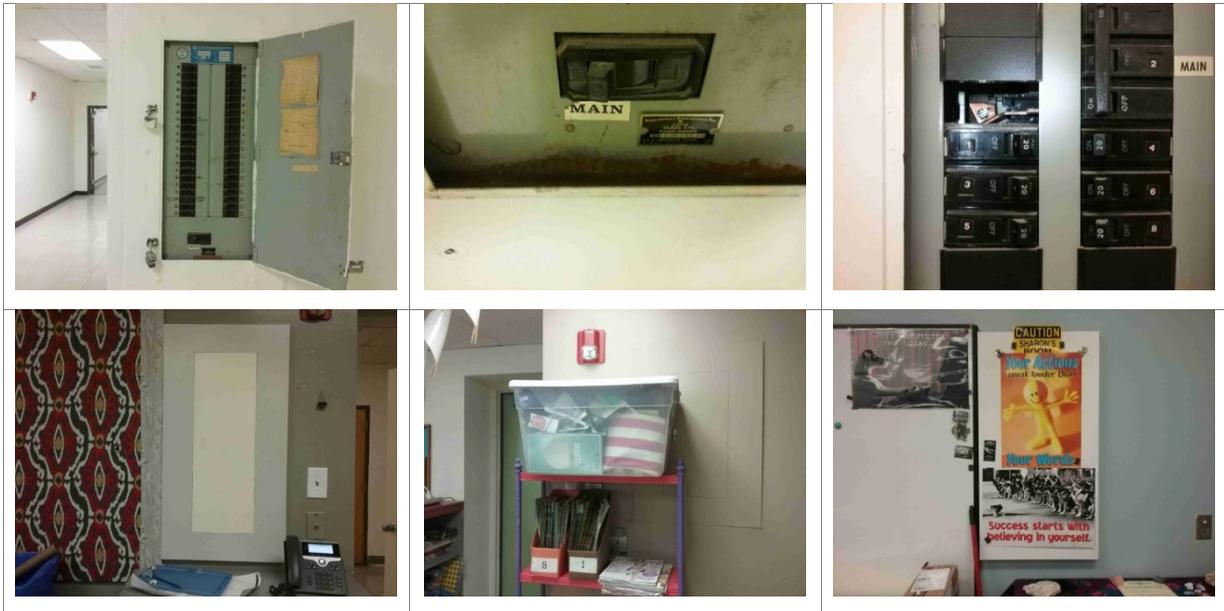
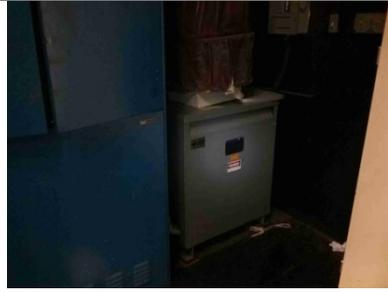
Electrical	Electrical Distribution	<p>The main electrical distribution equipment is predominately located in room STO100, although a few panelboards are located in various rooms and corridors. The electrical feed (from BLDG-043C) for the building appears to enter at the 277/480-volt, 800-amp panelboard, which feeds transformers and other 277/480-volt panelboards. The building does not have a lightning protection system.</p> <p>The electrical distribution equipment was observed to</p>	Average

System	Subsystem	Condition and Deficiency Overview	System Condition Rating
		<p>be in average condition. The building has several ITE Imperial/ Gould ITE panelboards that are approaching their typical design service life. One ITE Imperial panelboard, located in COR13, was found with corrosion forming on the front access cover for the breakers. A panelboard located within room 305 was observed with missing breaker slot covers, which should be considered a life safety hazard. A number of classroom and corridor located panelboards have non-functional or damaged latches due to being painted several times. This impeded or completely prevented panelboard access, which should be considered a life safety hazard. One classroom panelboard was observed with posters and signs hanging over the panelboard, obscuring its visibility. Another classroom had shelving blocking the panelboard access. Blocking visibility or access to the panelboard should also be considered a life safety hazard. A transformer installed in the stage area was observed with items being stored on top of the enclosure, which should be considered a fire hazard. Faculty reported that many of the subpanels are full with no expansion space available.</p>

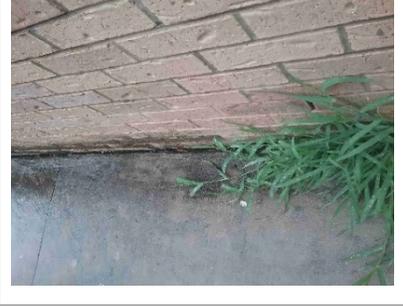
System	Subsystem	Condition and Deficiency Overview	System Condition Rating
Exterior	Exterior Walls	<p>The exterior façade is brick with an upper plaster band wrapping around the building directly below the roof. Plaster soffits are installed at the two main lobby entries. Mechanical louvers are installed at various locations in the brick.</p> <p>The exterior wall and soffits appeared to be in good condition. The staff reported that there were cracks in the brick mortar joints, but this condition was not identified during the assessment. Louvers appeared to be in good condition but were beginning to show age. Wall sealant appeared to be in good condition but was absent at grade where the brick extend below the exiting grade at some locations.</p>	Good
	Exterior Windows	<p>Windows are painted, single-glazed, aluminum units. Both fixed and awning units are present.</p> <p>Units appeared to be in good condition with good perimeter sealant. The staff reported that two windows in the kitchen needed to be replaced, but these windows appeared to be in good condition at the time of assessment.</p>	Good

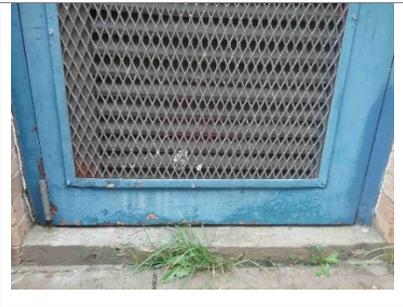
Exterior Doors

System	Subsystem	Condition and Deficiency Overview	System Condition Rating
		good condition, the system was rated as average due to service doors, where the paint finishes were chipped and peeling. The staff reported that gymnasium exit doors leak during storm events. Although it was raining during this assessment, no leaking was observed.	
Roofing	<p>The modified bitumen roof is internally drained.</p> <p>The roof membrane, metal roof curbs, and metal edge flashing appeared to be in good condition. A tree made contact with the roof at the southeast corner of the kitchen. The staff reported that this roof was a built-up roof with ponding. This roof system was not a built-up system and little ponding was observed except above the same southeast corner of the kitchen.</p>		Good
Interior Construction	Interior Walls	<p>Interior walls are either CMU (concrete masonry unit), brick, or gypsum wallboard on conventional stud framing. Woven wire mesh equipment cages are installed in the locker rooms.</p> <p>All walls appeared to be in good condition except the locker room wire cages. The cage paint was chipped.</p>	Good

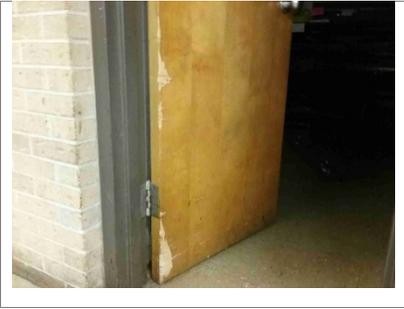
Interior Doors	<p>Solid-core, stained wood doors are installed in painted hollow metal frames. The door frames at the kitchen and choir offices include sidelights. An approximate 12' wide by 10' high rolling grille is installed between the upper entry lobby and the northwest corridor. A 7' wide by 4' high rolling shutter is installed between the upper lobby and the student store.</p> <p>Doors and shutters appeared to be in good condition. The face and frame of a choir door were damaged. Hardware in the door between the orchestra room and band office was damaged.</p>	Good
	Interior Specialties	System not present.	N/A
Stairs	Exterior Stairs	<p>The choir/band/orchestra wing exits onto a cast-in-place concrete ramp that extends to grade. The ramp has flanking wall-mounted steel pipe handrails.</p> <p>The ramp was cracked across the surface, but this crack did not appear to affect the service of the ramp and did not transfer through the adjacent side walls. The paint on the galvanized pipe handrail was peeling.</p>	Average

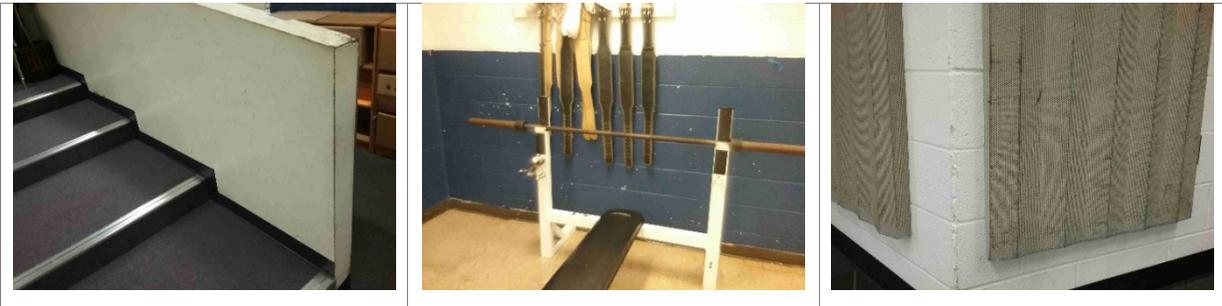
Interior Wall Finishes

System	Subsystem	Condition and Deficiency Overview	System Condition Rating
		<p>the basement level gymnasium and locker room wing. The stairs and ramp appeared to be in good condition.</p>	
<p>Interior Finishes</p>	<p>Interior Wall Finishes</p>	<p>The majority of the finish is paint on either CMU or gypsum wallboard. Paint is applied to the inside face of the concrete or CMU exterior walls. Ceramic tile is installed in the restrooms, kitchen, and locker room showers. Unfinished brick is the finish in the lobby area and some of the cafeteria. Perforated metal acoustic panels are installed on walls in the music rooms and gymnasiums. Mirrors are installed on the weight and ballet room walls.</p> <p>Wall finishes were in good condition with the exception of several deficiencies. The choir and weight rooms wall finish was worn and chipped. Ceramic tile observed in the locker room shower areas appeared to be in good condition. This condition could not be completely confirmed because many items were stored in these areas. Restroom tile was in good, newer condition. The acoustic panels installed on the lower area of the music room walls were scuffed but not otherwise damaged. Some acoustic panels in the small gymnasium were slightly damaged, but this should not affect acoustic performance.</p>	<p>Good</p>

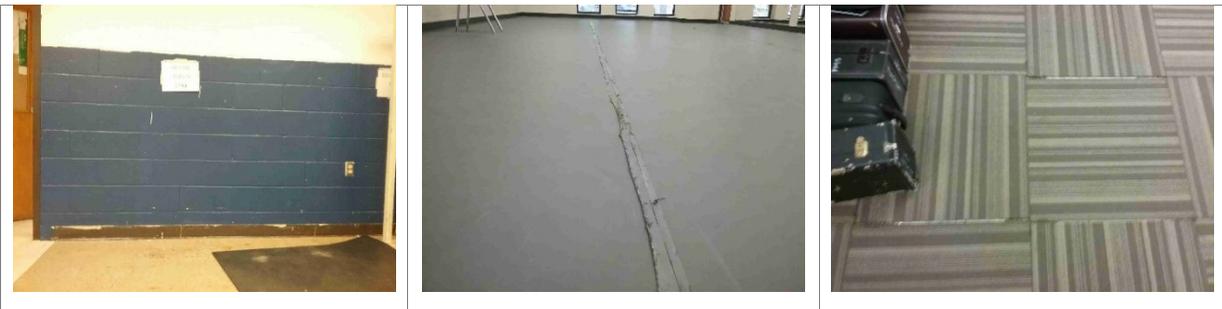
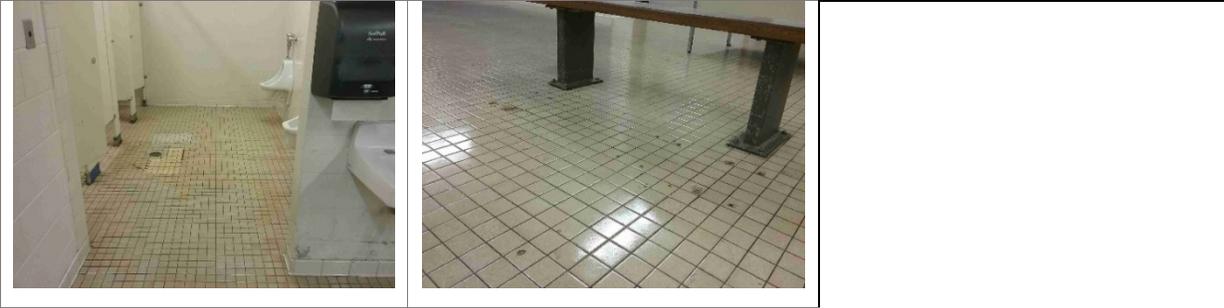
Interior Floor Finishes

<p>Interior Floor Finishes</p>	<p>Resilient tile and base is installed in the main entry lobby, corridors, cafeteria, and weight room. Slip-resistant, resilient sheet flooring is installed on the main lobby ramp. Resilient athletic sheet flooring and base is installed in the ballet room. Carpet tile and vinyl base is installed in the band-orchestra-choir area. Stained, wood flooring with a steel angle wall base is installed in the gymnasiums. Porcelain tile is installed in the restrooms, locker rooms, and kitchen.</p> <p>Resilient flooring and base appeared to be in good condition except at two locations. The weight room tiles were rust stained. The ballet room sheet floor seams were separating. The staff reported that the resilient sheet on the ramp was coming up but this condition was not observed. The cafeteria and lobby floors were being refinished at the time of this assessment. Carpet tile appeared to be in good condition except in the music lab where seams are worn. Wood floors appeared to be in good condition, but the joints of the steel angle base were uneven. Porcelain floor tile appeared to be in good condition. Restroom tile appears to be the same newer</p>	<p>Average</p>

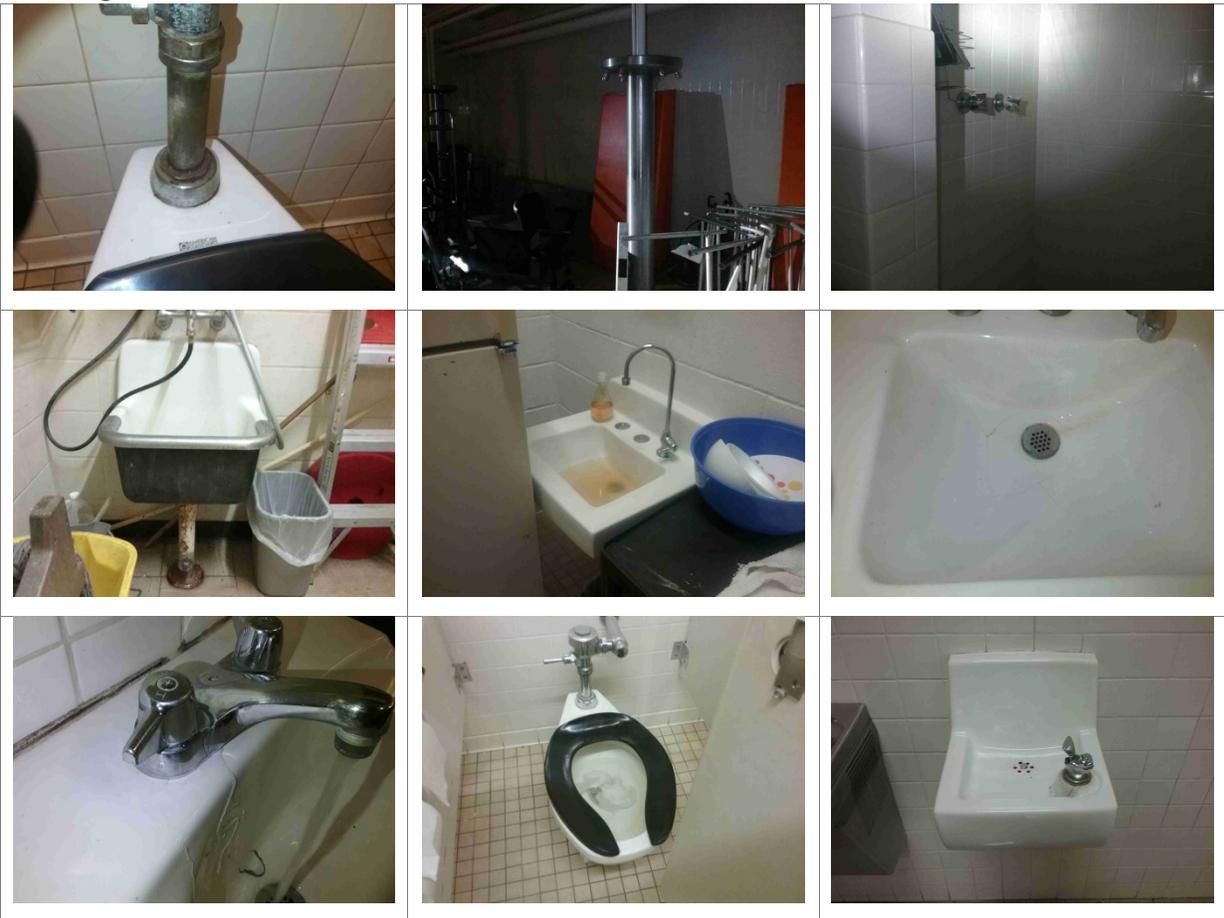
Conveying	System not present.		N/A
Plumbing	Plumbing Fixtures	<p>The building contains predominantly multi-use restrooms. The restrooms contain floor-mounted vitreous china water closets. Wall-hung vitreous china urinals with manual flush valves are located in the dedicated male multi-use restrooms. Restrooms contain under mount stainless steel or wall-mounted vitreous china sinks. Single-use restrooms are in the kitchen and in the male and female dressing room offices. Dressing rooms also contained multi-use and single use showers. Stainless steel and vitreous china drinking fountains are in the corridors throughout the building.</p> <p>A commercial kitchen is located in the school's cafeteria. The kitchen contains stainless steel kitchen equipment, including two triple basin prep sinks. It also has various wall-mounted stainless steel and vitreous china sinks for personal use. Two multi-use coated cast iron hand washing sinks are outside the cafeteria. The building also has service sinks located in various janitorial closets.</p> <p>The majority of the plumbing fixtures were in average working condition with some fixtures showing corrosion on the connections. Multi-use showers in the male dressing room no longer had knobs attached. It was reported by physical education staff that they were no longer in use. The multi-use shower area of the female dressing room was inaccessible due to excessive chairs</p>	Average

System	Subsystem	Condition and Deficiency Overview	System Condition Rating
		<p>blocking the entrance. These showers were also reported to no longer be in use. The shower located in the office of the male dressing room was observed to be leaking from its hot water knob.</p> <p>Service sinks in the janitorial closet were observed to have rust around their base. A sink in the restroom off the office in the female dressing room was observed to be clogged. One of the sinks in the male dressing room was observed to be cracked. One of the vitreous china personal use sinks in the kitchen was observed to be leaking from the faucet. One of the water closets in the female dressing room was observed to be clogged. The drinking fountain outside the choir room was observed to have no flow. It was reported in the facility interview that the handwashing sinks outside the cafeteria plug and cause backups frequently. Additionally it was reported in the facility interview that the kitchen had sewage back up into it in the past.</p>

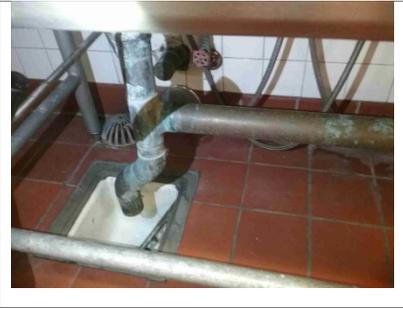
Domestic Water Distribution	<p>Domestic hot water to the kitchen is provided by two 100 -gallon electric water heaters stored in mechanical room (AHU16). The mechanical room in the basement (GYMMECH) has a series of instant water heaters; these are in place of where boiler B-3 used to be. It is assumed these split feed the gymnasium showers and the HVAC system.</p> <p>Domestic hot water is not supplied to the classroom plumbing fixtures. Water heaters were newer and in good condition. Distribution plumbing was observed to be average condition with signs of deterioration and corrosion associated with age.</p>	Average
	Other Plumbing	<p>Other plumbing consists of roof drains and floor drains. Floor drains are located throughout the kitchen, in mechanical rooms, and in the restrooms and locker rooms.</p> <p>The floor drain in AHU15 was observed to have rusted grate. One of the floor drains in the kitchen was observed to be missing its grate. Grates on the roof drains were observed to be rusted.</p>	Average

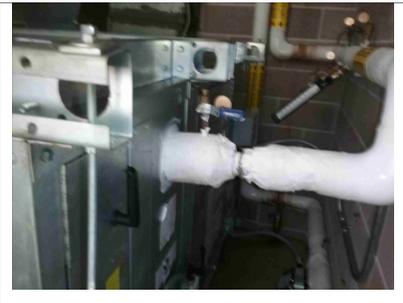
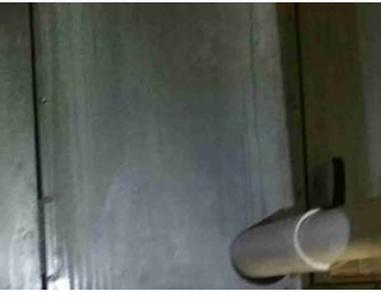
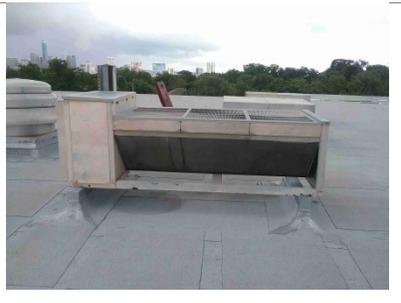
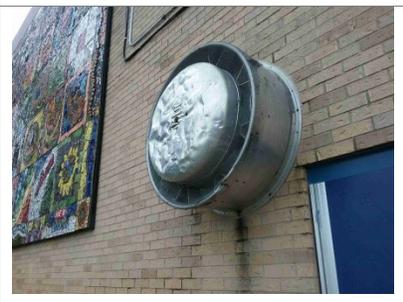
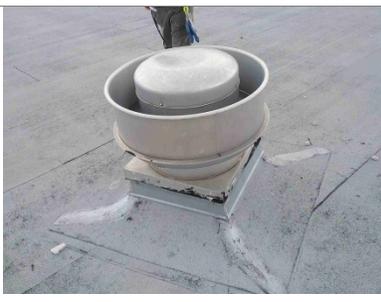
Mechanical/HVAC System Deficiency Examples

Mechanical/ HVAC		<p>The building's HVAC system is composed of AHUs and a RTU (rooftop unit). It is assumed the building receives heating and additional cooling from the chillers located outside building BLDG-043C and the instant flow water heaters in place of the old boiler. Various exhaust fans serve the building.</p> <p>AHU-14 was observed to be making a squealing noise during operation. AHU-15 was observed to have condensate build up on the exterior of the unit. The RTU</p>	Average

System	Subsystem	Condition and Deficiency Overview	System Condition Rating
		<p>was observed to be using out of date R-22 refrigerant. This unit is original to the building and is extremely aged and rusted. It was reported by the facility that the kitchen and cafeteria areas were always warm, and the air conditioning system may be undersized. It was observed to be very warm in the female dressing room indicating lack of HVAC distribution to this area. It was confirmed by staff that this area does not receive sufficient air flow to keep it properly heated or cooled. Some EFs were dented and showed signs of age. EF-5 was observed to be making a loud vibrating noise when operating,</p>	
Fire Protection	Fire Alarm	<p>The building has a fire alarm system that consists of alarm and signaling devices such as strobes, horn/strobe combinations, pull stations, and detectors.</p> <p>The fire alarm system was observed to be in good condition. No deficiencies were observed during the assessment.</p>	Good

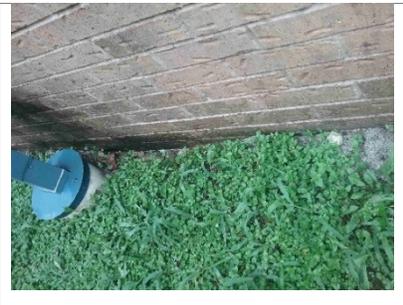
System	Subsystem	Condition and Deficiency Overview	System Condition Rating
Exterior	Exterior Walls	<p>The exterior wall construction is the same as BLDG-043B and BLDG-043C, but there is an additional plaster band that courses horizontally around the building above the first floor windows.</p> <p>As reported by the staff, an exterior re-grading project was being completed on the exterior south and west side of the building during this assessment. A flooding event occurred during the assessment but this was assumed to be caused by the current incomplete state of construction.</p> <p>The wall system appeared to be in average condition due to one critical deficiency. Brick at the base of the building perimeter was in contact with grade, which could allow for the wicking of moisture into the exterior brick and create a condition for failure.</p>	Average
	Exterior Windows	<p>Exterior windows are painted, aluminum casement with screens. Painted metal awnings are installed over the west and one of the south-facing windows.</p> <p>The windows and sealant appeared to be in good condition.</p>	Good

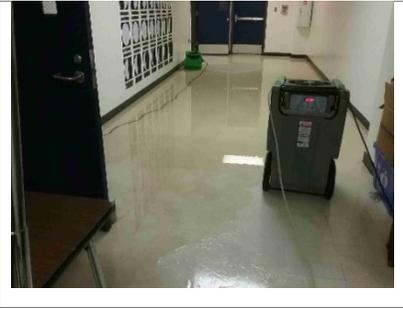
System	Subsystem	Condition and Deficiency Overview	System Condition Rating
	Exterior Doors	Exterior doors are painted hollow metal set in painted hollow metal frames. Door assemblies and hardware appeared to be in good condition. The staff reported that the current regrading project should solve the leaking under the doors. The entire lower level was observed to be flooded during a rain event during this assessment.	Good
Roofing		A modified bitumen roof system is installed at two levels. The upper roof drains through leader boxes connected to downspouts that discharge directly onto the lower roof. The lower roof drains with leader boxes and downspouts that discharge at grade. A high-slope metal roof is installed over the stair well. The roof membrane on both levels of this building appeared to be worn with granular ballast displaced and membrane bubbled. Utility support pads appeared to be in good condition. The roof installation is in poor condition, while the associated sheet metal appeared to be in good condition.	Poor

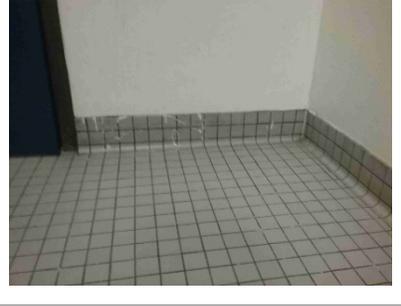
Interior Floor Finishes	Resilient floor tile and base is installed in the corridors and classrooms. Porcelain floor tile and base is installed in the restrooms. Floors and base appeared to be in good condition. Wall paint was misplaced on some of the porcelain tile.	Good

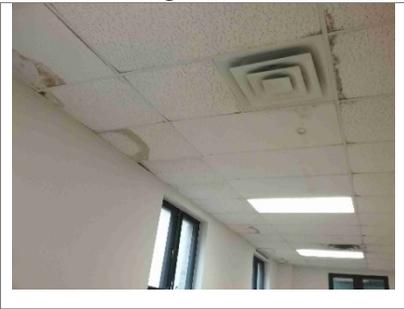
System	Subsystem	Condition and Deficiency Overview	System Condition Rating
	Interior Ceiling Finishes	A 2'x4' acoustic tile and suspended grid system is installed in the corridors and classrooms. Painted gypsum board ceilings are installed in the restrooms. Ceilings appeared to be in average condition as many of the classroom acoustic tiles are damaged.	Average
Conveying		The building is equipped with a two-stop, 2,100-pound elevator located in corridor COR17 on the first floor. The mechanical equipment for the elevator is located within ELEVMECH. The inspection certification for the equipment is current. The building conveying system was observed to be in good condition.	Good
Plumbing	Plumbing Fixtures	Multi-use restrooms are on both the main level and basement levels of the building. A faculty single-use restroom is on the main floor of the building. Restrooms contain floor-mounted vitreous china water closets with wall-mounted vitreous china urinals in the dedicated male restrooms. Restrooms contain under mount vitreous china and stainless steel basin sinks. A stainless steel sink for personal use is in FKKRM505. Rooms 500-502 in the basement level are science rooms that have multiple black resin sinks and eye wash/safety shower stations. Stainless steel drinking fountains are in the corridors of the building. The plumbing fixtures were in average condition. The sinks in GRR504 and BRR504 were observed to have no flow and missing their push button. The in-island sinks in classrooms 501 and 502 were observed to not be connected and have no flow. One of the sinks in room 502 was missing its handle and was unable to be turned on. Two different sinks in room 502 that had their handle was observed to have no flow. Due to flooding objects were placed in many of the sinks in the basement in order to get them off of the floor. For this reason, not all sinks were able to be assessed for functionality. One of the water closets in BRR504 was observed to be missing its seat. One of the water closets in GRR500 was observed to be leaking when flushed and to have a loose seat. One of the water closets in GRR504 was observed to not flush. The drinking fountain outside of BRR500 and GRR500 was observed to have no flow.	Average

1. Replace damaged ceiling tiles.

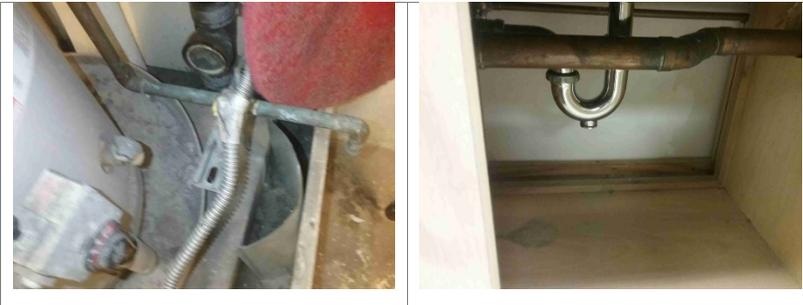
Domestic Water Distribution	A medium sized 40-gallon water heater is in the mechanical room ELECMECH. It is assumed that this water heater serves the FKKRM505 and janitorial service sink in ELECMECH. Distribution plumbing was in average condition with	Average

System	Subsystem	Condition and Deficiency Overview	System Condition Rating
		minor signs of corrosion observed on it. The water heater was aged and original to the building. Signs of corrosion and rust were observed on the exterior of the unit.	
	Other Plumbing	Other plumbing consisted of floor drains in the restrooms and in the basement science rooms near the safety showers. Floor drains were in average condition with wear associated with the age of the building.	Average
Mechanical/ HVAC		The building's HVAC system consists of roof top units, rooftop heat pump units, and air handler units. Various exhaust fans serve the building. Air handler units were observed to be original to the building and reaching the end of their typical design service life. roof top units were observed to have rust on the exterior of the unit. Heat pump and roof top units were observed to be using out of date refrigerant R-22 that is being phased out of use. Exhaust fan GEF-3 was observed to not be properly mounted and to be dangling by its connecting ductwork.	Average

1. Repair sinks that are not functioning properly.
2. Address any rust or corrosion observed to the equipment, its associated piping, or any other sub-asset by cleaning, re-painting, and/or repairing by any other means to prevent further deterioration.

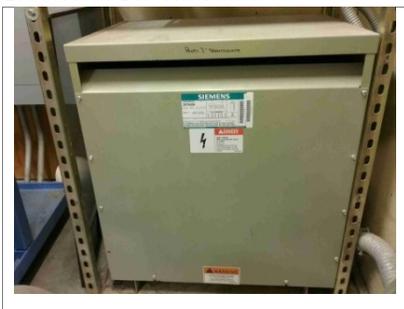
Fire Protection	Fire Alarm	The building has a fire alarm system that consists of alarm and signaling devices such as strobes, horn/strobe combinations, pull stations, and detectors. The fire alarm system was observed to be in good condition. No deficiencies were observed during the assessment.	Good
	Fire Protection/ Suppression	A fire suppression system does not exist in the building. Fire extinguishers are located throughout the building. The fire extinguishers were in average condition. The fire extinguisher in ELEVMECH was observed to be out of date on its annual inspection.	N/A
Electrical	Electrical Distribution	Electrical distribution for the building is located in room ELEC500. The main electrical distribution panelboard is a two-section 277/480-volt, 250-amp panelboard that supplies power to two transformers and other 277/480-volt mechanical equipment. Each transformer supplies a 120/208Y-volt panelboard. The electrical distribution equipment was observed to be in good condition. One transformer that provides distribution to Panel L was observed with a loud vibration.	Good

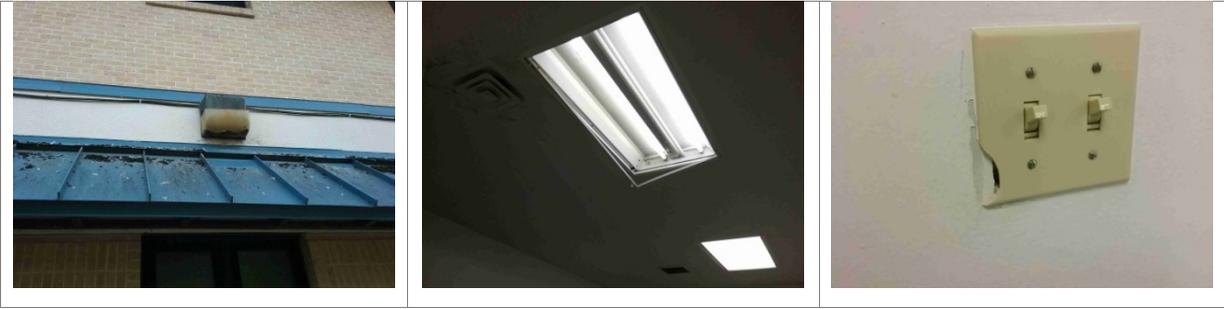
Lighting

System	Subsystem	Condition and Deficiency Overview	System Condition Rating
		<p>fluorescent luminaires.</p> <p>The lighting for the building was observed to be in good condition. One exterior luminaire was found to be extremely worn. An interior luminaire was missing a lens cover and lamps. One light switch was found with a damaged faceplate.</p> <p>Faculty reported issues with a tripping circuit feeding room 500. Faculty reported that the majority of the exterior lighting has been upgraded to LED luminaires, but the remaining non-LED luminaires are difficult to access.</p>	
	Communications & Security	<p>The building is equipped with telecommunication/data systems, with the main equipment located in room CC500. VOIP is used for voice communications. The building security consists of interior surveillance cameras, motion detectors, and a proximity card access system. Interior surveillance cameras overlook building egresses.</p> <p>The communications and security system were found to be in good condition. Faculty requested a card reader for the south entrance. Faculty also requested an additional surveillance camera to overlook the adjacent parking lot.</p>	Good

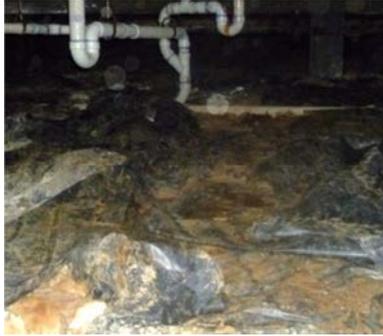
<p>Standing water on plastic sheeting</p>

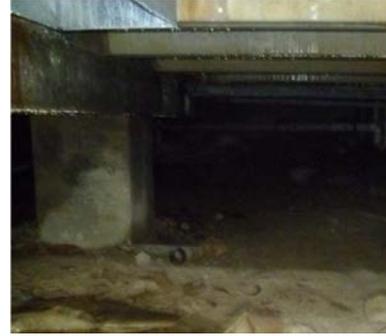
<p>Saturated soil</p>

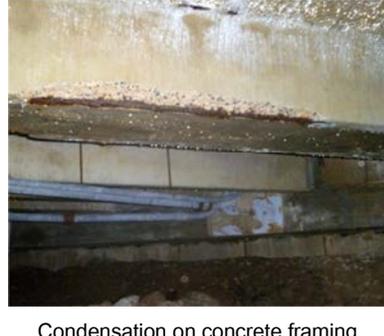
<p>Condensation on concrete framing</p>

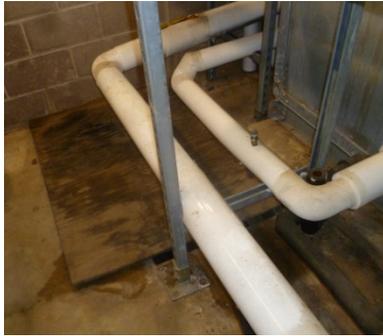
<p>Hatch opening covered by plywood, pipe block access to hatch opening</p>

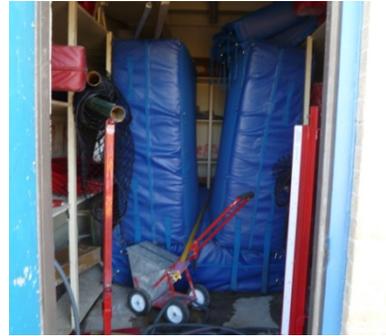
<p>West floor hatch blocked by gym equipment</p>

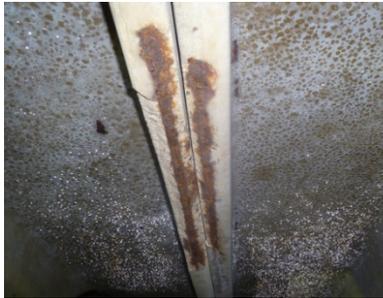
Exposed and corroded channel leg longitudinal steel

1. Repair spalled concrete pan joist webs by cleaning exposed reinforcement and patching spalled concrete. Widen channel webs as necessary to obtain sufficient concrete cover.
2. Patch spalled slab areas.

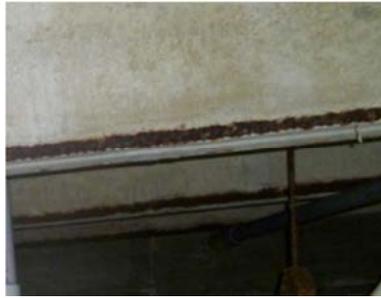
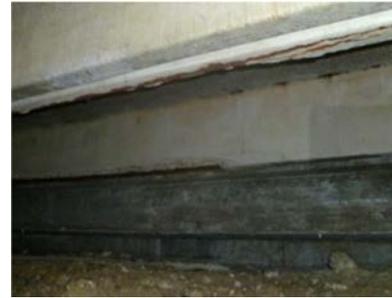
Multiple adjacent channels with severely corroded web reinforcement

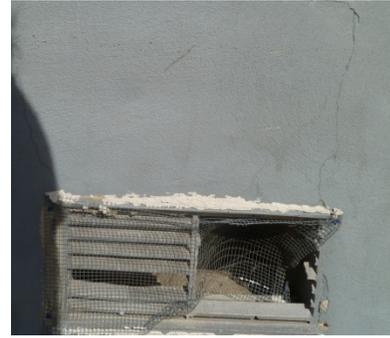
Torn vent screen

1. Repair/replace torn screens on vents.
2. Install bridge or other means to cross over pipes blocking access to south crawl space (see attached plans for approximate location).

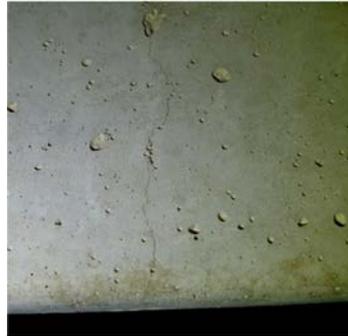
Flexural crack in a precast channel leg

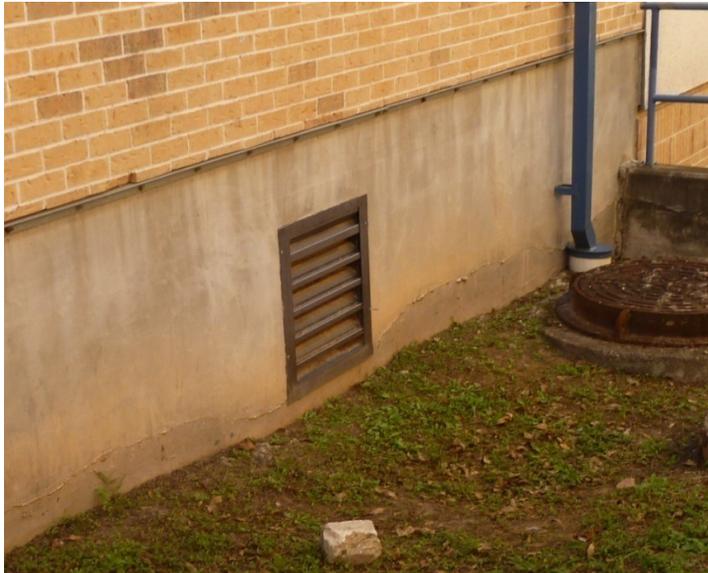
The crawl space in Building D was inaccessible. The only potential access points were the side vents, but they were screwed shut (and possibly too small with a 24" x 24" opening). A typical vent is shown in the image below. No access point was found in the existing plans and the head custodian was unaware of any interior access points.

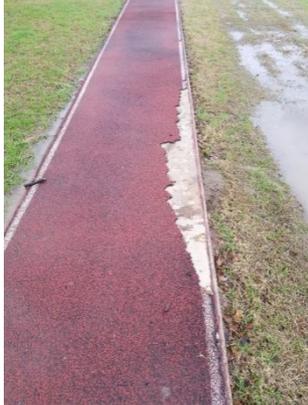
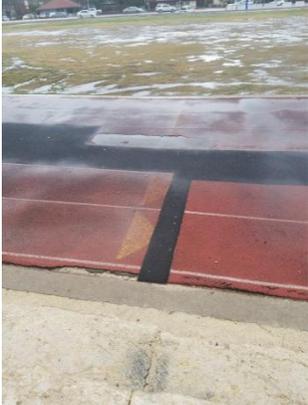
<p>Peeling and missing track sections</p>	<p>Broken tracks sections</p>	<p>Patches and ponding on track</p>

1. Replace the track surface.
2. Repair or replace broken volleyball net.
