Gorzycki Middle School Site Summary

Site/Civil Assessment

Gorzycki MS
7412 W. Slaughter Ln.

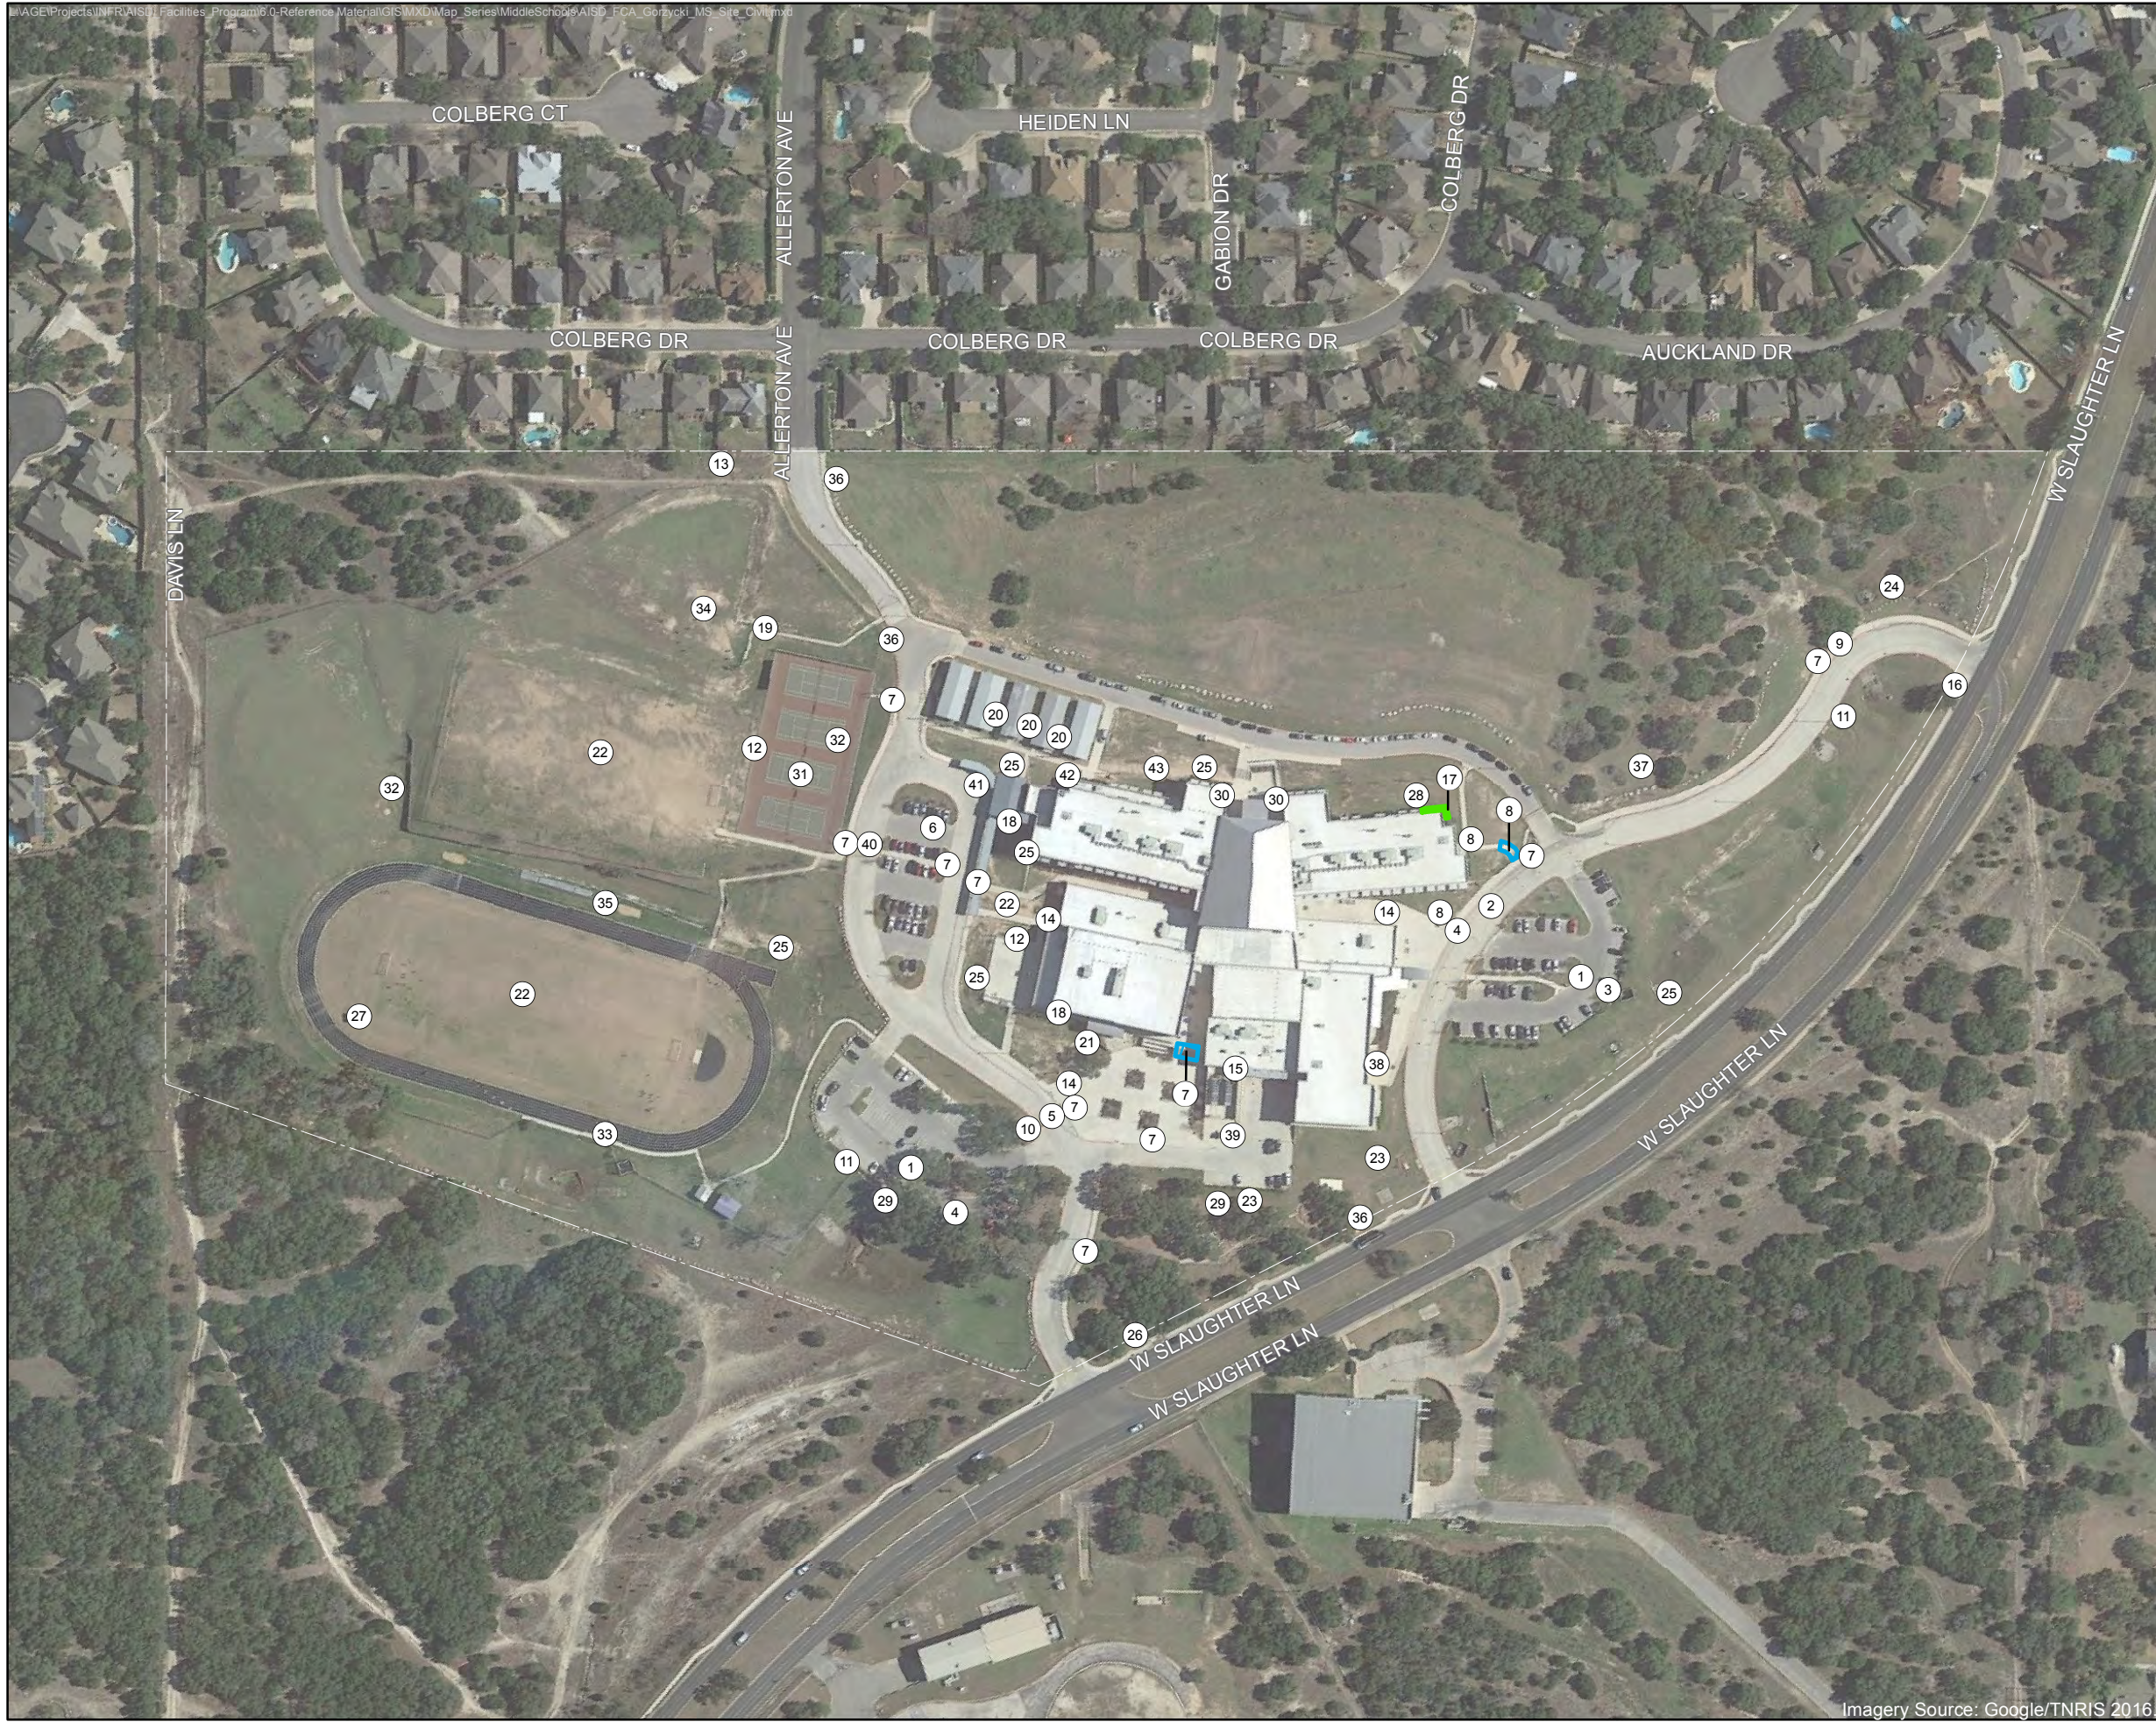
- Legend**
- ① Recommended Improvements
 - Drainage Improvement
 - Pavement Improvement
 - Sidewalk Improvement
- NOTES:**
1. THERE IS RUTTING IN THIS AREA.
 2. THERE ARE TRANSVERSE CRACKS IN THIS AREA.

3. THERE ARE SLIPPAGE CRACKS IN THIS AREA.
 4. THERE ARE LONGITUDINAL CRACKS IN THIS AREA.
 5. THERE IS ALLIGATOR CRACKING IN THIS AREA.
 6. THERE IS A POT HOLE IN THIS AREA.

1. Seal minor cracks
2. Replace missing fence ties
3. Assess erosion from court water runoff
