## Kealing Middle School Site Summary

## Administration and Classroom Building – BLDG-044A

## Cafeteria, Gymnasium, and Auditorium Building – BLDG-044B

## Classroom Building – BLDG-044C

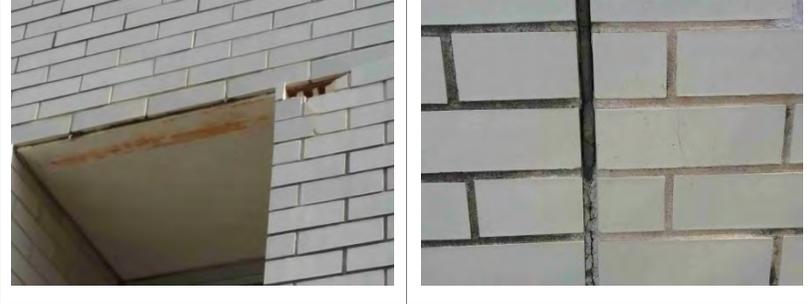
System	Subsystem	Condition and Deficiency Overview	System Condition Rating
<b>Exterior</b>	Exterior Walls	The exterior of the building consists of a 100% brick façade. The exterior of the building appeared to be in good condition. The vertical expansion joints were deteriorating. The lintels above the exit overhangs were rusting.	Good
	Exterior Windows	The windows are aluminum metal framed inset into the brick façade. The exterior windows appeared to be in good condition. Clearstory window film over the staircase is bubbling as are the greenhouse windows.	Good
	Exterior Doors	There are double exterior metal doors throughout the campus. The exterior doors appeared to be in average condition. They are heavily used but open and close well. They are faded from the sun, and have chipped paint in some areas. Staff reported that the kitchen door at the loading dock was not locking properly.	Average

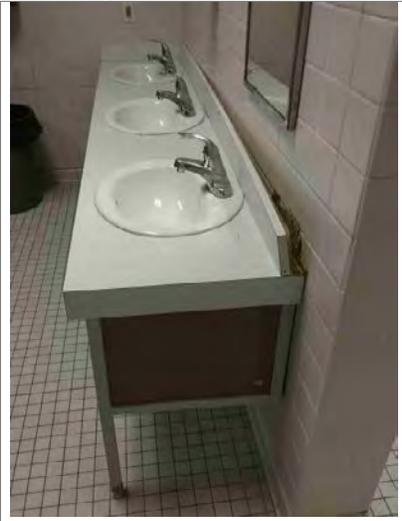
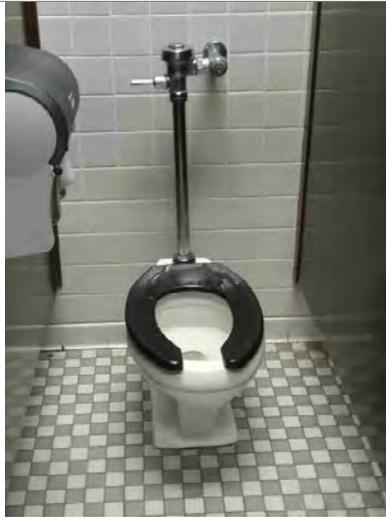
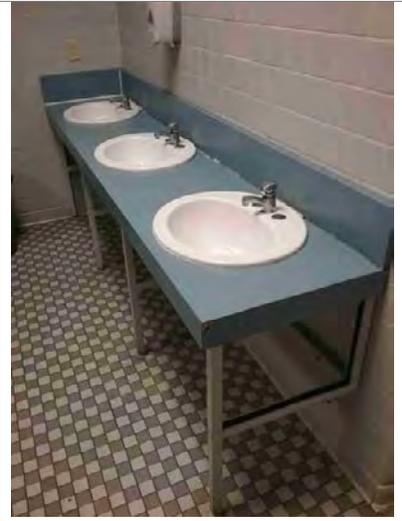
Plumbing Fixtures

System	Subsystem	Condition and Deficiency Overview	System Condition Rating
		<p>plumbing fixtures was observed to be in good condition. The Staff reported that the facility only had hot water in the kitchen and locker rooms showers, however, no additional concerns were identified in regards to the facilities hot water service. The Staff also reported that there was a lack of isolation valves for the restroom plumbing fixtures.</p>	
	Other Plumbing	<p>The roof had two types of drainage systems, external and internal. The internal system is equipped with low point drains that have dome type roof covers constructed of carbon steel.</p> <p>The other plumbing systems were observed to be in good condition during the assessment.</p> <p>The Staff reported that there were drainage issues in the courtyard area between Building B and Building A and adjacent to the MAINMECH room. The Staff also stated that during high intensity rain events, the drains were easily overwhelmed and flooding in this area occurred.</p>	Good

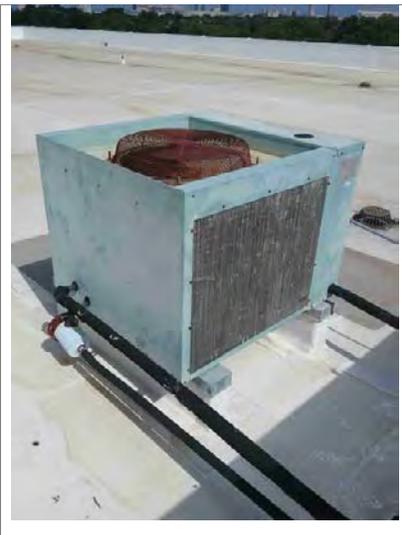
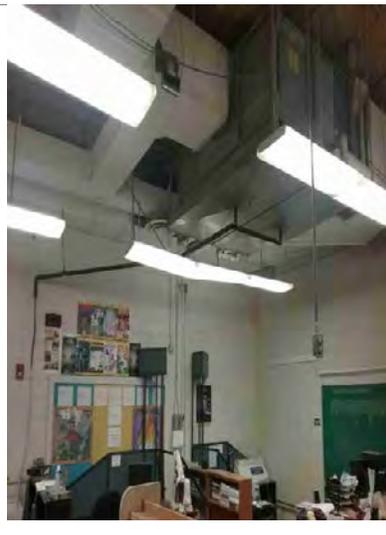
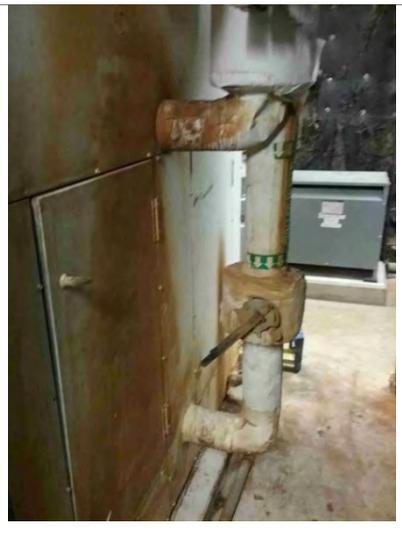
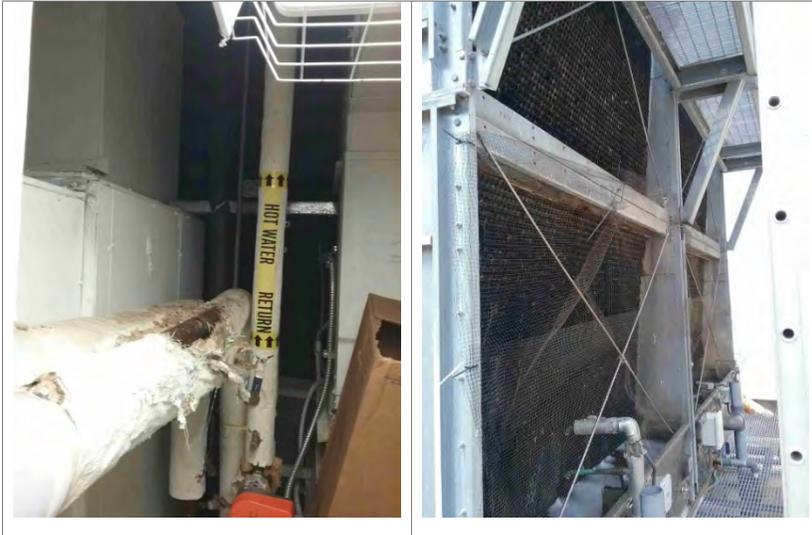
**Mechanical/HVAC System Deficiency Examples**

<b>Mechanical/ HVAC</b>		<p>This building has 12 HVAC (heating, ventilating, and air conditioning) systems. The major mechanical equipment consists of indoor modular AHUs, large roof top-mounted split system AC (air conditioning) units, and roof top-mounted EFs (exhaust fans). Many of the indoor modular AHUs are supported by the two 300-TON centrifugal water chiller systems that are individually serviced by two one cell external cooling towers rated at 235-TON each and four horizontal gas-fired boilers with a rated output capacity ranging from 339 MBH to 1,760 MBH.</p> <p>Three split system AC units are on the roof and one large EF. The refrigeration capacities of the RTUs (roof top units) range from 5- to 24-TON and the EFs ranges from 200 to 1000 CFM (cubic feet per minute). The remainder of the HVAC units consist of indoor modular AHUs, ranging in capacity from an estimated 5,000 to 15,000 CFM. These AHUs are located on the first and second floor throughout the building and are multi-zone AHUs that have been equipped with electronic damper actuators.</p> <p>The Staff reported that the AHU's in this facility were reaching the end of their useful life span. The Staff also reported that AHU-12 &amp; AHU-13 on the first floor of the west side of the facility had no mechanical closets and were difficult to access for maintenance staff. Additionally, the Staff stated there was a health and safety concern because there was condensation on piping (exposed to classrooms below) and no ladder to access. The Staff went on to report that these units were suspended above the floor and attached to the ceiling. The Staff also stated that the hot water coils were breaking down frequently and were installed in approximately half of the facility. The Staff also stated that the cooling tower system was estimated to be 100 tons short of the needed size and capacity. The Staff believed that this existing condition required the chillers to run 24 hours per</p>	Average

System	Subsystem	Condition and Deficiency Overview	System Condition Rating
		<p>day when the temperature was above 95 degrees. Lastly, It was reported by the Staff that there was a problem with temperature regulation in Room 104.</p> <p>The HVAC equipment was observed to be in average condition. Many of the deficiencies recorded were corrosion on the supply or return piping and external shell of equipment. Other HVAC deficiencies observed include extreme aging of the equipment, damaged insulation, air leaks from the AHU housing, and leaks from the supply/return hot and cold water lines. Also, all of the HVAC assets were observed to be using R-22 refrigerant, which is being phased out. Additionally, AHUs 12 and 13 on the west side in classrooms 109B and 108, respectively, were both considered to be health and safety issues for the maintenance staff, due to the equipment being suspended from the ceiling and lack of accessibility. Also, the enclosure of the cooling tower was rusted and was missing the birdcage that protects the cooling tower's honeycomb fill. Lastly, the roof top supply air fan, SF-04, located in area four, was extremely aged and had excessive wear and tear to the expansion joint material.</p>

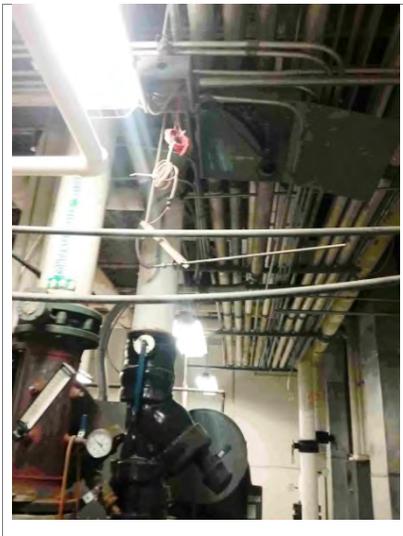
<b>Fire Protection</b>	Fire Alarm	<p>The building contains a fire alarm system by Silent Knight consisting of an IntelliKnight electronic main panel, detectors, pull stations, and horn/strobe combination units.</p> <p>The equipment appeared to be in good condition and did not show any system faults. The exterior strobe/horn units in the courtyard showed small signs of weathering.</p>	Good
	Fire Protection/ Suppression	<p>The building is not equipped with a fire sprinkler/suppression system; however, it is protected by portable fire extinguishers that are stationed throughout the building.</p> <p>All portable fire extinguishers observed were inspected within the last year and appeared to be in good condition.</p>	N/A
<b>Electrical</b>	Electrical Distribution	<p>The main service transformer, disconnect switches, and capacitor cabinet are located south of the complex centered between the three buildings. West of the courtyard south entrance is the outdoor backup generator manufactured by Cummins. A main electrical room exists east of the main mechanical room entrance. A 480VAC, 1600A switchboard along with additional transformers and panelboards supply power throughout the building. Panelboards are located at each floor on each wing supplying power to classrooms and offices. A bank of solar panels was located on the south wall, near the roof of this building. It is believed to supply power to a greenhouse.</p> <p>The equipment appeared to be in good condition. In the main mechanical room, electrical pull and junction</p>	Good

System	Subsystem	Condition and Deficiency Overview	System Condition Rating
		<p>boxes do not have the covers installed. There are conduits unsupported and abandoned cables hanging from junction boxes and conduit.</p>	
	Lighting	<p>The exterior of the building is outfitted with what appears to be HID (high-intensity discharge) fixtures. Compact fluorescent fixtures exist at various entrances to the building and are mounted directly over the doorway. The interior lighting is mainly fluorescent with the occasional incandescent fixture in closets. There are exit signs at every exit.</p> <p>The exterior lighting was observed to be in good condition. Various exit signs were not illuminated. The facility requested the exterior lighting at the loading dock be upgraded as it malfunctions regularly.</p>	Good
	Communications & Security	<p>A Gemini security system is currently installed. Motion detectors are installed in interior areas and security cameras are installed throughout the interior of the building and strategically on exterior corners. The facility appears to have wireless routers installed in the ceiling throughout the building.</p> <p>The system appeared to be in good condition. No damaged security panels or cameras were observed. The facility reported limited camera coverage at the main entrance facing Pennsylvania Avenue.</p>	Good

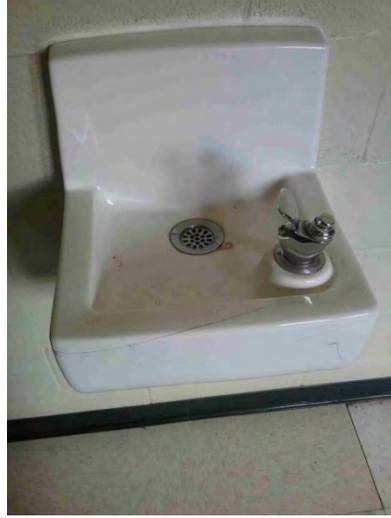
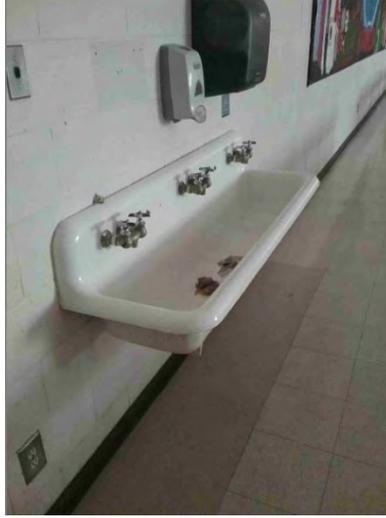
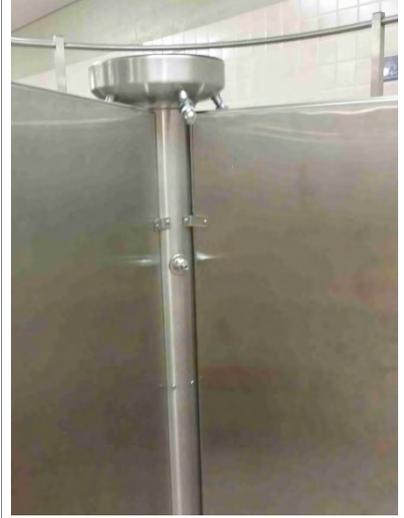
**Plumbing Fixtures**

System	Subsystem	Condition and Deficiency Overview	System Condition Rating
		<p>restrooms, male/female privacy multi-stall column type locker room showers, janitorial closets with service sinks, and a commercial kitchen. These restrooms typically have porcelain, vitreous china, or stainless steel hand sinks mounted in particleboard laminated counter-top wash stands with manual faucets or metering faucets; vitreous china (possibly porcelain), floor-mount/wall toilets with manual flushing valves; and vitreous china, wall-hung urinals in the men's restrooms with manual flushing valves. There are wall-mounted service sinks in the janitorial closets.</p> <p>The restroom plumbing fixtures were observed to be in average condition. All of the fixtures observed were very aged, some dating back to when the school was originally constructed. Although the fixtures observed were still operational, many were running inefficiently, such as flushing slowly or draining water slowly. Additionally, in the male/female locker rooms there were non-functional showers observed. In the male locker room, there was a leaking shower head observed and both the male and female locker rooms had showers with missing manual actuators. Lastly, there were aged or broken water fountains outside of large gymnasium and auditorium.</p>

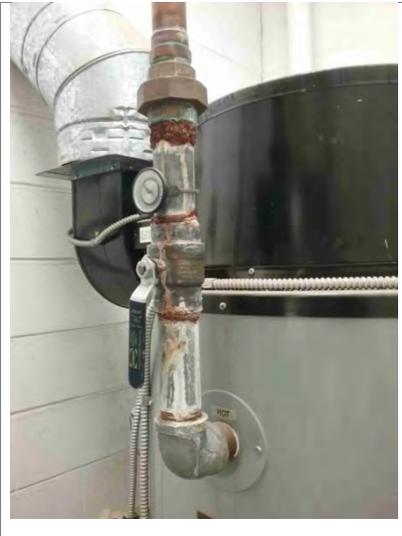
**Domestic Water Distribution**

Domestic Water Distribution	<p>The plumbing systems observed in this facility are not serviced by any heat generating systems from the main mechanical room except for the commercial kitchen and locker room showers. GWH (gas water heater)-1 located near the commercial kitchen was manufactured in 1998.</p> <p>The plumbing distribution piping assessed for the plumbing fixtures was observed to be in good condition. The only notable deficiency is the corrosion on the hot water and cold water supply lines for GWH.</p>	Good
	Other Plumbing	<p>The roof had two types of drainage systems, external and internal. The internal system is equipped with low point drains that have dome type roof covers constructed of carbon steel.</p> <p>The other plumbing systems were observed to be in good condition during the assessment.</p>	Good
<b>Mechanical/ HVAC</b>	This building has 11 HVAC systems. The major mechanical equipment consists of indoor modular AHUs, large roof top-mounted split system AC units, and roof top-mounted EFs. Many of the indoor modular AHUs are supported by the two 300-TON centrifugal water chiller systems that are individually serviced by two one cell		Average

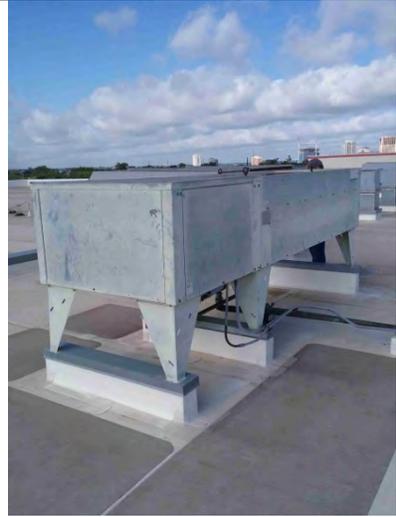
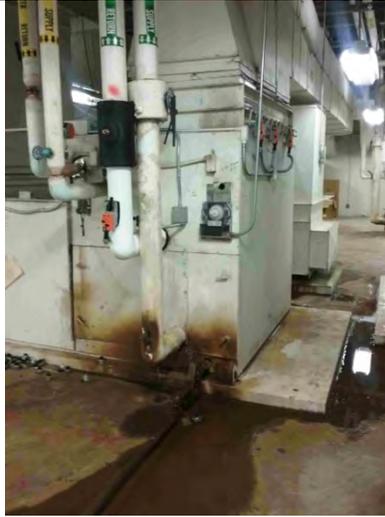
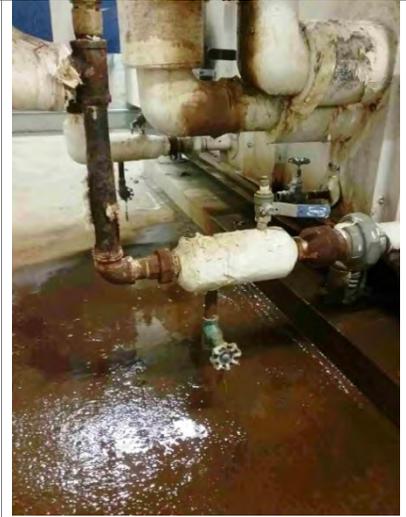
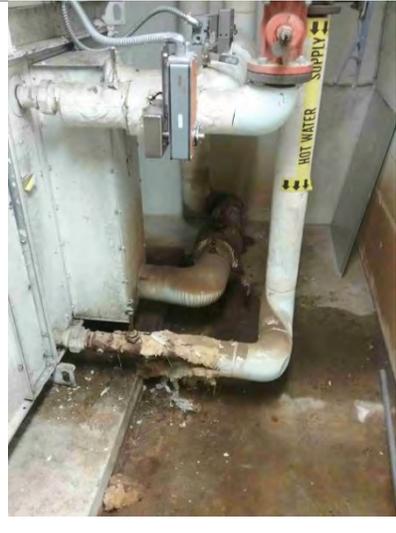
**Mechanical/HVAC System Deficiency Examples**

System	Subsystem	Condition and Deficiency Overview	System Condition Rating
		<p>external cooling towers rated at 235-TON each and four horizontal gas-fired boilers with a rated output capacity ranging from 339 MBH to 1,760 MBH.</p> <p>One split system AC unit is on the roof. The refrigeration capacity of the RTU ranges from 14- to 24-TON. The remainder of the HVAC units consist of indoor modular AHUs, ranging in capacity from an estimated 3,000 to 18,410 CFM. These AHUs are located on the first and mezzanine level floor throughout the building and are multi-zone AHUs equipped with electronic damper actuators.</p> <p>The HVAC equipment was observed to be in average condition. Many of the deficiencies recorded were corrosion on the supply or return piping and external shell of equipment. Other HVAC deficiencies observed include extremely outdated equipment, damaged insulation, air leaks from the AHU housing, and leaks from the supply/return hot and cold water lines. Also, all of the HVAC assets were observed to be using R-22 refrigerant, which is being phased out.</p>

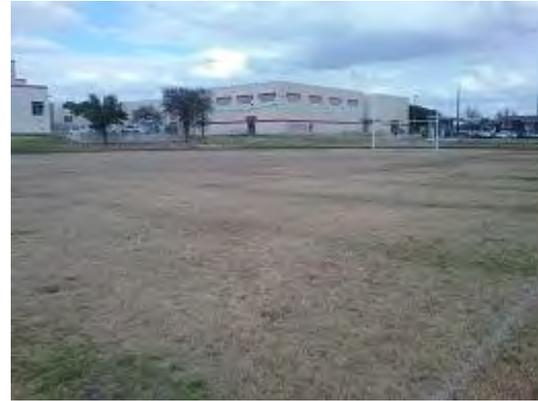
System	Subsystem	Condition and Deficiency Overview	System Condition Rating
Playfields	Tennis Courts	Signs of water pooling in various spots and longitudinal cracking between courts.  Tennis Court Deficiencies: <ul style="list-style-type: none"> <li>• Longitudinal Cracking</li> <li>• Signs of water pooling</li> </ul>	Average
	Track	Track has many patches on all sides. Remaining track is showing large cracks and aging.  Track Deficiencies: <ul style="list-style-type: none"> <li>• Track has many patches</li> <li>• Large cracks</li> </ul>	Poor
	Soccer Field/ Football	Soccer field is worn down to dirt in the middle. Edges of playable field runs onto track. Field drains on the south side.  Soccer Field Deficiencies: <ul style="list-style-type: none"> <li>• No grass in the center</li> <li>• Field boundary runs onto track</li> </ul>	Poor
	Green Space	No observable greenspace associated with school. City park next to school with no clear boundary.	Average
