## Lamar Middle School Site Summary

## Main School Building – BLDG-045A

Building Purpose	Administration Offices, Classrooms, Cafeteria and Gymnasium
Building Area	105,203 SF
Inspection Date	June 14-16, 2016
Inspection Conditions	95° F, sunny
Facility Condition Index

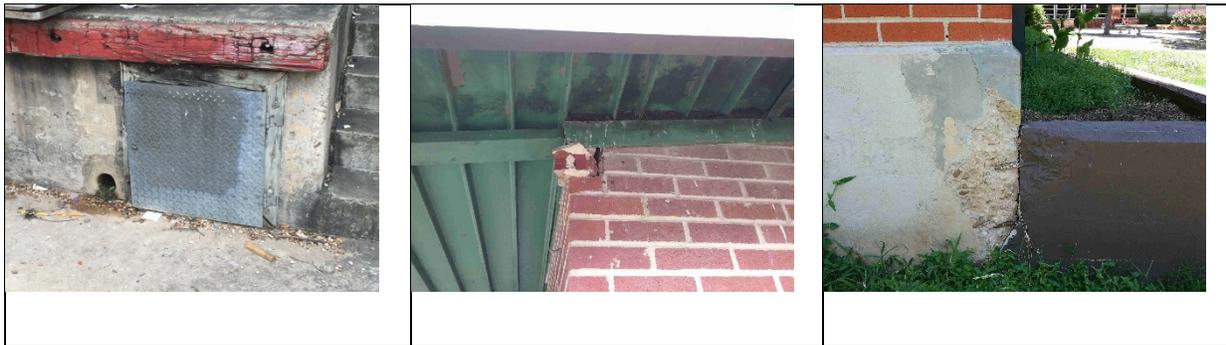
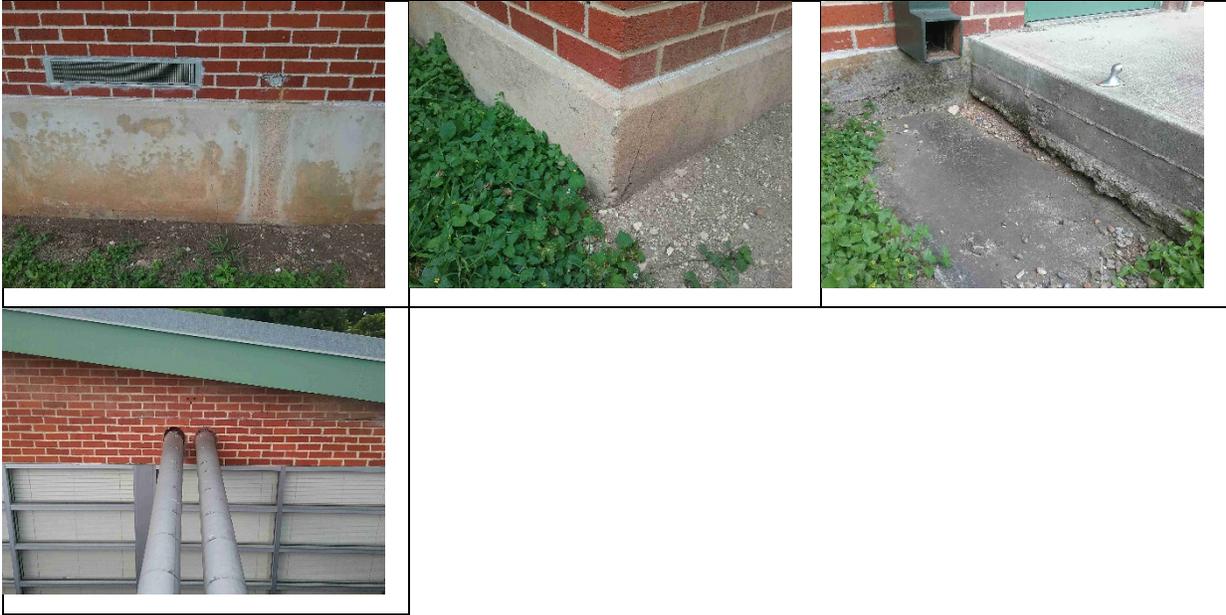
System	Subsystem	Condition and Deficiency Overview	System Condition Rating
<b>Exterior</b>	Exterior Walls	<p>The exterior of the single story building, consists of a brick façade. A painted metal eave extends approximately three feet over the edge of the wall on the majority of the building.</p> <p>The exterior of the building was observed to be in average condition with visual signs of age. The top corners of some of the brick walls were missing bricks and there were several other missing bricks across the building. The foundation wall was observed to be in good condition except for several places of erosion and cracking. At the corners of the east side of the building, “v” shaped hairline cracks were observed at the foundation wall corners. At several other locations, rebar was observed as exposed from eroded concrete. There were two unsealed pipe penetrations near the loading dock leading into the kitchen and the crawl space entry doors were not locked closed. These could be areas of potential pest entrance.</p>	Average

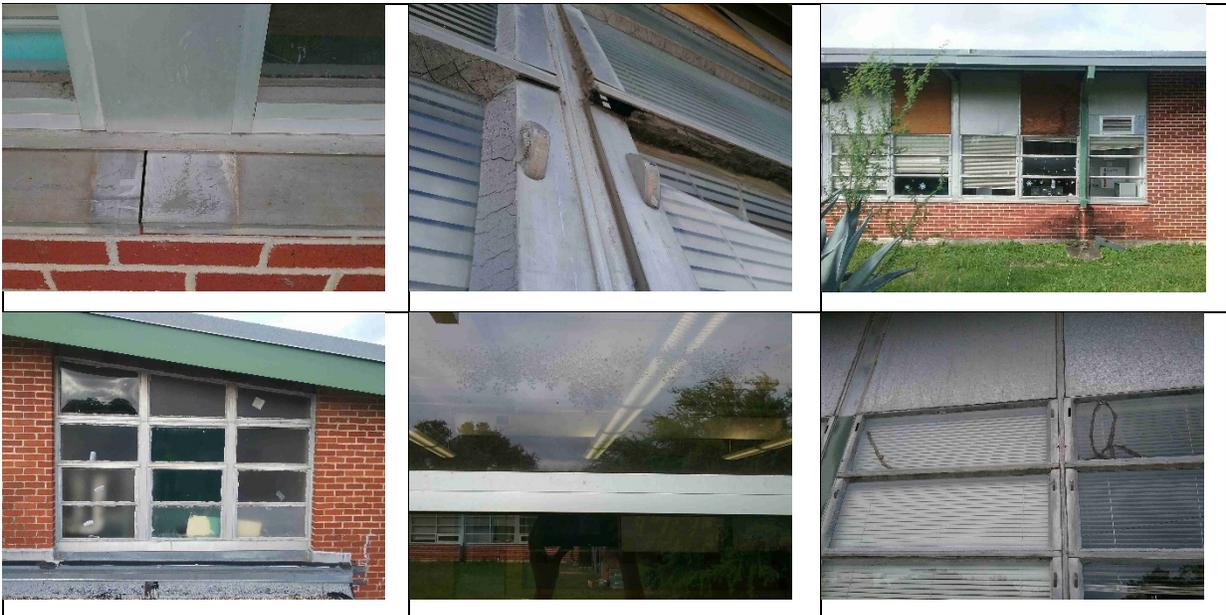
Exterior Windows	<p>A portion of the window system consists of single pane glazing set in a metal framing system. The remaining portion of the windows consists of double pane glazing set in an updated aluminum framing system. The window units are installed in horizontal bands.</p> <p>The window system which appeared original to the building was observed to be in poor condition due to</p>	Poor

System	Subsystem	Condition and Deficiency Overview	System Condition Rating
		<p>mismatched glazing panes, broken panes, and cracked sealant. The aluminum framed window system, in average condition, was also observed to have pinholes to the outside and condensation between panes. The foil sheathing that has been placed over the windows was observed to be replaced with plywood where foil possibly failed or was removed. The appearance of the foil was observed to be in poor condition. It was reported that the window latches are failing around the campus.</p>	
	<p>Exterior Doors</p>	<p>There is one main public entry located at the west side of the building, near the library and café. The entry doors are glazed in painted metal frames, set in horizontal bands of windows and in painted metal frames. The system appears to be original to the building and is covered by a deep awning of painted metal. The exterior doors around the building are manually operated. Near the loading dock, a manually operated wooden roll-up door leads to classroom 502, an art room.</p> <p>The exterior doors appeared to be in good condition needing only minor repair. However, the doorframe leading to the kitchen from the loading dock appeared deteriorated from rust at the bottom of the frame. Some doors were observed with surface scratches from general wear and use. The wood roll-up door appeared to be in working condition, but the painted finish on the door was observed to be in poor condition as it was peeling and blistering.</p>	<p>Good</p>

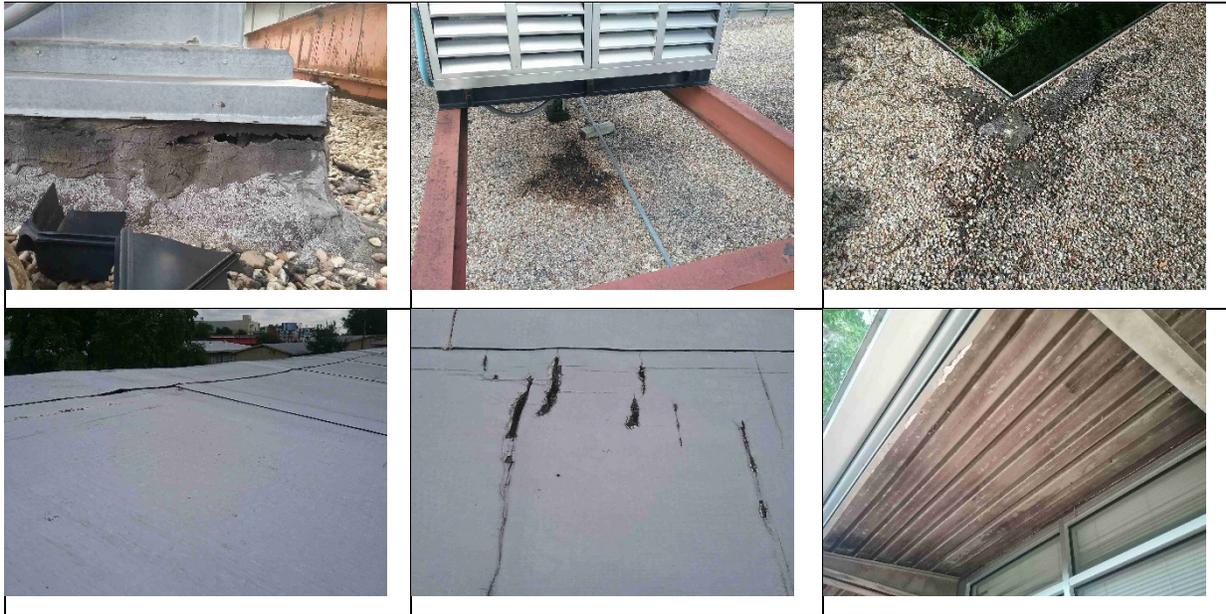
**Roofing Deficiency Examples**

System	Subsystem	Condition and Deficiency Overview	System Condition Rating
<b>Roofing</b>	<p>Built-up asphalt with granular topping material covers about two-thirds of the building while a single ply membrane material covers the majority of the 100-, 200-, and 400-wings. The majority of the roof was estimated to have been installed 15-20 years ago due to the observed lightly aged condition of the materials. There are six skylights on the roof, three of which open into the exterior side of the main entry and three of which open into the interior side of the main entry.</p> <p>The roof surfaces were observed to be in good condition. The skylights appeared clean and leak-free. There were small patches of disturbed gravel at the built-up roof above the main entrance and in the valley joints. Expected discoloration was observed at the valleys. A possible source of ponding/leakage was observed at the refrigeration fan, evidenced by a patch of discolored gravel. There was also visible cracking and deterioration at the flashing above the kitchen. The single ply membrane roof, constituting about a third of the roof, appeared to be more worn and sun-weathered. Many gaps were observed where the membrane sheets overlapped and there were many scratches on the membrane. There was extreme deterioration of the metal panel eave in the courtyard.</p>		Good

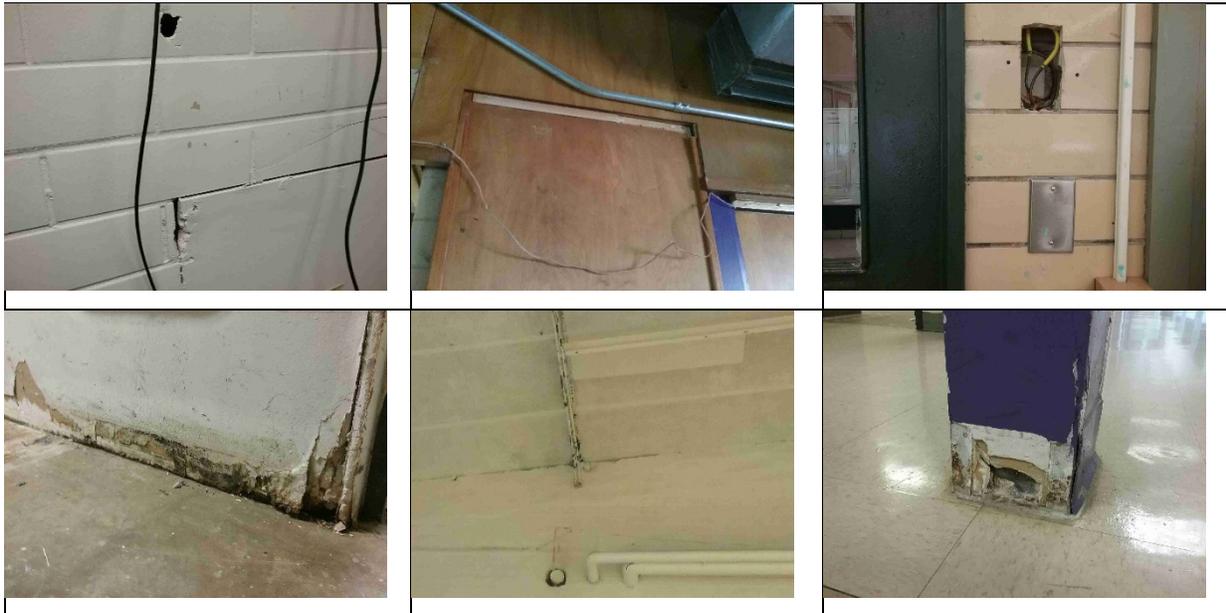
**Interior Walls**

<b>Interior Construction</b>	Interior Walls	<p>The interior walls are constructed of concrete masonry unit (CMU) block. Some walls are furred-out with a gypsum board finish.</p> <p>The construction of the walls was observed to be in average condition. There were several holes observed needing minor repairs. Several of the original locker room dividing partitions, constructed with ceramic-faced masonry units, were broken.</p>	Average
	Interior Doors	<p>The majority of the classroom doors were painted metal with glazed vision panels in metal frames. There are four folding doors in the building: two wooden doors in the cafeteria lunch line and two gate corridor dividers.</p> <p>The metal interior doors and frames were observed to be in average condition. The painted finish on many doors was excessively scratched. The door to room 209 was observed to catch on the floor and not close properly. The wooden doors in the administration wing were observed to be in good condition, although the hardware was observed to be dated and one door was missing hardware or it had been removed. There were instances of damage above cased openings. The wooden folding doors in the cafeteria were observed to be dated and extremely difficult to operate. The folding gates in the corridors appeared to be seldom utilized.</p>	Average

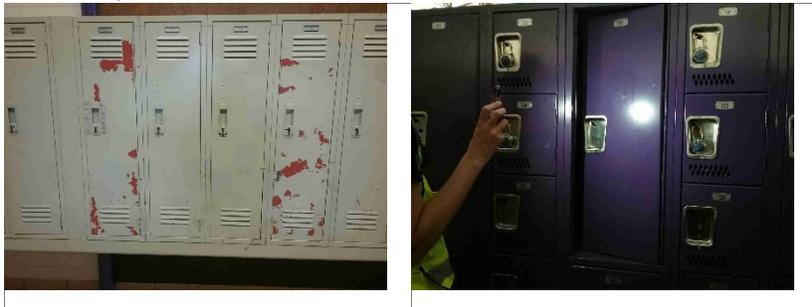
Interior Specialties

System	Subsystem	Condition and Deficiency Overview	System Condition Rating
		The wall-mounted lockers were in poor condition, showed excessive wear and tear, and an estimated one in five lockers in the corridors was found to have dysfunctional latches. The boys' gymnasium lockers were in average condition, exhibiting strong wear and tear on the exterior of the lockers. The girls' gymnasium lockers were in good condition; however, one locker was pushed into its housing.	
<b>Stairs</b>	Exterior Stairs	System not present.	N/A
	Interior Stairs	<p>There are two concrete stair and ramp systems in the building, which are finished in laminate. One ramp and adjacent two-step stair is in the 400-wing corridor. The second system is in the corridor adjacent to the large gymnasium. In the health room, there is a wooden stair leading to the upper mezzanine.</p> <p>The systems were observed to be in average condition, though the handrail of the 400-wing ramp was discolored and unclean. The health room stair was observed to be unstable and have an unsuitable rating.</p>	Average

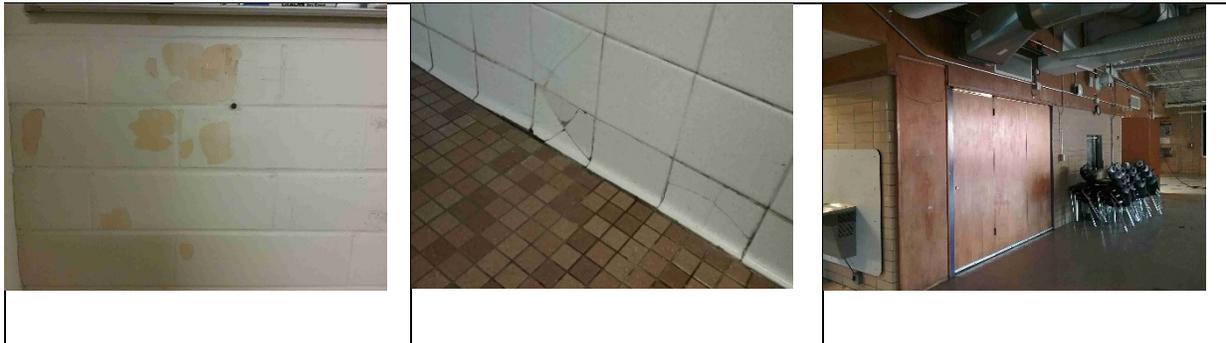
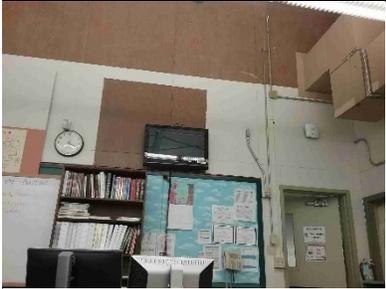
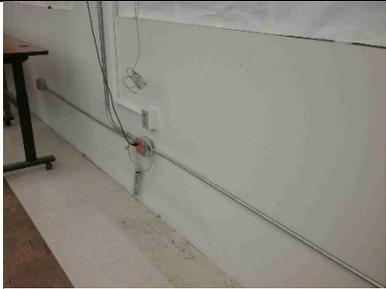
<b>Interior Finishes</b>	Interior Wall Finishes	<p>The wall finishes throughout the building include painted and ceramic faced masonry unit walls with wood paneling and interior windows. Several rooms have painted gypsum board walls, and many classrooms have a combination of all finishes. The majority of the interior finishes appeared to be original to the building except the painted gypsum board walls.</p> <p>Wall finishes throughout the building were observed to be in average condition, needing only cosmetic restoration and cleaning, though the materials appeared outdated. The wood paneling on the walls especially appeared outdated. In the 500-wing, the classrooms appeared unfinished, with various patched wall materials and loose wires. The kitchen finishes were observed to be clean and in good condition.</p>	Average
	Interior Floor Finishes	<p>The floor finishes throughout the building include linoleum floor tile with ceramic face masonry base or rubber base. The library and administration wing are finished in carpet, and the gymnasiums are finished with a wooden athletic flooring material. The kitchen and some restrooms have ceramic tile floors.</p> <p>The linoleum floor appeared to be well maintained and in average condition considering its age. It was reported that the floor tile adhesive in the 200-wing is breaking down and tiles are becoming loose. The ceramic-faced</p>	Average

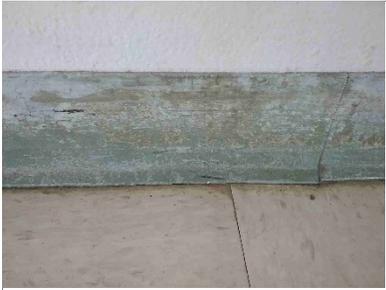
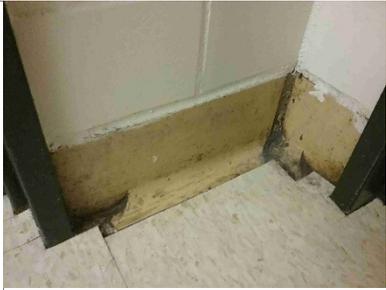
Interior Floor Finishes

System	Subsystem	Condition and Deficiency Overview	System Condition Rating
	Interior Ceiling Finishes	<p>base was found to be in average condition but excessively dirty, while the rubber base near classroom 115 was found to be in poor condition, as it was extremely dry and discolored.</p> <p>The ceiling finishes vary throughout the building and include painted woodwool panels, painted oriented strand board (OSB), and acoustical ceiling tile (ACT). Much of the ceiling was observed to be damaged and in poor condition. Water damage and staining was noted to affect an estimated third of the ceiling, regardless of material. This is reportedly caused by leaking condensate water from mechanical equipment. Holes and deterioration of the ceilings were observed in various rooms. In the corridor, several discolored spots were observed. In the library, the ceiling was found to be in poor condition, except the gypsum board portion (est. 450 sf.). In the library, water stains were observed at every panel joint, as were black spots on the ACT tees, possibly evidence of mold. A strong mildew odor was also detected in a significant portion of the classrooms.</p>	Poor

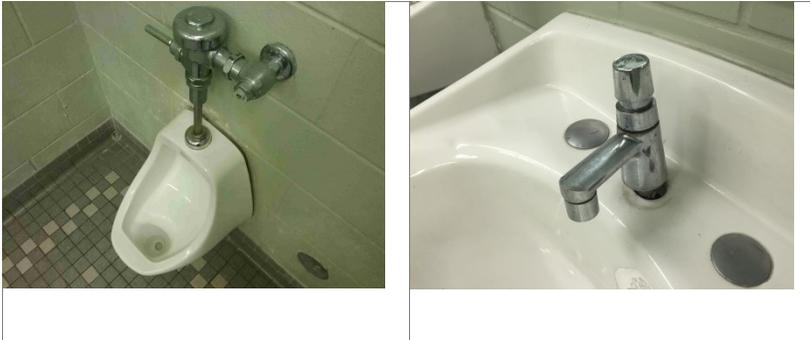
<b>Conveying</b>		There is a mechanical wheelchair lift backstage of the cafeteria. It was reported to be in good working condition and has no apparent deficiencies.	Good
<b>Plumbing</b>	Plumbing Fixtures	<p>The building has both single-user and multi-user restrooms for students and staff located throughout the facility. Typical restrooms have wall-hung, porcelain lavatories with manual faucets along with floor-mounted, porcelain toilets with manual flush valves. There are wall-hung, porcelain urinals with manual flush valves in the males' restrooms. The building also has multiple janitor closets with utility sinks. Typical classrooms have a single bowl stainless steel sink with a drinking fountain attachment, or a single bowl porcelain washbasin along with an individual drinking fountain. Water coolers and bottle fillers can be found throughout the main corridors of the building.</p> <p>A commercial kitchen serves the school's cafeteria located within the building. The kitchen has wall-mounted vitreous china sinks for personal use and stainless steel kitchen equipment throughout including one, two, and three-basin dish/prep sinks.</p> <p>Plumbing fixtures were observed to be in average condition with the exception of wall-hung toilets in the males' restrooms in poor condition. These are</p>	Average

System	Subsystem	Condition and Deficiency Overview	System Condition Rating
		<p>reportedly being damaged by the students, especially in restroom BRR300. The restrooms' 'push-type' faucets were often found to stick in the on-position. It was reported that the fixtures are reported aged mostly in the 100-, 200-, and 400-wing.</p>	
	<p>Domestic Water Distribution</p>	<p>The sole water supply for the Lamar Middle School campus was found along Wynona Avenue, with double meter isolation and no evidence of a backflow prevention device for individual buildings or the main campus supply line.</p> <p>Domestic hot water for administration, kitchen/cafeteria, and nurse staff was supplied by three small electric hot water heaters with capacities of 30 gallons or less. Domestic hot water is not supplied for student restrooms or locker/shower areas. The domestic hot water system was observed to be in average. There is potential galvanized piping in the facility.</p>	<p>Average</p>

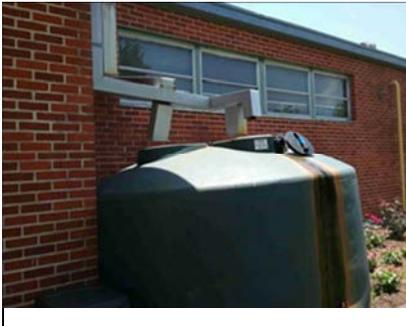
Other Plumbing

<p>Other Plumbing</p>	<p>Deficiencies were noted with regard to the roof leaders, such as cracked entries, outlets discharging to piles of trash, and lack of supports. Sanitary sewer header vents and gas piping appeared in good condition.</p> <p>Staff interviews report the sanitary lines in the 100-, 200-, and 400-wings are near the end of their service life.</p>	<p>Average</p>
<p><b>Mechanical/ HVAC</b></p>		<p>Seven 7.5 to 40 ton packaged air conditioning units and two smaller split packaged systems supply cool air from the rooftop level to the kitchen/cafeteria, gymnasium/locker room, and main corridor areas. Classrooms were typically served by fan coil units, which are served by the chiller plant (BLDG-045D). Administrative offices and a number of isolated corridors were cooled by ten 4 to 8-ton ground level, outside condenser/indoor air handler split systems.</p> <p>Several indoor modular, ceiling-hung, or mezzanine-mounted air handling units circulate air in the big and small gymnasiums and the 500-wing "COR1" corridor areas.</p> <p>Four air handling units located inside mechanical rooms, ranging in size from to 15 to 17 tons, circulate air for some classrooms.</p> <p>The primary temperature control unit for the building (with exception of the administrative offices) is located in the 400-wing mechanical room adjacent to AHU-401.</p> <p>Multiple exhaust fans of various sizes were mounted on the rooftop level. Several wall exhaust units were present in the gymnasium areas.</p> <p>Two gas/water tube boilers serving the administration, kitchen/cafeteria, and nurse areas were not in operation and appeared to be partially dismantled. A 1920MBH gas/water tube boiler located in the mezzanine above the gymnasium mechanical room appeared to be supplying heat to air handlers for 500-wing corridor COR1.</p>	<p>Average</p>

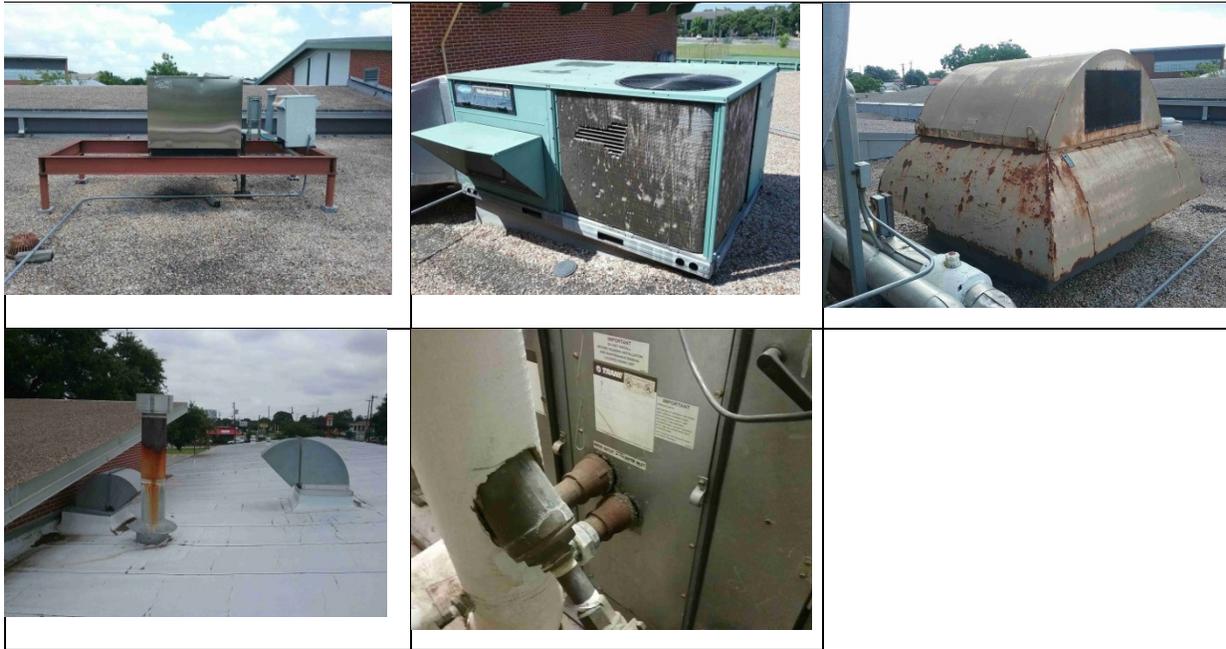
**Mechanical/HVAC System Deficiency Examples**

System	Subsystem	Condition and Deficiency Overview	System Condition Rating
		<p>This was reportedly nonfunctional.</p> <p>Multiple exhaust fans of various sizes mounted on the rooftop level appeared in mostly good condition, with a minority in average to poor condition. Some, such as EF-10 (SC002476) and EF-NE (SC002483), despite appearing relatively new, delivered a loud, erratic noise during operation. One rooftop vent stack (above the 200-wing) was severely corroded.</p> <p>The condition of the packaged air conditioning units varied considerably, as some equipment was more recently installed (i.e., the administration offices and part of the big gymnasium), but most others appeared beyond their typical design life, with operating noise, wear and tear, mildew buildup, and exterior corrosion issues. Staff reports that facility HVAC is not properly balanced, as some rooms are too cold while others are too warm. It is also reported that the HVAC units and fresh air units do not function together with reliability. Facility staff reported functional issues with the rooftop A/C units for the gymnasium areas, and condensation pans not draining properly.</p> <p>The air handling units for the big and small gymnasiums and the 500-wing "COR1" corridor areas were mostly inaccessible for assessment, but indicated good to average condition, with instances of corrosion, missing fasteners, and exposed electrical connections. The split packaged system serving the administrative offices appeared in good condition. Missing fasteners and denting were common observations on exhaust fans. Two exhaust vents had significant corrosion (one in roof section A-12, the other in A-29).</p>

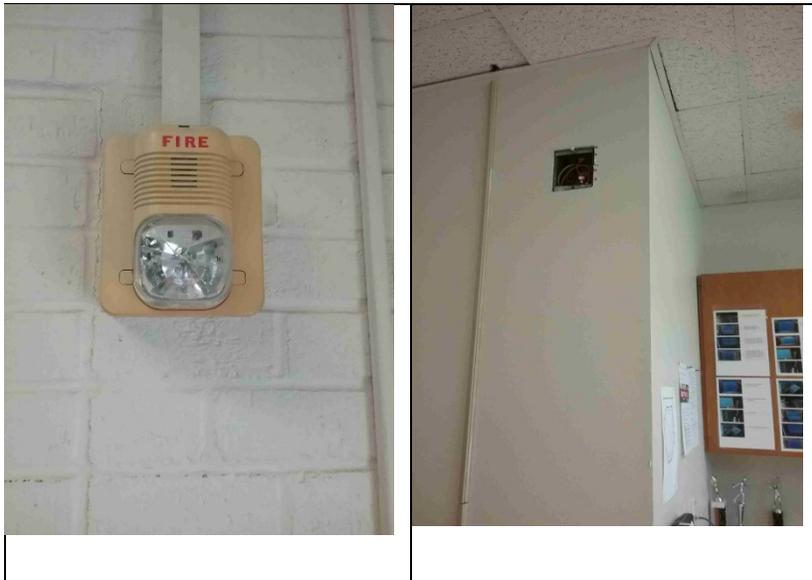
**Fire Alarm**

<b>Fire Protection</b>	Fire Alarm	<p>The building has a fire alarm system that consists of alarm and signaling devices such as horns/annunciators, strobes, horn/strobe combos, pull stations, and detectors. The fire alarm system is controlled by the Silent Knight 5820XL control panel. Re-wiring of fire electrical system in the 500-wing is occurring this summer.</p> <p>The fire alarm system was observed to be in good condition, but there are areas where fire alarm end devices are aged past their design life or have been vandalized. The self-closing smoke doors in "Corridor 8" are malfunctioning leaving the doors permanently open, and the alarm is on in perpetuity. Panels are behind the CMU and are inaccessible to staff.</p>	Good
	Fire Protection/Suppression	<p>The fire suppression system consists of fire extinguishers throughout the building. Visual inspection showed these are in average condition.</p>	Average

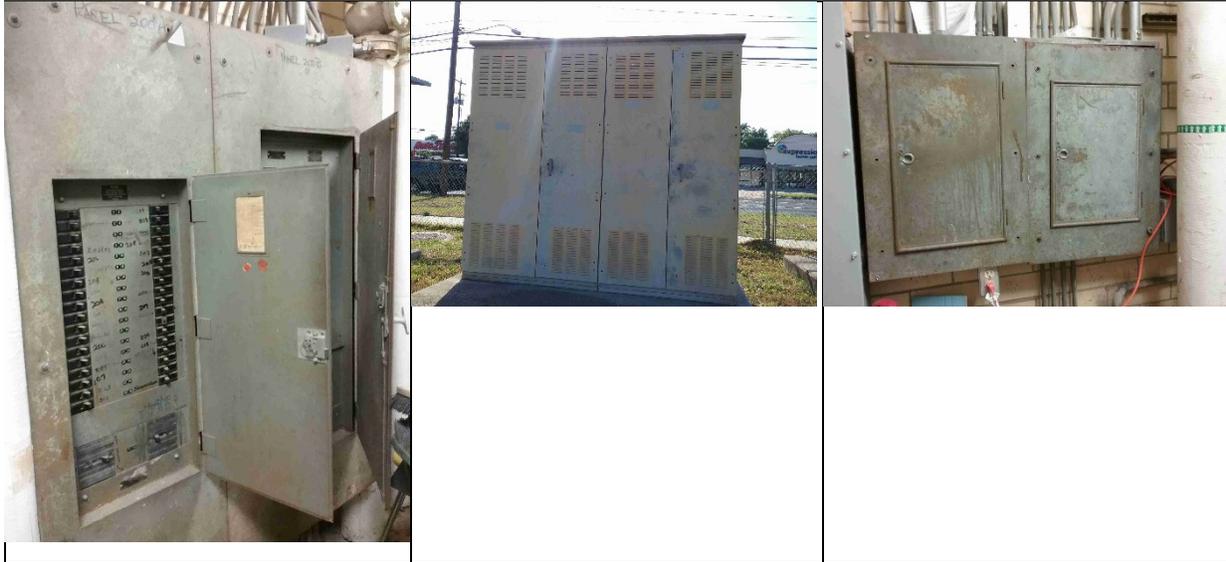
**Electrical Distribution**

System	Subsystem	Condition and Deficiency Overview	System Condition Rating
		<p>Mechanical Room Building. The service feeds transformers and low voltage panelboards, which are located in various electrical rooms throughout the main building and in other buildings on the campus. There are nine distribution transformers rated at 480-volt primary that step-down the voltage to 120/208-volt secondary, which feeds power to 120/208-volt panelboards. The building does not have a lightning protection system.</p> <p>The electrical distribution equipment was observed to be in average to poor condition, with a majority in poor condition. A majority of the assets were observed with corrosion. There are several panelboards from the original construction and they are at end of their useful life, especially those in the 500-wing classrooms and in the gymnasium areas. It was also reported that 500-wing does not have adequate quantity of electrical receptacles.</p>

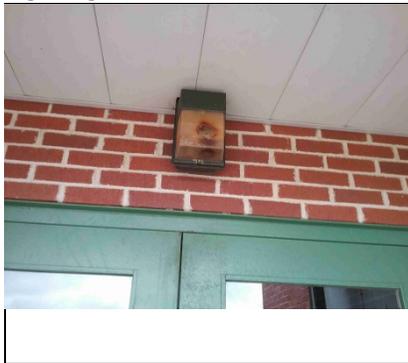
**Lighting**

Lighting	<p>The building's exterior lighting consists of mostly HID luminaries. Several LED luminaries were observed at the loading dock. There is only one pole mounted light fixture in the south parking lot and one pedestrian height pole mounted light fixture at the north parking lot.</p> <p>The interior lighting primarily consists of T8 fluorescent luminaires, most of which appeared to have been installed as recently as five years ago. The classroom wings, library, cafeteria, and similar areas have direct/indirect pendant fixtures. The big and small gymnasiums have fluorescent high bay fixtures with wire guards and the gymnasium support areas (such as locker rooms, coach's offices, corridors, similar areas) have surface mount vandal resistant fluorescent wrap fixtures.</p> <p>The 200, 300, and 400-wings appeared to have occupancy sensors in the majority of the areas, with exception of the cafeteria, which had all manual controls. The 100- and 500-wings appeared to lack occupancy sensors. However, both the big and small gymnasiums have occupancy sensors.</p> <p>The lighting for the building was observed to be in average to poor condition, with a majority in poor condition. Most of the exterior luminaires appeared to be aged past their typical design life and was lacking throughout the campus. Many interior luminaires were observed with burned out lamps. Specifically, most of</p>	Poor

System	Subsystem	Condition and Deficiency Overview	System Condition Rating
		<p>the light fixtures in the big gymnasium were observed with burned out lamps. General observed deficiencies included broken lenses, inconsistent color temperatures, and non-functional fixtures.</p> <p>There are exit signs present in the building, however, most appeared to be from the original construction. Several areas appeared to have emergency egress fixtures either from the original construction or from more than 20 years ago. However, it appeared that the 100-, 200-, and 400-wings lacked emergency lighting all together.</p>	
	Communications & Security	<p>There is a Gemini security system, including surveillance cameras. There are two public address system headends in the facility, one new and one old. The building has an outdated school bell system. The building is equipped with tele/data systems, but the main backbone equipment is located in an inaccessible room. There are Wi-Fi access hubs throughout the facility.</p> <p>It was reported that the security system is working, but are aged and experience blind spots. It was reported that both public address system headends are working and have no issues. The Wi-Fi access hubs appeared to be in good condition, however, it was reported that the Wi-Fi signal is weak throughout the campus.</p>	Good

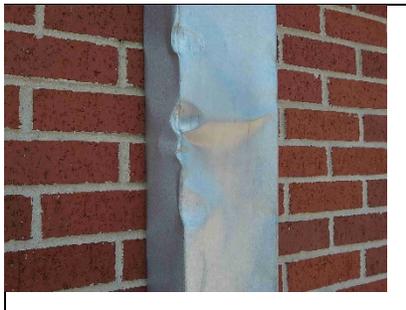
System	Subsystem	Condition and Deficiency Overview	System Condition Rating
<b>Exterior</b>	Exterior Walls	<p>The exterior of BLDG-045B, a single story building, consists of a brick façade with flat metal panel accents. An eave of flat metal panels extends approximately six feet over the edge of the wall on the majority of the building.</p> <p>The exterior walls of the building were observed to be in good condition, needing only regular maintenance and care. One aluminum downspout was observed to be extremely dented and damaged.</p>	Good
	Exterior Windows	<p>The window system consists of double pane fixed windows in aluminum frames. Installed in horizontal bands, the window units begin 14 feet above finish floor and span to the top of wall.</p> <p>The exterior windows of the building were observed to be in good condition needing only cleaning. Excessive bird droppings were observed on the windows and frames.</p>	Good

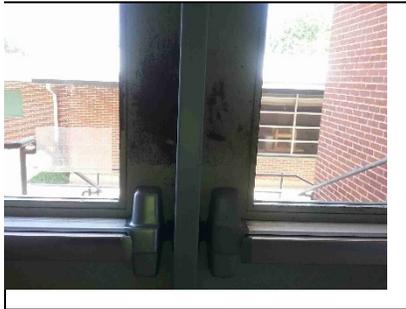
System	Subsystem	Condition and Deficiency Overview	System Condition Rating
<b>Exterior</b>	Exterior Walls	The exterior of BLDG-045C, a single story building, consists of a brick façade with flat metal panel accents. An eave of flat metal panels extends about four feet over the edge of the wall on the majority of the building. The exterior was observed to be in good condition. The only noted deficiency was slightly chipped paint visible on the steel beams supporting the eave.	Good
	Exterior Windows	The window system consists of double pane fixed windows in aluminum frames. The windows are installed in horizontal bands and the window units begin 14 feet above finish floor and span to the top of the wall. No deficiencies were observed of the exterior windows.	Good
	Exterior Doors	There is one main public entry located at the southwest side of the building. The entry doors are half glazed, painted metal double doors set in storefront window systems. All of the exterior doors in the building are manually operated. The doors were observed to be in good condition. The metal frame to the entry door was observed to have normal wear and tear with chipped paint at the edges of the door.	Good

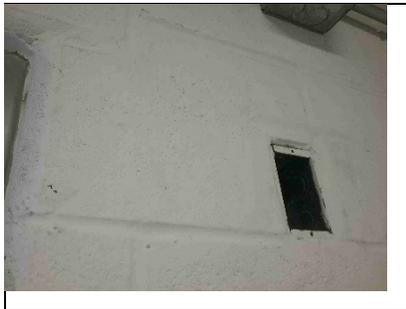
Interior Walls

System	Subsystem	Condition and Deficiency Overview	System Condition Rating
		except for missing electrical boxes and some unsealed penetrations. Holes were visible in the gypsum board furr-outs in some classrooms. Storage room walls were observed to have unsealed penetrations.	
	Interior Doors	The doors are painted metal in painted metal frames. Several of the interior doorframes were observed to have excessive scratching of the paint finish. The doors were observed to be in good condition.	Good
	Interior Specialties	System not present.	N/A
<b>Stairs</b>	Exterior Stairs	A large expanse of terracing concrete connected with cast-in-place ramps and steps links BLDG-045B and BLDG-045C.  The majority of the stairs were observed to be in good condition, and no immediate structural issues were observed on site. The surfaces of the handrails were observed to be worn. The supports of many handrails were set in rust-stained or cracking concrete. Several instances of eroded concrete were observed.	Good

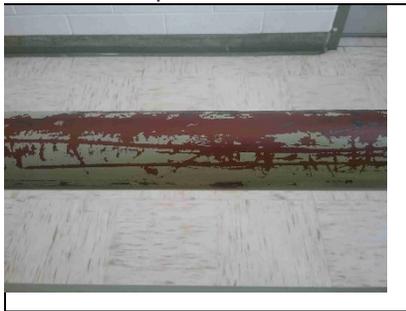
Interior Ramp

Interior Stairs	There is a linoleum-faced ramp in the corridor allowing access to the stage height of room 604.  The ramp structure was observed to be in good condition, but the handrail was noted to have excessive wear and tear.	Good
<b>Interior Finishes</b>	Interior Wall Finishes	The interior walls are painted CMU and gypsum board. The walls were observed to require repainting in several areas to maintain a uniform appearance. Examples were observed in the restrooms and in the corridor. The dance room wall finishes were observed to have small holes.	Average
	Interior Floor Finishes	The floor finish consists of linoleum floor tile with rubber base.  The floor was observed to be in good condition. The rubber base was observed to be in failing condition, as it was discolored, cracked, and peeling from the wall.	Poor
	Interior Ceiling Finishes	The majority of the ceiling is ACT with exposed metal deck in some portions and gypsum board in the restrooms.  Near the main entrance, a large water stain was observed on one ceiling tile.	Average

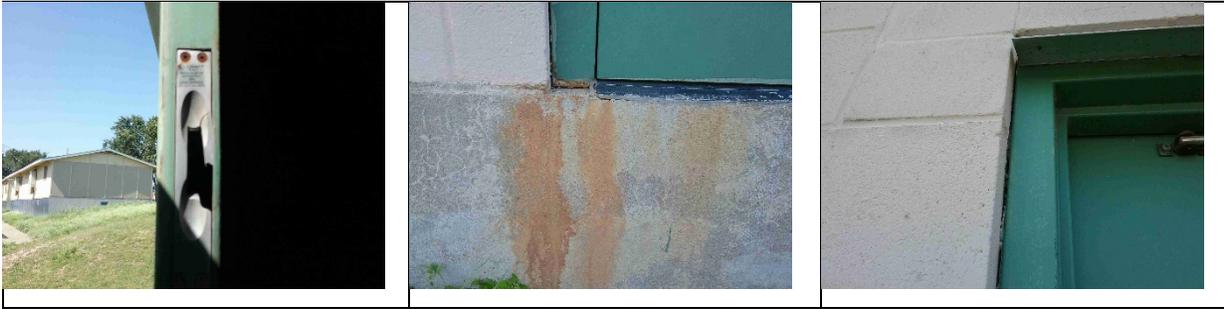
Exterior Windows	System not present.	N/A
	Exterior Doors	<p>There are two entries into the main space, each a set of painted metal double doors with louvers. The separated ELECCHLR room is accessed through a single painted metal door from the exterior.</p> <p>The door hardware was noted to be in good condition, except for a broken catch on the north door. The door frame of the south door exhibited evidence of rust, and staining of the concrete below was observed. Slight gapping between the wall and door frame was also observed where sealant was missing.</p>	Good

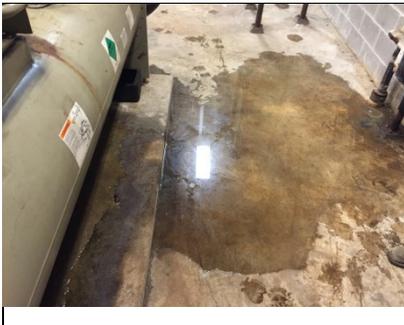
Interior Floor Finishes	The floor in this building is concrete slab on grade.  Extensive ponding was observed beneath the interior equipment.	Average
	Interior Ceiling Finishes	System not present.	N/A
<b>Conveying</b>	System not present.		N/A
<b>Plumbing</b>	Plumbing Fixtures	System not present.	N/A
	Domestic Water Distribution	Domestic hot water is not supplied to this building.	N/A
	Other Plumbing	Roof leaders are present.  They appeared in good condition and were piped to a storm water catch basin.	Good
<b>Mechanical/ HVAC</b>	Two centrifugal, water-cooled chiller units supply two galvanized steel cooling towers in the mechanical yard of the building. Four rooftop exhaust fans exhaust air from the building; however, they were inaccessible for assessment due to roof height. Ceiling-hung exposed ductwork originating from the packaged AC unit in the mechanical room distributes air to the building.  The cooling equipment was found to be in average condition. Both chiller units had damaged seams on the outer skin of their evaporator tanks and were leaking water. One of the cooling towers (CT-1) had full rust-through penetration at several areas. Cooling water pumps CWP-3 and CWP-1 appeared to be out of service with internal corrosion issues. Both cooling towers exhibited slight exterior corrosion throughout and slight absorption rack damage.		Average

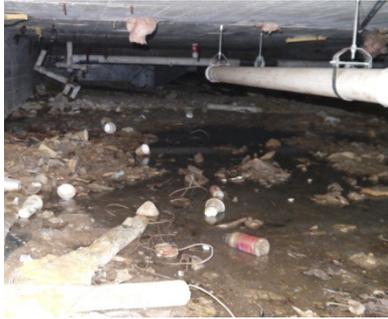
Ponding water due to poor drainage

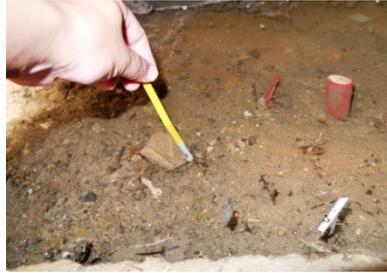
Standing water in crawl space due to poor drainage

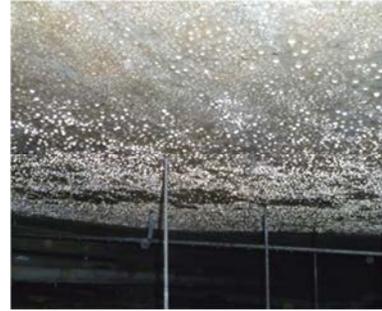
Condensation on underside of slab indicates poor ventilation

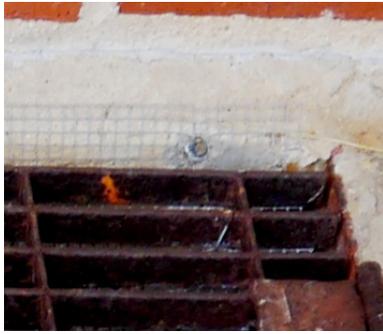
Wire mesh attached to areaway grate is screwed into concrete, areaway inaccessible

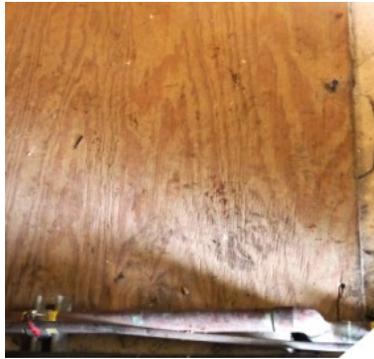
Areaway is screwed closed and inoperable

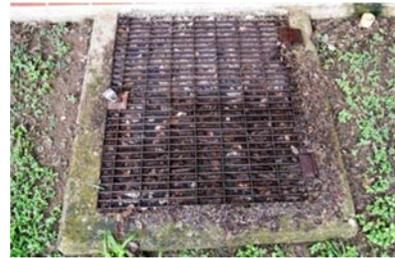
Low areaway curbs permit surface water to flow into crawl spaces

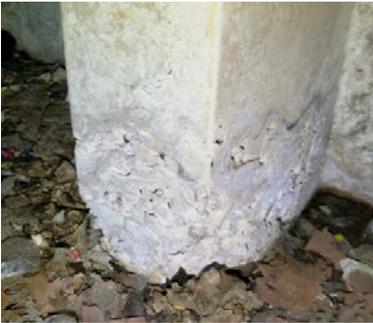
<p>Column honeycombing</p>

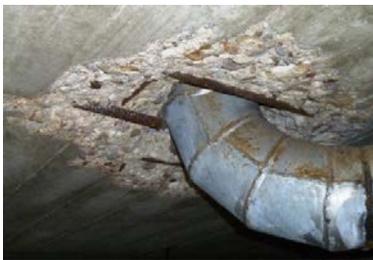
<p>Exposed/corroded slab reinforcement</p>

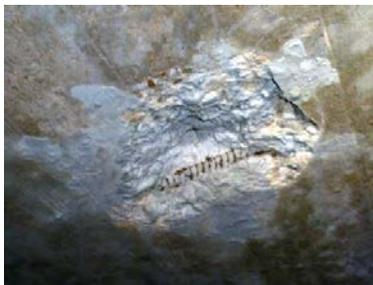
<p>Slab spalling</p>

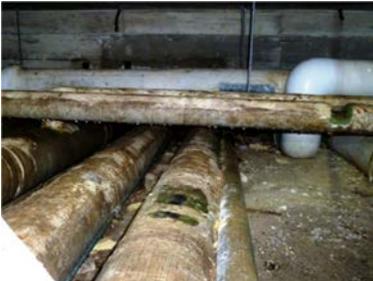
<p>Degraded pipe insulation</p>

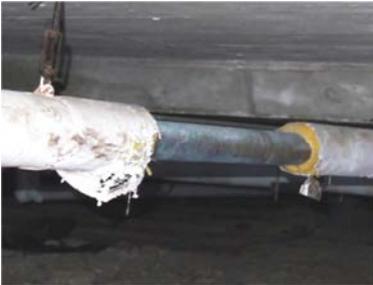
<p>Missing/damaged pipe insulation</p>

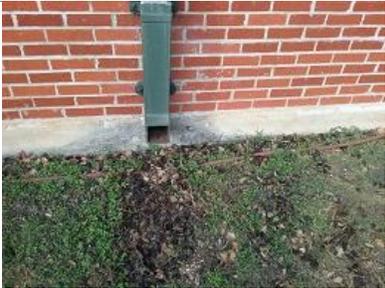
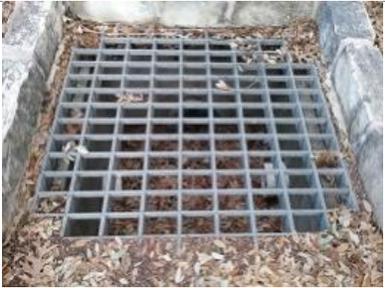
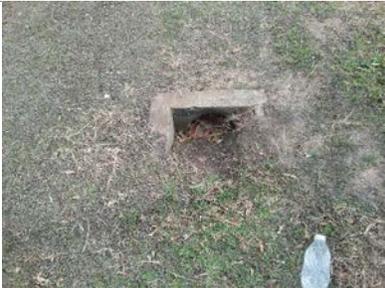
Downspout does not tie underground	Maintain inlet	Outfall blocked

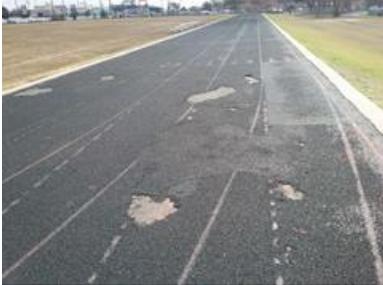
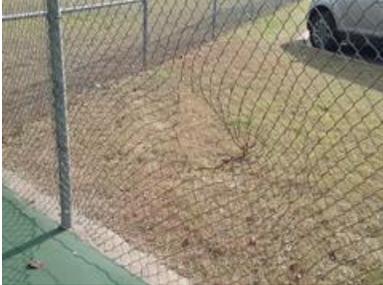
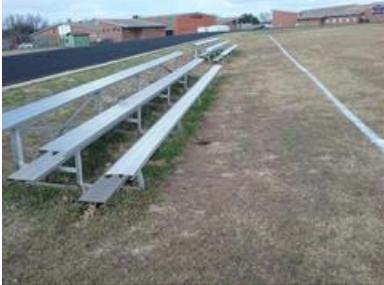
Raveling track surface (west side)	Fencing/cracking at tennis courts	Bleachers without concrete pad

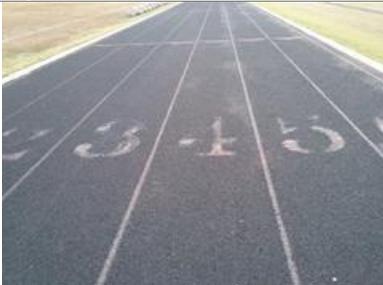
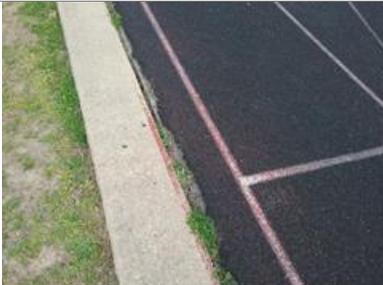
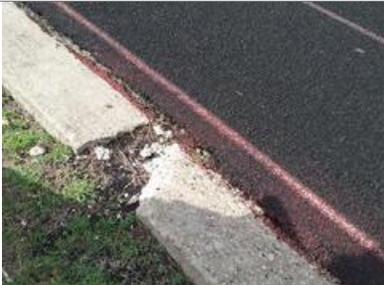
Faded lane markings	Curb pulling away from track	Broken curb along interior of track
