## Martin Middle School Site Summary

## Main School Building – BLDG-051A

## Building B – BLDG-051B

## Site/Civil Assessment

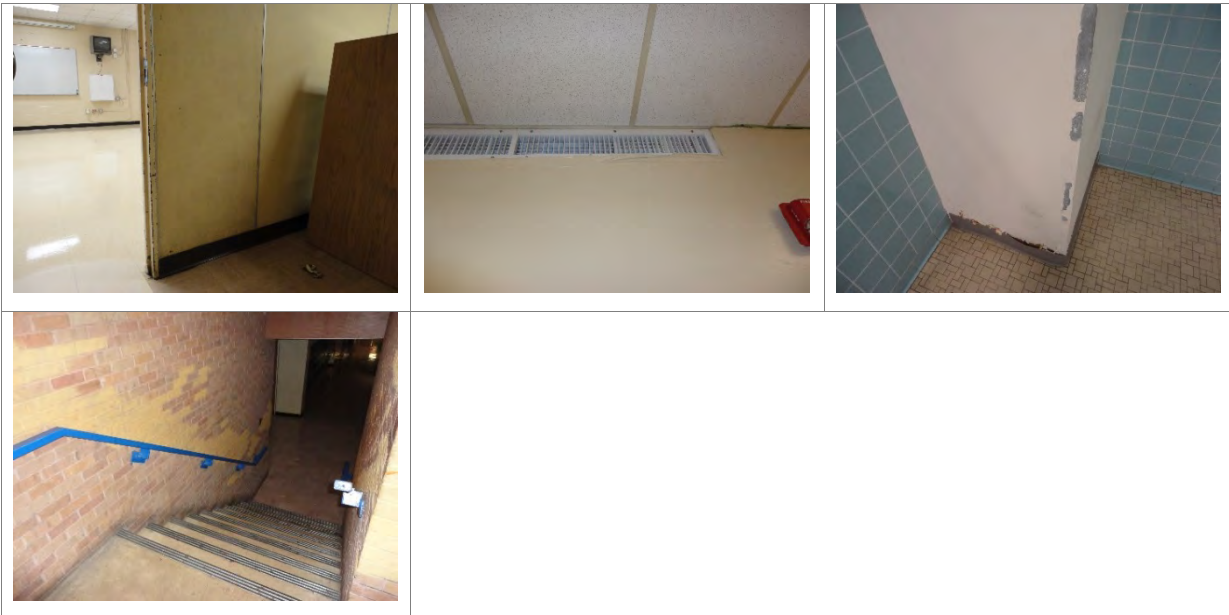
### Interior Wall Finishes

System	Subsystem	Condition and Deficiency Overview	System Condition Rating
		<p>panels in the classrooms and corridors with aluminum trim. The restrooms have ceramic tile on the full height of the walls.</p> <p>The interior wall finishes appeared to be in average condition. The plastic laminate in the corridors showed signs of wear due to high use. There was a moisture issue in room 104 near the HVAC (heating, ventilating, and air conditioning) vent that caused the paint to separate from the wall. Further investigation is required to identify the cause of the issue. There was damaged drywall in restroom GRR100 that did not have ceramic tile finish. The brick in the interior stairwells appeared to have been painted at one point in areas of high use or with graffiti above handrails.</p>	
	Interior Floor Finishes	<p>The floor finishes in the classrooms are vinyl composition tile. The restrooms, including faculty restrooms, have ceramic tile. There is vinyl/rubber cover base at all vinyl composition tile. In the administration areas, there is carpet and a small area of Saltillo tile.</p> <p>The flooring appeared to be in average condition due to age and various areas where the vinyl composition tile had been replaced. There were several areas throughout the building where a small portion of rubber cover base was missing, for example, in the second floor corridor between rooms 212 and 214. Facility staff reported an odor associated with the library carpeting and maintenance issues with the tile in the administration restrooms.</p>	Average

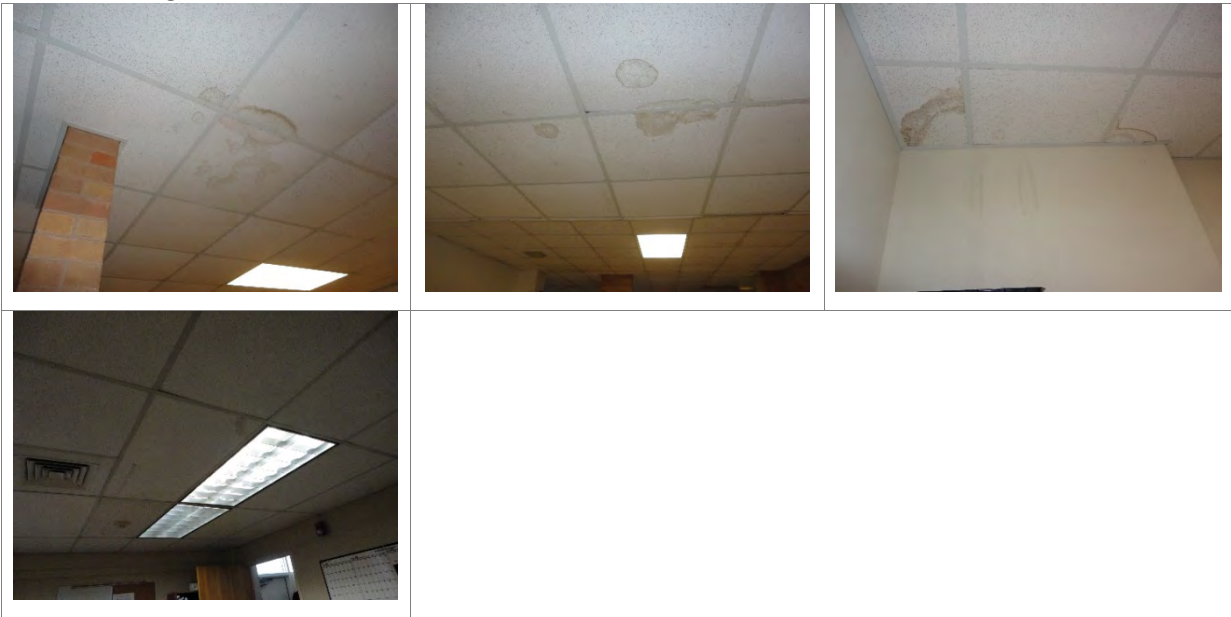
Interior Ceiling Finishes	<p>The ceiling finishes are ACT (acoustic ceiling tile) and grid throughout the classrooms and painted gypsum board in the restrooms. There is a painted stucco soffit in the exterior corridors.</p> <p>The ceiling tile appeared to be in average condition with numerous areas of damaged and discolored ceiling tiles. The ceiling tiles appeared to be aged and mismatched throughout the entire building.</p>	Average
<b>Conveying</b>	<p>The building is equipped with an elevator for second floor access. The hydraulic system for the elevator appears to have been replaced in 2009.</p> <p>The conveying system appeared to be in good condition.</p>		Good
<b>Plumbing</b>	Plumbing Fixtures	<p>The building contains predominantly multi-use restrooms throughout the facility, with single-use restrooms found in the nurse's office, room 104 and faculty restrooms on both the first and second floors. Typical restrooms have floor-mounted vitreous china</p>	Average

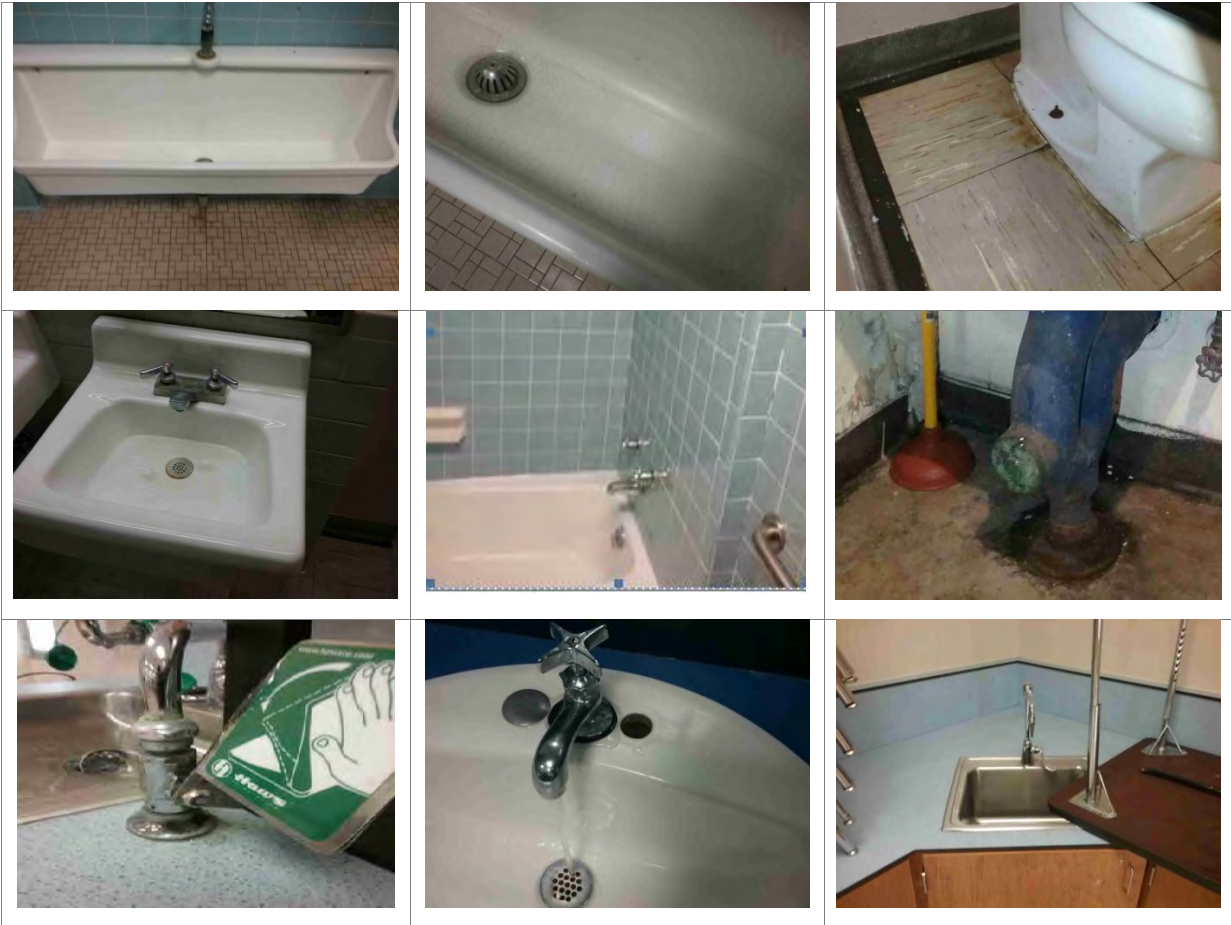
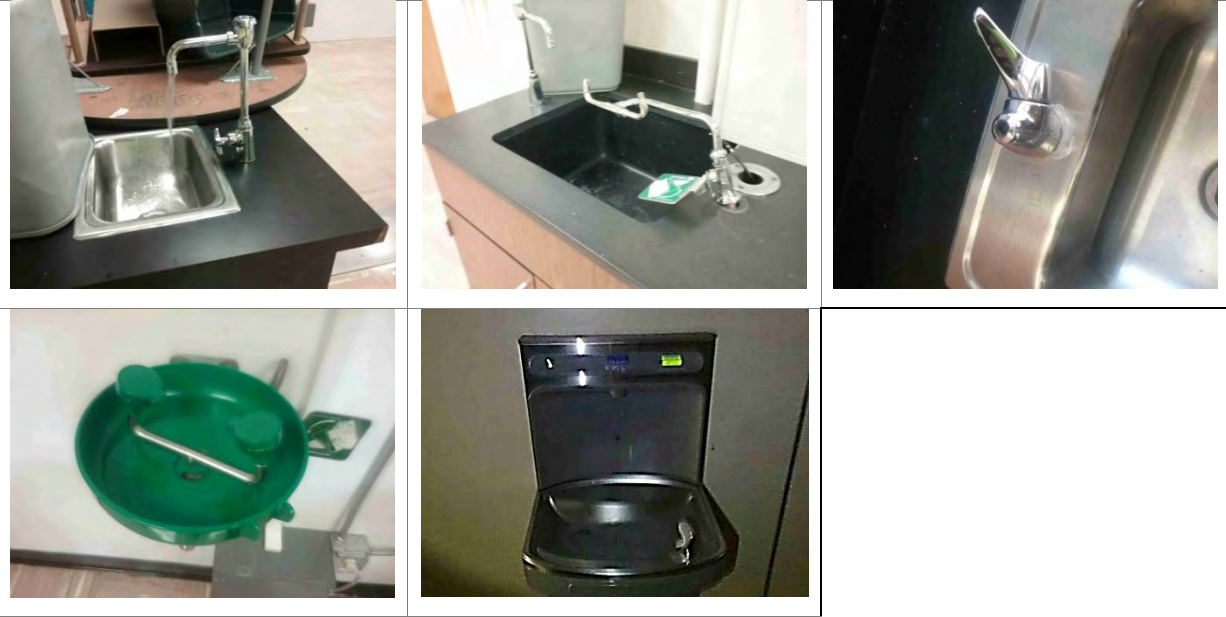
Plumbing Fixtures

System	Subsystem	Condition and Deficiency Overview	System Condition Rating
		<p>water closets with manual flush valves and predominantly vitreous china sinks. Additionally, wall-hung vitreous china urinals with manual flush valves are located in the dedicated multi-use male restrooms. Room 104 contains a full restroom with bathtub and shower combination. Some of the classrooms contain a single-basin stainless steel or resin basin sink. The science classrooms have eyewash stations. Storage rooms 117STO and 118STO contain stainless steel sinks with drinking fountains attached. Stainless steel drinking fountains and some combination drinking fountain and water bottle fill stations can be found in the corridors of the building. Multiple mop sinks are found in janitorial closets throughout the building.</p> <p>A few plumbing fixtures were observed to be showing minor signs of deterioration, corrosion and rust but still operational. The male restroom outside the library (BRRLIB) contained a trough urinal and toilets that were dirty and emitting a smell with slight corrosion observed. The urinal in the second floor male restroom BRR200E had low flow and rust on the connection. There was a leak on one of the sinks in the second floor male restroom BRR200W; additionally, the urinal trough was cracked. Corrosion was observed inside the toilet in the male restroom BRR100.</p> <p>The toilet in the nurse's restroom showed evidence of leaks. The sink in the administration restroom was clogged and not draining properly. Room 104 contained a full bathtub that was draining slowly; this restroom was noted to have frequent clogging according to facility staff.</p> <p>Room 117 has five sinks; two sinks had no flow. One of the sinks that had water flow was dripping when the faucet was turned off. The eyewash station had a leak. Room 118 has five sinks; one had no faucet. There are five sinks in room 119. Three of the five sinks were not working; two had no flow, and the third did not have a knob to turn the faucet on. The sink in room 121 had a loose faucet. Room 120 contained four sinks. The eyewash station connected to one sink was not working. Two of the sinks in room 120 were not working. A trough basin with a double-faucet sink in room 120 was working. The sink in room 219 was missing the faucet. The eyewash station in room 219 was draining slowly. The library sink appeared in good condition.</p>

System	Subsystem	Condition and Deficiency Overview	System Condition Rating
		<p>It was reported that the female restroom in the office had clogging problems. The sink was clogged and having issues draining at the time of assessment.</p> <p>There was one combination filling station and drinking fountain upstairs that appeared to be in good condition. There was also a combination drinking fountain and water bottle fill station that had flow to the drinking fountain, but the fill station did not function. The majority of mop sinks had signs of wear and tear as well as corrosion and rust at the base.</p>	
	Domestic Water Distribution	<p>There is a 40-gallon GWH (gas water heater) under the S2 stairs. It is suspected that this feeds the bathtub fixture in room 104. The GWH showed signs of corrosion and rust with leakage on the floor. Various smaller electric water heaters are located throughout the building to provide heated domestic water to specific locations in the school (i.e., 116KIT and library). Domestic hot water is not supplied to the classroom plumbing fixtures.</p> <p>The plumbing distribution equipment appeared to be in average condition with damaged insulation and corrosion and rust observed on piping throughout the building. Several sinks had corrosion and rust in the connecting piping to the sink. The administration kitchen, nurse's office, and nurse's restroom had a hot water faucet, but no hot water was observed coming to the fixtures.</p> <p>The female and male restrooms outside the library contained one sink where the hot water knob had no flow. No flow was observed to the sink when only the hot water faucet was turned on in the second floor female restroom (GRR200W).</p> <p>The sink in room 213 had evidence of a leak. Room 116 contained a sink that had its own water heater underneath it and showed evidence of leaks. The sink containing an eyewash station in room 213 had evidence of leaks and corrosion on the surrounding piping. Damaged connection plumbing was observed in GRR100. There was evidence of leaks under the sink of 118STO.</p>	Average

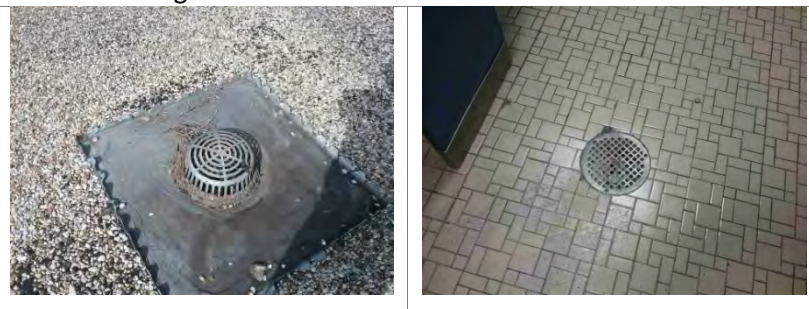
#### Other Plumbing

Other Plumbing	<p>The roof drains are equipped with metal grate covers to prevent debris from entering the drainage system, but the covers had some corrosion. Roof drains showed evidence of debris around them, which could cause the</p>	Average

System	Subsystem	Condition and Deficiency Overview	System Condition Rating
		<p>drains to become clogged.</p> <p>The ADMINWHRR and BRRLIB were emitting a sewage smell suspected to be coming from the floor drains. It was reported that there are no water line isolation valves for maintenance to the building and that the school has to be shut down for any water line repairs.</p>	
<b>Mechanical/ HVAC</b>		<p>The building's HVAC system is primarily composed of roof top packaged systems, roof top HRUs (heat recovery units), RTUs (roof top units) and chilled water FCUs (fan coiled units) fed by the boilers and chiller found in the MAINMECH room of BLDG-051B and a cooling tower. Through-wall air conditioned units and heat pump units are found throughout the building to provide heating and cooling to specific locations in the school. Multiple roof top EFs (exhaust fans) ranging in size serve the building.</p> <p>Roof top HRUs were observed to be in average condition, showing minor signs of corrosion and rust. RTUs were older and showed significant signs of corrosion and rust. The chilled water FCUs were observed to be in average condition, with some showing signs of age and wear on the insulation. The FCUs were reported to be original to the building according to facility staff. These units appeared aged and out of date. Units FC-4 and FC-5 were making a loud churning noise during operation. FC-5 was missing the shield covering the belt.</p> <p>FCU-4 was noted to have an active condensation pump on the floor, indicating excessive condensation. According to facility staff, this unit was reported to be leaking and needing excessive maintenance. There was no visible dampness observed on the ground or around the unit, but the storage basin of the pump was full of water.</p> <p>Rooms 202 and 204 were warmer than other upstairs classrooms. This could be an indication that the HVAC feeding these rooms was not working as efficiently as the others. Ceiling-mounted space heater/coolers were found in the exterior restrooms GRR100E, BRR100E, GRR200E, and BRR200E, as well as the female restroom outside the library, GRRLIB. These units were not working, and the units in BRR200E and GRRLIB had no associated thermostat and control present.</p> <p>Some of the roof vents and EFs had minor corrosion. The EF in the upstairs male restroom (BRR200W) was abnormally loud. Multiple HVAC units were using R-22 refrigerant, which is an outdated refrigerant that is being phased out of use.</p>	Average

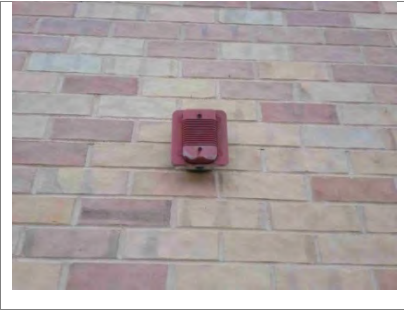
### Fire Alarm

System	Subsystem	Condition and Deficiency Overview	System Condition Rating
<b>Fire Protection</b>	Fire Alarm	<p>The building has a fire alarm system that consists of alarm and signaling devices such as horns/annunciators, strobes, horn/strobe combinations, pull stations, and detectors. The fire alarm system is controlled by the Silent Knight control panel.</p> <p>The fire alarm system appeared to be in average condition due to some of the fire alarm end devices being aged or worn, especially those located on exterior walls. Facility staff reported fire alarm system faults that need to be investigated.</p>	Average
	Fire Protection/Suppression	<p>The fire suppression system consists of fire extinguishers throughout the building. Visual assessment showed these were in average condition. The fire extinguishers in room 116KIT, CUSTSTO, and the administration area were past due on their annual inspections. Multiple fire extinguisher housings were locked so extinguishers inside could not be visually assessed.</p>	Average

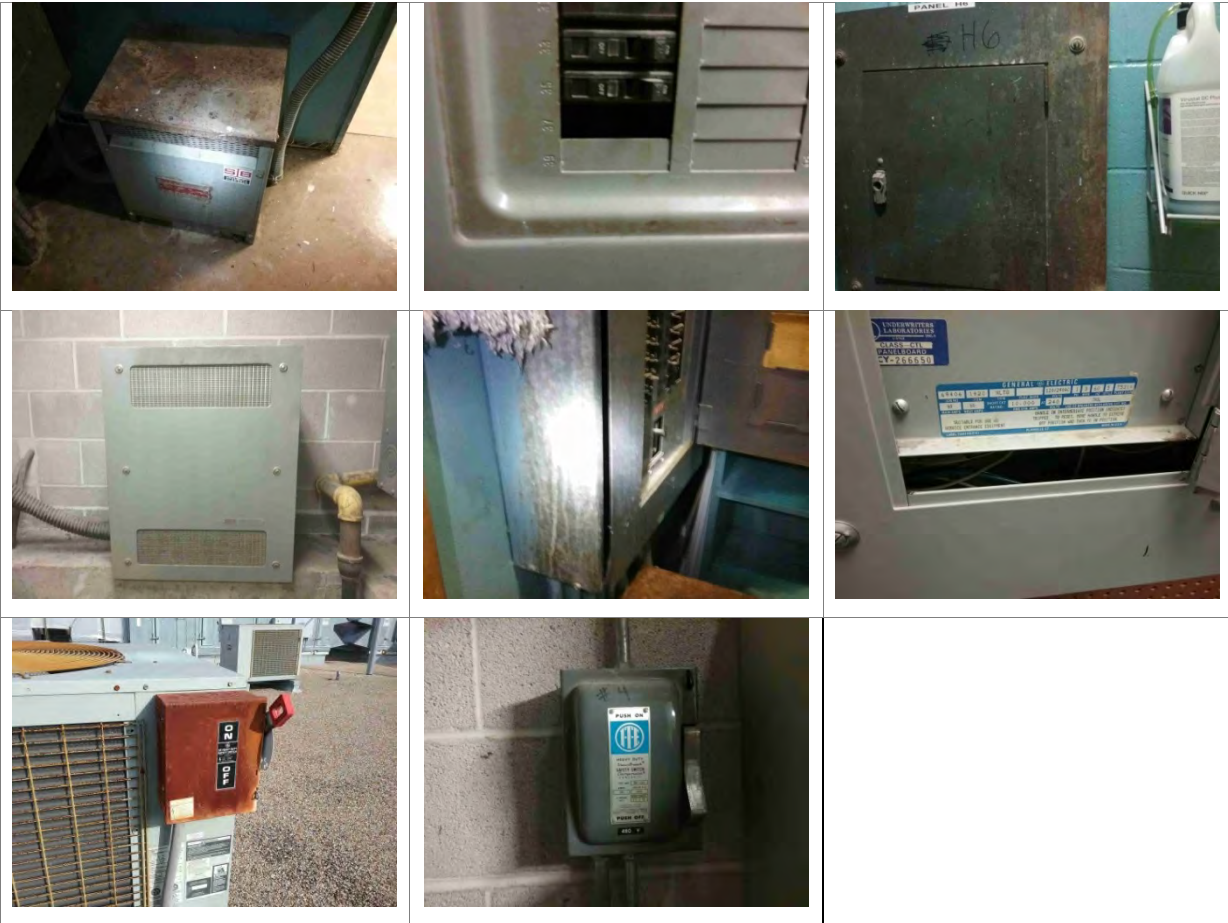
### Electrical Distribution

<b>Electrical</b>	Electrical Distribution	<p>The building's 277/480-volt electrical service is distributed with various panelboards and transformers. The service feeds transformers and high-voltage panelboards located in various rooms throughout the building. The transformers step down the voltage to 120/208-volt secondary, which feeds power to 120/208-volt panelboards and other miscellaneous equipment. The building does not have a lightning protection system.</p> <p>The electrical distribution equipment was observed to be in poor condition. The majority of the electrical distribution equipment, (e.g., panelboards, transformers, electrical shutoff switches, and controllers) are original to the building construction, although some were added in the 1990s and 2000s. The original panelboards were predominantly manufactured by ITE and were obsolete. Along with the obsolete electrical equipment, common deficiencies included missing screws from panelboard covers, missing breaker covers, corrosion, or lack of specification plates on in-wall transformers. A panelboard located in room 113 was found to have open gaps between the front cover and panel housing. Gaps, loose covers, and open breaker slots should be considered life safety hazards. Several roof top safety switches feeding HVAC equipment were found to be worn and corroded.</p>	Poor

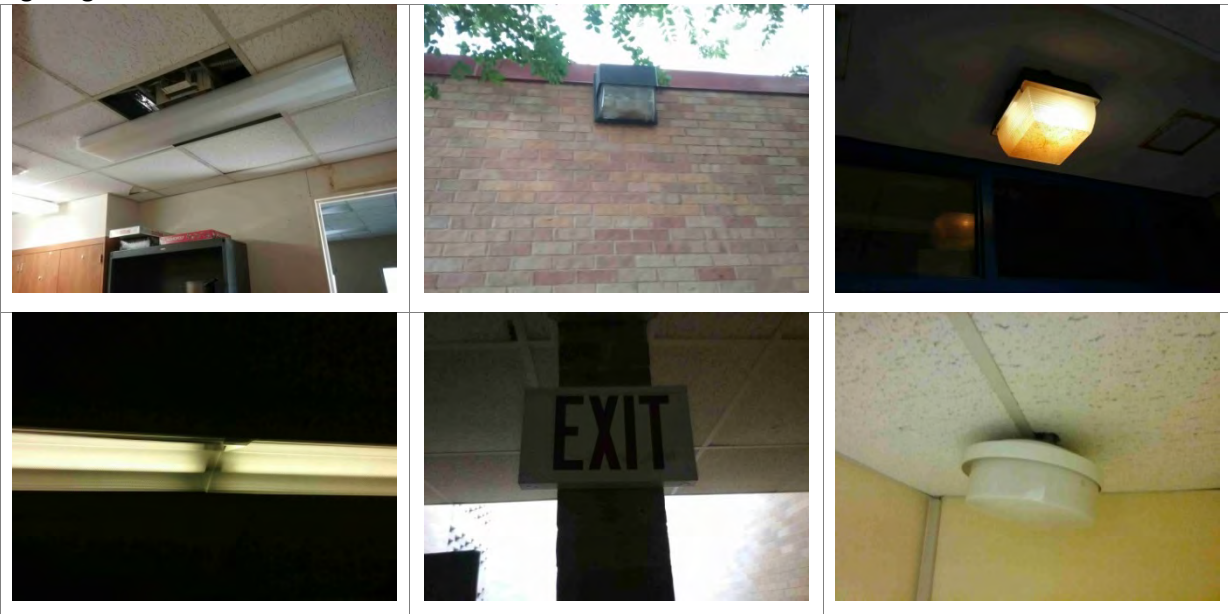
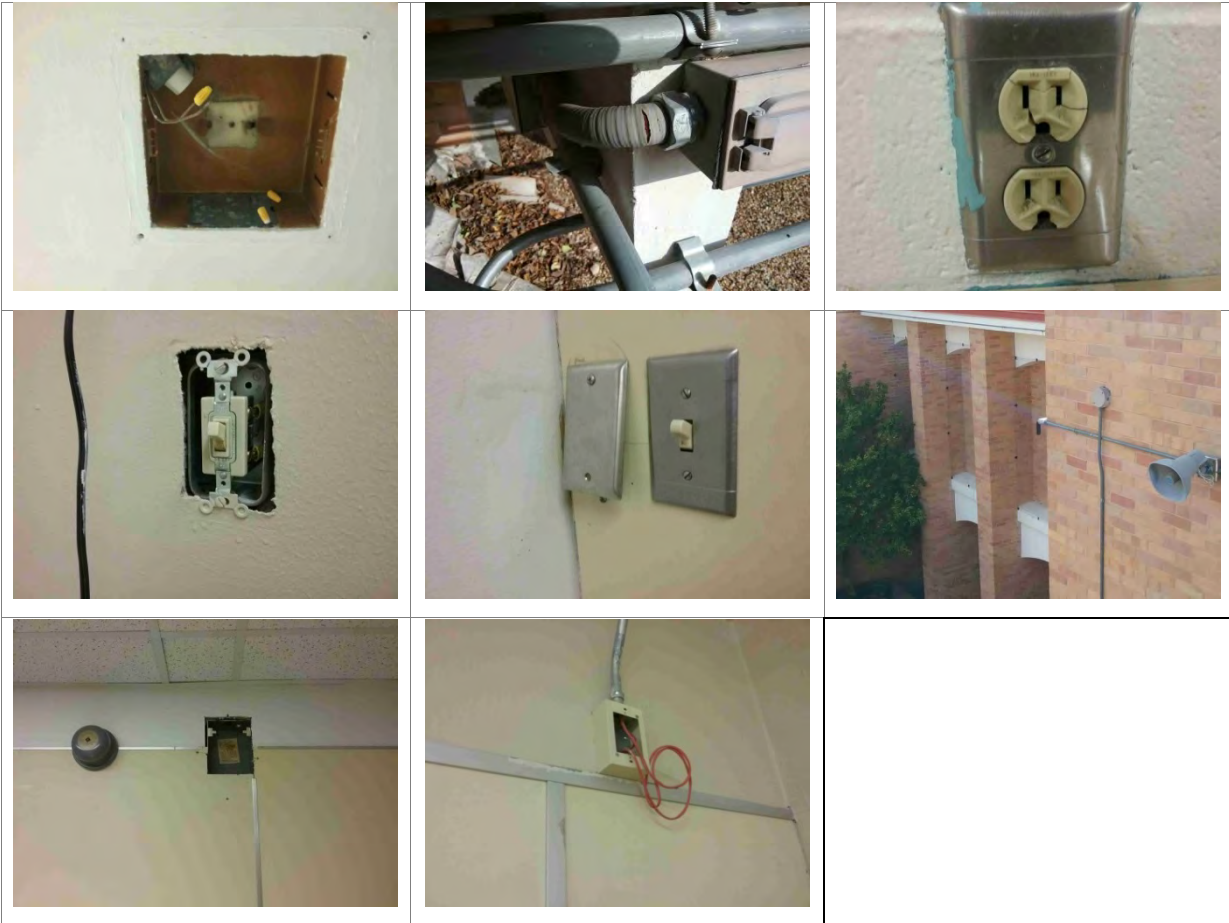
## Lighting

System	Subsystem	Condition and Deficiency Overview	System Condition Rating
	Lighting	<p>The building's exterior lighting consists of metal-halide/ high pressure sodium and LED (light-emitting diode) luminaires that are located around the building, building egress points, and on the covered walkways within the courtyard area. The interior lighting primarily consists of T8 fluorescent luminaires. It is worth noting that the building's corridor lighting was predominantly keyed-off, which prevented a complete assessment of the interior lighting.</p> <p>The lighting system appeared to be in average condition. Many interior and exterior luminaires appeared to be aged past their design service life. Observed deficiencies included broken or cracked lenses, worn/discolored lenses, and non-functional fixtures. The teacher's lounge had a loose fixture that was not properly mounted. Many of the mechanical and HVAC equipment rooms had extremely poor lighting. There were exit signs throughout the building, but some were non-functional or dim.</p> <p>There were several issues in the branch wiring, including damaged or loose conduit, missing/open junction box covers, and worn/damaged electrical receptacles. Several electrical receptacles had cracked faces with metal exposed. The laboratory classrooms also had corroded receptacles with evidence of arcing on the faceplate. These deficiencies with the electrical receptacles should be considered a life safety hazard and replaced immediately. Many of the classroom light switches were worn. Some stairwell light switches were broken or decommissioned. Facility staff reported that some incandescent bulb style fixtures were installed on the west end of the building and were constantly on. Facility staff also reported dim lighting within the building corridors.</p>	Average

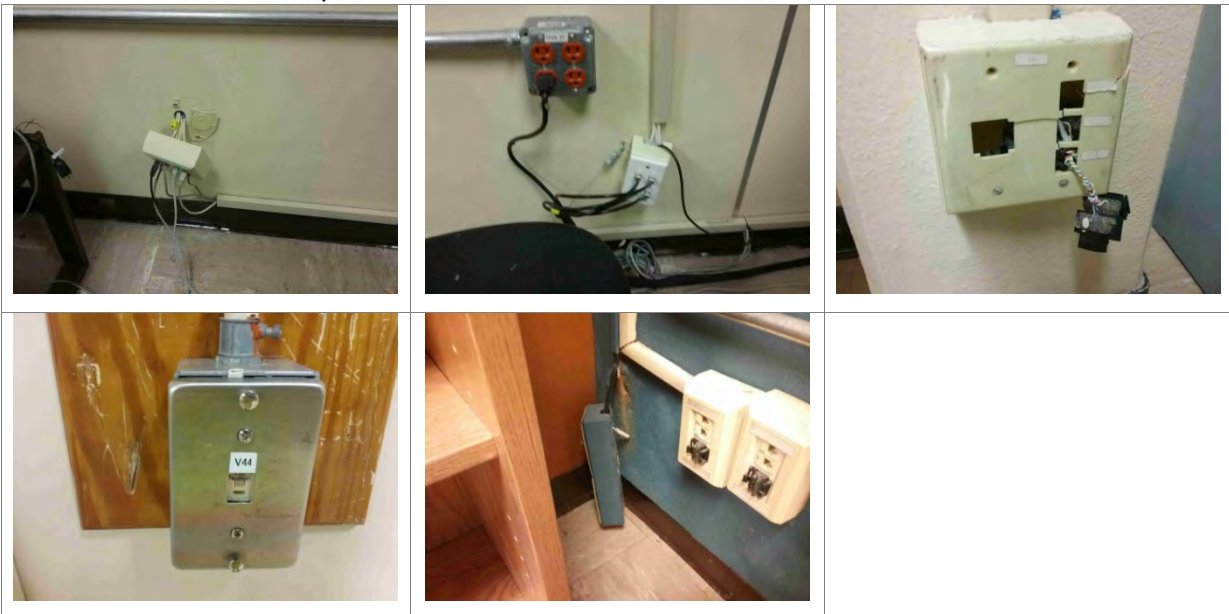
### Communications & Security

Communications & Security	<p>The building is equipped with telecommunications/cable systems, with the main backbone equipment located in various electrical and mechanical rooms. The building also has a large satellite dish mounted on the roof. Networking Wi-Fi access points are installed throughout the building. VOIP (Voice Over Internet Protocol) telephones are used for voice communications. Many classrooms had damaged or exposed telephone cabling. Remnants of 1980s Token Ring LAN networking were still present in some of the classrooms. The building security includes surveillance cameras,</p>	Average

System	Subsystem	Condition and Deficiency Overview	System Condition Rating
		<p>motion detectors, and a proximity card access system.</p> <p>The communications and security system was observed to be in average condition. According to facility staff, the surveillance cameras are inadequate for the building and provide inadequate coverage. The parking area and south side of the building were specific areas that needed surveillance improvements. Facility staff reported there were no issues with the timekeeping and intercom systems.</p>

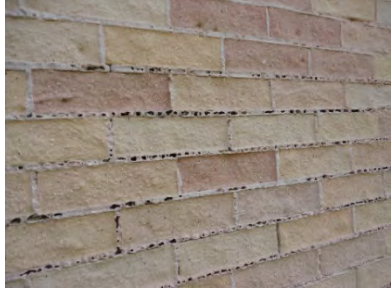
### Exterior Walls

System	Subsystem	Condition and Deficiency Overview	System Condition Rating
Exterior	Exterior Walls	<p>The exterior walls are composed of brick with concrete panels above and below the exterior windows. The band building appears to be of more recent construction than the rest of BLDG-051B. The band building has a brick facade with accent bands of brick and limestone and painted stucco surrounding the exterior main entrance and windows.</p> <p>The exterior walls appeared to be in good condition with one isolated area of mortar failure on the south side of the locker room exterior wall. A band of approximately 12 courses of brick had failing mortar midway up the wall with numerous holes. Facility staff reported pest control issues in the kitchen and 300-wing.</p>	Good
	Exterior Windows	<p>The exterior windows are aluminum-framed units with single-pane glazing. The majority of windows have metal security screens for protection. There are very few windows on the north, south and east elevations.</p> <p>The windows were observed to be in average condition due to age as most seals at the frames have deteriorated.</p>	Average

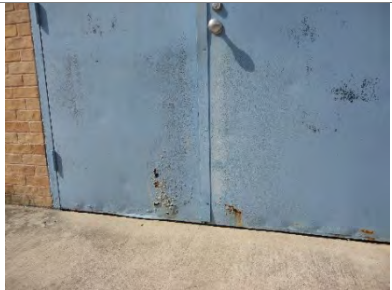
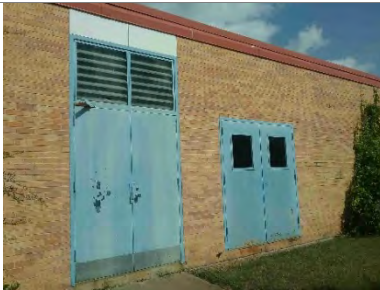
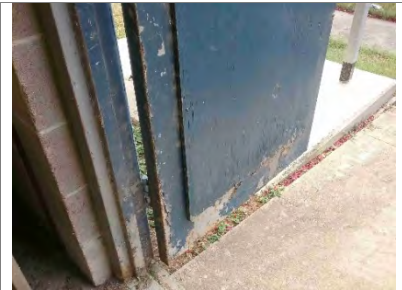
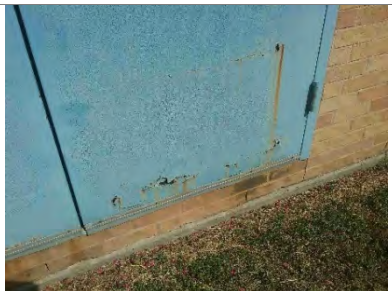
### Exterior Doors

System	Subsystem	Condition and Deficiency Overview	System Condition Rating
	Exterior Doors	<p>The exterior doors are painted metal with painted metal frames.</p> <p>The doors on the north and east sides were deteriorating due to age and corrosion. The doors from the small gymnasium and the locker rooms to the exterior did not close properly. Daylight was visible at the floor.</p>	Average
<b>Roofing</b>	<p>The main flat roof level of BLDG-051B is built-up roof covering with ballast. There are roof drains internal to the building from the flat roof. The big gymnasium, small gymnasium, and cafeteria have low slope modified bitumen roof covering and gutters and downspouts that drain to the flat roof with splash pads provided. There is roof access from the mechanical room yard and additional ladders from flat roof areas to higher sloped areas. There is no ladder to the band roof, which is pre-finished metal standing seam roofing.</p> <p>The roof was reportedly replaced ten years ago and appeared to be in good condition with minor areas where patching or repairs have occurred on the modified bitumen roof over the small gymnasium. Facility staff reported leaks over the 300-wing. Further investigation is required to determine the cause of these leaks.</p>		Good
