Means YWLA Site Summary

Address	6401 North Hampton Drive Austin, TX 78723
Number of Permanent Campus Facilities	2
Original Year of Construction	1958
Total Campus Building Area (combined)	132,760 SF

Bertha Sadler Means Young Women's Leadership Academy is located at 6401 North Hampton Drive in Austin, Texas. Originally built in 1958, the campus includes the Main School Building (BLDG-065A) and the Auditorium Building (BLDG-065B) with spaces for the band, orchestra, and choir. At the time of the assessment, it appeared that water infiltration remediation was taking place in both buildings. The buildings are connected by a covered walkway.

Main School Building – BLDG-065A

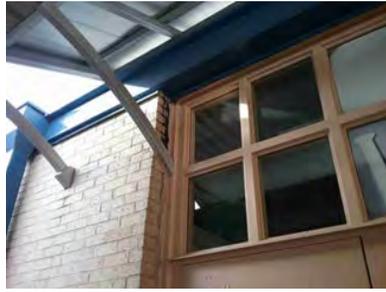
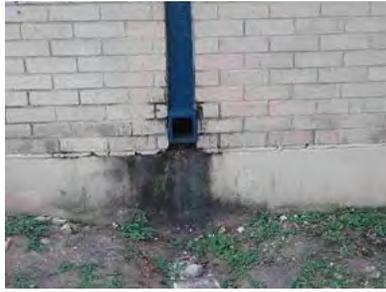
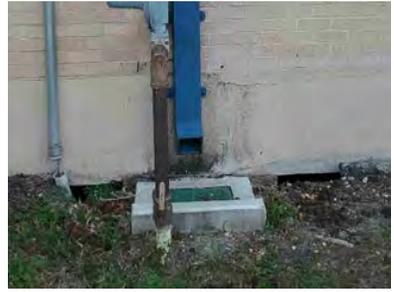
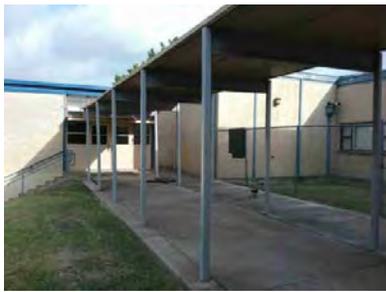
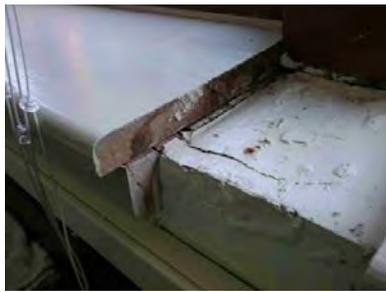
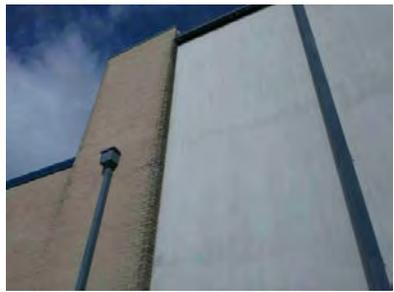
System	Subsystem	Condition and Deficiency Overview	System Condition Rating
Exterior	Exterior Walls	<p>The exterior walls are comprised of brick and metal panel. Runs of brick and panel are interrupted by exposed tube steel columns that are inset, interrupting the brick. Where they occur, downspouts are typically installed in front of the columns inside the inset formed by the interrupted brick.</p> <p>The exterior walls are in average condition. In room 115, there was a flood cut of the drywall, which means the interior of the wall was exposed for the bottom four feet. It is assumed that this is remediation from a flooding event. It was not clear if this was an exterior wall failure or a roof failure. Much of the brick at the sill and below the sill on the first floor was stained. Sealant was observed between downspouts and brick at insets. Water was noted to be leaking out from behind downspouts in two locations. It is unclear if this is for pest or water control. In multiple locations, brick was noted stained as a result of uncontrolled run-off from the roof. The foundation was undermined resulting in the canopy being out of plumb. Holes at the foundation at grade were noted and downspouts appeared to be directing water into the crawlspace from the configuration of catch basins placed at grade. Aged and failing sealants were also noted. Staff reported problems with rodents and ants inside the building. Staff also reported leaks in the exterior walls of rooms 701 and 703.</p>	Average

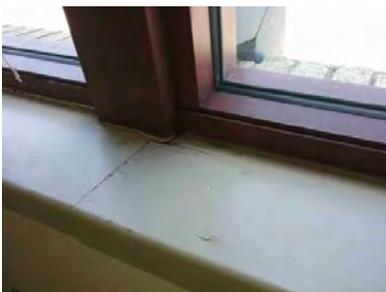
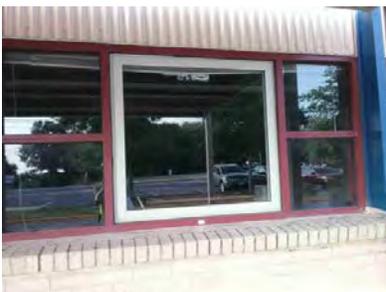
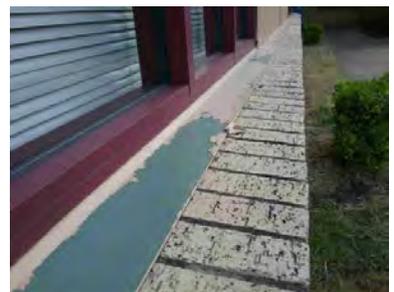
System	Subsystem	Condition and Deficiency Overview	System Condition Rating
	Exterior Windows	<p>The exterior windows are of aluminum-frame construction with single pane glazing. The windows did not appear to be original to the building.</p> <p>The exterior windows are in average condition. Water damage was observed on interior window sills. It was not clear whether this was caused by water infiltration through the brick window sill, failure of exterior joints, or failure of the window system. Many exterior window sills were warped or shifted. This is usually a sign of moisture within the cavity below. Sill flashing had been painted, and the paint system was failing. Staff reports leaks at the windows of rooms 501, 503, and 620.</p>	Average
	Exterior Doors	<p>The exterior doors are hollow metal doors set in hollow metal frames.</p> <p>The exterior doors are in poor condition. Many of the doors exhibited significant rust on the sills. In one case, the top of the door was rusting. Rusting was estimated to be present at 75% of the door panels and 50% of the frames.</p>	Poor

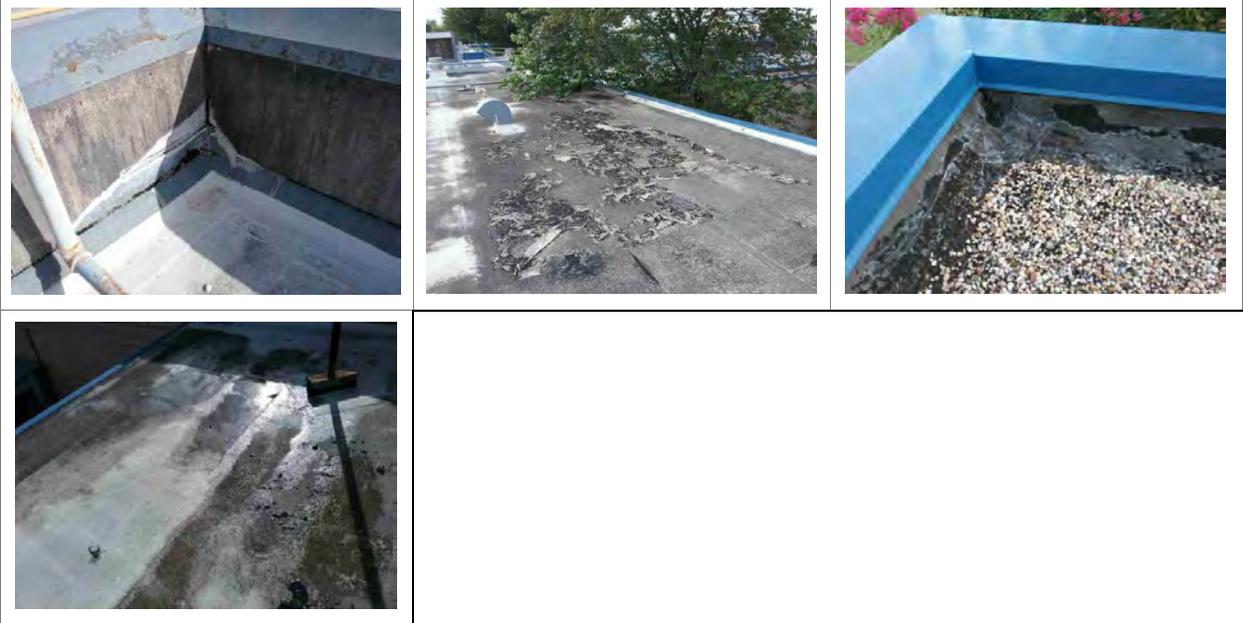
Roofing Deficiency Examples

Roofing	<p>The roof areas are covered in several different systems. Metal, single ply, built-up and modified bitumen are all present.</p> <p>The roofing systems are in poor condition. Only roof section A-13 was considered to be in good condition. Roof sections A01, A07, A10, A17 thru A19, A23, A24, and A29 are in poor condition. The remainder are in average condition. The poor rating was determined by the large number of damaged ceiling tiles observed inside of the building and the condition of the roofing systems. The roofing systems exhibited ponding, peeling, age damage, and physical damage in the form of broken parapet materials.</p>		Poor
Interior Construction	Interior Walls	<p>The walls in the classrooms are drywall on metal studs, while corridors are glazed and unglazed masonry units. The unglazed masonry is painted.</p> <p>The interior walls are in good condition. Cracks in the masonry system were noted in the kitchen. In the lower level of the 600-wing, there were two significant cracks in the masonry wall system. In the cafeteria, the wall system below the exterior windows was warping and pulling away from the structure. In the shop area the gypsum board partition at a structural beam appeared deteriorated. The gypsum board construction at the roll up door in the shop area was unsealed and uninsulated. Sealant was noted as damaged in the expansion joint at the elevator.</p>	Good

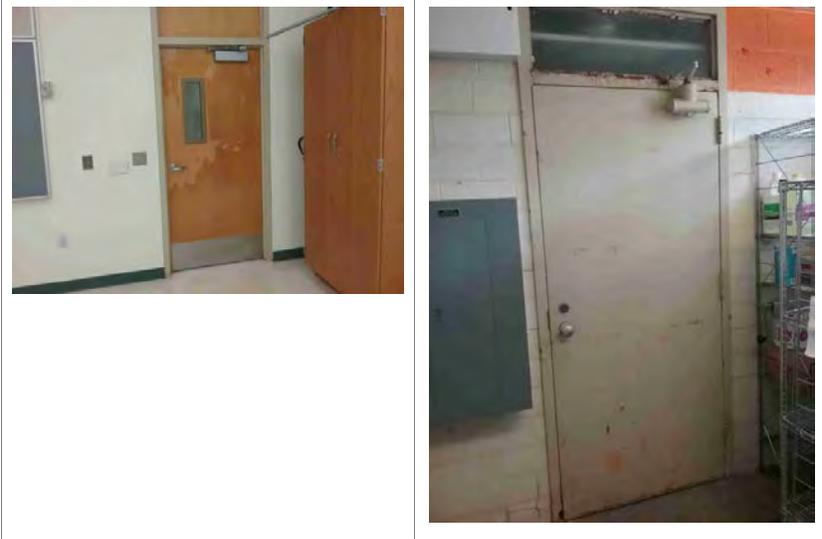
System	Subsystem	Condition and Deficiency Overview	System Condition Rating
	Interior Doors	<p>The interior doors are typically solid-core wood doors set in hollow metal frames.</p> <p>The interior doors are in average condition. Deterioration was observed to the finishes and the veneer of the doors throughout the facility. Rust was observed on one door and one door frame in the kitchen.</p>	Average
	Interior Specialties	<p>Metal lockers are located in corridors and in the locker rooms of the gymnasium.</p> <p>The lockers are in average condition. The finish system on lockers was aged or displayed wear and tear.</p>	Average
Stairs	Exterior Stairs	<p>The exterior stairs are cast-in-place concrete with pipe railings are painted or a galvanized coating. At the 600-wing, the landing of the second floor stair is supported by a steel structure.</p> <p>The exterior stairs are in poor condition. Rusting was noted on railings. One railing was observed as leaning and another as missing. Trip hazards resulting from damaged anti-slip nosing pieces and cracked concrete sections were noted.</p>	Poor

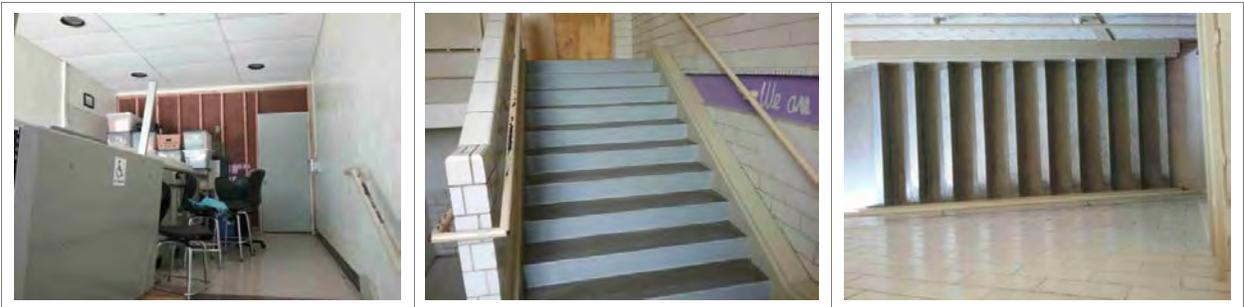
Interior Stairs	<p>The interior stairs are cast-in-place concrete with metal anti-slip nosing pieces.</p> <p>The interior stairs are in good condition. Much of the anti-slip character of the nosing had worn off, and many of the railings had chipped or worn paint. One egress stairway in the 600-wing had been closed off and was being used for storage.</p>	Good
Interior Finishes	Interior Wall Finishes	<p>The interior finishes are glazed block, painted gypsum board, and ceramic tile in the bathrooms.</p> <p>The interior wall finishes are in good condition. It has been reported that there was a significant mold issue in the basement of the 600-wing. While reviewing the classrooms and corridor in this area, surface residue was noted on the wall finishes. In some areas, the cove base was coming off of the walls. Cracking in the drywall finish system was also noted in four locations.</p>	Good
	Interior Floor Finishes	<p>The floor finish systems are VCT (vinyl composition tile), carpet, strip wood flooring in the Gyms and on the stage, ceramic tile in the bathrooms and locker areas, quarry tile in the kitchen and painted concrete in the shop.</p> <p>The interior floor finishes are in average condition. VCT was observed to be pitted and damaged throughout the</p>	Average

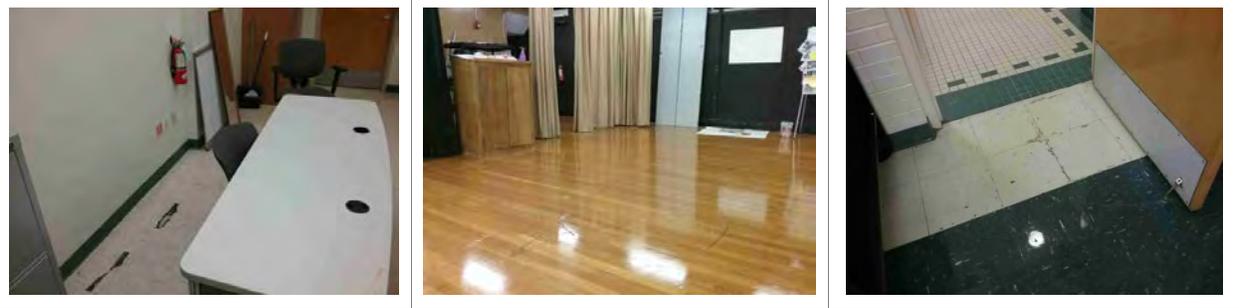
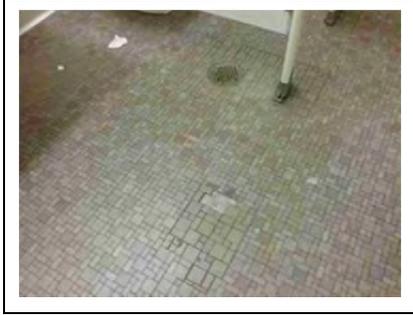
Interior Floor Finishes

System	Subsystem	Condition and Deficiency Overview	System Condition Rating
		<p>facility. In areas, the VCT was affected by substrate failure. These issues existed in newer VCT installations, such as the main entry hall, and in the older installations. The tile floors in the restrooms consistently had small patches missing. The wood flooring in the gymnasiums was in good condition. The stage had a substantive scratch in it that will require sanding to remove.</p>	
	Interior Ceiling Finishes	<p>The ceiling finishes are exposed acoustic decking at the roof system with exposed mechanical and electrical systems. 2'x4' and 1'x1' Suspended ceiling systems are installed in portions of the facility and vinyl-coated 2'x4' tiles are installed in the kitchen area. Gypsum board ceiling systems are in restrooms.</p> <p>The interior ceiling finishes are in average condition. Water damaged ceiling tiles were noted throughout the facility. The suspended ceiling system in the lower level of the 600-wing exhibited humidity damage. The 12x12 acoustical panel system was observed loose from its structure. Where chilled water lines are exposed in classrooms, discoloration was noted in the paint systems at the valve joints. It was reported by district staff that mold was generated by the failed insulation on the chilled water lines and that most of it had already been cleaned off during summer maintenance. PM Laura Gass reported that the mold/mildew has since returned due to the air conditioning being turned off in the classroom. This is an ongoing issue.</p>	Average

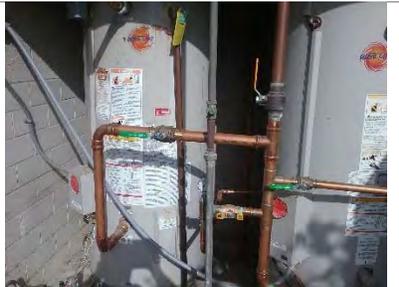
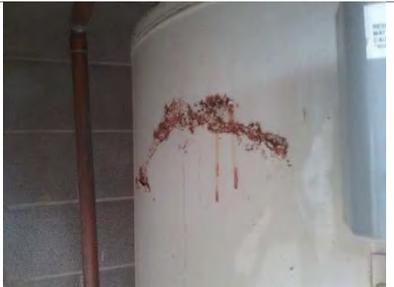
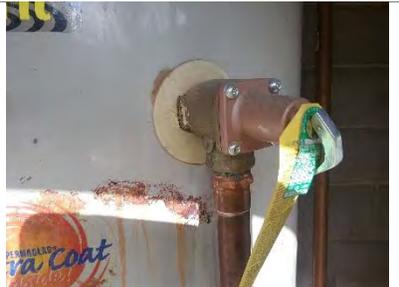
System	Subsystem	Condition and Deficiency Overview	System Condition Rating
		<p>typically aged but still operational.</p> <p>The plumbing fixtures in the specialty locations were observed to be in good condition.</p>	
	Domestic Water Distribution	<p>All of the plumbing fixtures are serviced with hot water from multiple GWHs or EWHs (gas water heaters or electric water heaters) located throughout the building. The water heaters are primarily near the cafeteria kitchen and gymnasium. EWH-1 is located in the nurse's office. It was assumed that EWH-1 serves room 102.</p> <p>The GWHs serving the kitchen area were located in a mechanical room on the kitchen dock. GWH-1 serviced the dishwasher directly, and GWH-2 serviced the rest of the kitchen equipment.</p> <p>The GWH-1 tank showed many signs of rusting through, as did many of the associated pipes and pipe fittings. GWH-2 (12 years old) did not show any signs of deterioration. Discharge and supply piping connections on the water heater showed signs of corrosion, and the isolation valve on the cold water side had a pinhole leak causing additional corrosion at its connection point. Galvanized piping was observed in the kitchen water heater room.</p> <p>The recirculation pump associated with EWH-1 had significant corrosion.</p>	Average

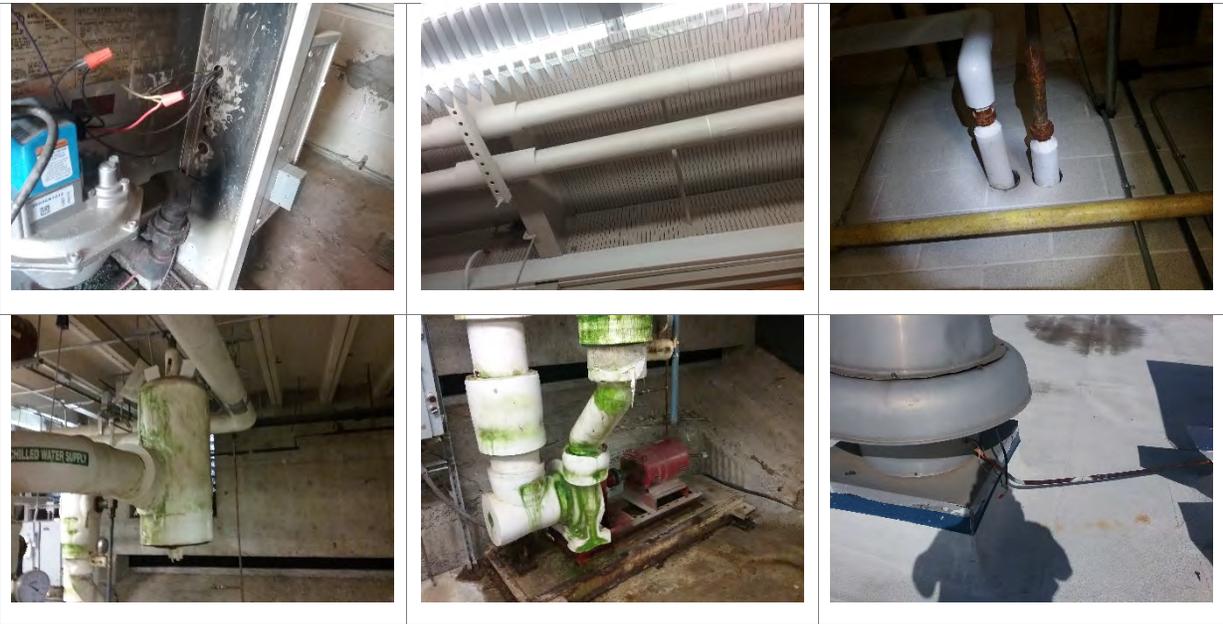
Mechanical/HVAC System Deficiency Examples

Other Plumbing	<p>The roof drains are equipped with metal grate covers to prevent debris from entering the drainage system.</p> <p>These drains were observed to be in good condition.</p>	Average
Mechanical/ HVAC		<p>The mechanical system consists of three chillers, two located in the basement mechanical room of the 600-wing, and one on the roof of the 100-wing. Each classroom is served by one or two chilled water FCUs (fan coil units) with heating coils. There are 17 packaged RTUs (roof top units) that serve the administration areas, cafeteria, kitchen, and gymnasium. Each wing is supported by its own boiler and associated pump.</p> <p>The mechanical system was in average condition. RTU-7, 9, and 12 were recently replaced in 2014. The remaining 14 RTUs were approaching or had passed their service dates. Many have had several repairs and been damaged through either vandalism or weather.</p> <p>The classroom FCUs were past their service date. They did not show any signs of failure. There were several areas in the 600-wing in which mold was found growing on chilled water piping and some walls. This item is a health and safety risk for the students and staff. The chillers in the 600-wing basement had excessive amounts of mold growing on the insulation, as well as accelerated deterioration of the insulation. The complete 600-wing was very humid and not</p>	Average

System	Subsystem	Condition and Deficiency Overview	System Condition Rating
		being controlled. In conversations with staff, the mold was identified as a perpetual item that had to be dealt with continuously. Local controls were not very responsive on a user level.	
Fire Protection	Fire Alarm	The building has a fire alarm system that consists of an alarm and signaling devices such as horns/annunciators, strobes, horn/strobe combinations, pull stations, and smoke detectors. It was reported by staff that room 520 did not have a fire alarm device. The fire alarm system was observed to be in good condition with no deficiencies to report.	Good
	Fire Protection/Suppression	The building does not have a fire suppression system. The building is protected by portable fire extinguishers placed throughout the facility. All observed portable fire extinguishers had inspection tags dated within the last year as required.	N/A

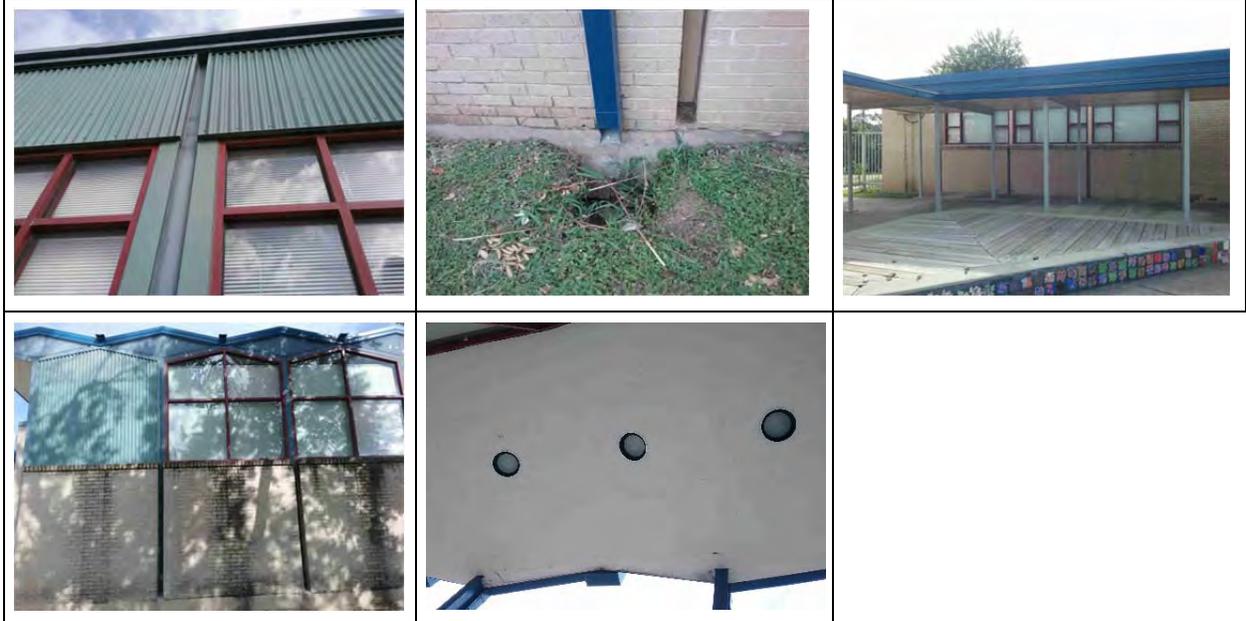
System	Subsystem	Condition and Deficiency Overview	System Condition Rating
Exterior	Exterior Walls	<p>The exterior walls are comprised of brick and metal panel. Runs of brick and panel are interrupted by exposed tube steel columns.</p> <p>The exterior walls are in average condition. Deficiencies noted were water staining as a result of uncontrolled run-off from the roof, downspouts directing water into the crawlspace through holes in the ground at the foundation, and failure of sealants. The underside of the extension of the roof at the main entry was noted to be stained and damaged. While assessing the exterior walls, drainage issues were noted on the tennis courts.</p>	Average
	Exterior Windows	<p>The exterior windows are aluminum frame construction with clear glazing. Windows do not appear to be original to the building.</p> <p>The exterior windows were in good condition. Interior sill of the exterior windows was observed with minor warping or shifting.</p>	Good

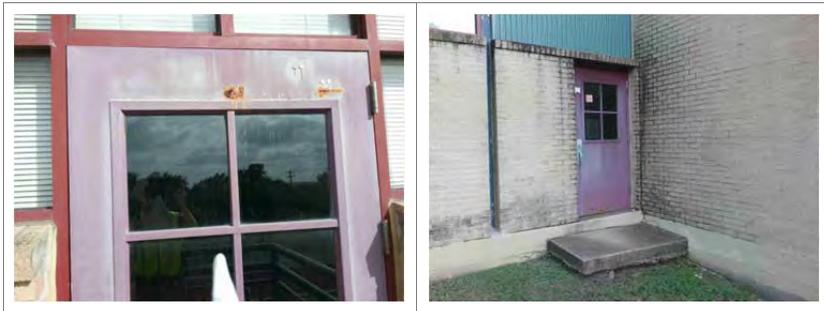
Exterior Doors	<p>The exterior doors are hollow metal doors set in hollow metal frames.</p> <p>The exterior doors are in poor condition. Doors exhibited significant rust on the sills.</p>	Poor
Roofing	<p>The roofing system is inaccessible due to the lack of roof access.</p> <p>The roof was rated as poor due to the damage observed on the interior of the building. This included the flood remediation taking place and the ceiling tile damage at the band storage rooms.</p>		Poor

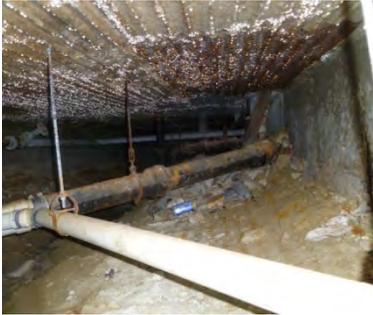
<p>Condensation on underside of slab</p>

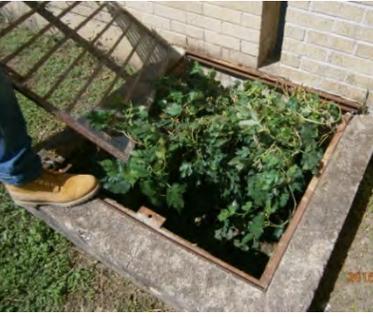
<p>Inaccessible crawl space due to vegetation</p>

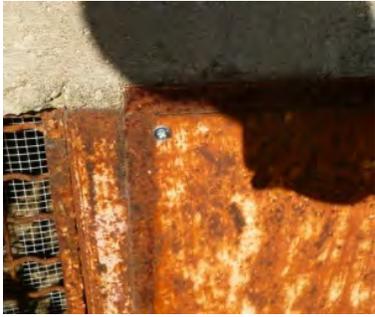
<p>Inaccessible crawl space – hatch door screwed closed</p>

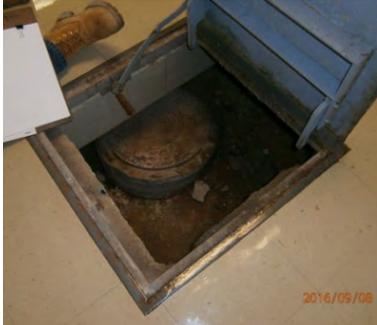
<p>Inaccessible crawl space due to low clearance</p>

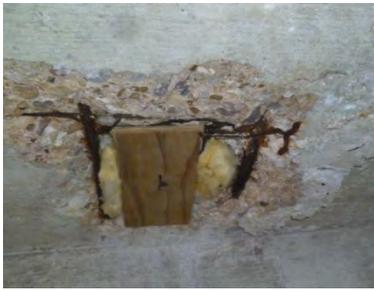
<p>Slab damage at abandoned penetration, exposed/corroded reinforcing</p>

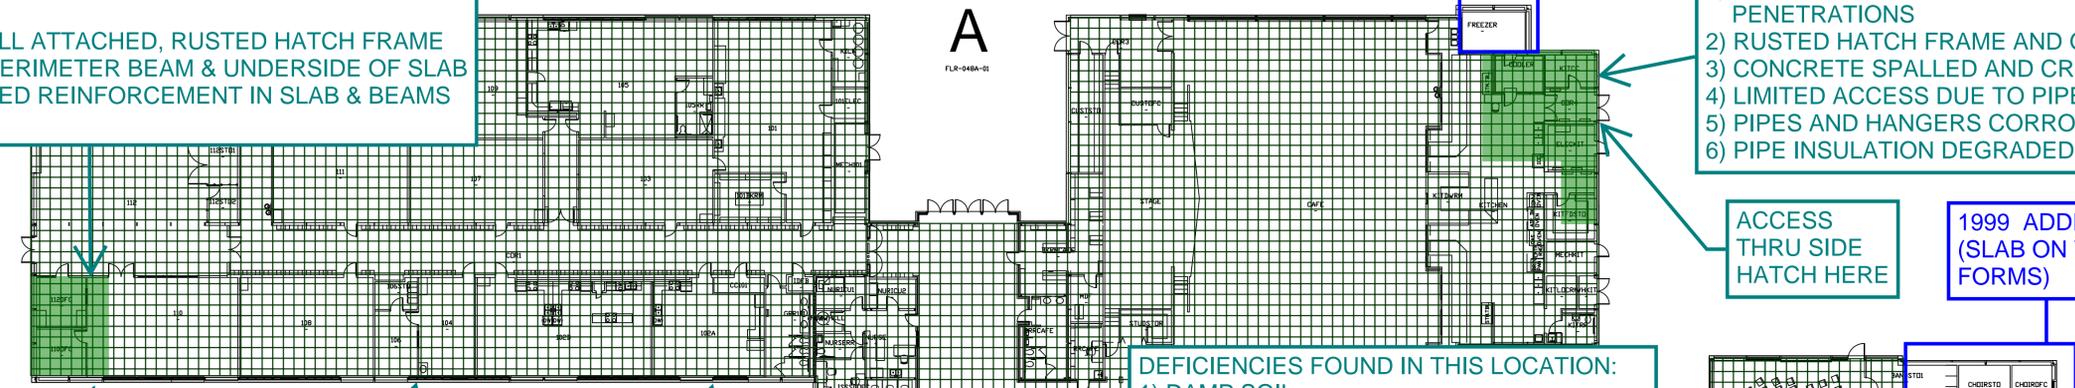
1999 ADDITION
(SLAB ON VOID FORMS)

DEFICIENCIES FOUND IN THIS LOCATION:
 1) MINOR SPALLING AT SLAB UNDERSIDE AND DAMAGE AT PIPE PENETRATIONS
 2) RUSTED HATCH FRAME AND GRATE
 3) CONCRETE SPALLED AND CRACKED NEAR HATCH
 4) LIMITED ACCESS DUE TO PIPE CONGESTION
 5) PIPES AND HANGERS CORRODED
 6) PIPE INSULATION DEGRADED AND MISSING

AREAWAY GRATE JAMMED SHUT; INACCESSIBLE

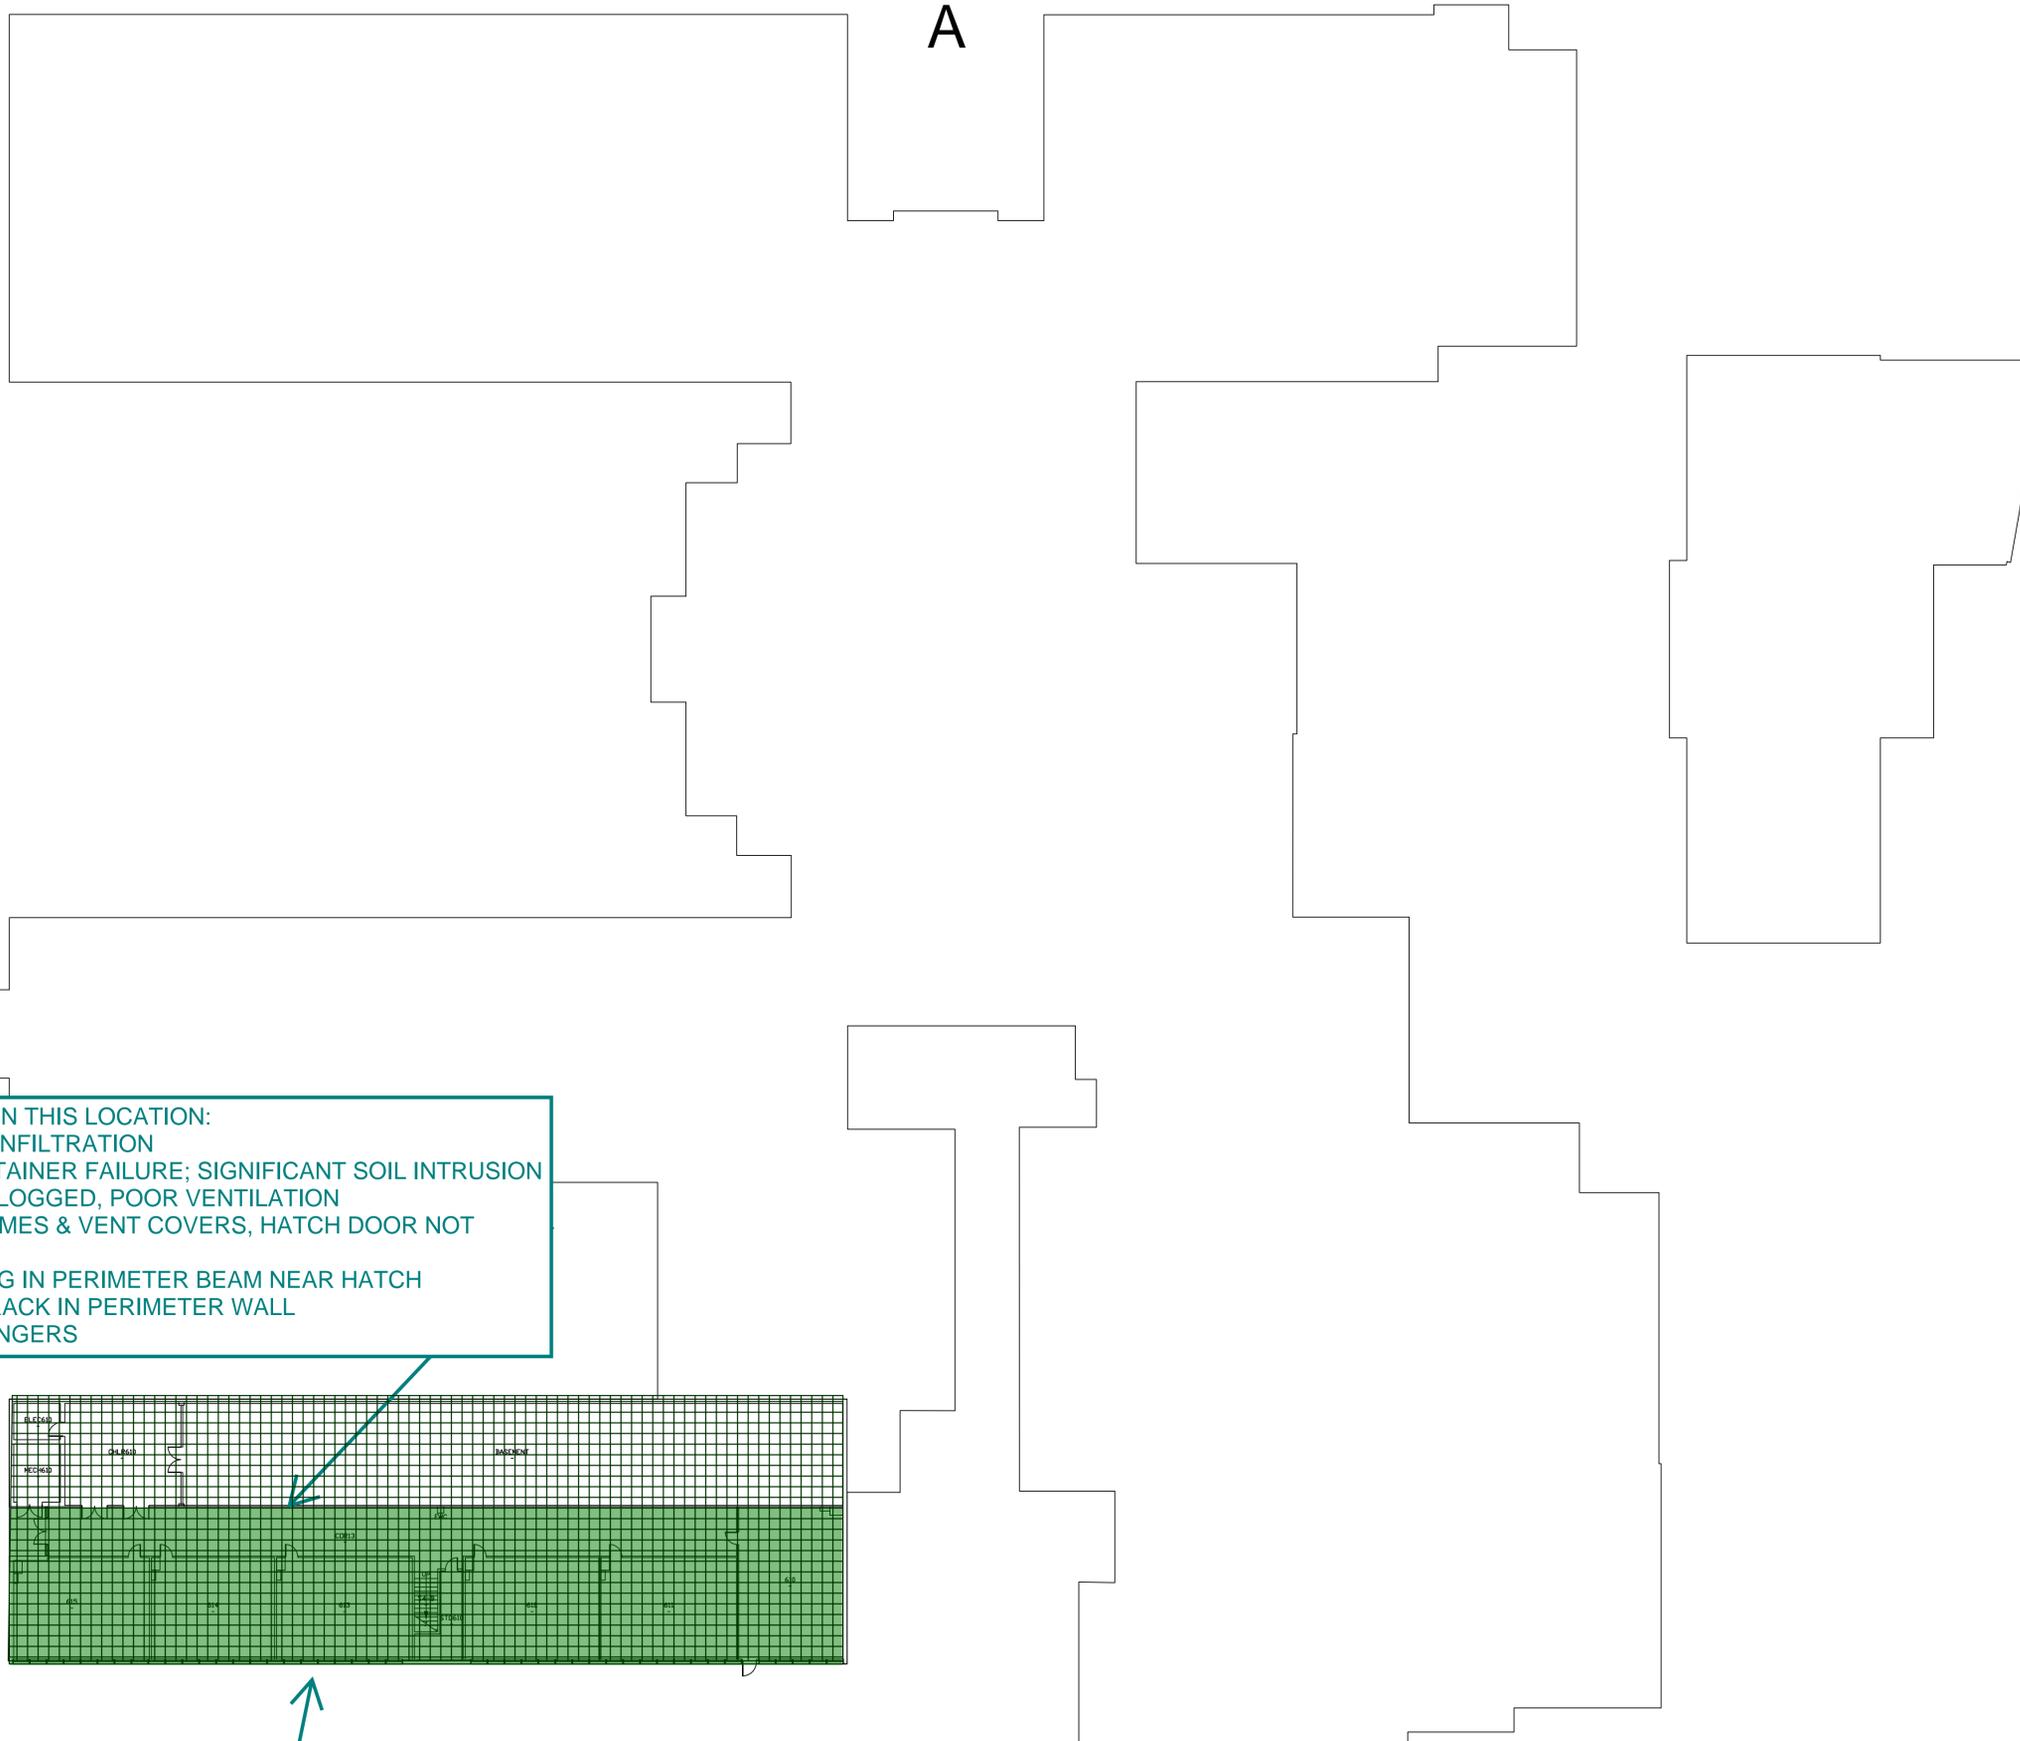
**FLOOR PLAN
 1ST FLOOR**

DEFICIENCIES FOUND IN THIS LOCATION:
 1) DAMP SOIL, WATER INFILTRATION
 2) EXTENSIVE SOIL RETAINER FAILURE; SIGNIFICANT SOIL INTRUSION
 2) VENTS PARTIALLY CLOGGED, POOR VENTILATION
 3) RUSTED HATCH FRAMES & VENT COVERS, HATCH DOOR NOT WELL ATTACHED
 4) MODERATE SPALLING IN PERIMETER BEAM NEAR HATCH
 5) LARGE VERTICAL CRACK IN PERIMETER WALL
 6) RUSTED PIPES & HANGERS

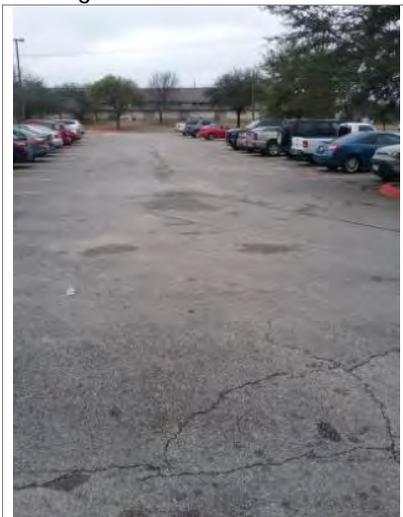
P1: Pothole at end of patch

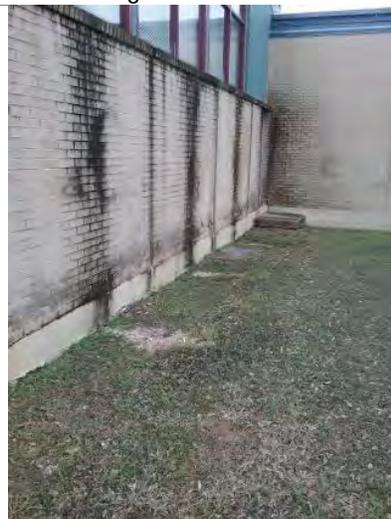
Gutters required on east wall of band building

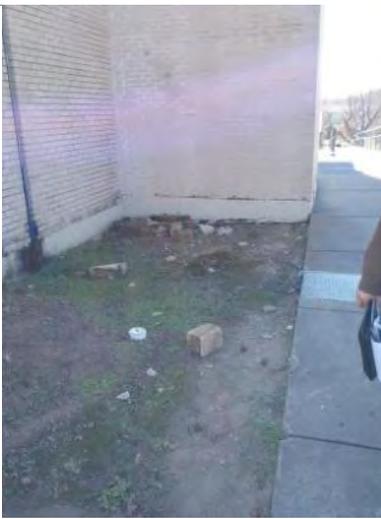
Demolished flume leading away from building

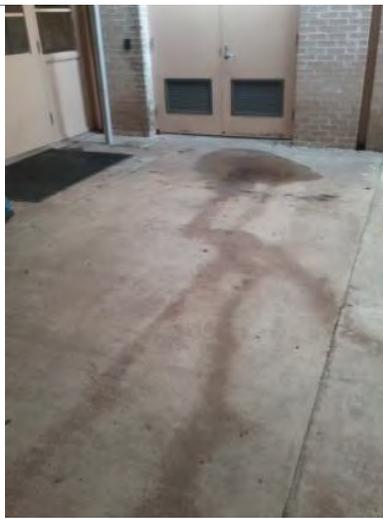
Ponding water in covered passageway between gym and "500" building

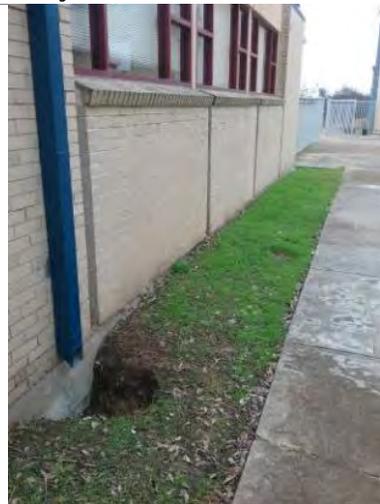
Erosion under downspout in courtyard

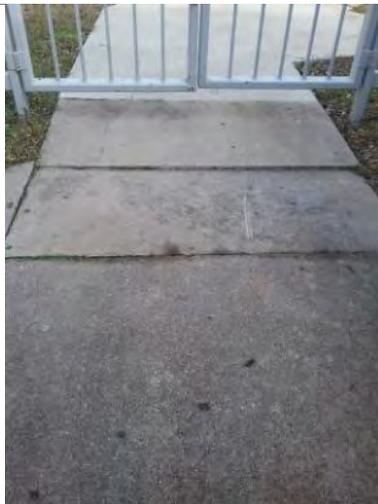
Un-level sidewalk leading out north gate of courtyard

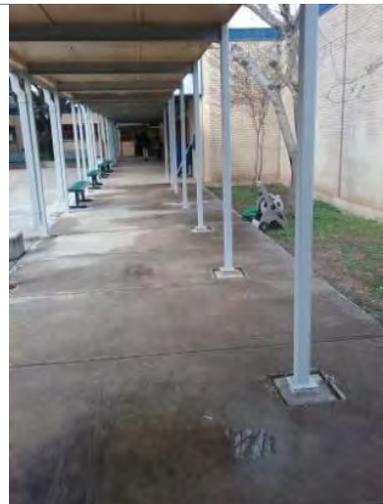
Poor drainage reported at sidewalk on north side of courtyard

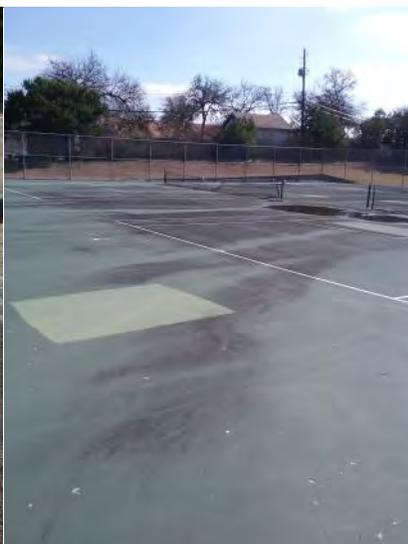
Severe ponding

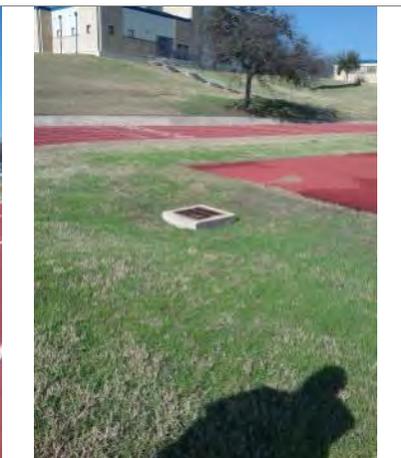
Storm drain above ground level

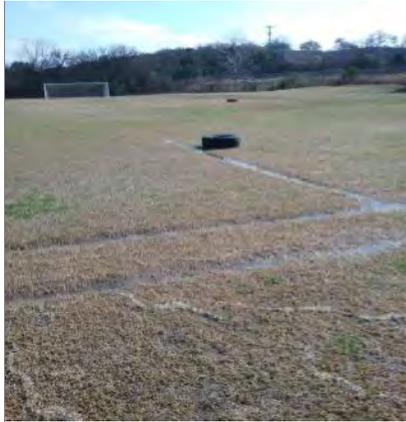
Ponding on soccer field

1. Drainage study required to prevent ponding on Soccer Field due to low elevation on site. High-volume area inlet in vicinity of field.
2. Re-sod and re-stripe field.
3. Replace / Repair Kickball fences.
