Mendez Middle School Site Summary

Main School Building – BLDG-058A

South Addition/Theater Building – BLDG-058B

West Addition Building – BLDG-058C

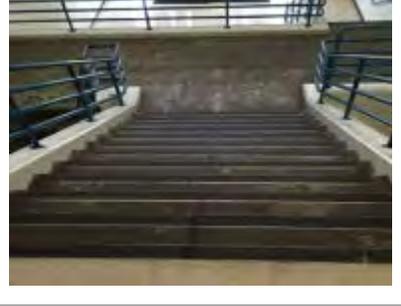
System	Subsystem	Condition and Deficiency Overview	System Condition Rating
	According to AISD staff, a complete roof replacement project has been funded for the Mendez MS buildings. The project is currently under design and could possibly be executed in the summer of 2017.		
Interior Construction	Interior Walls	The first and second wall finishes are comprised of concrete masonry unit (CMU) walls or gypsum walls. The gymnasium areas have CMU walls. The interior construction was observed to be in good condition, with isolated areas in need of repair.	Good
	Interior Doors	The majority of the interior doors were wood with metal frames. Select wood doors show extensive wear and tear.	Average
	Interior Specialties	The metal lockers appeared to be in average condition.	Average
Stairs	Exterior Stairs	System not present.	N/A
	Interior Stairs	All stairs and landings are concrete. All stairs and landings were aged and stained.	Poor

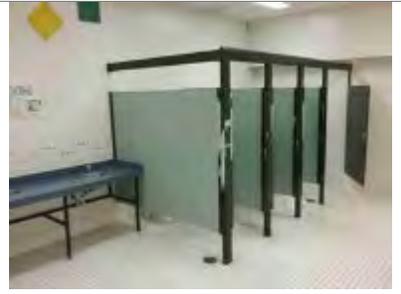
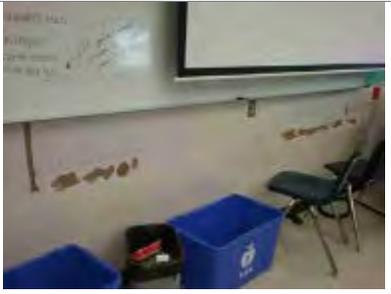
Interior Finishes	Interior Wall Finishes	The female locker room has ceramic tile walls. The female locker room ceramic tile walls were observed to be in average condition showing signs of wear and use. The interior painting in some of the classrooms and corridors appeared to be chipped and flaking.	Average
	Interior Floor Finishes	The first and second floor finishes are comprised of vinyl composition tile (VCT) flooring. The gymnasium areas have wood flooring. The female locker room has ceramic tile flooring. The female locker room flooring was observed to be in average condition showing signs of wear and use. Floor staining and a strong odor were observed in the chemistry closet on the first floor.	Average
	Interior Ceiling Finishes	The first and second floor ceiling finishes are comprised of acoustical ceiling tile (ACT). The gymnasium areas have exposed ceiling to the above structure. There was an active leak and water damage observed in the male locker room shower area. Various areas of stained ceiling tile were observed due to active roof leaks.	Average

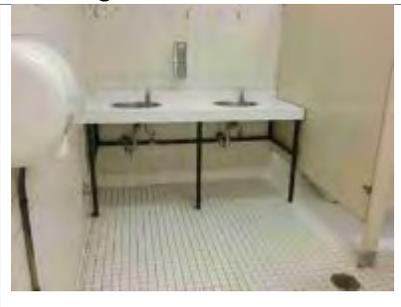
Plumbing Fixtures

System	Subsystem	Condition and Deficiency Overview	System Condition Rating
		<p>single occupant restrooms in the Health Services and in Administration offices. The school has male and female locker rooms to support athletics and the physical education department. The typical toilet and urinals fixtures throughout the facility are vitreous china with manual flush valves while the sinks are stainless steel with manual faucets. The locker rooms also have single and multi-occupant showers. The single occupant showers have manual controls, and the multi-occupant stainless steel shower terminals have push button "timed" controls. The kitchen has wall mounted vitreous china sinks for personal use and stainless steel kitchen equipment throughout including one, two, and three basing dish/prep sinks. The student lab rooms and faculty break rooms have molded in-counter sinks with manual faucets.</p> <p>Facility-wide, the plumbing fixtures are in average condition with typical wear and tear associated with the age of the system and general everyday use. The wall mounted sink in the health office is separating from the wall.</p>

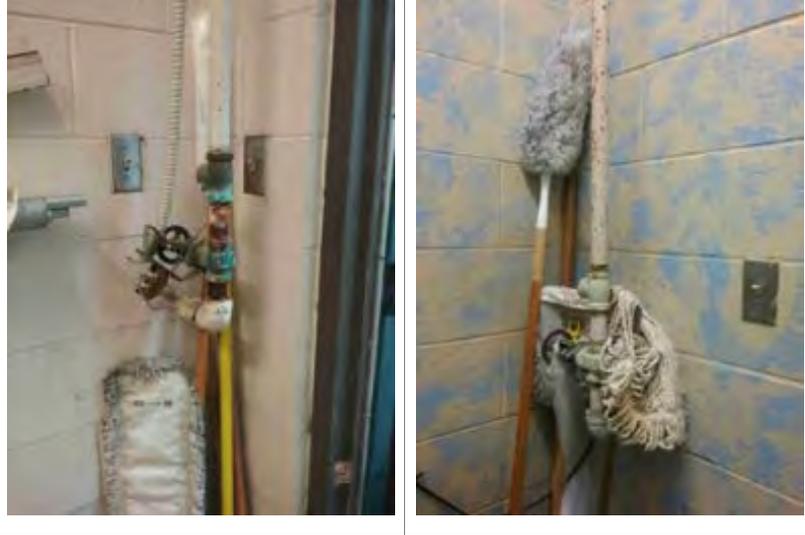
Fire Protection/Suppression

<p>Fire Protection/ Suppression</p>	<p>The building has a wet pipe fire sprinkler system serving the janitors closets and laboratory spaces. Portable dry chemical fire extinguishers are used for fire protection throughout the rest of the school. The kitchen has a dedicated chemical fire suppression system for the exhaust hoods designed for grease fires.</p> <p>The fire protection system is in average condition. The observed fire extinguishers have up-to-date inspection tags and the chemical fire suppression system in the kitchen is in proper working order. However, a majority of the observed wet pipe fire sprinkler system's piping has surface corrosion, which could affect the systems reliability.</p>	<p>Average</p>
<p>Electrical</p>	<p>Electrical Distribution</p>	<p>The building's electrical service originates in a locked room, maintained by the utility provider, adjacent to the building's main electrical room. A bus bar comes through the wall of the main electrical room and feeds the building's main 5000-amp switchboard. The switchboard has seven sections with one section for metering and six sections with fuse switches. Each fused switch feeds one of the main distribution panels throughout the campus. There are six electrical distribution areas inside the main building, two on the first floor, two on the second floor, one between the large and small gymnasiums, and one in the kitchen. Panel MD10 adjacent to the switchboard, has an outdoor power factor correction capacitor bank.</p> <p>The building's electrical service distribution is well maintained and in good condition. Minor deficiencies were observed throughout the building, such as open</p>	<p>Good</p>

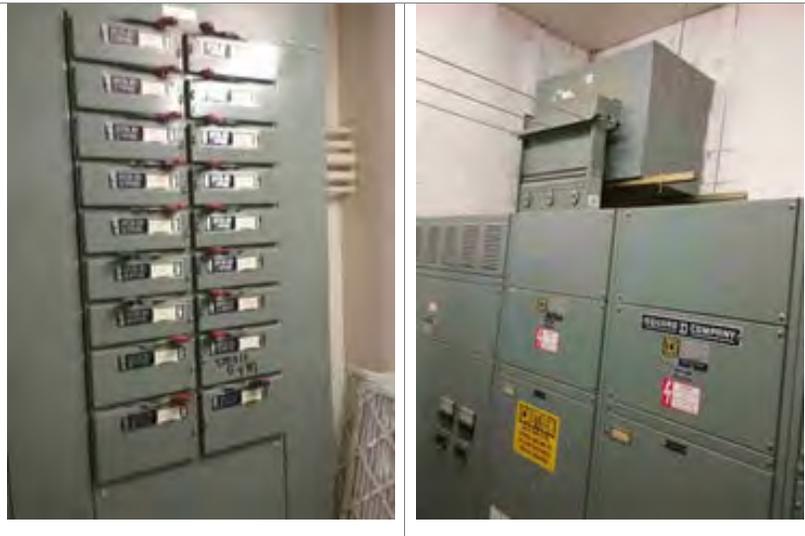
Electrical Distribution

System	Subsystem	Condition and Deficiency Overview	System Condition Rating
		<p>junction boxes with exposed wiring. In addition, the building staff reported issues with tripping breakers in the administration area along with insufficient power capacity in the cafeteria.</p>	
	Lighting	<p>The interior lighting throughout the main school is predominantly T8 fluorescent fixtures. Most corridors, offices, and classrooms had two foot by four foot lensed troffers. Emergency and exit lighting is located throughout the building. The main building exterior lighting consists of HID wall pack fixtures. PM Florence Rice reported the majority of interior lighting within the corridor are LED (light-emitting diode) luminaires.</p> <p>Common issues with the lighting were broken or missing covers and lamps that were either missing or inoperable. The exterior lighting of the main school and covered canopies is aged and inadequate. Many of the fixtures have degraded and broken lenses. Some fixtures under the canopies are beginning to separate and detach from their soffits. Areas on the southwest and east facades do not have exterior lights.</p>	Poor

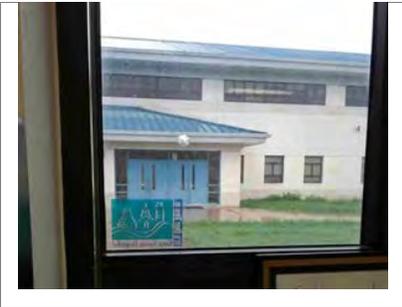
System	Subsystem	Condition and Deficiency Overview	System Condition Rating
Exterior	Exterior Walls	The exterior consists of limestone panels. The limestone panels appear to be soiled in various locations while the joints between the limestone panels are dried, deteriorated, and missing in areas. A large hole was observed at grade along the exterior foundation wall of the south façade of the building, possibly caused by soil erosion and poor water drainage. The exterior concrete patio slab located at the east façade of the building was observed to be cracked. The joint between the patio slab and building slab was observed to be deteriorated.	Average
	Exterior Windows	The windows are metal framed with single pane glazing. The windows are in average condition. The glazing was scratched and cloudy in some areas obscuring view to the exterior. Some glazing units have BB gun damage/holes.	Average

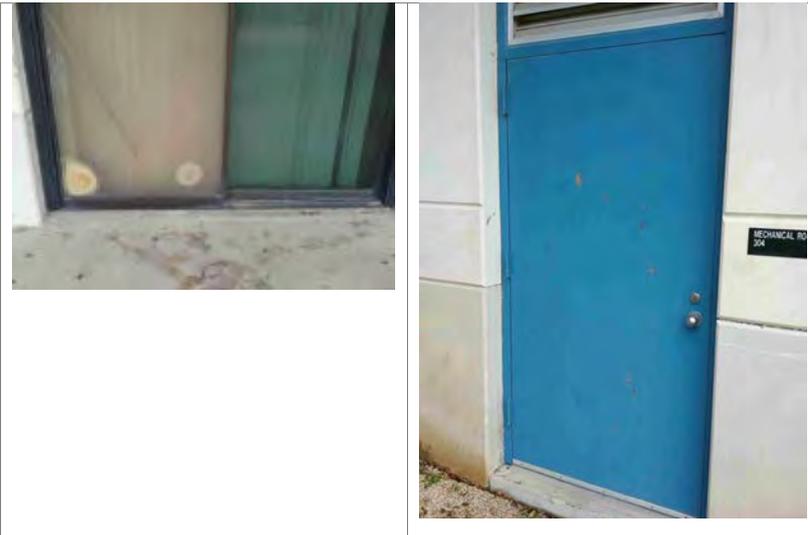
Exterior Doors	The exterior doors are metal doors with metal frames. There is a secure main entry located along the west elevation. The entry doors and remaining service doors around the facility are metal. There is a set of sliding patio doors located at the northeast corner of the building. The exterior service doors are steel and in average condition. Exterior sliding patio doors are in poor condition as the doors do not slide or function well in the frame and track. The polycarbonate glazing in the doors is broken and cloudy, obscuring view to the exterior.	Average

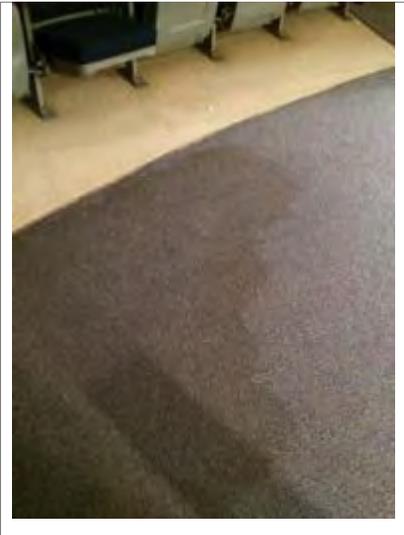
Interior Floor Finishes	The interior floor finishes are comprised of vinyl composition tile (VCT) flooring. The restroom has tile flooring. The floor of the theater is carpeted. The VCT flooring was in good condition. The restroom tile floors are aged and in average condition. AISD staff reported that the restrooms will be renovated in the near future under a funded design project. The carpet in the theater is in poor condition in some areas due to wear and water damage.	Average
	Interior Ceiling Finishes	The interior has acoustical ceiling tile (ACT). The theater has a gypsum ceiling. The ACT was generally in good condition.	Good
Conveying	System not present.		N/A

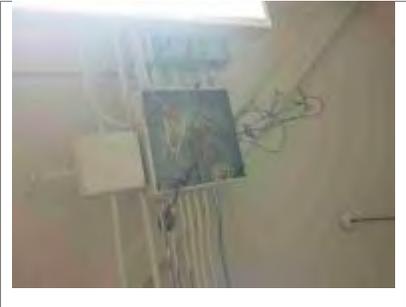
Electrical Distribution

System	Subsystem	Condition and Deficiency Overview	System Condition Rating
		<p>The fire protection system is in good condition with minimal signs of wear and tear and no visible deficiencies. The observed fire extinguishers have up-to-date inspection tags supporting the observation of proper system maintenance. Additionally, the sprinkler system has been inspected within the last year and a five-year internal valve inspection was performed in June 2015.</p>	
<p>Electrical</p>	<p>Electrical Distribution</p>	<p>The South Addition/Theater's electrical system is fed from the main school to a main switchboard (DP1) in electrical room 309B. There are various other distribution panels fed from this switchboard within the building.</p> <p>The building's electrical distribution system is in good condition. However, there is a large junction box in the storage room with no cover leaving many wires exposed. No other major deficiencies were observed.</p>	<p>Good</p>

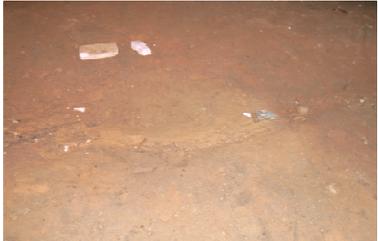
<p>Evidence of soil erosion in crawl space due to failed retainer panels</p>

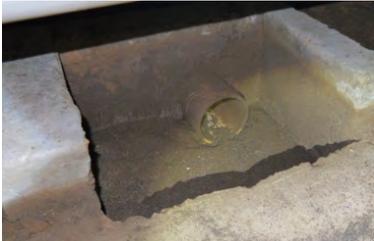
<p>Sump pit filled with soil & inoperable</p>

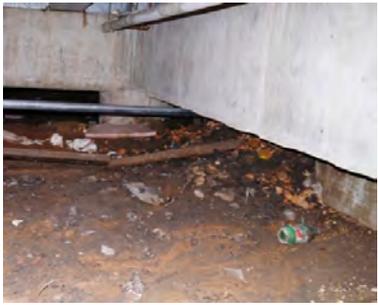
<p>Soil Retainers removed to accommodate pipe</p>

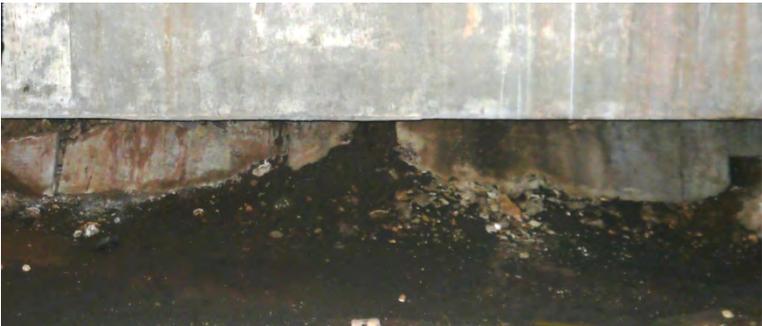
<p>Undermined soil retaining panels</p>

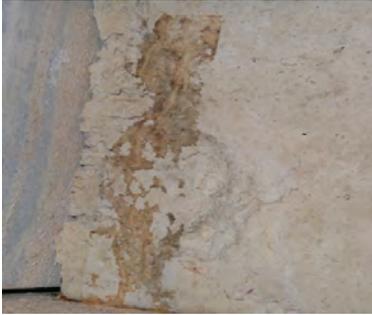
<p>Honeycombing at end of double tee</p>

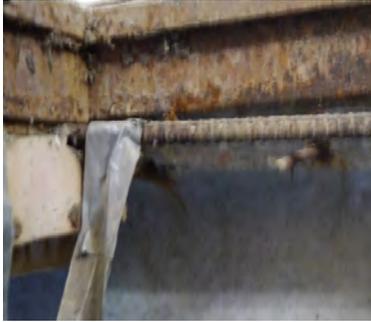
<p>Exposed rebar at crawl space access hatch</p>
----------------------------------------------------------------------------------------------------------------------------------------	----------------------------------------------------------------------------------------------------------------------------	--------------------------------------------------------------------------------------------------------------------------------------

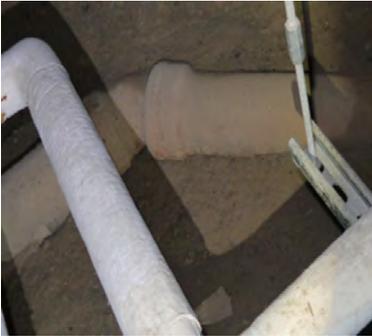
<p>Pipe bearing on soil instead of being suspended</p>

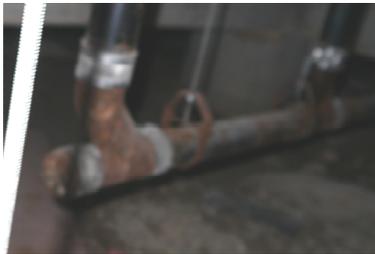
<p>Rusted cast iron pipe</p>

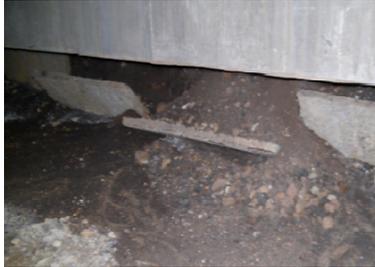
Overturned soil retaining panels

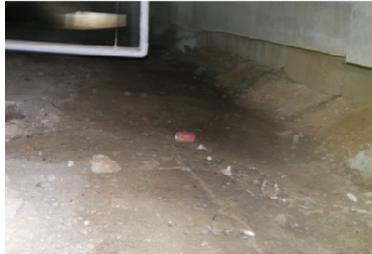
Moist/saturated soil around perimeter of building

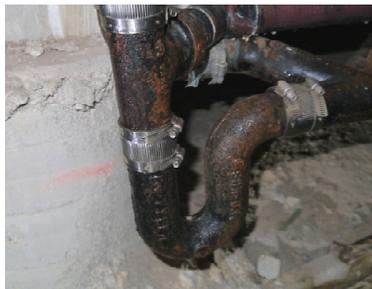
Rusted cast iron pipe

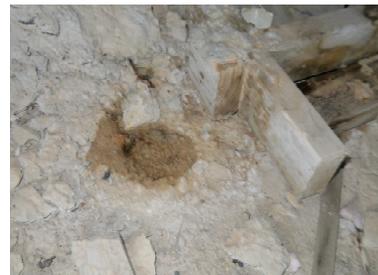
Minor leak from rusted pipe
