Murchison Middle School Site Summary

Introduction

Main School Building – BLDG-052A

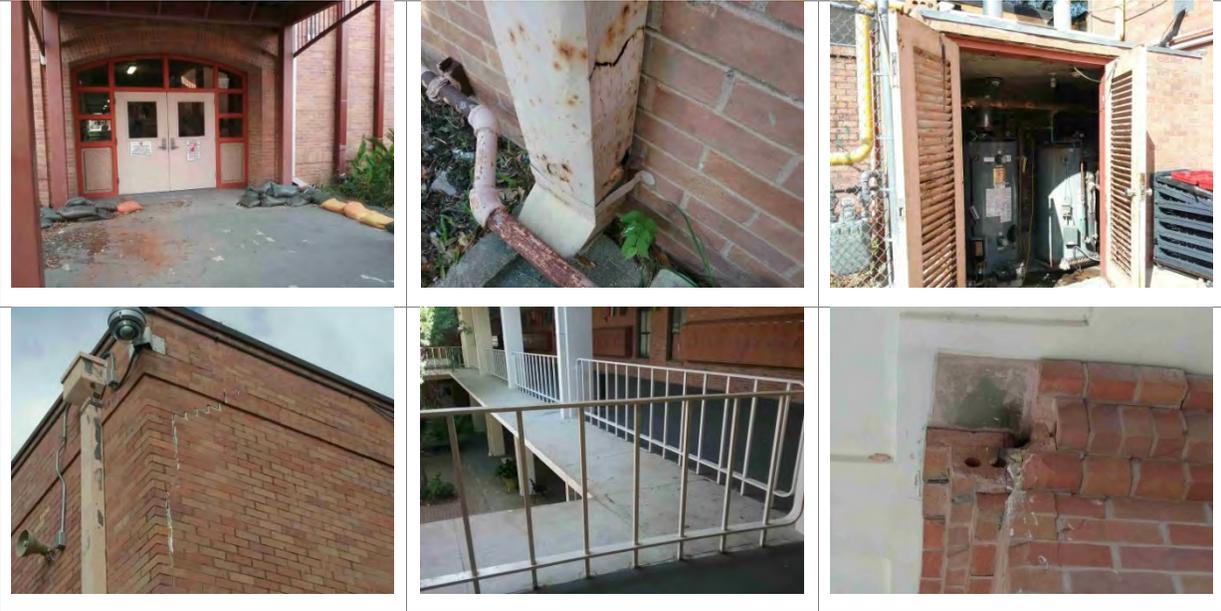
System	Subsystem	Condition and Deficiency Overview	System Condition Rating
Exterior	Exterior Walls	<p>The exterior of this large primary building is a brick façade. The building consists of two stories and has two courtyard atriums. The halls and staircases are covered by the corridor from above, but open to the elements. They are in average condition.</p> <p>There is a life safety issue which was reported by staff. The railing balusters around the courtyard atriums are too far apart, allowing children to slip through or climb over and stand on the overhanging ledge of the courtyard atrium. Principal Rebekah Van Ryn reported that the railing anchors and rebar are corroded and separating from the concrete base of the ledge.</p> <p>Staff also reported that excessive rain water pools and enters through the doors at the west entrance of the building due to the downspouts being buried. Sand bags were observed lining the sidewalk.</p> <p>The brick façade appeared to be in average condition with specific areas that are cracked (northeast corner of the small gymnasium) and areas with missing cornice bricks (southeast corner of the cafeteria).</p> <p>The exterior closet housing the kitchen water heater is 4 inches below grade, which causes water to collect inside. The louver doors are rusted, and the roof needs to be replaced. This small closet appeared to be in average condition.</p> <p>Teacher James Wood reported that there is water infiltration under the glass walls in the foyer.</p>	Average

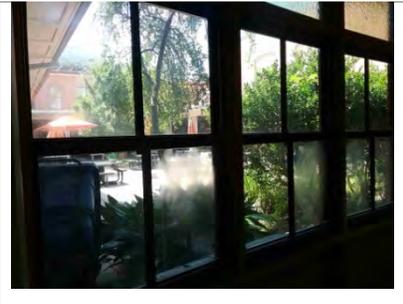
System	Subsystem	Condition and Deficiency Overview	System Condition Rating
	Exterior Windows	<p>The windows have bronze metal frames and appear to be single paned.</p> <p>The exterior window system was observed to be in average condition. The windows were observed with fogged glass and the surrounding caulk was cracked. Teacher James Wood, also reported that the glazing compound is missing from many panes and cracked glass is present.</p>	Average
	Exterior Doors	<p>Through out the campus, there are many exterior double metal doors connecting air conditioned corridors to non- air-conditioned corridors.</p> <p>These doors are heavily used but open and close well and were in average condition. Teacher James Wood reported a number of other deficiencies present: poor seals, non-functioning closures, missing closure covers, leaking closures, or cracked hinge points, and doors do not reliably close.</p>	Average

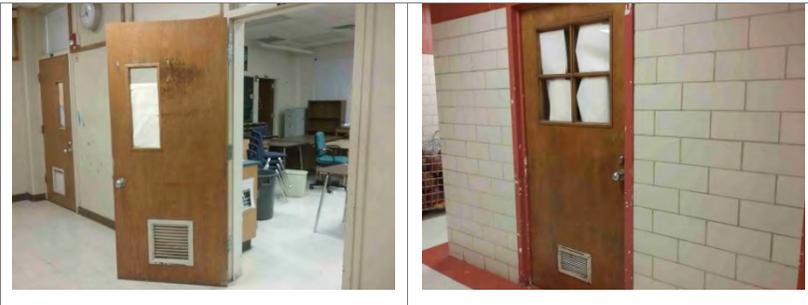
System	Subsystem	Condition and Deficiency Overview	System Condition Rating
	Interior Doors	The interior doors are wood veneer with a metal frame and lites. Some are metal in metal frames with a lite. The doors appeared to be in average condition. The paint on most of the frames was chipped and the doors are worn, and scratched.	Average
	Interior Specialties	Lockers are metal with vents, in non-air conditioned corridors. Lockers in the first-floor atrium area, where they are exposed to sun and rain, and were faded with peeling paint. Lockers in locker rooms are also metal with vents or metal mesh type. The lockers were in good condition.	Good
Stairs	Exterior Stairs	The one exterior staircase at the west end of the building is concrete. The stairs were viewed to be blackened from water damage. Teacher James Wood reported that the traction strips are loose with some bolts sheared. The stairs were observed to be in average condition.	Average

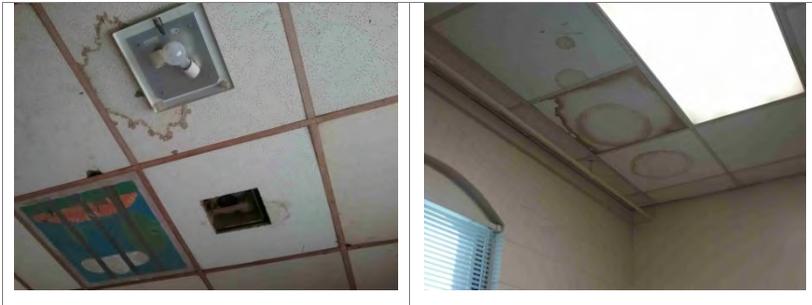
System	Subsystem	Condition and Deficiency Overview	System Condition Rating
	Interior Ceiling Finishes	The majority of interior ceilings are metal grid with acoustical tile in classrooms and administration areas. There are gypsum board ceilings in restrooms. The remaining ceilings (in the two gymnasiums and the locker rooms) are Tectum brand acoustical ceiling panels. The acoustical tiles and grid were old, sagging, water-stained, and unclean especially in the locker room areas. The grid was unclean and rusted on the second floor.	Poor
Conveying		BLDG-052A is outfitted with a Dover hydraulic two-story elevator in the center of the courtyard. The machine room houses the elevator's hydraulic sump, pump, and controls east of the elevator car on the first floor. Facility staff report that the elevator was original construction and had frequent service calls. An ADA (Americans with Disabilities Act) vertical lift for a single person exists in the gymnasium. The facility staff report frequent service calls were made regarding this lift. The conveying equipment was observed in good condition.	Good

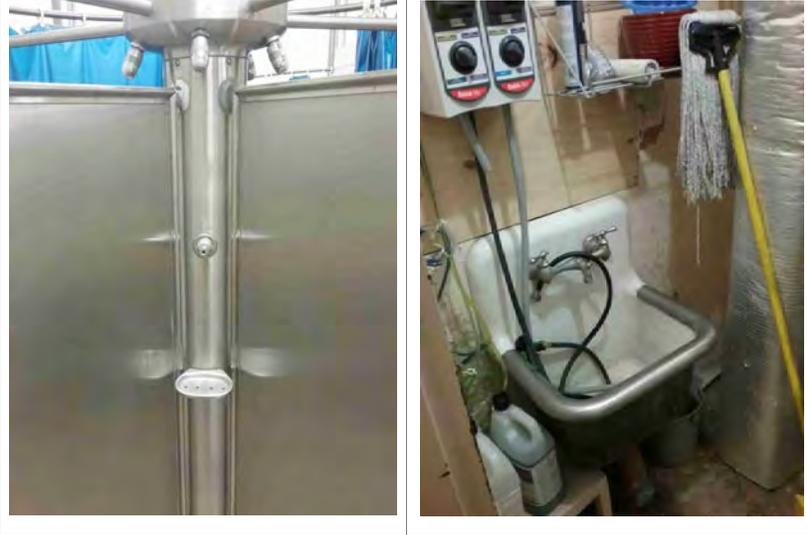
Plumbing Fixtures

System	Subsystem	Condition and Deficiency Overview	System Condition Rating
		<p>sinks.</p> <p>Classrooms 208 and 214 were observed to have two sink faucets that are not operating properly at the time of assessment. It was also observed that none of the chemistry classrooms that appear to be housing hazardous materials (room 207) have actual safety showers for use in case of emergency.</p> <p>The plumbing fixtures in this building are old but were operating normally.</p>	
	<p>Domestic Water Distribution</p>	<p>The commercial kitchen is serviced by two vertical gas water heaters (99-gallon capacity), and the culinary classroom is serviced by a vertical electric water heater (40-gallon capacity).</p> <p>The domestic water distribution system had the following deficiencies at the time of assessment:</p> <p>At the time of assessment, an extremely old water heater was observed to be servicing the commercial kitchen and reported to also service the locker room. PM Craig Estes reported that this water heater was replaced during Summer 2016. At the time of the assessment, it was observed that this water heater was installed in 1996 and had excessive corrosion from a leaking hot water supply line. The water heater shell was severely corroded, and the distribution piping insulation was damaged from leaking pipes. The adjacent water heater, that also services the commercial kitchen, was installed in 2009 and was tied together with the hot water supply lines are leaking. Another deficiency observed was that the mixing valves in the male/female locker room showers had excessive corrosion on the pipe and valve boxes.</p> <p>The domestic water distribution system was rated to be in average condition at the time of assessment. Teacher James Wood reported there is no hot water fed to the locker rooms.</p>	<p>Average</p>

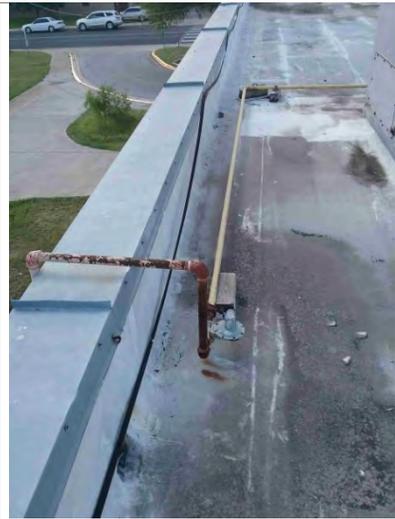
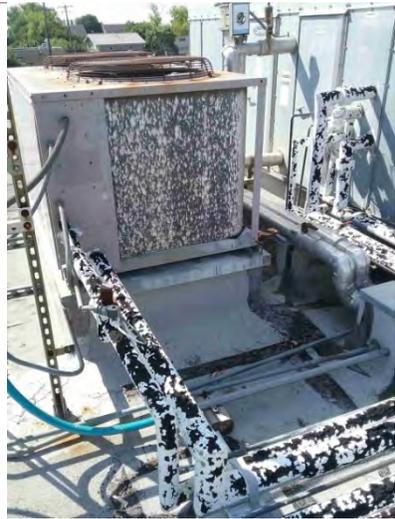
Mechanical/HVAC System Deficiency Examples

System	Subsystem	Condition and Deficiency Overview	System Condition Rating
		<p>feeds many of the units on the south side of the building was extremely corroded and should be addressed as soon as possible to avoid a natural gas leak; the natural gas line was located on the north side of A-28 (band room). The remaining areas assessed were A-27 (kitchen), A-38 (main classrooms first and second floors), A-03 (small gymnasium area), and A-02 (male/female locker room area). These areas all have units that were charged with R-22, and associated ductwork or piping insulation was damaged from exposure to the elements. AHU-1, OAU-3, and OAU-4 are three examples of damaged insulation and ductwork that should be addressed to further the efficiency of the systems. Teacher James Wood reported that there are a number of hot and cold areas through out the school. It was also reported that several gas and electrical conduit lines that feed HVAC equipment are supported on the roof.</p>

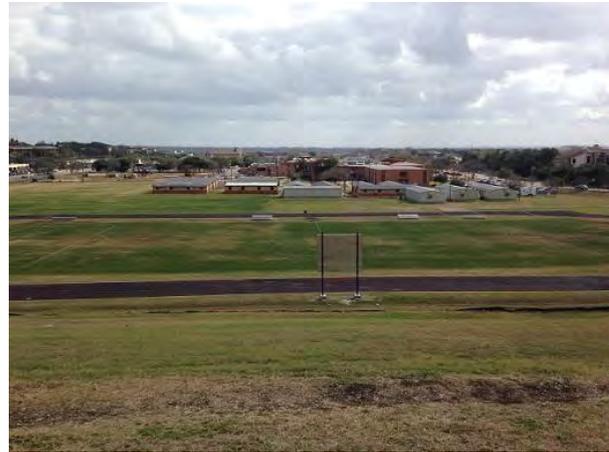
System	Subsystem	Condition and Deficiency Overview	System Condition Rating
Playfields	Tennis Courts	<p>The tennis courts have some cracks in court surface, as well as some small holes in court. There are some broken fence posts on the east were they tie into the concrete footing. On the south side of the courts, there is ponding on courts from adjacent sidewalk and area not draining properly.</p> <p>Tennis Court Deficiencies:</p> <ul style="list-style-type: none"> • Surface cracks • Holes in surface • Broken fence posts • Court ponds from adjacent sidewalks lack of proper drainage. 	Poor
	Soccer/ Multi-Purpose	<p>Minor grass maintenance is needed for various areas of the field, especially behind the goal posts. Goal posts are in good condition themselves. The field drains to one area inlet which is damaged and needs to be replaced.</p> <p>Soccer/ Multi-Purpose Deficiencies:</p> <ul style="list-style-type: none"> • Minor grass maintenance. • Damaged area drain inlet 	Good

Baseball / Softball fields	<p>The baseball fields in general need maintenance for weed control/growth into the infield's dirt surface, as well as grading and erosion issues around the fields. The score keeper boxes are weathered. Not all bleachers are on concrete pads, some concrete pads are broken. Brick / paver walkways are inconsistently located around perimeter. They need to be maintained or replaced. There is fence damage along portions of the fields, the back stop fencing needs replaced. The tower in center needs electrical conduit to cover exposed wiring.</p> <p>Baseball / Softball Field Deficiencies:</p> <ul style="list-style-type: none"> • General maintenance for weed control into infield. • Erosion around fields • Weathered score keeper boxes • Brick & paver walkways inconsistently located, need maintained or replaced. • Perimeter fence damaged in several locations • Central tower needs electrical conduit for exposed wiring 	Average
