## O. Henry Middle School Site Summary

## Main School Building – BLDG-047A

### System Deficiency Overview

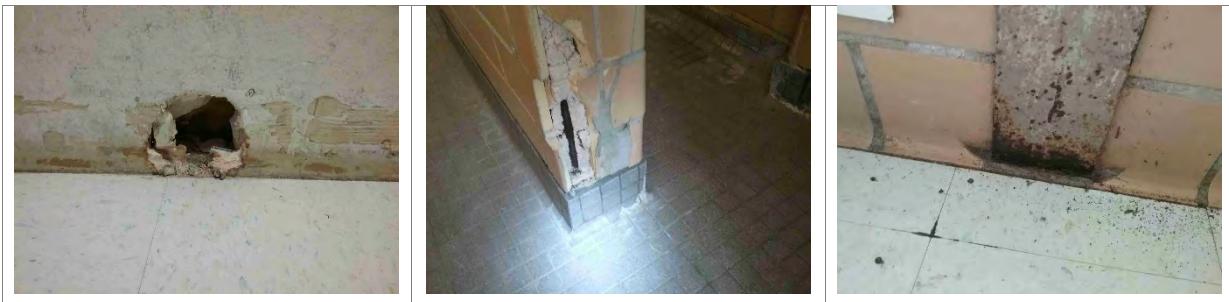
#### Interior Walls

| System | Subsystem | Condition and Deficiency Overview | System Condition Rating |
|---|---|---|---|
| <b>Interior Construction</b> | Interior Walls | <p>The interior walls are constructed of CMU (concrete masonry units) with ceramic-glazed blocks as a low wainscot. The shower room walls are constructed of ceramic-faced masonry units. There are isolated areas of metal stud and gypsum board walls.</p> <p>The interior walls were in good condition with a few isolated areas needing repair. In the 100-wing classrooms, a mildew odor was observed. In the 700-wing, a fist-sized hole at the base of the drywall partition was observed. Two corners in the shower room walls were severely damaged with cracked and missing ceramic wall tile, exposing the structure below. A steel column imbedded into the load-bearing walls was observed to be rusting.</p> | Good |

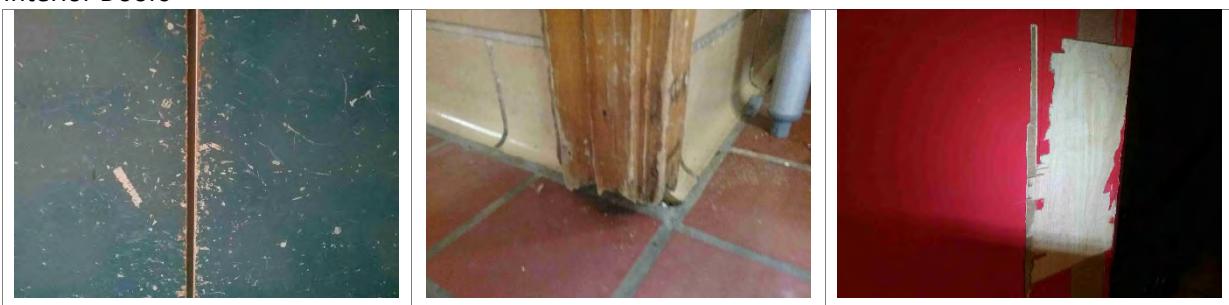
#### Interior Doors

| System | Subsystem | Condition and Deficiency Overview | System Condition Rating |
|---|---|---|---|
| | Interior Doors | <p>The interior doors are a mixture of metal doors with or without narrow lites and wooden doors with or without door lites. The doors in the music wing are 48" wide, while the rest are 34" wide. There are also many wider metal doors accessing mechanical and electrical equipment rooms that are installed on 8" curbs. The hardware ranges from lever pulls to knob pulls.</p> <p>Most of the doors were in good condition with very little wear and tear. However, the music hall doors were scratched, and the wooden door frames in the kitchen were very worn and damaged. The wooden door leading to the small gymnasium was damaged and was missing strips of wood veneer finish.</p> | Good |

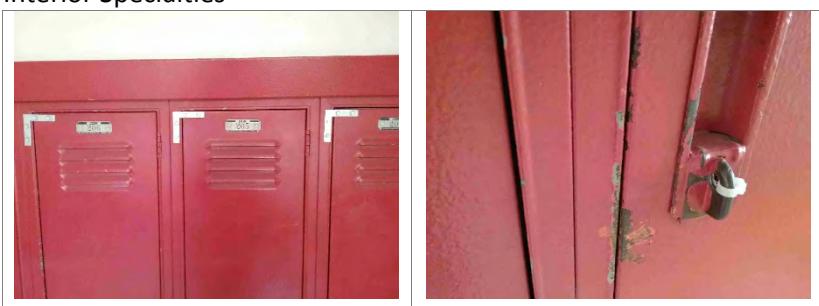
#### Interior Specialties

| System | Subsystem | Condition and Deficiency Overview | System Condition Rating |
|---|---|---|---|
| | Interior Specialties | <p>The lockers in the school are recessed metal lockers, lining the majority of corridors. The lockers in the locker rooms are prefinished metal, both fixed and rolling.</p> <p>The lockers in the corridors were in average condition.</p> | Average |

| System | Subsystem | Condition and Deficiency Overview | System Condition Rating |
|---|---|--|---|
| | | About 10% of the corridor lockers were screwed shut and inoperable. Some of the surface paint was scratched. The locker room lockers were in good condition. | |

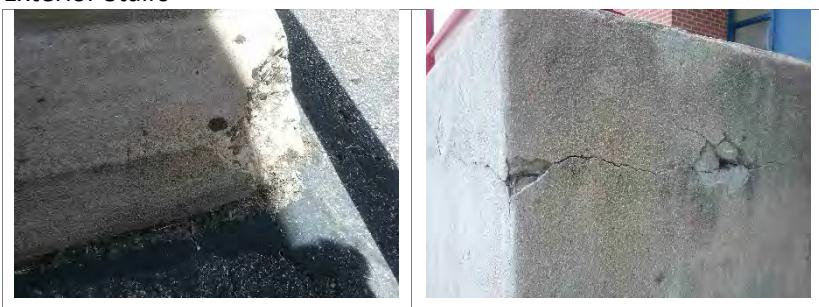
#### Exterior Stairs

| System | Subsystem | Condition and Deficiency Overview | System Condition Rating |
|---|---|--|---|
| <b>Stairs</b> | Exterior Stairs | <p>There are various exterior stairs and ramps providing access to side entrances. They are constructed of concrete with metal handrails.</p> <p>The stairs were in average condition with a few areas in need of repair. One concrete corner of a stair tread and riser had spalling concrete, and hairline cracks were observed at the perimeter concrete foundation of the stairway.</p> | Average |

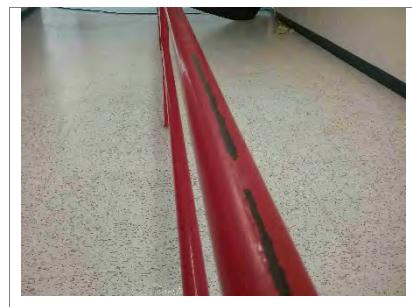
**Interior Stairs**

| System | Subsystem | Condition and Deficiency Overview | System Condition Rating |
|---|---|--|---|
| | Interior Stairs | <p>There is a series of ramps throughout the building and a set of wooden stairs backstage. The ramps are finished in vinyl composition tile with painted metal handrails.</p> <p>Both the ramps and the stage stairs were observed to be in good condition with little sign of wear. However, the paint on the metal handrails of the ramps was peeling.</p> | Good |

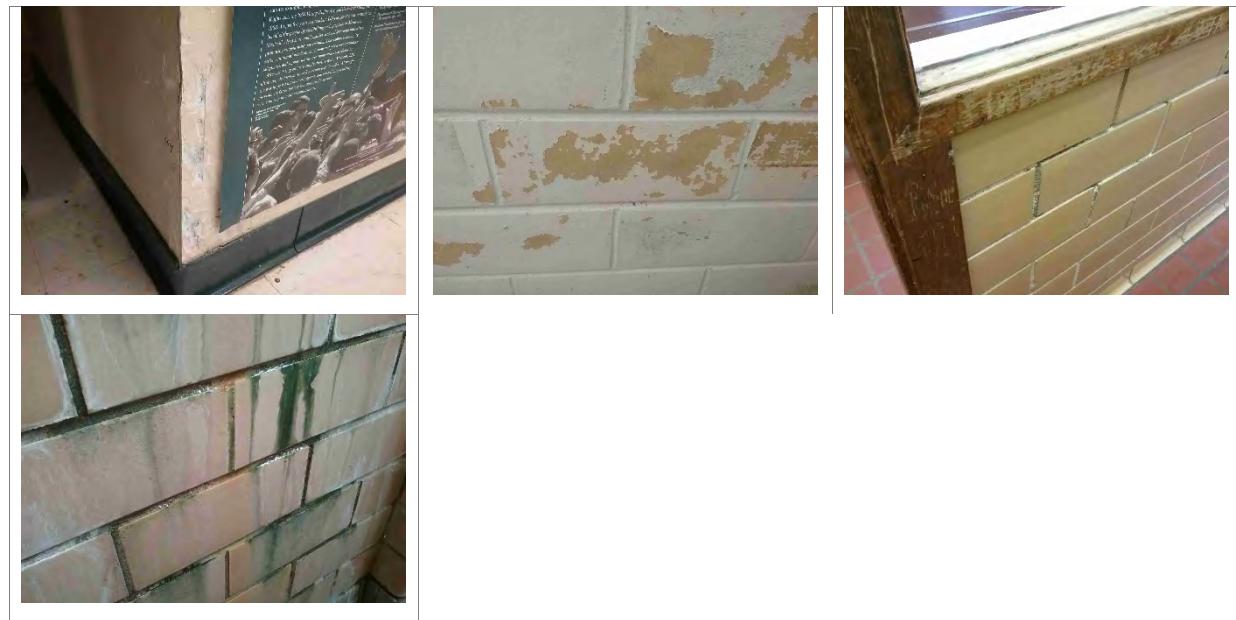
**Interior Finishes Deficiency Examples****Interior Wall Finishes**

| System | Subsystem | Condition and Deficiency Overview | System Condition Rating |
|---|---|--|---|
| <b>Interior Finishes</b> | Interior Wall Finishes | <p>The wall finishes are a mixture of painted CMU and painted gypsum board. There are wall-mounted acoustical panels in the music hall. The shower rooms near the small gymnasium are constructed of ceramic-faced masonry units.</p> <p>The interior wall finishes were observed to be in average condition. The finishes in the 500-wing appeared to be older than those of the 100- and 400-wing as they showed more signs of wear. A few spots of dented gypsum board were observed, as were a few areas of peeled paint. The acoustical panels appeared to be in excellent condition. The wooden frame around the lunch line kitchen window was scratched. The wall finishes in the showers adjacent to the small gymnasium were in poor condition as they were stained and exhibited organic growth.</p> | Average |

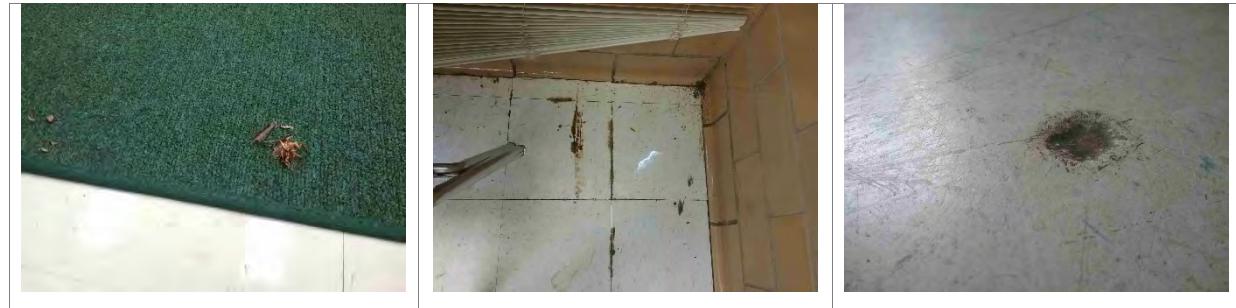
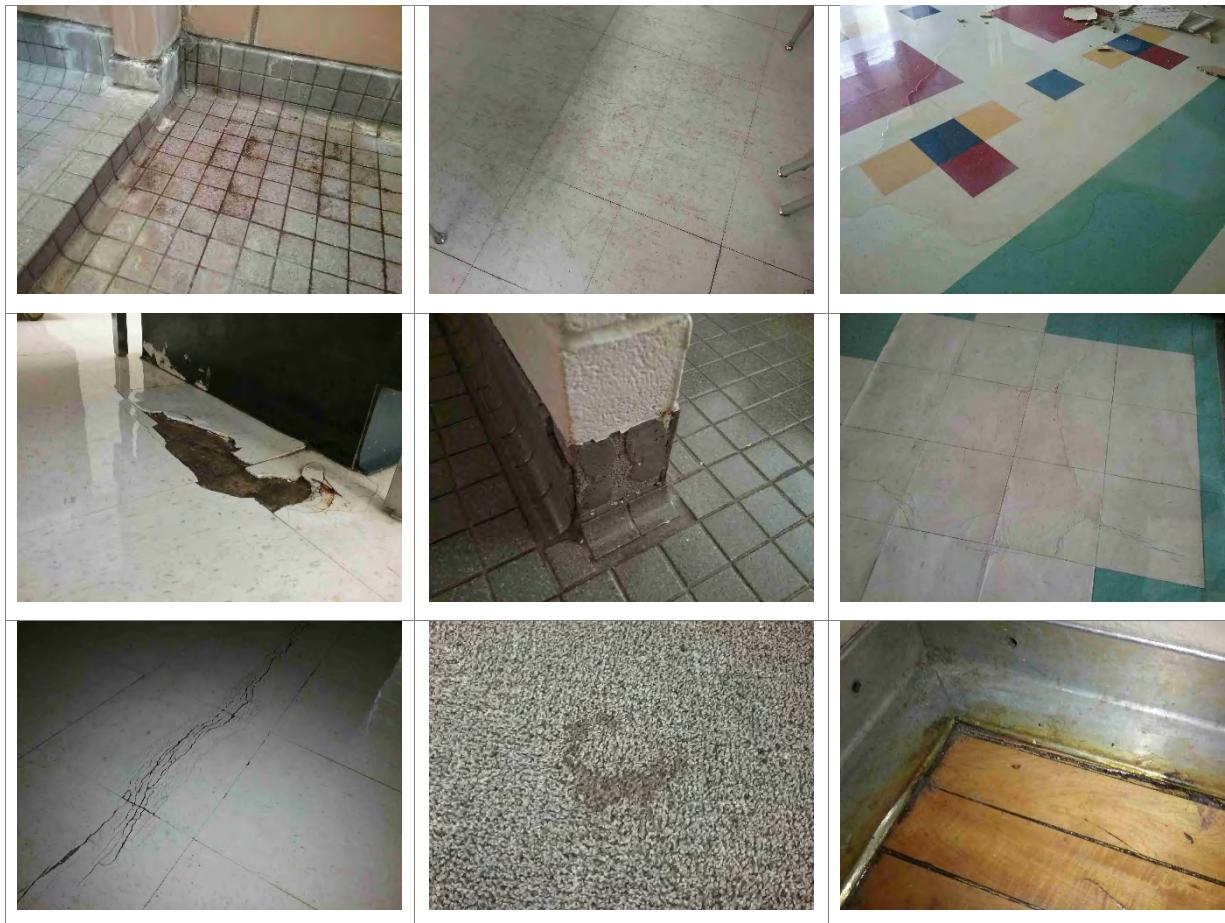
**Interior Floor Finishes**

| System | Subsystem | Condition and Deficiency Overview | System Condition Rating |
|---|---|--|---|
| | | <p>The floor finishes were observed to be in average condition. The flooring in the administration offices was being repaired at the time of the assessment possibly due to the foundation issue reported. Much of the floor was dirty, especially at the wall base edges and in corners. Many of the floor tiles were dented or cracked. A few areas were missing rubber base. The classroom floors in the 100-wing were scratched.</p> <p>A large puddle of water was observed in the corridor between rooms 206 and 208 due to a major ceiling leak. Some floor tiles under the puddle were beginning to fade.</p> <p>In the 400-wing, there was cracked VCT that has been sealed with wax. The restrooms floors appeared to be in good condition with only a few spots of missing ceramic tile wall base. The floor finishes in the 500-wing exhibited more evidence of damage than those of the 100- and 400-wing. Areas of VCT were broken, and some had rust-colored stains where metal cabinetry once sat. Cracks and floor level problems were reported, and a slightly sunken area of the floor and tile was observed at the double doors leading to the 700-wing. The 600- and 700-wing corridors are bracketed with floor cracks at the corridor transition points. A few stains were observed on the library carpet. The metal wall base in the small gymnasium is discolored with wood varnish. The ceramic flooring in the shower rooms were stained from mineral deposits and organic growth. It was reported that the kitchen floors have cracks, which cause the facility to receive penalties. No cracks were observed in the material, but the floor was observed to be covered with debris.</p> | |

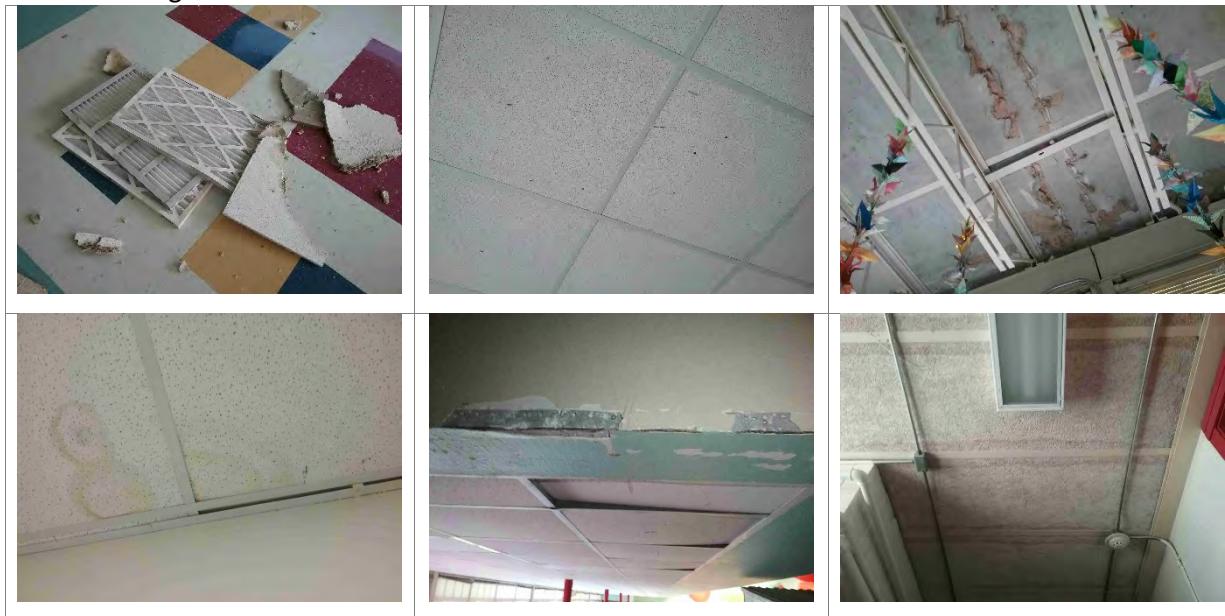
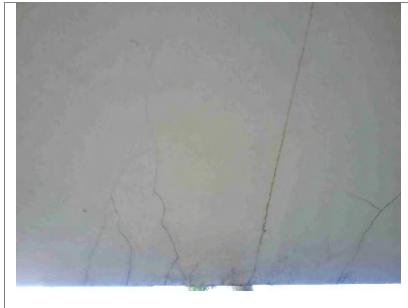
| System | Subsystem | Condition and Deficiency Overview | System Condition Rating |
|---|---|--|---|
| | Interior Ceiling Finishes | <p>The majority of the ceilings are ACT (acoustic ceiling tile) and the restroom ceilings are painted drywall. The 600-wing ceiling has exposed structure and fibrous ceiling panels. The library ceiling is comprised of ACT and gypsum board. The administration offices and cafeteria have ACT. The kitchen ceiling is in the process of being replaced. The main gymnasium is in the process of abatement and is closed, but the ceiling in the small gymnasium and adjacent corridors is wood wool panels. The locker and shower rooms have painted gypsum board ceilings. The exterior walkways are finished with painted gypsum board.</p> <p>The ceilings were in average condition with some areas</p> | Average |
