## Webb Middle School Site Summary

<b>Address</b>	601 E St. Johns Avenue Austin, TX 78752
<b>Number of Permanent Campus Facilities</b>	2
<b>Original Year of Construction</b>	1961
<b>Total Campus Building Area (combined)</b>	120,985 SF

## Main School Building – BLDG-053A

## Site/Civil Assessment

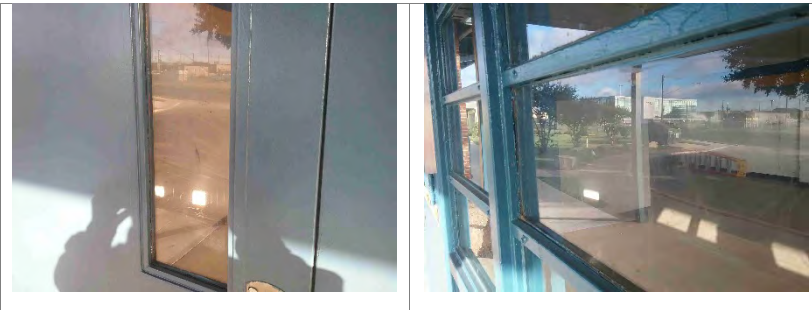
### Exterior Doors

System	Subsystem	Condition and Deficiency Overview	System Condition Rating
	Exterior Doors	<p>The exterior doors are steel with hollow-metal frames. The entry doors have vision panels, and have side-lites and transoms with fixed glazing.</p> <p>The exterior doors were observed to be in average condition. The exterior door hardware was aged and in marginally functional condition in some instances. Acrylic glazing was found in some exterior doors and side-lites; multiple panes of acrylic glazing were observed at the east gymnasium entrance. Thresholds are reported to require frequent replacement and water intrusion was reported to occur at the east entry to COR12. The exterior doors at the east entry to the BIGGYM and COR8 did not function consistently. The removable astragal between the doors was loose.</p>	Average
Roofing		<p>The main building roof is comprised of smooth-finish modified bitumen, granular surfaced modified bitumen, and built-up roof membrane types. There are continuous gutters and downspouts along most roof edges.</p> <p>It was reported that approximately 65% of the main building roof was replaced in 2007 with the smooth-finished modified bitumen membrane and was observed to be in good condition. The remaining modified bitumen and built-up roofs were visibly aged and had ponding water and deteriorated surfaces. These older roof surfaces were observed to be in poor condition. The remaining original gutters appeared to be severely corroded and no longer functional. Roof leaks were reported above room 111 and 113, the east entrance to COR4 adjacent to the cafeteria, and near the entrance to the library. <a href="#">PM Andrew Miller reported the roof vent flashing at the penetrations has deteriorated and needs to be replaced.</a></p>	Average

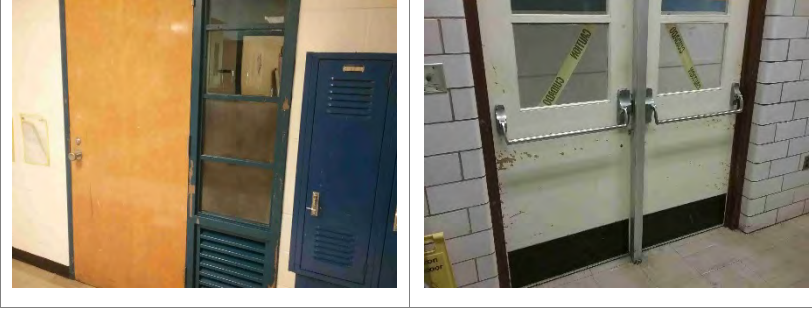
### Interior Doors

System	Subsystem	Condition and Deficiency Overview	System Condition Rating
		observed to be in average condition. Acrylic glazing was found in some side-lite panels in the 100- and 200-wing classrooms.	
	Interior Specialties	Painted metal lockers are in the classroom wing corridors and in the athletic dressing rooms.  The lockers were observed to be in average condition. General wear and scuffing was visible, but lockers functioned adequately.	Average
<b>Stairs</b>	Exterior Stairs	There are concrete stairs and ramps with metal railing at the building entrances on the east and south sides of the main building. There is a steel loading dock with steel steps at the kitchen.  The exterior concrete stairs, ramps, and metal railings were observed to be in good condition. It was reported that a metal barrier on the exterior stairs adjacent to the cafeteria was loose and required replacement. The steel loading dock and steps were observed to be in average condition.	Average

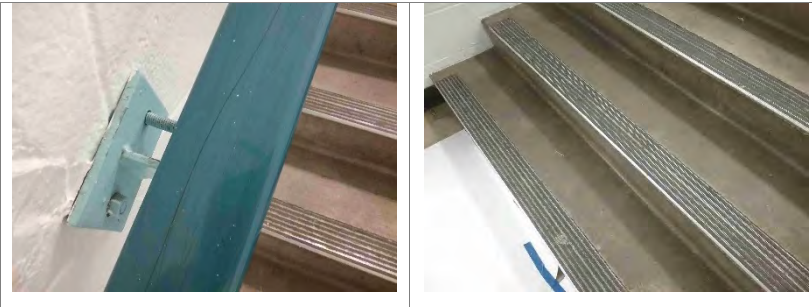
### Interior Stairs

Interior Stairs	There are multiple sets of interior concrete stairs with metal non-slip nosing and handrails in the main building. There are wood steps for stage access.  The concrete stairs and nosings were observed to be in average condition with visible wear. The stair handrails at S4 in COR4 were observed to be inadequately secured to the wall and unsafe to use. Brackets were fabricated with two holes but only one bolt was used to secure the railings. Bolts or nuts were loose at numerous railing brackets. The wood stage steps appeared to be in good condition.	Average
<b>Interior Finishes</b>	Interior Wall Finishes	The interior wall finishes are predominantly painted CMU or gypsum board surfaces. The interior walls in the cafeteria and the large and small gymnasiums have glazed masonry units at their lower half and painted CMU above. Glazed masonry units are found in the kitchen and the athletic support spaces.  The glazed masonry units and painted interior wall surfaces were observed to be in average condition and had visible wear and scuffing.	Average

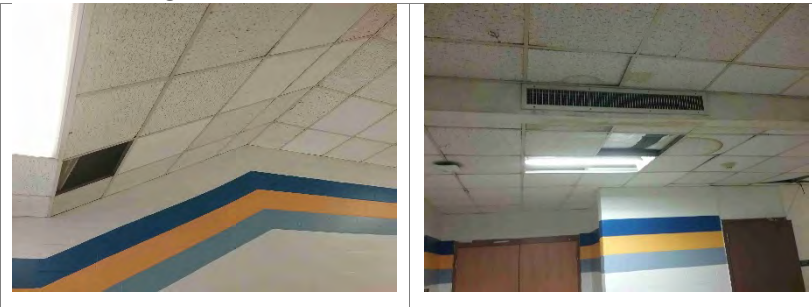
### Interior Ceiling Finishes

System	Subsystem	Condition and Deficiency Overview	System Condition Rating
		<p>weight room has a rubber impact absorbing flooring material. The flooring in the shower and dressing rooms are concrete with a liquid applied non-slip coating.</p> <p>The interior floors were observed to be in average condition. The vinyl flooring throughout most of the building was aged and visibly worn. It was reported that tiles required replacement frequently in the ground level classroom wing due to water intrusion. The dressing room floors were observed to be in good condition.</p>	
	Interior Ceiling Finishes	<p>There are suspended lay-in acoustical tile ceilings throughout much of the main building. The painted steel structural members and cement-fiber roof deck is exposed in the large and small gymnasiums. Restrooms have painted gypsum board ceiling surfaces and the shower and dressing rooms ceilings painted cement plaster. The kitchen lay-in ceiling tiles are vinyl covered.</p> <p>The interior acoustical tile ceilings were observed to be in average condition. Many tiles have been replaced and some staining was visible from roof or mechanical system leaks. Lay-in tiles in the 130-139 classroom wings were reported to fall from their grid. Attached acoustic tiles were reported to fall frequently and were observed to be missing or partially secured in classrooms. The ceiling grid at the intersection of COR3 and COR4 was sagging, had missing tiles, and gaps between the tiles and grid were visible in numerous locations.</p>	Average

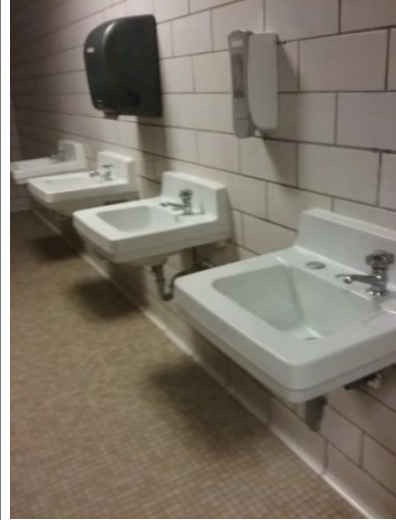
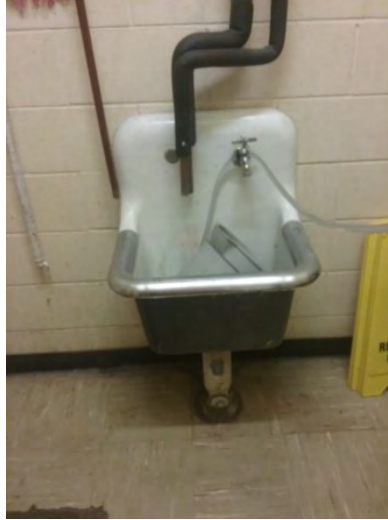
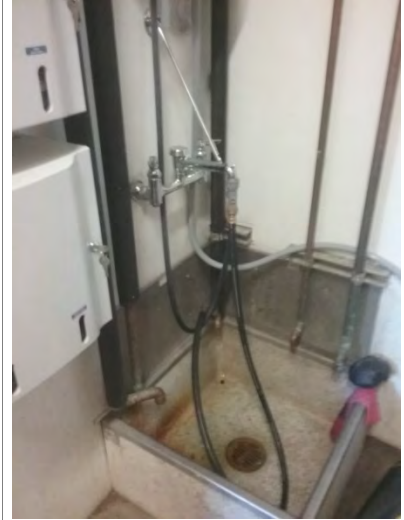
### Plumbing Fixtures

System	Subsystem	Condition and Deficiency Overview	System Condition Rating
		The building's plumbing fixtures were observed to be in average condition. Plumbing fixtures in the kitchen were observed to be in good condition. The fixtures located in the restrooms appeared to be aged but in working order and in average condition. The service sinks located in the custodial closet were observed to be in average condition due to age. <a href="#">PM Andrew Miller reported that the ground floor restrooms in the north wing are not ADA compliant.</a>	
	Domestic Water Distribution	The sinks located throughout the facility are equipped with hot water. The primary hot water service for the building is provided by two water heaters located in the main mechanical room.  The plumbing distribution equipment serving the facility was observed to be in good condition. The water heaters serving the building were observed to be in good condition.	Good

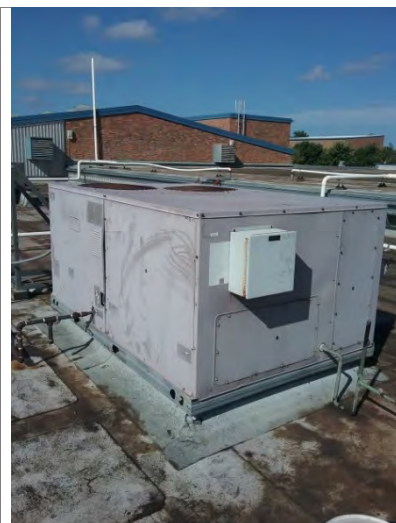
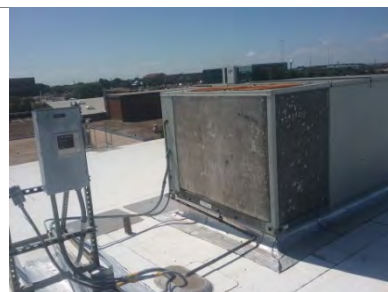
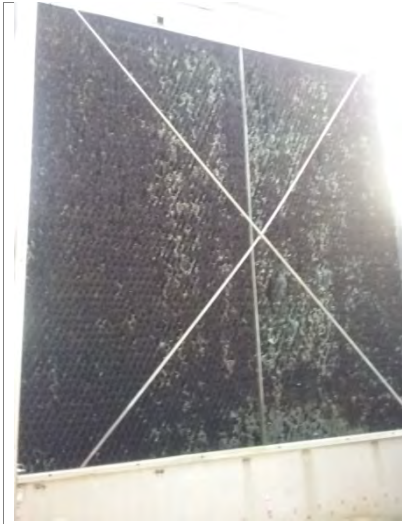
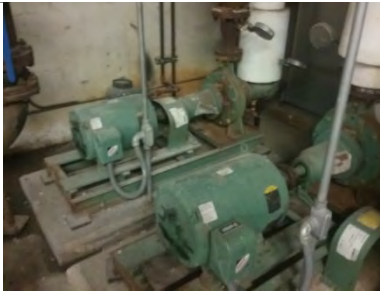
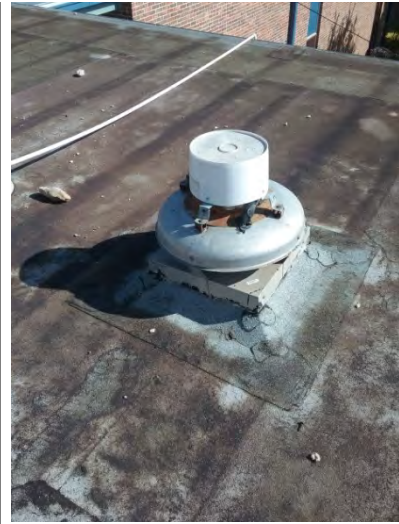
## Mechanical/HVAC System Deficiency Examples

System	Subsystem	Condition and Deficiency Overview	System Condition Rating
		appeared to be aged and in average condition. The cooling tower appeared to be aged and in poor condition. Organic growth was observed on the cooling tower cell media. <a href="#">PM Andrew Miller reported the cooling tower was overflowing and the cooling fins were deteriorated. It was reported that debris and trash is entering the cooling tower. In addition, the RTU at the kitchen needs to be replaced.</a> The boilers appeared to be new and in good condition. A unit which appeared to be a supplemental boiler was observed to be aged and past its useful life. The distribution pumps were observed to be aged and in poor condition.	
Fire Protection	Fire Alarm	The building has a fire alarm system that consists of alarm and signaling devices such as horns/annunciators, strobes, horn/strobe combinations, pull stations, and detectors. The fire alarm system is controlled by the Silent Knight control panel.  The fire alarm system appeared to be in good condition.	Good

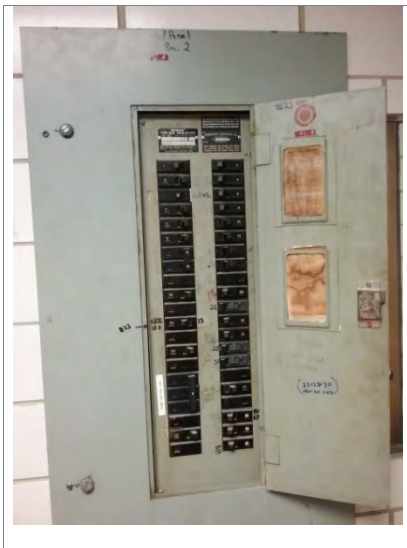
#### Electrical Distribution

Fire Protection/Suppression	The building is not equipped with a fire suppression system. The building was equipped with portable fire extinguishers. The portable fire extinguishers were observed to have been inspected within the last year.	N/A
Electrical	Electrical Distribution	The electrical service enters the building at the 277/480-volt 1600-amp main exterior switchboard with no main breaker, located near the kitchen. The service feeds transformers and high-voltage panel boards, which are located in various electrical rooms throughout the building. There are six transformers rated at 480-volt primary that step-down to a 120/208-volt secondary, which feeds power to 120/208-volt panel boards. The building does not have a lightning protection system.  The electrical distribution equipment appeared to be in average condition. A majority of the assets were observed with out-of-date equipment, and panel capacities were full. Panel A-1, located in the electrical equipment room (corridor 5), was observed to have a missing circuit breaker plate which was considered to be a life safety hazard.	Average

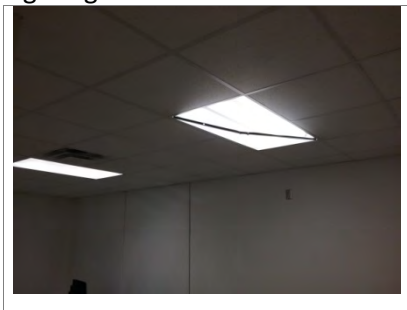
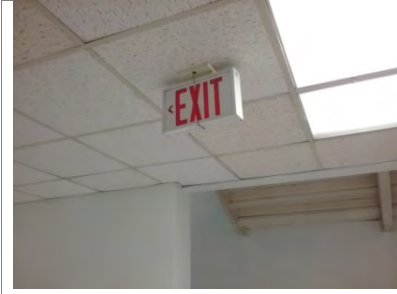
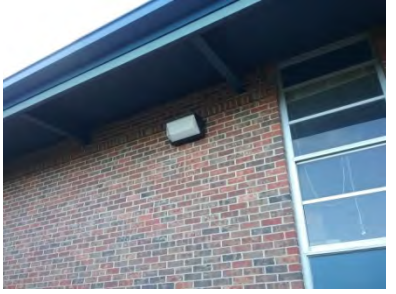
#### Lighting

Lighting	The building exterior lighting consists of HID (High Intensity Discharge), and LED (Light Emitting Diode) light fixtures that are located along the entire perimeter and canopies. The interior lighting consists of primarily T8 fluorescent light fixtures.  Lighting for the exterior of the building appeared to be in average condition. About 30% of the exterior building lights were not functioning. Lighting for the interior of the building appeared to be in poor condition. Many interior lights appeared aged and past their design life.	Poor

System	Subsystem	Condition and Deficiency Overview	System Condition Rating
		Observed deficiencies included: broken lenses, inconsistent lamp color temperatures and non-functional fixtures. The facility reported there was no light switch to control the lighting in corridor 12 or for corridor 10-15. The exit light signs in the building appeared aged, and some are being held together with wire.	
	Communications & Security	<p>There is a Gemini security system including surveillance cameras in the building. There is public address system in the building.</p> <p>According to facility staff, more interior and exterior cameras were needed.</p> <p>The security system appeared to be in good condition...</p> <p>The public address system appeared to be in good condition with no reported deficiencies.</p>	Good
