NELSON BUS TERMINAL

2016 Facility Condition Assessment as of August 2016

7105 Berkman Dr.
Austin, TX 78752

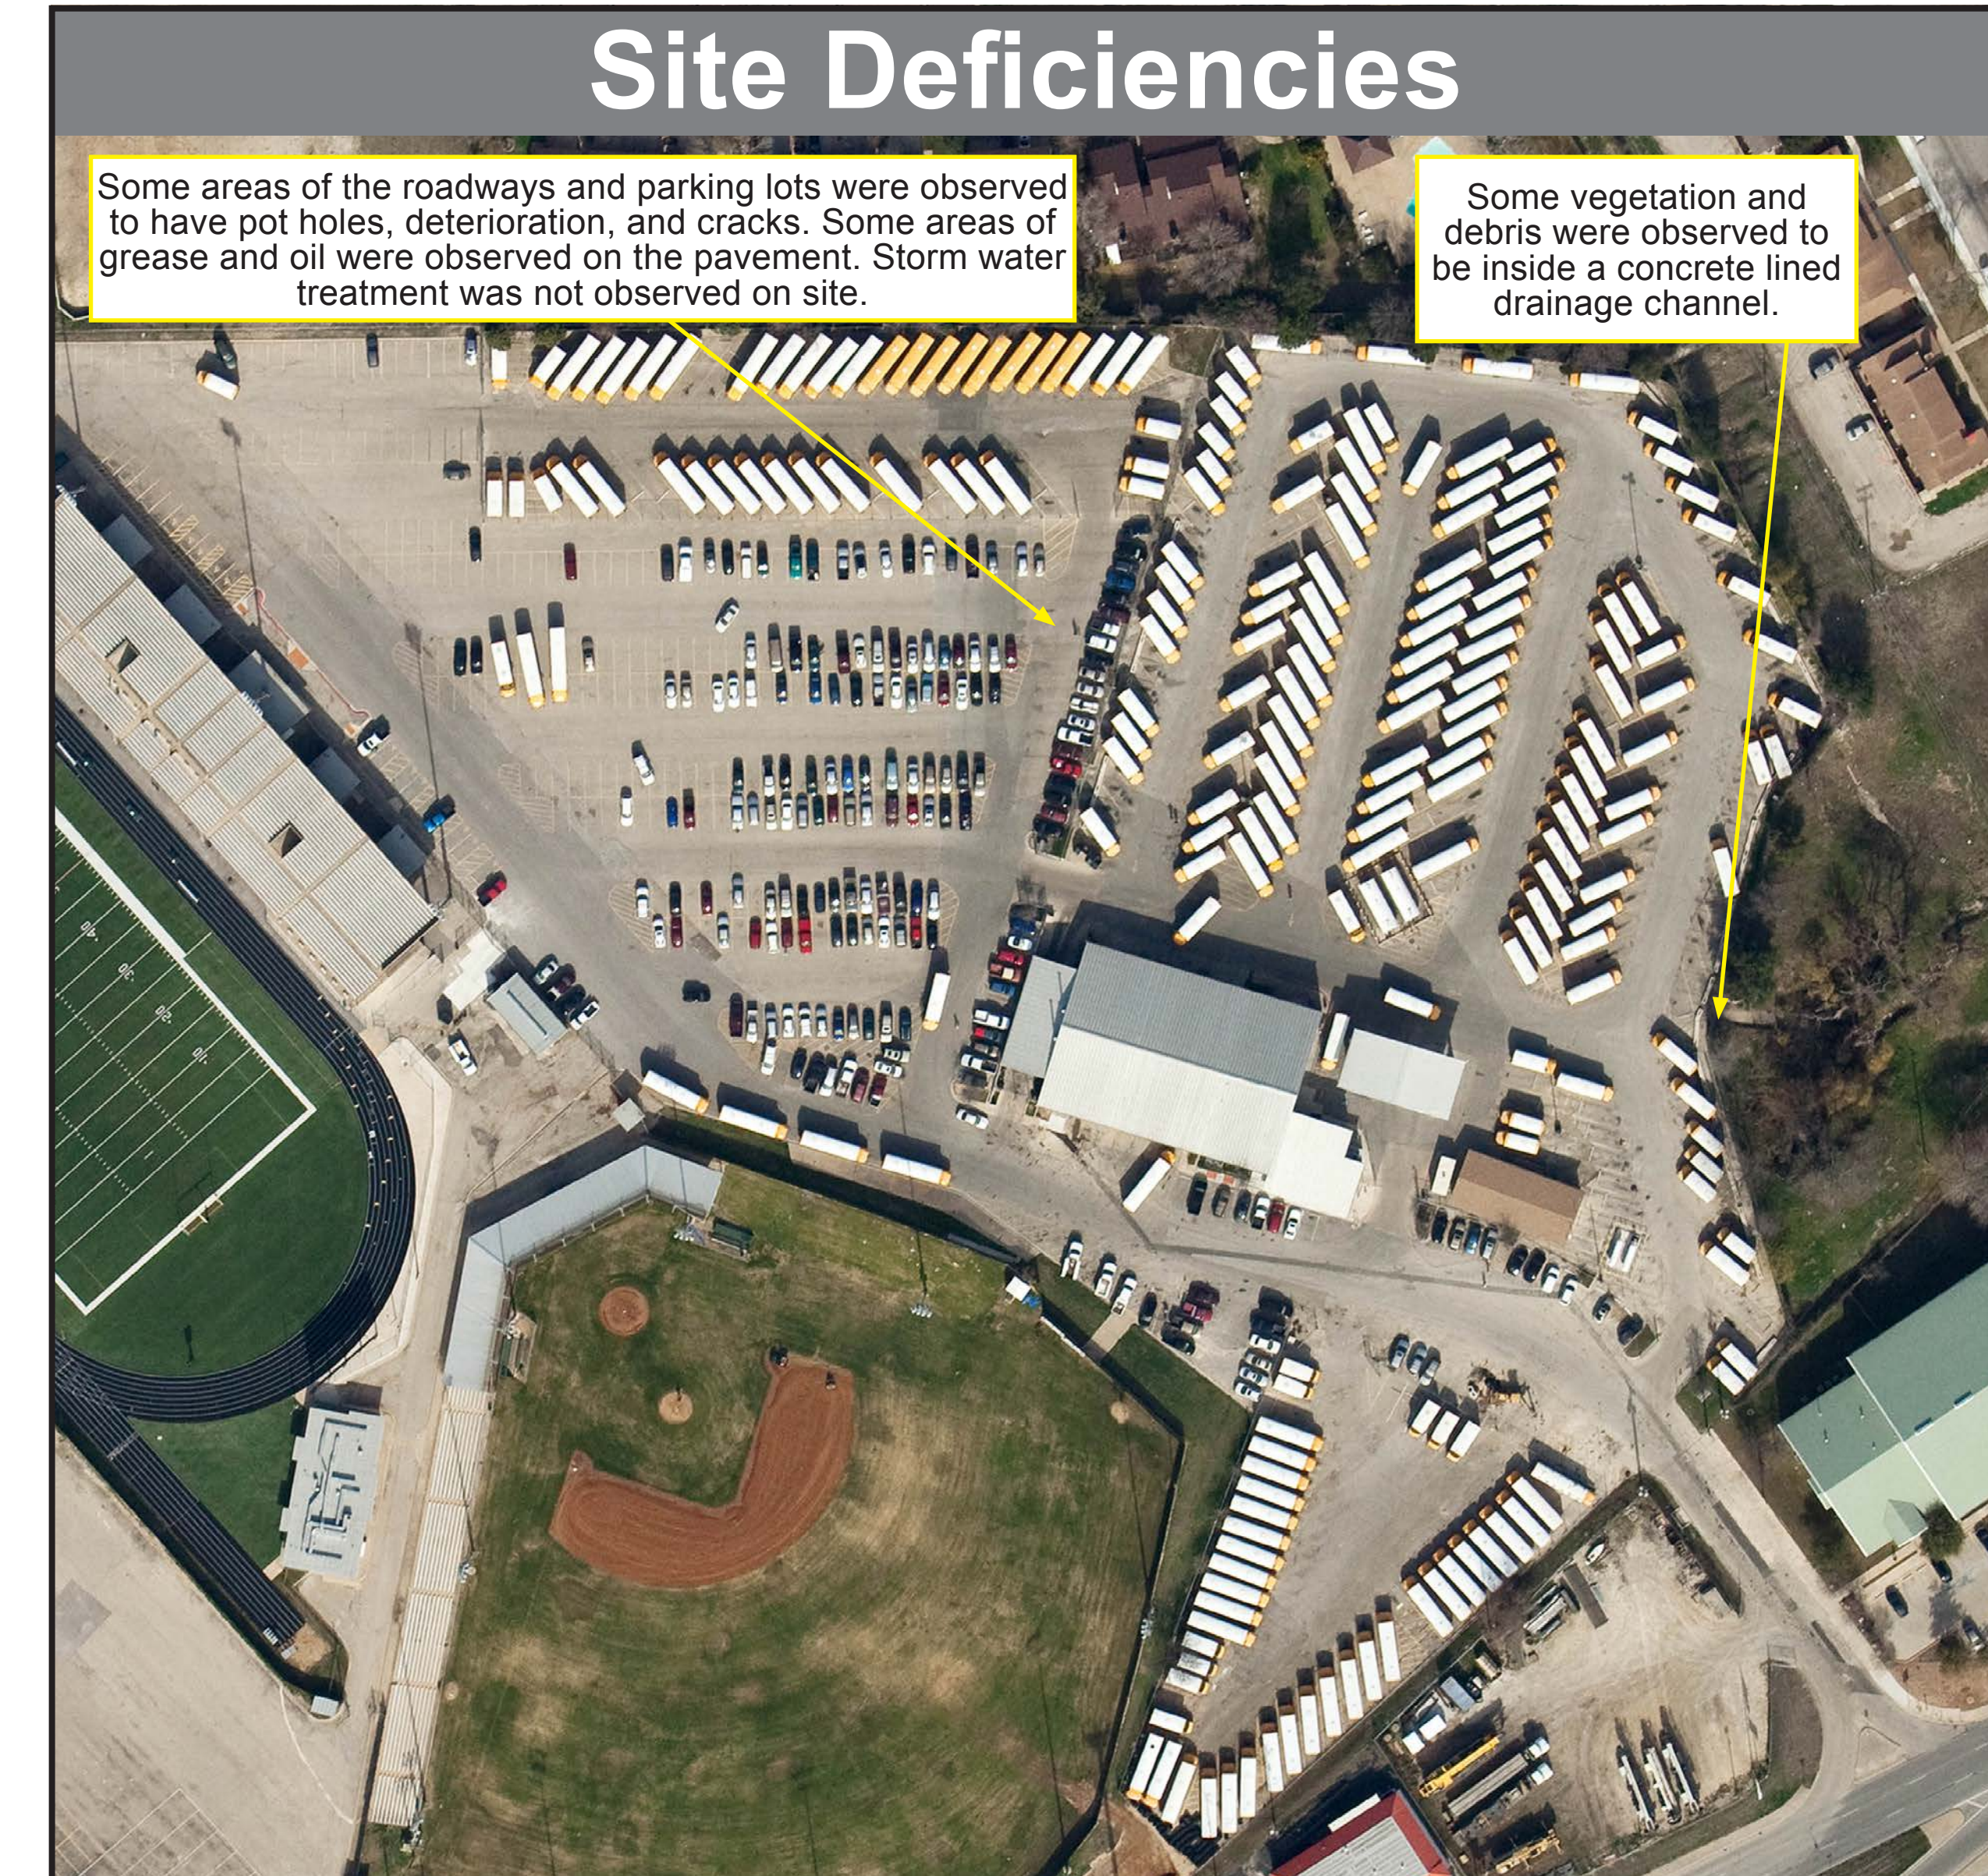
Some areas of the roadways and parking lots were observed to have pot holes, deterioration, and cracks. Some areas of grease and oil were observed on the pavement. Storm water treatment was not observed on site.

Some vegetation and debris were observed to be inside a concrete lined drainage channel.
