# **FACILITY CONDITION ASSESSMENT**

Bedichek MS | February 2022

#### **Executive Summary**

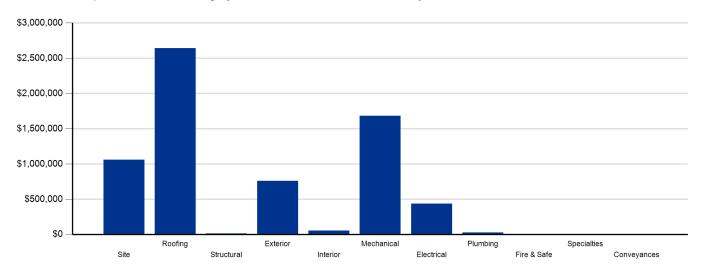
Figure 1: System Deficiencies

The chart below represents the building systems and associated deficiency costs.
