## **FACILITY CONDITION ASSESSMENT**

Garza Independence HS | February 2022

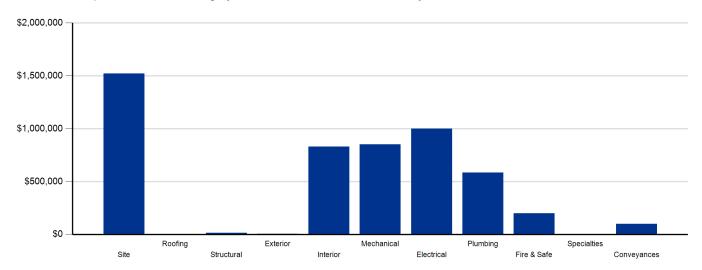
The chart below represents the building systems and associated deficiency costs.

Figure 1: System Deficiencies

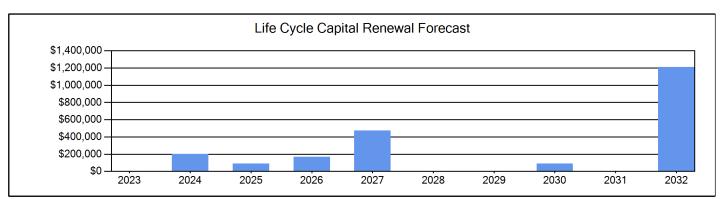
Figure 2: Ten Year Capital Renewal Forecast
