FACILITY CONDITION ASSESSMENT

Hill ES | February 2022

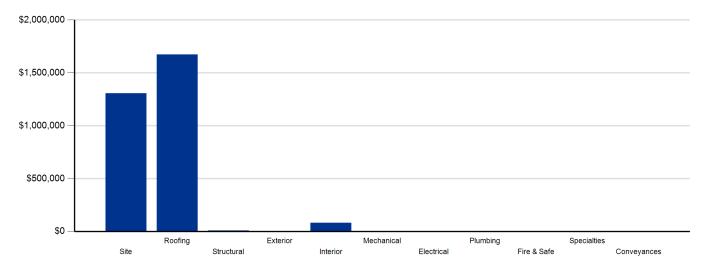
Figure 1: System Deficiencies

The following table summarizes this site's current deficiencies by building system and priority.

During the facility condition assessment, assessors inspected all major building systems. If an assessor identified a need for immediate replacement, a deficiency was created with the item's repair costs. The identified deficiency contributes to the facility's total current repair costs.

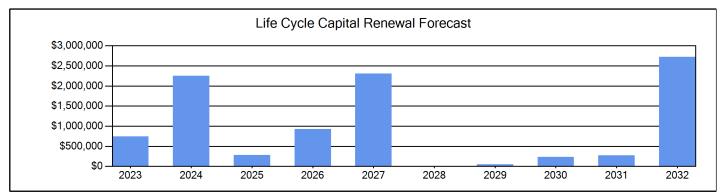
Figure 2: Ten Year Capital Renewal Forecast

Life Cycle	Capital Renewal	Projections			
System	Total 1-5	Year 6 2028	Year 7 2029	Year 8 2030	Year 9 2031	Year 10 2032	Total 6-10	Total 1-10
Site	\$322,817	\$0	\$0	\$105,022	\$0	\$0	\$105,022	\$427,839
Roofing	\$0	\$0	\$0	\$0	\$0	\$0	\$0	\$0
Exterior	\$747,569	\$0	\$0	\$0	\$0	\$0	\$0	\$747,569
Interior	\$1,753,629	\$0	\$50,846	\$0	\$136,451	\$175,326	\$362,623	\$2,116,252
Mechanical	\$2,492,973	\$0	\$0	\$35,763	\$0	\$86,795	\$122,558	\$2,615,531
Electrical	\$55,744	\$0	\$0	\$11,639	\$0	\$12,498	\$24,137	\$79,881
Plumbing	\$864,541	\$0	\$0	\$25,532	\$0	\$2,450,092	\$2,475,624	\$3,340,165
Fire and Life Safety	\$0	\$0	\$0	\$0	\$138,024	\$0	\$138,024	\$138,024
Conveyances	\$0	\$0	\$0	\$0	\$0	\$0	\$0	\$0
Specialties	\$285,922	\$0	\$0	\$52,811	\$0	\$0	\$52,811	\$338,733
Crawlspace	\$0	\$0	\$0	\$0	\$0	\$0	\$0	\$0
Total	\$6,523,195	\$0	\$50,846	\$230,767	\$274,475	\$2,724,711	\$3,280,799	\$9,803,994

Life Cycle Forecast: Life cycle analysis evaluates the ages of a building's systems to forecast system replacement as they reach the end of serviceable life. An example of a life cycle system replacement is a roof with a 20-year life that has been in place for 15 years and may require replacement in five years.
