FACILITY CONDITION ASSESSMENT

Joslin ES | February 2022

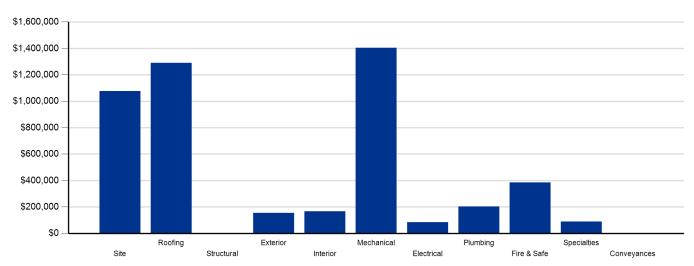
Figure 1: System Deficiencies

The chart below represents the building systems and associated deficiency costs.
