FACILITY CONDITION ASSESSMENT

Kocurek ES | February 2022

Kocurek ES is located at 9800 Curlew Dr in Austin, Texas. The oldest building is 34 years old (at time of 2020 assessment). It comprises 78,704 gross square feet.

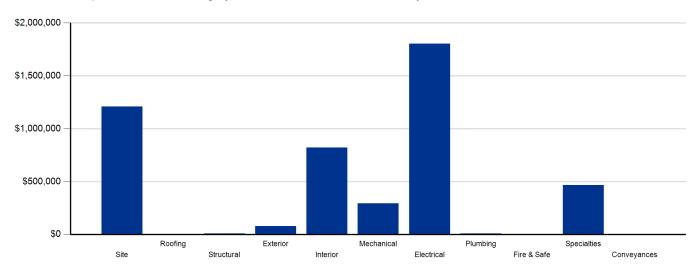
The chart below represents the building systems and associated deficiency costs.

Figure 1: System Deficiencies

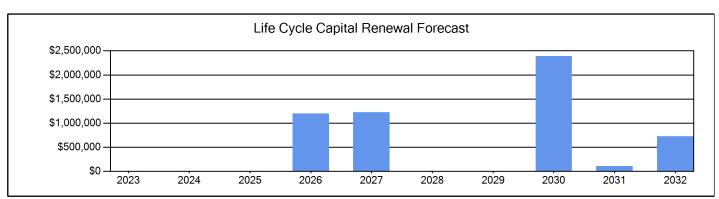
Figure 2: Ten Year Capital Renewal Forecast

Table 3b: Capital Renewal Forecast (Yrs 6-10)

Life Cycle	Capital Renewal F	Projections			
System	Total 1-5	Year 6 2028	Year 7 2029	Year 8 2030	Year 9 2031	Year 10 2032	Total 6-10	Total 1-10
Site	\$296,020	\$0	\$0	\$0	\$0	\$264,411	\$264,411	\$560,431
Roofing	\$0	\$0	\$0	\$0	\$0	\$284,115	\$284,115	\$284,115
Exterior	\$74,140	\$0	\$0	\$297,901	\$0	\$14,828	\$312,729	\$386,869
Interior	\$136,529	\$0	\$0	\$307,386	\$0	\$0	\$307,386	\$443,915
Mechanical	\$1,258,920	\$0	\$0	\$359,461	\$0	\$139,209	\$498,670	\$1,757,590
Electrical	\$144,023	\$0	\$0	\$102,116	\$0	\$0	\$102,116	\$246,139
Plumbing	\$6,384	\$0	\$0	\$5,059	\$0	\$22,651	\$27,710	\$34,094
Fire and Life Safety	\$40,848	\$0	\$0	\$156,982	\$108,292	\$0	\$265,274	\$306,122
Conveyances	\$0	\$0	\$0	\$0	\$0	\$0	\$0	\$0
Specialties	\$466,499	\$0	\$0	\$1,161,847	\$0	\$0	\$1,161,847	\$1,628,346
Crawlspace	\$0	\$0	\$0	\$0	\$0	\$0	\$0	\$0
Total	\$2,423,363	\$0	\$0	\$2,390,752	\$108,292	\$725,214	\$3,224,258	\$5,647,621
