FACILITY CONDITION ASSESSMENT

Liberal Arts and Science Academy | February 2022

Austin ISD - Liberal Arts and Science Academy

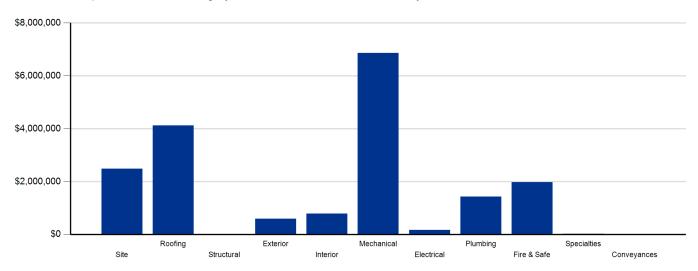
Figure 1: System Deficiencies

The chart below represents the building systems and associated deficiency costs.
