# FACILITY CONDITION ASSESSMENT

## Odom ES | February 2022

Odom ES is located at 1010 Turtle Creek Blvd in Austin, Texas. The oldest building is 50 years old (at time of 2020 assessment). It comprises 65,911 gross square feet.

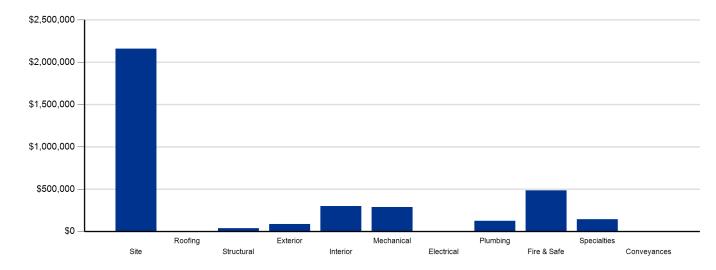
Figure 1: System Deficiencies

The chart below represents the building systems and associated deficiency costs.
