FACILITY CONDITION ASSESSMENT

Overton ES | February 2022

Overton ES is located at 7201 Colony Loop Dr in Austin, Texas. The oldest building is 13 years old (at time of 2020 assessment). It comprises 83,405 gross square feet.

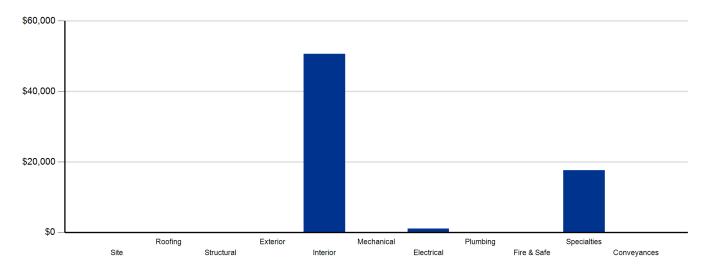
Figure 1: System Deficiencies

The chart below represents the building systems and associated deficiency costs.
