FACILITY CONDITION ASSESSMENT

Pleasant Hill ES | February 2022

Pleasant Hill ES is located at 6405 Circle S Rd in Austin, Texas. The oldest building is 35 years old (at time of 2020 assessment). It comprises 65,548 gross square feet.

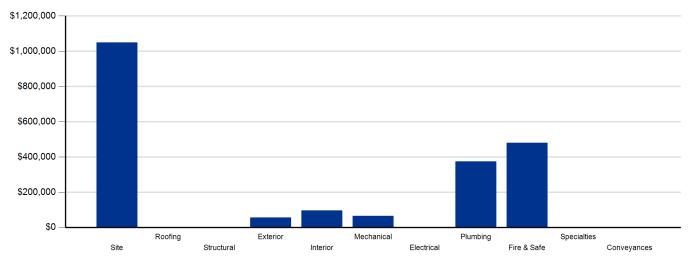
Figure 1: System Deficiencies

The following table summarizes this site's current deficiencies by building system and priority.

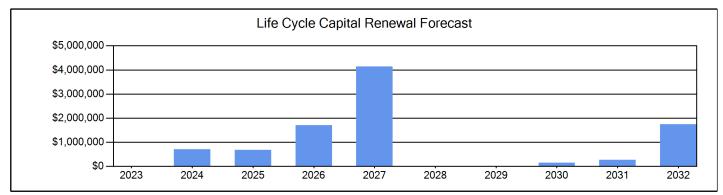
Figure 2: Ten Year Capital Renewal Forecast

Table 3b: Capital Renewal Forecast (Yrs 6-10)
