FACILITY CONDITION ASSESSMENT

Rosedale School | February 2022

Executive Summary

Rosedale School is located at 2117 W 49th St in Austin, Texas. The oldest building is 81 years old (at time of 2020 assessment). It comprises 36,549 gross square feet.

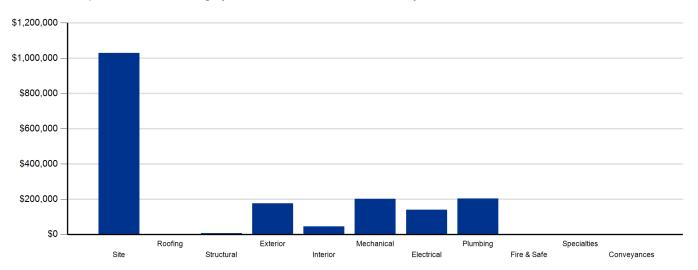
Figure 1: System Deficiencies

The chart below represents the building systems and associated deficiency costs.
