# **FACILITY CONDITION ASSESSMENT**

Summitt ES | February 2022

## **Executive Summary**

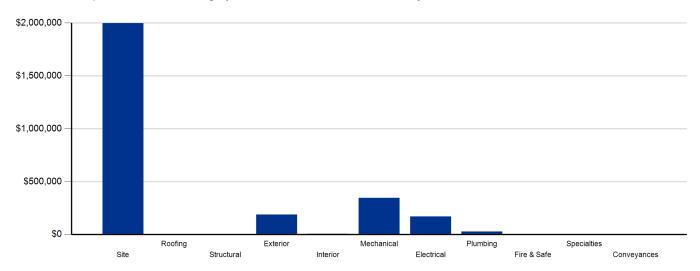
Figure 1: System Deficiencies

The chart below represents the building systems and associated deficiency costs.
