FACILITY CONDITION ASSESSMENT

Travis Heights ES | February 2022

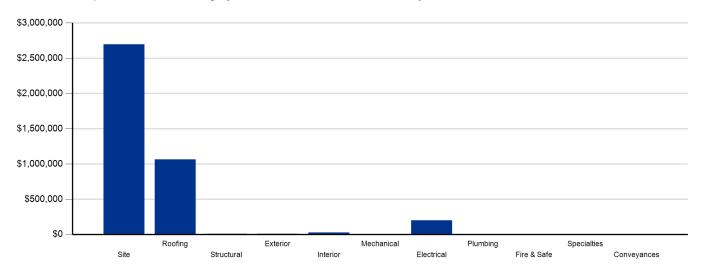
Figure 1: System Deficiencies

The chart below represents the building systems and associated deficiency costs.
