FACILITY CONDITION ASSESSMENT

Walnut Creek ES | February 2022

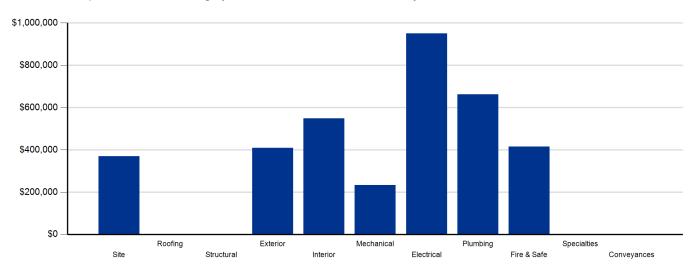
Figure 1: System Deficiencies

The chart below represents the building systems and associated deficiency costs.
