Educational Suitability Summary Report

Baranoff Elementary School

Date: 07/19/2016

Austin ISD Educational Suitability Assessment Criteria

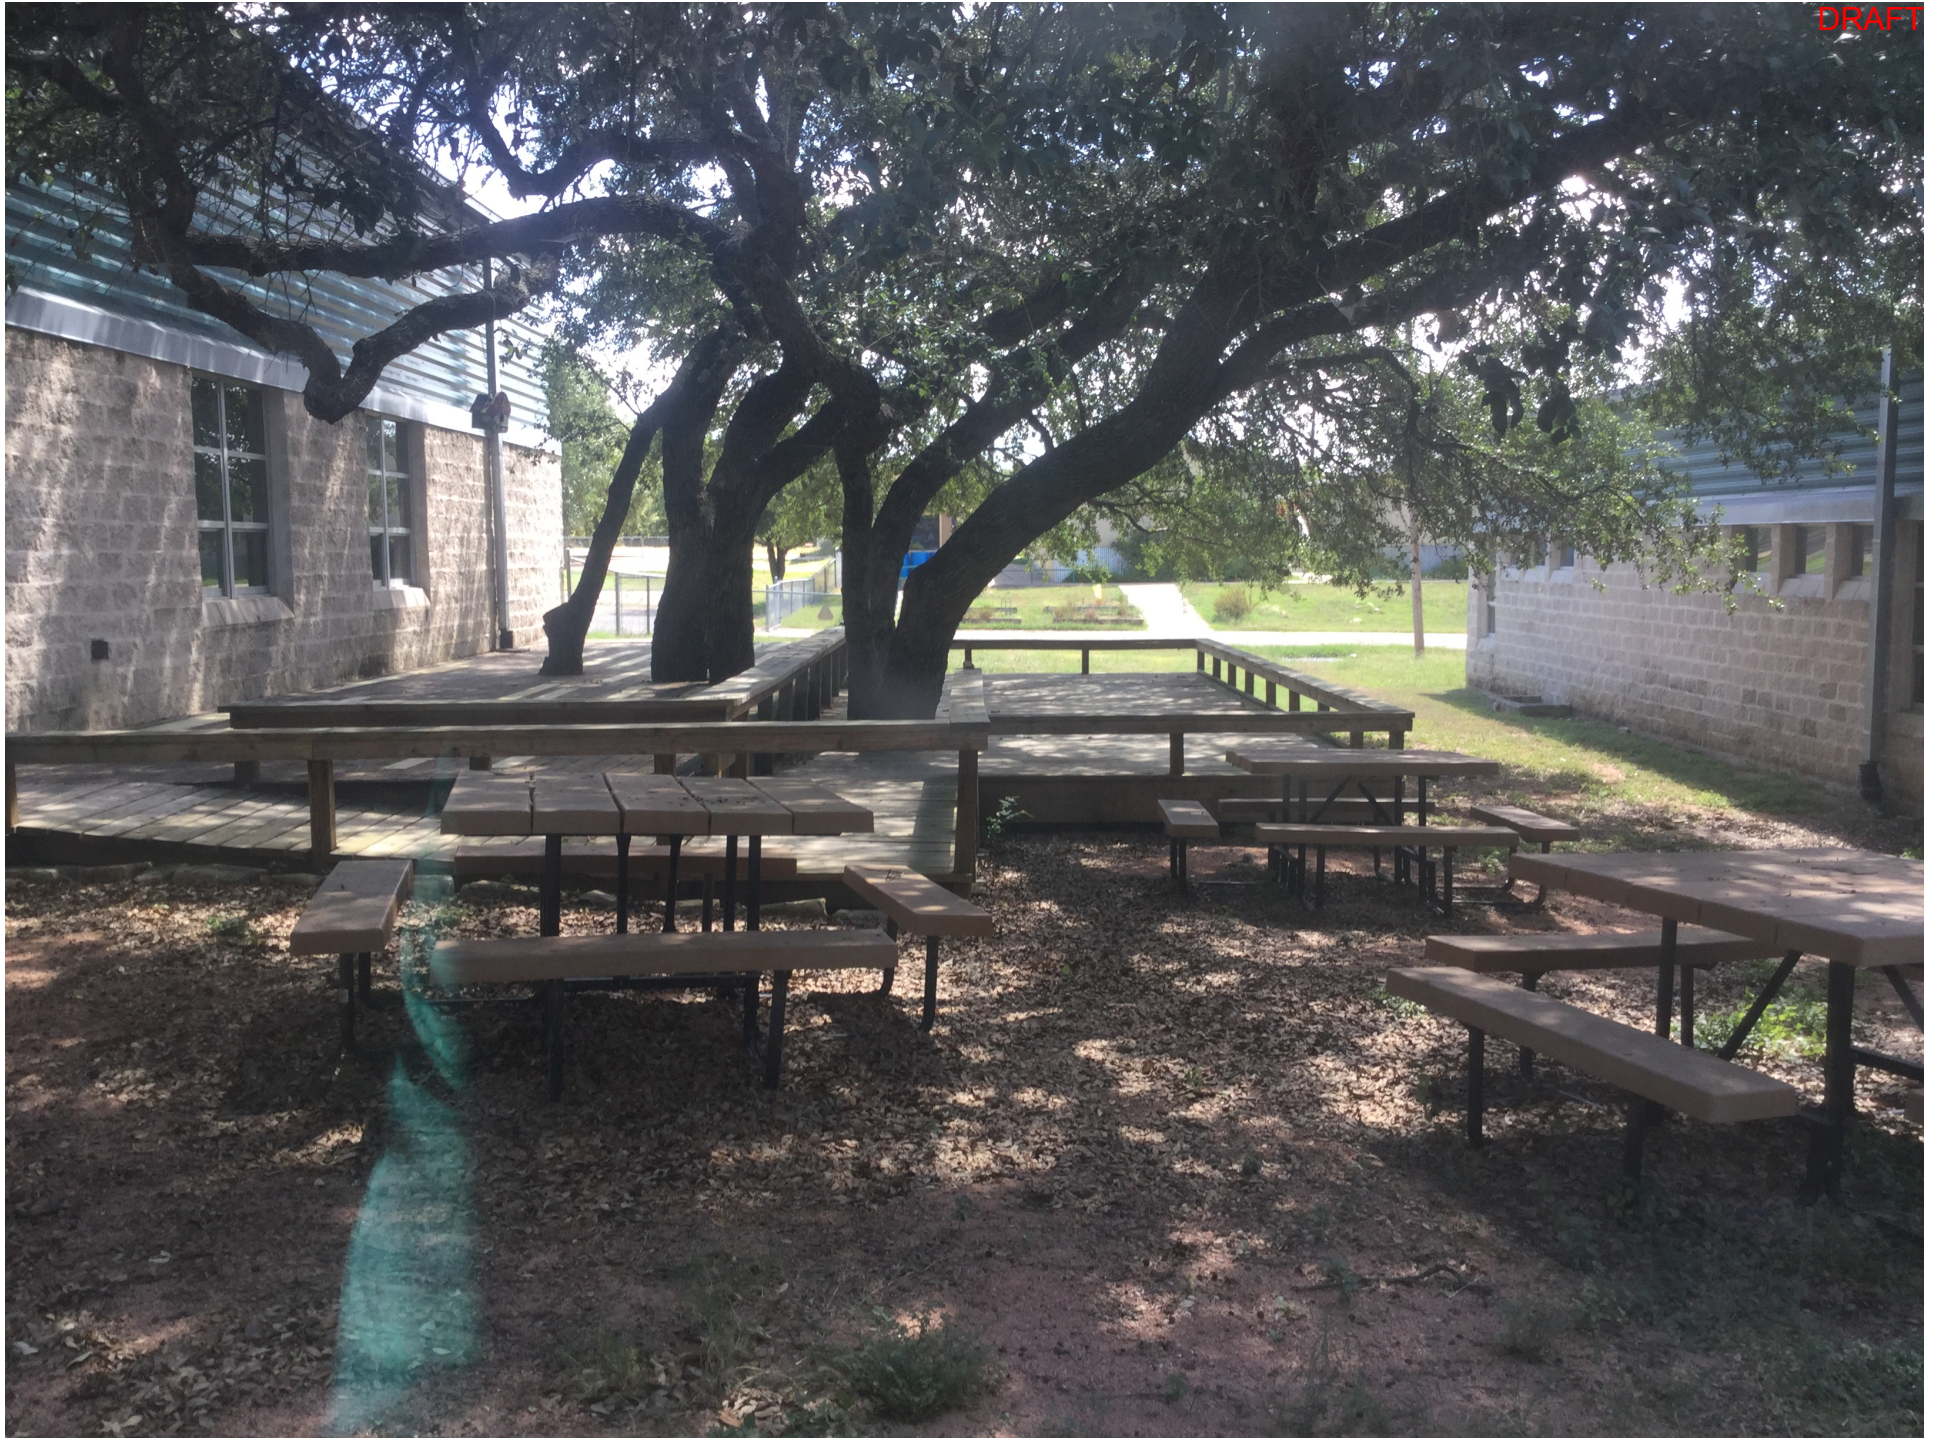
Photo 1.
1.2 Outdoor Learning Space

1.2	Are opportunities provided for outdoor learning (outdoor classrooms, gardens, etc.)?				4			Comments	1.00 4.00
1) Outdoor space exists is not developed 2) Outdoor space for learning exists but not connected to classroom learning areas. 3. Outdoor learning spaces exist and are accessible but not in good condition. 4. Outdoor learning spaces need minor improvements to function well. 5. Outdoor learning spaces are in excellent condition. N/A) Does not apply.									see photo 1

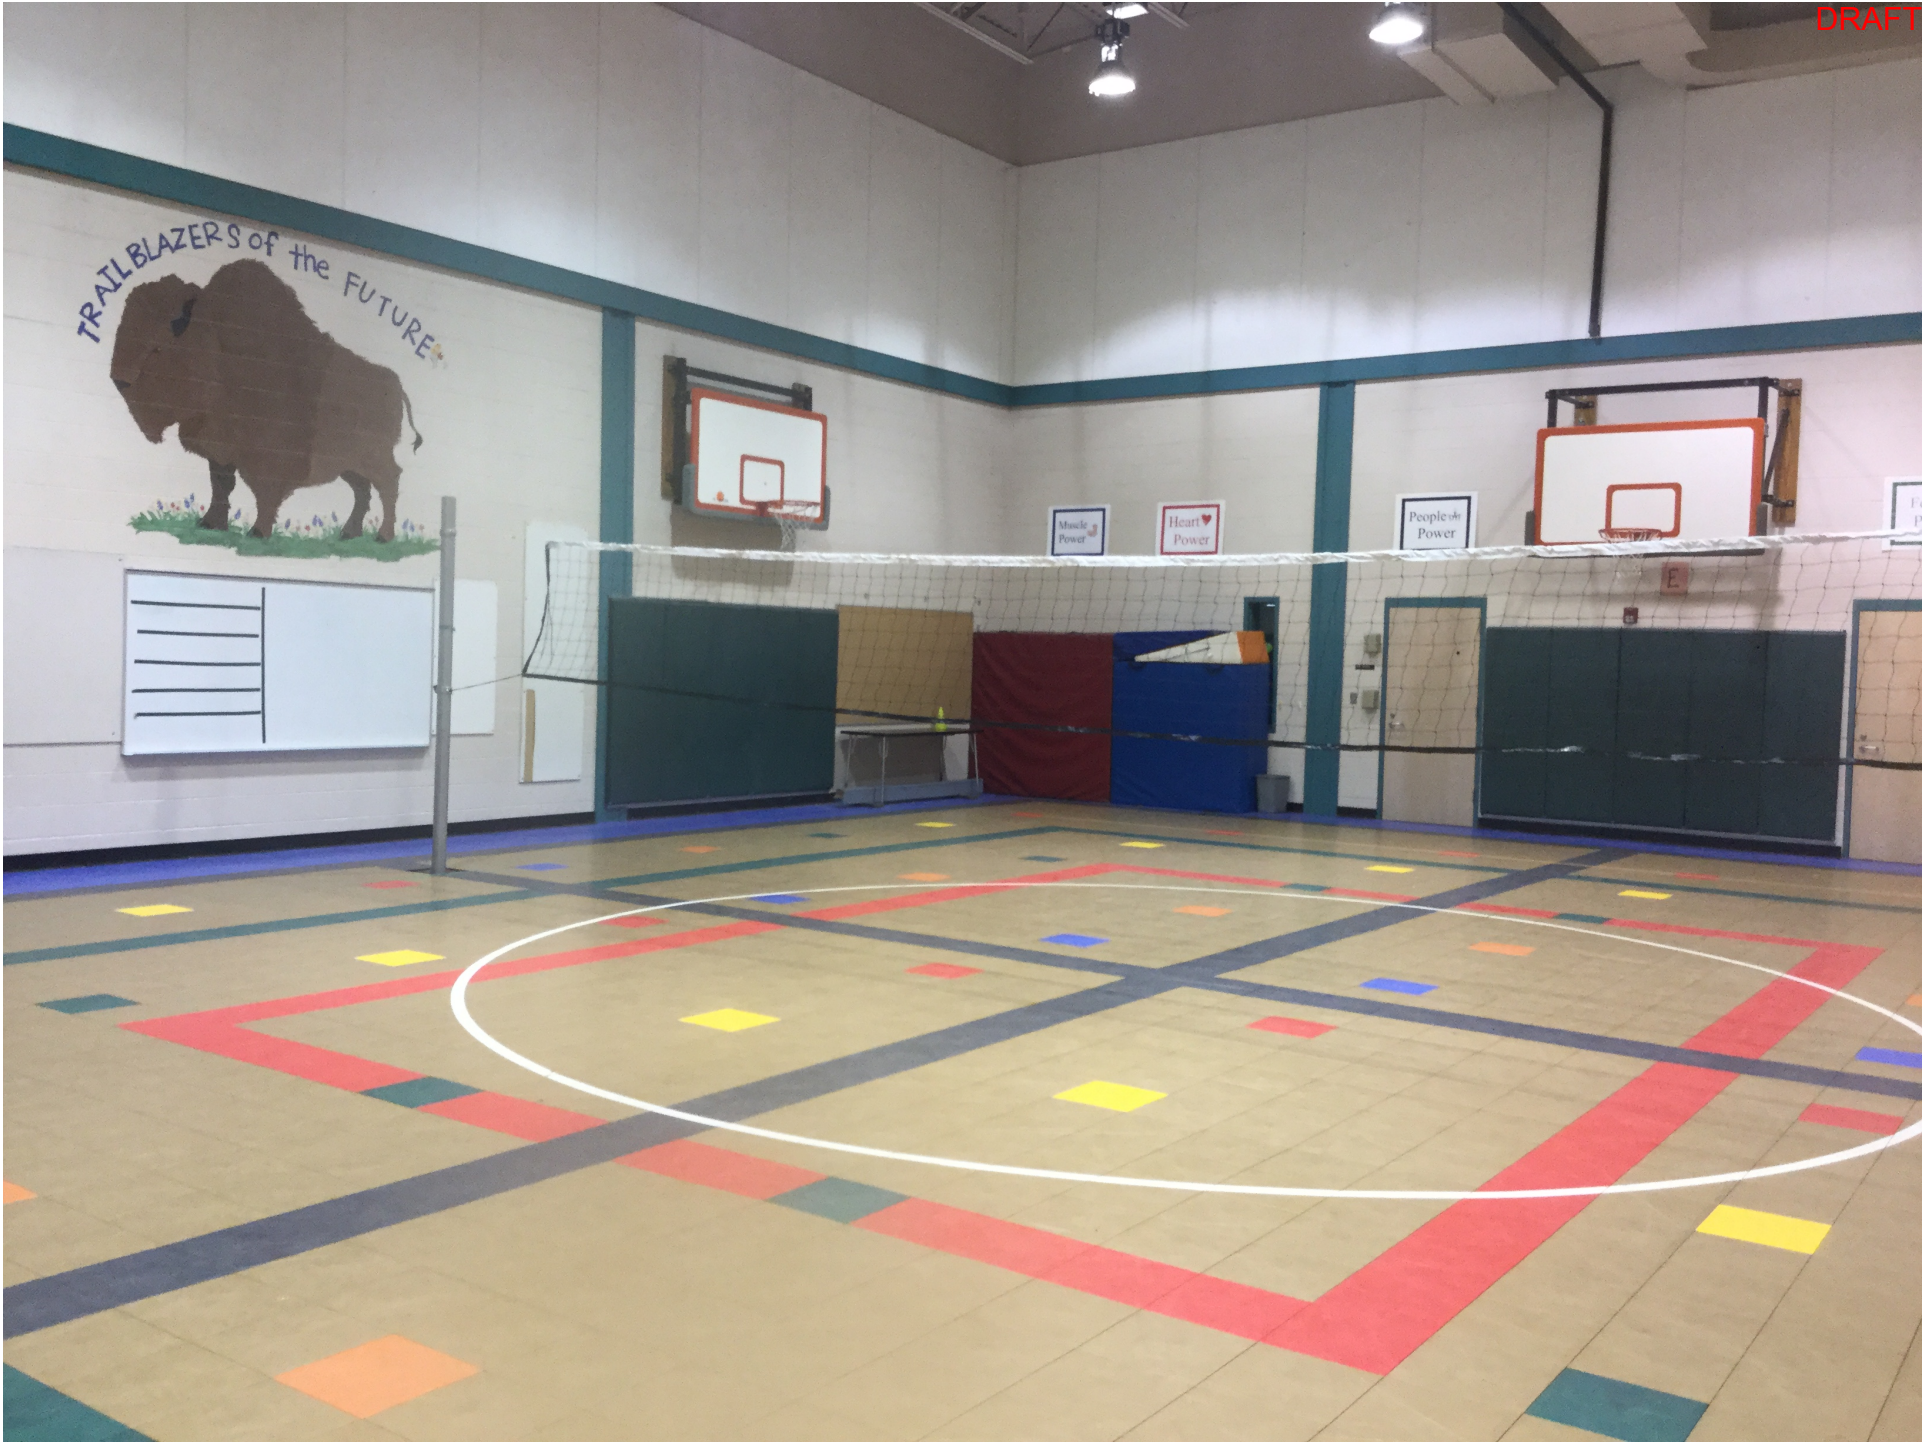
Photo 2.
3.6 Gym

1) Very unsatisfactory 2) Unsatisfactory 3) Average 4) Good 5) Very good N/A) Does not apply.						The athletic spaces are Inadequate in size due to the overcrowding in the school.	
see photo 2

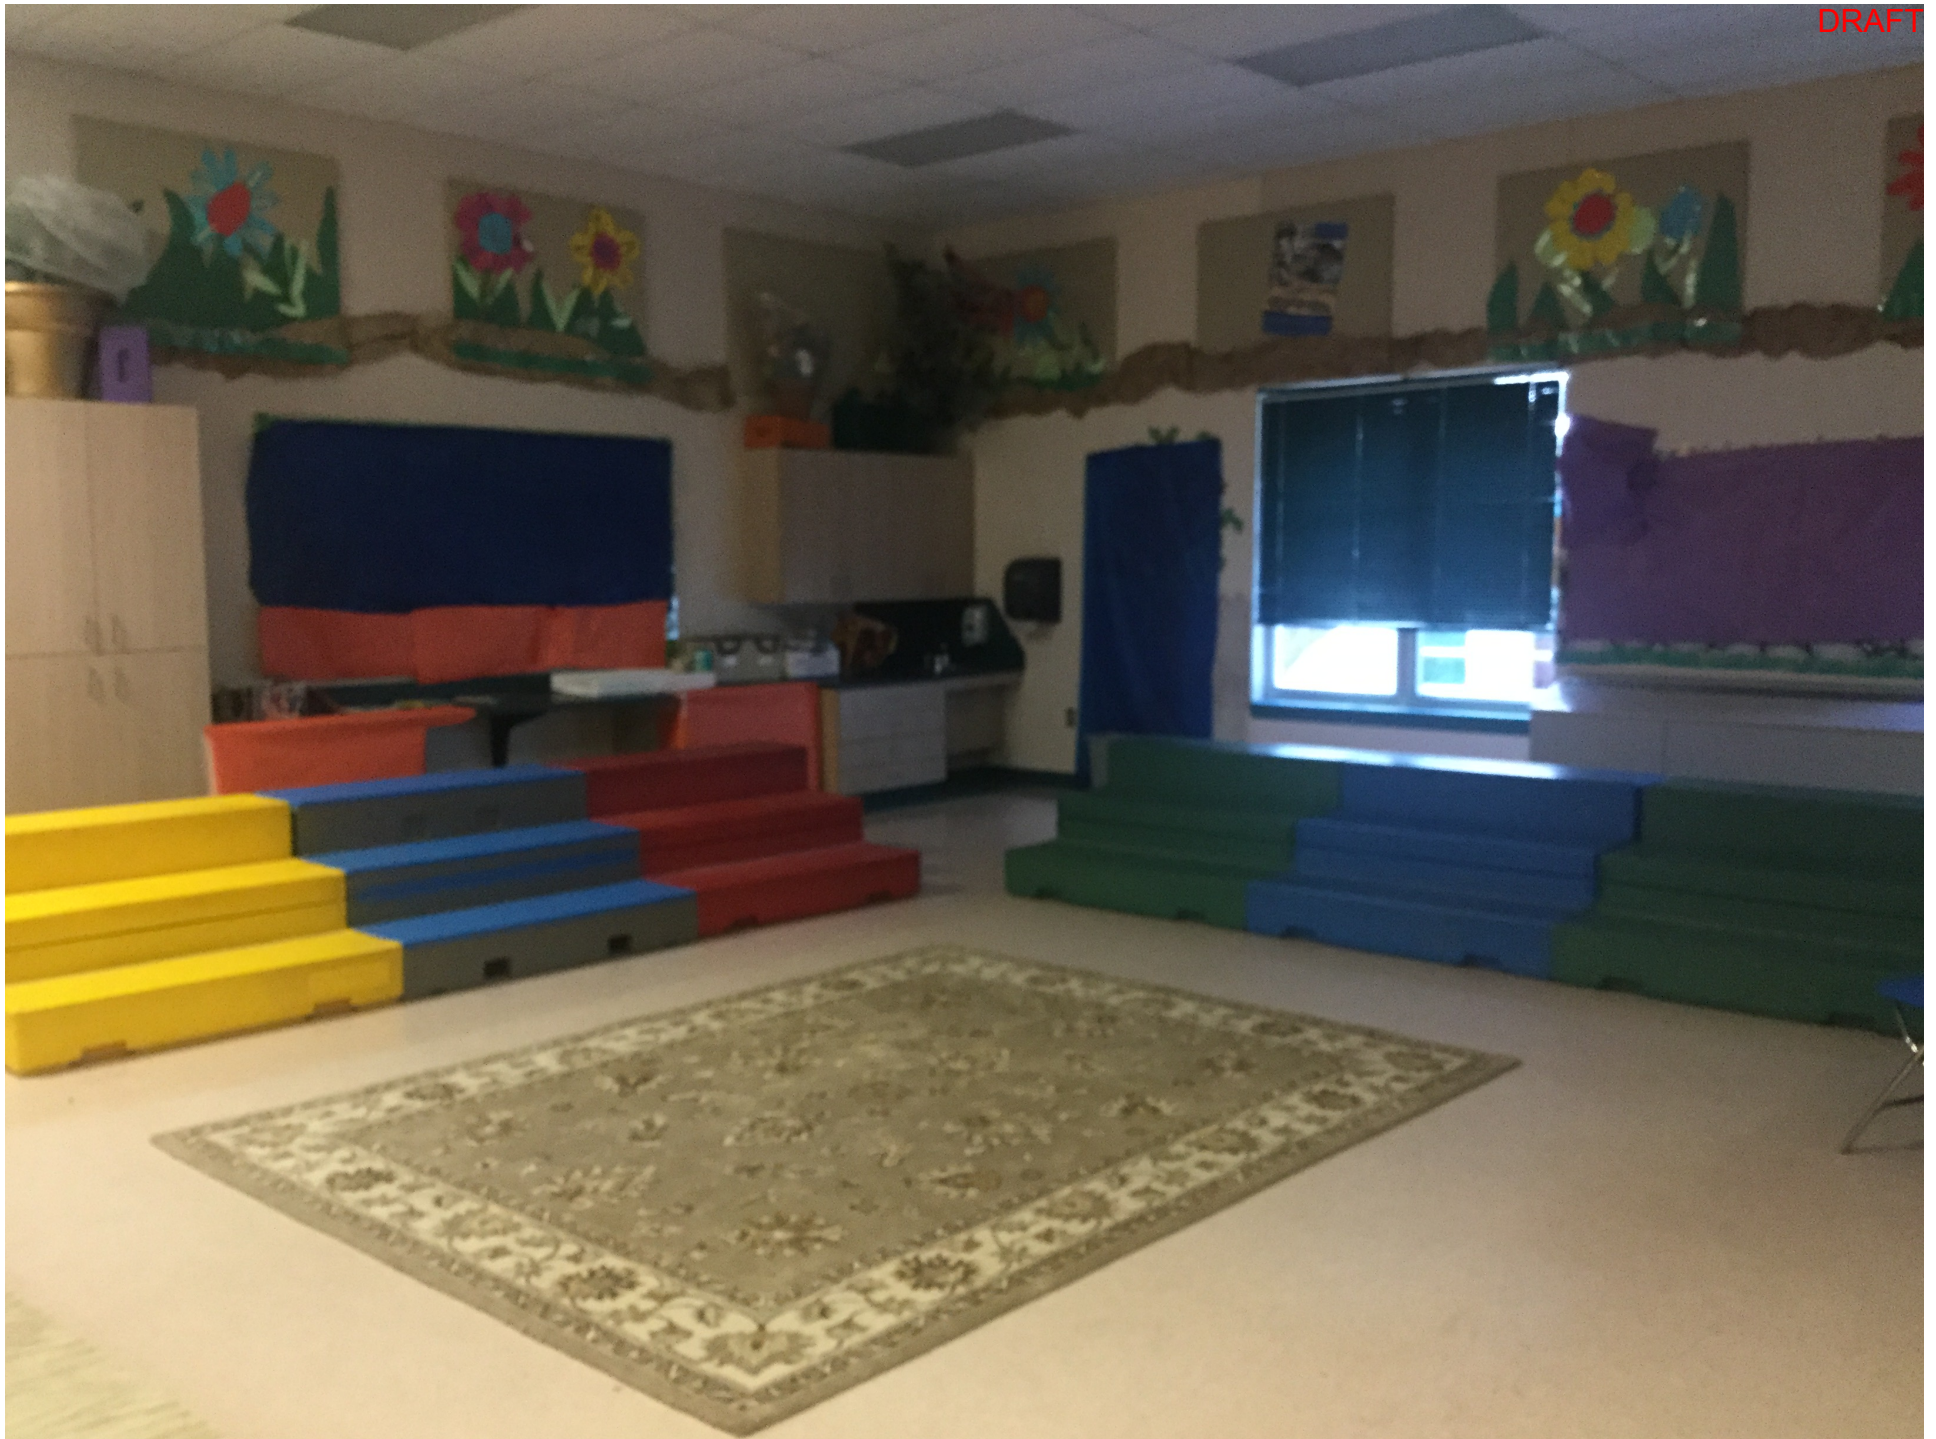
Photo 3.
3.8 Music Room

3.8	Are music, drama, or performance spaces appropriately configured per the ed spec?				4		
1) Very unsatisfactory 2) Unsatisfactory 3) Average 4) Good 5) Very good N/A) Does not apply.						Due to over capacity, they have added a section of art and music in portables. Currently there are two sections in the school.	
see photo 3

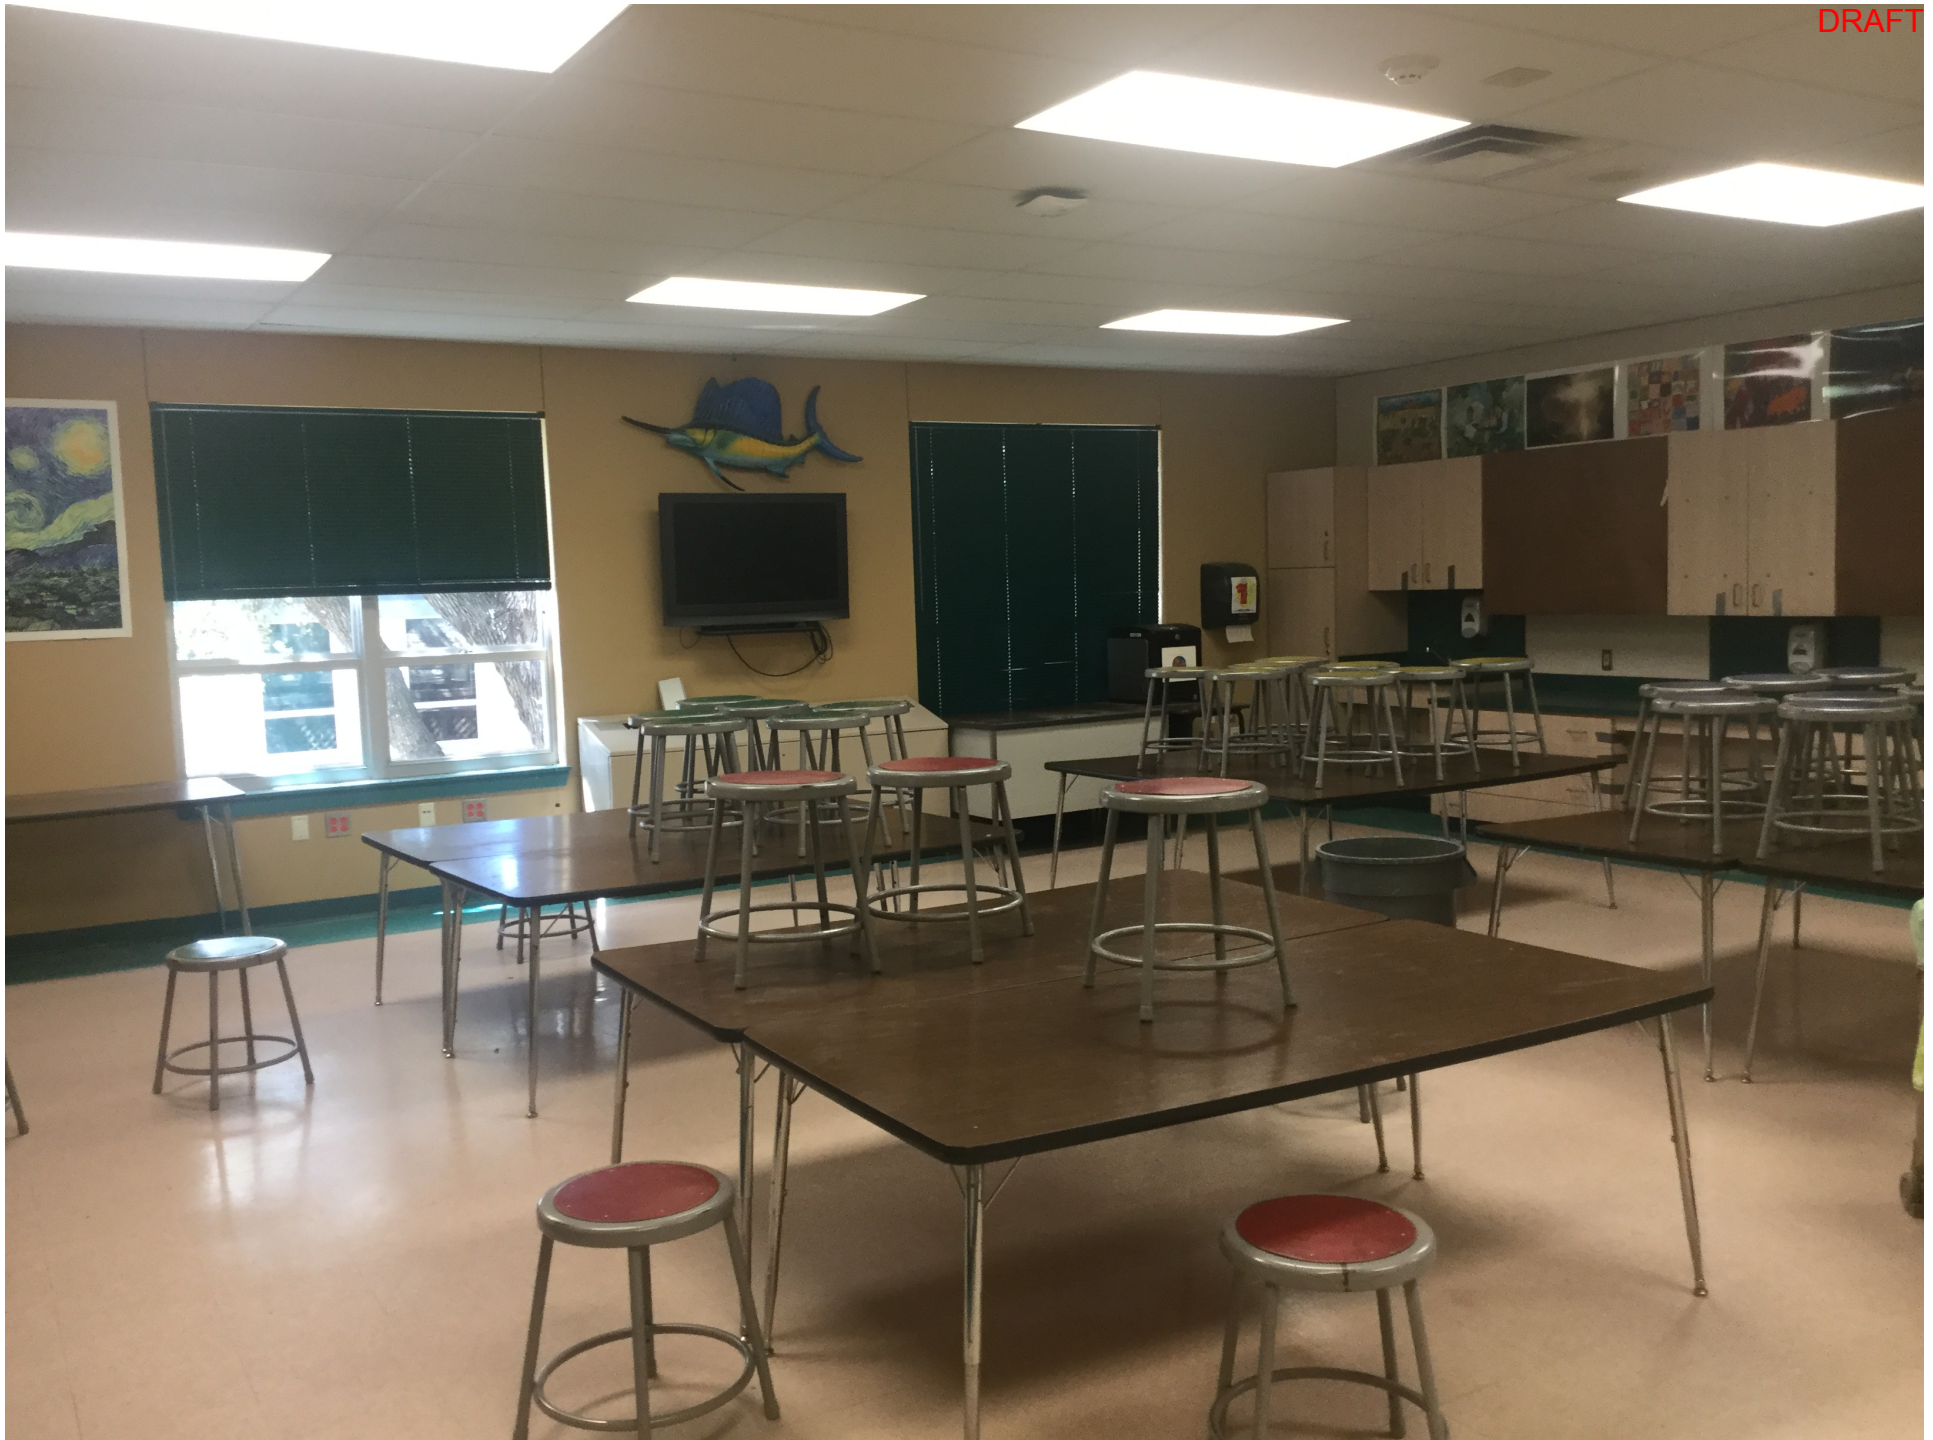
Photo 4.
3.10 Art Room

1) Very unsatisfactory 2) Unsatisfactory 3) Average 4) Good 5) Very good N/A) Does not apply.													There are two well equipped rooms inside the school for art, but due to overcrowding, one is in the portable.			see photo 4

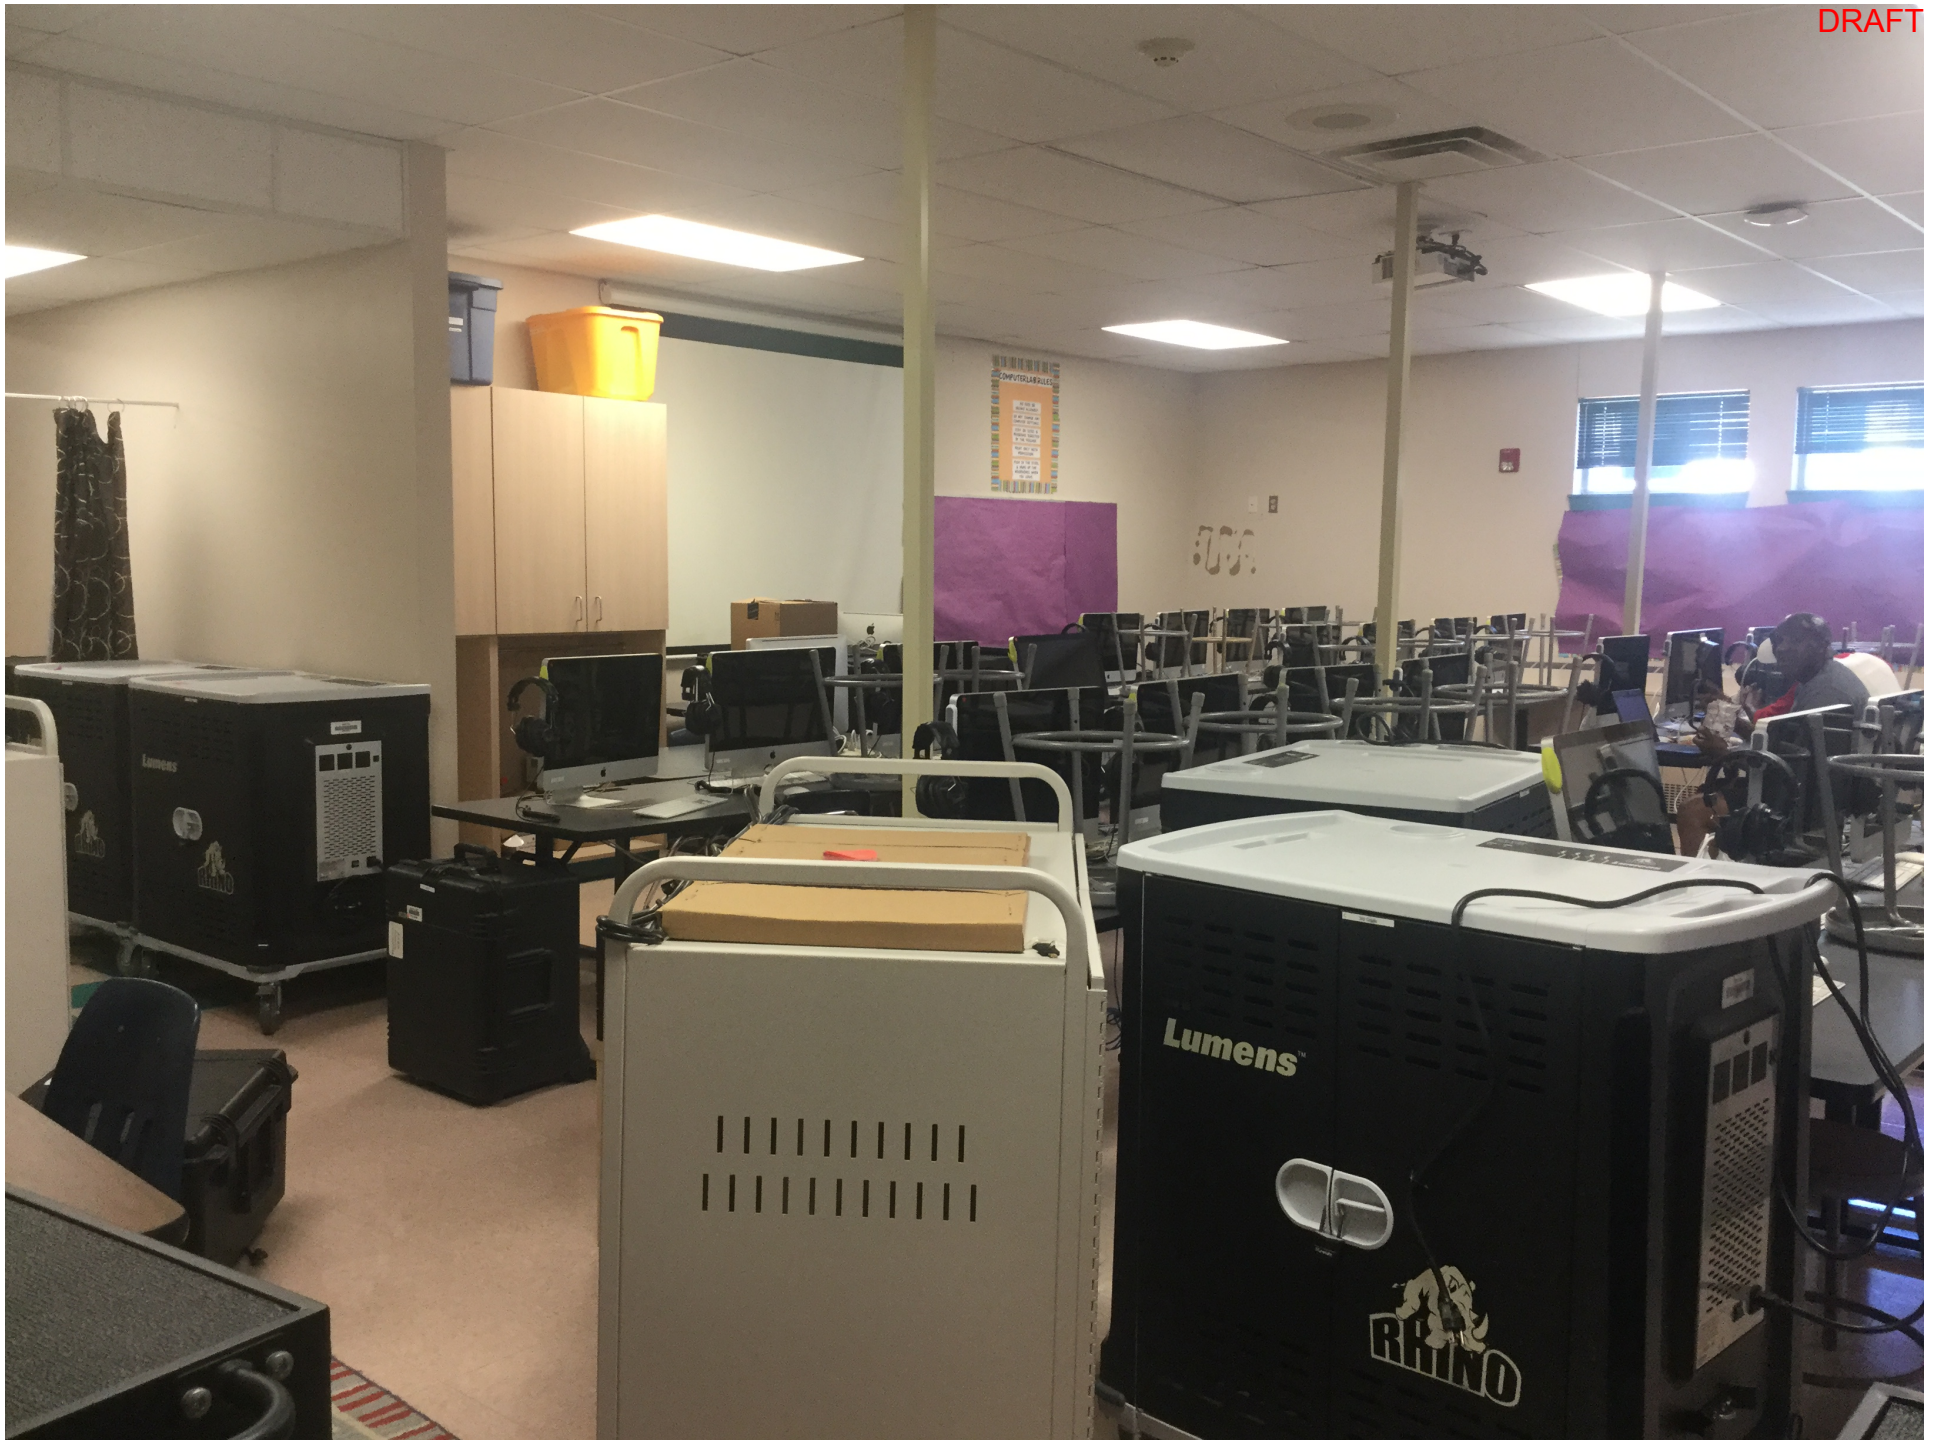
Photo 5.
3.12 Computer Lab

3.12	Are computer lab spaces appropriately configured?											5		Comments	1.00	5.00	
1) Very unsatisfactory 2) Unsatisfactory 3) Average 4) Good 5) Very good N/A) Does not apply.																see photo 5

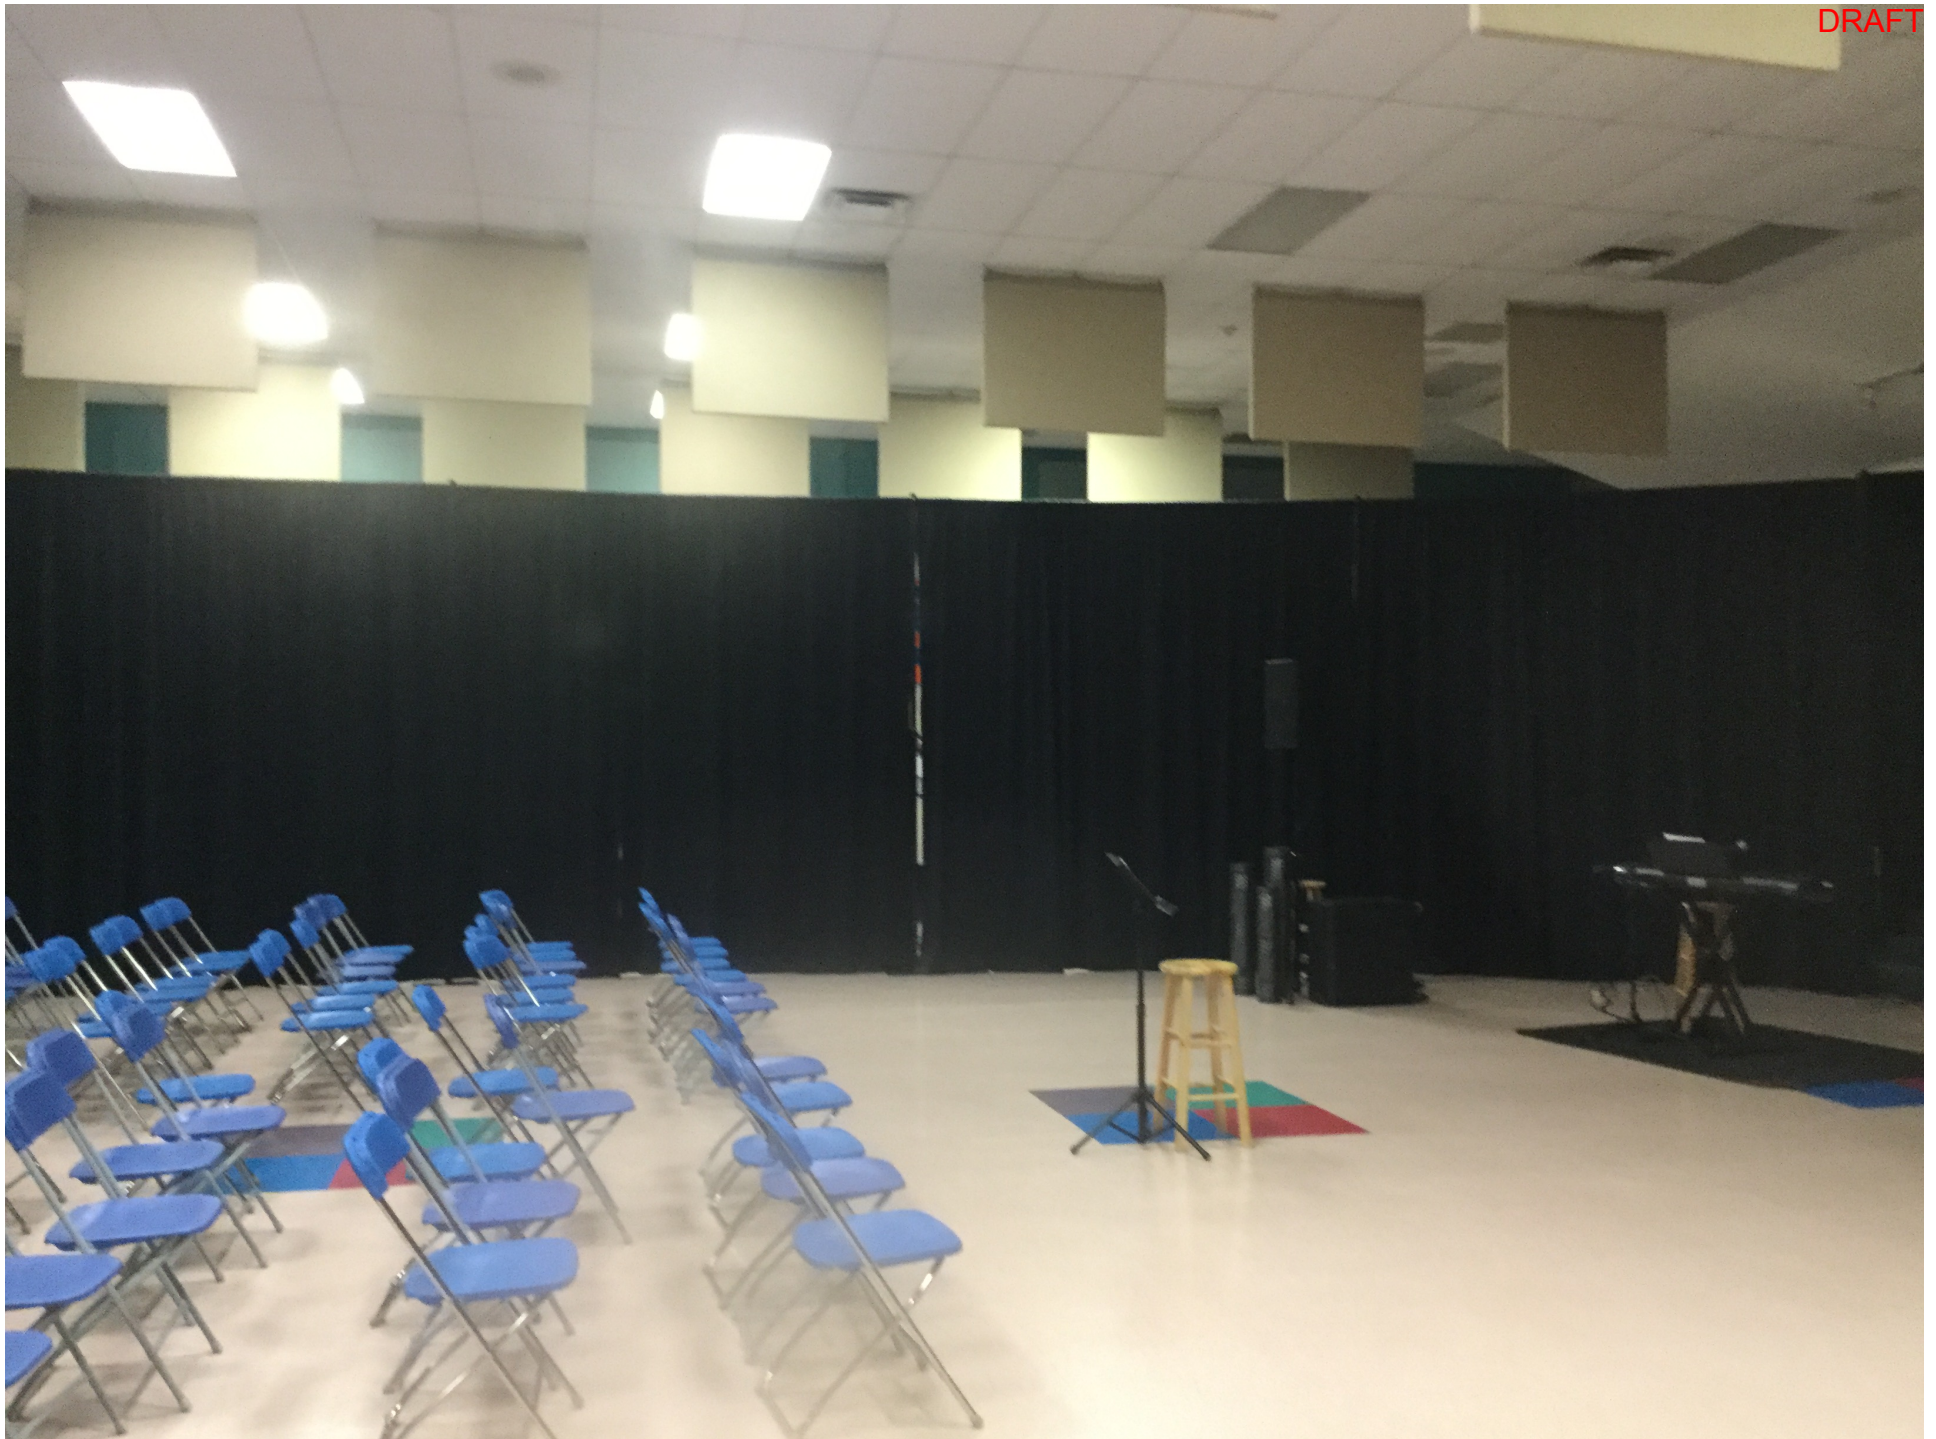
Photo 6.
3.16 Dining Facility

3.16	Are the student dining facilities appropriately configured?			3				Comments	1.00 3.00
1) Very unsatisfactory - Too small, poor circulation, inflexible seating in poor condition 2) Unsatisfactory - Too small or inadequate circulation, seating in poor condition 3) Average - moderate size, with adequate circulation, seating in okay condition 4) Good - good size, adequate circulation, seating in good condition 5) Very good - good size, adequate circulation, seating in good condition, with more than one option for eating space (ex: connection to outdoor eating space) N/A) Does not apply.								Due to over crowding there may be an issue with the number of serving lines.

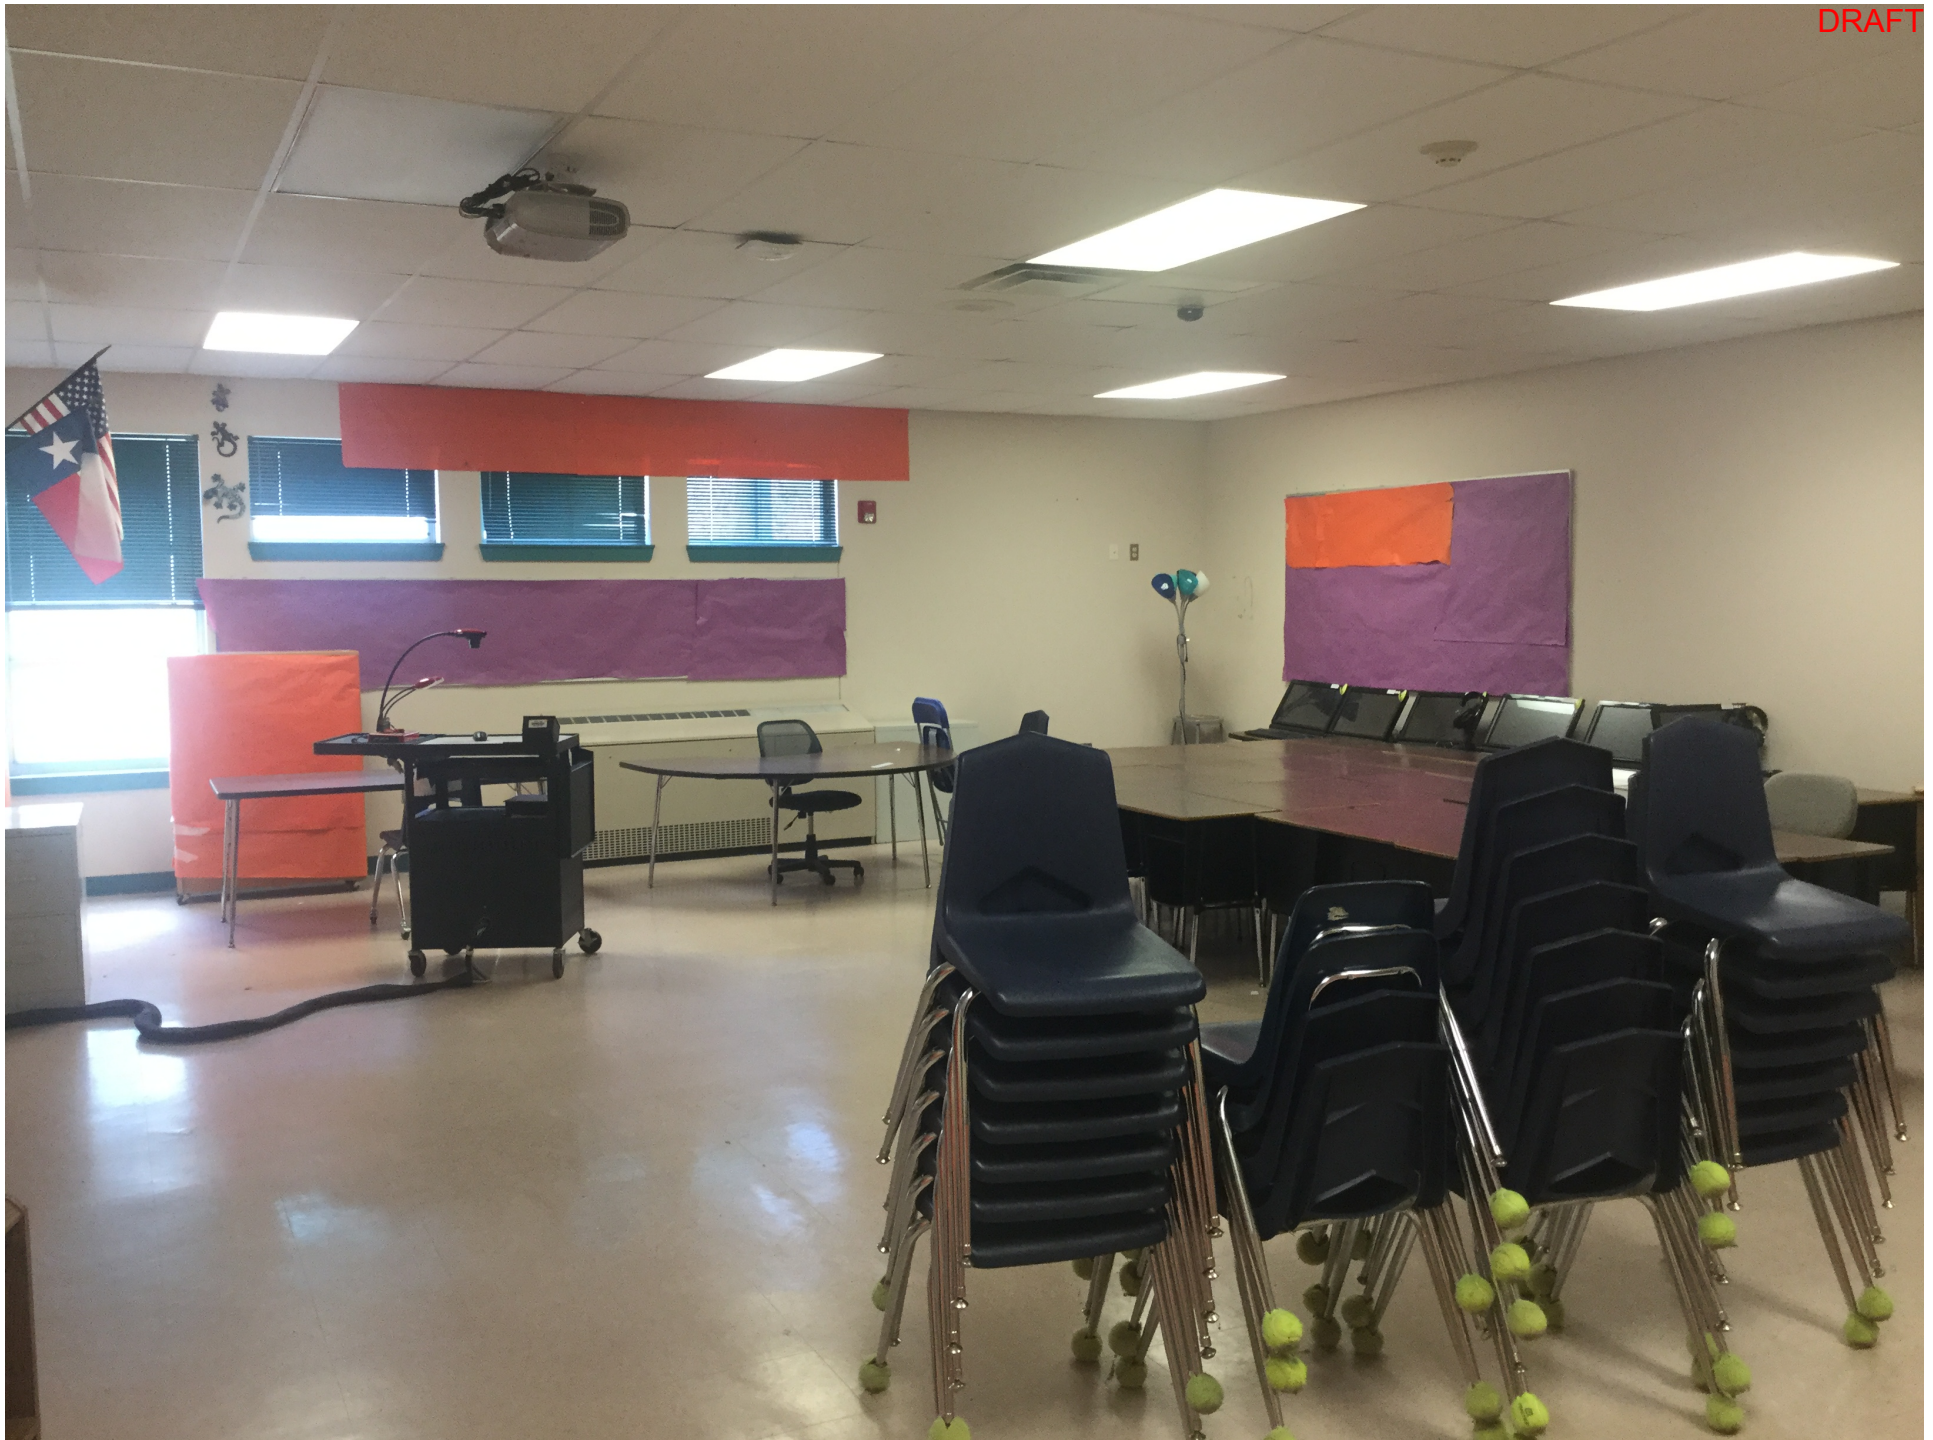
Photo 7.
4.2 Standard Classroom

4.2	Are general classrooms large enough to support project-based learning and multiple teaching modalities?				4			Comments	1.00 4.00
1) Very unsatisfactory -too small to move, set for lecture only, no connectivity, no flexibility 2) Unsatisfactory - adequate size but set for lecture only, no connectivity, no flexibility 3) Neutral - have flexibility and space for hands on or project based learning 4) Satisfactory - have flexibility and space for hands on or project based learning and connectivity for global learning 5) Very Satisfactory - space for hands on learning, flexibility for different groupings, and connectivity for global classrooms N/A) Does not apply.									see photo 7

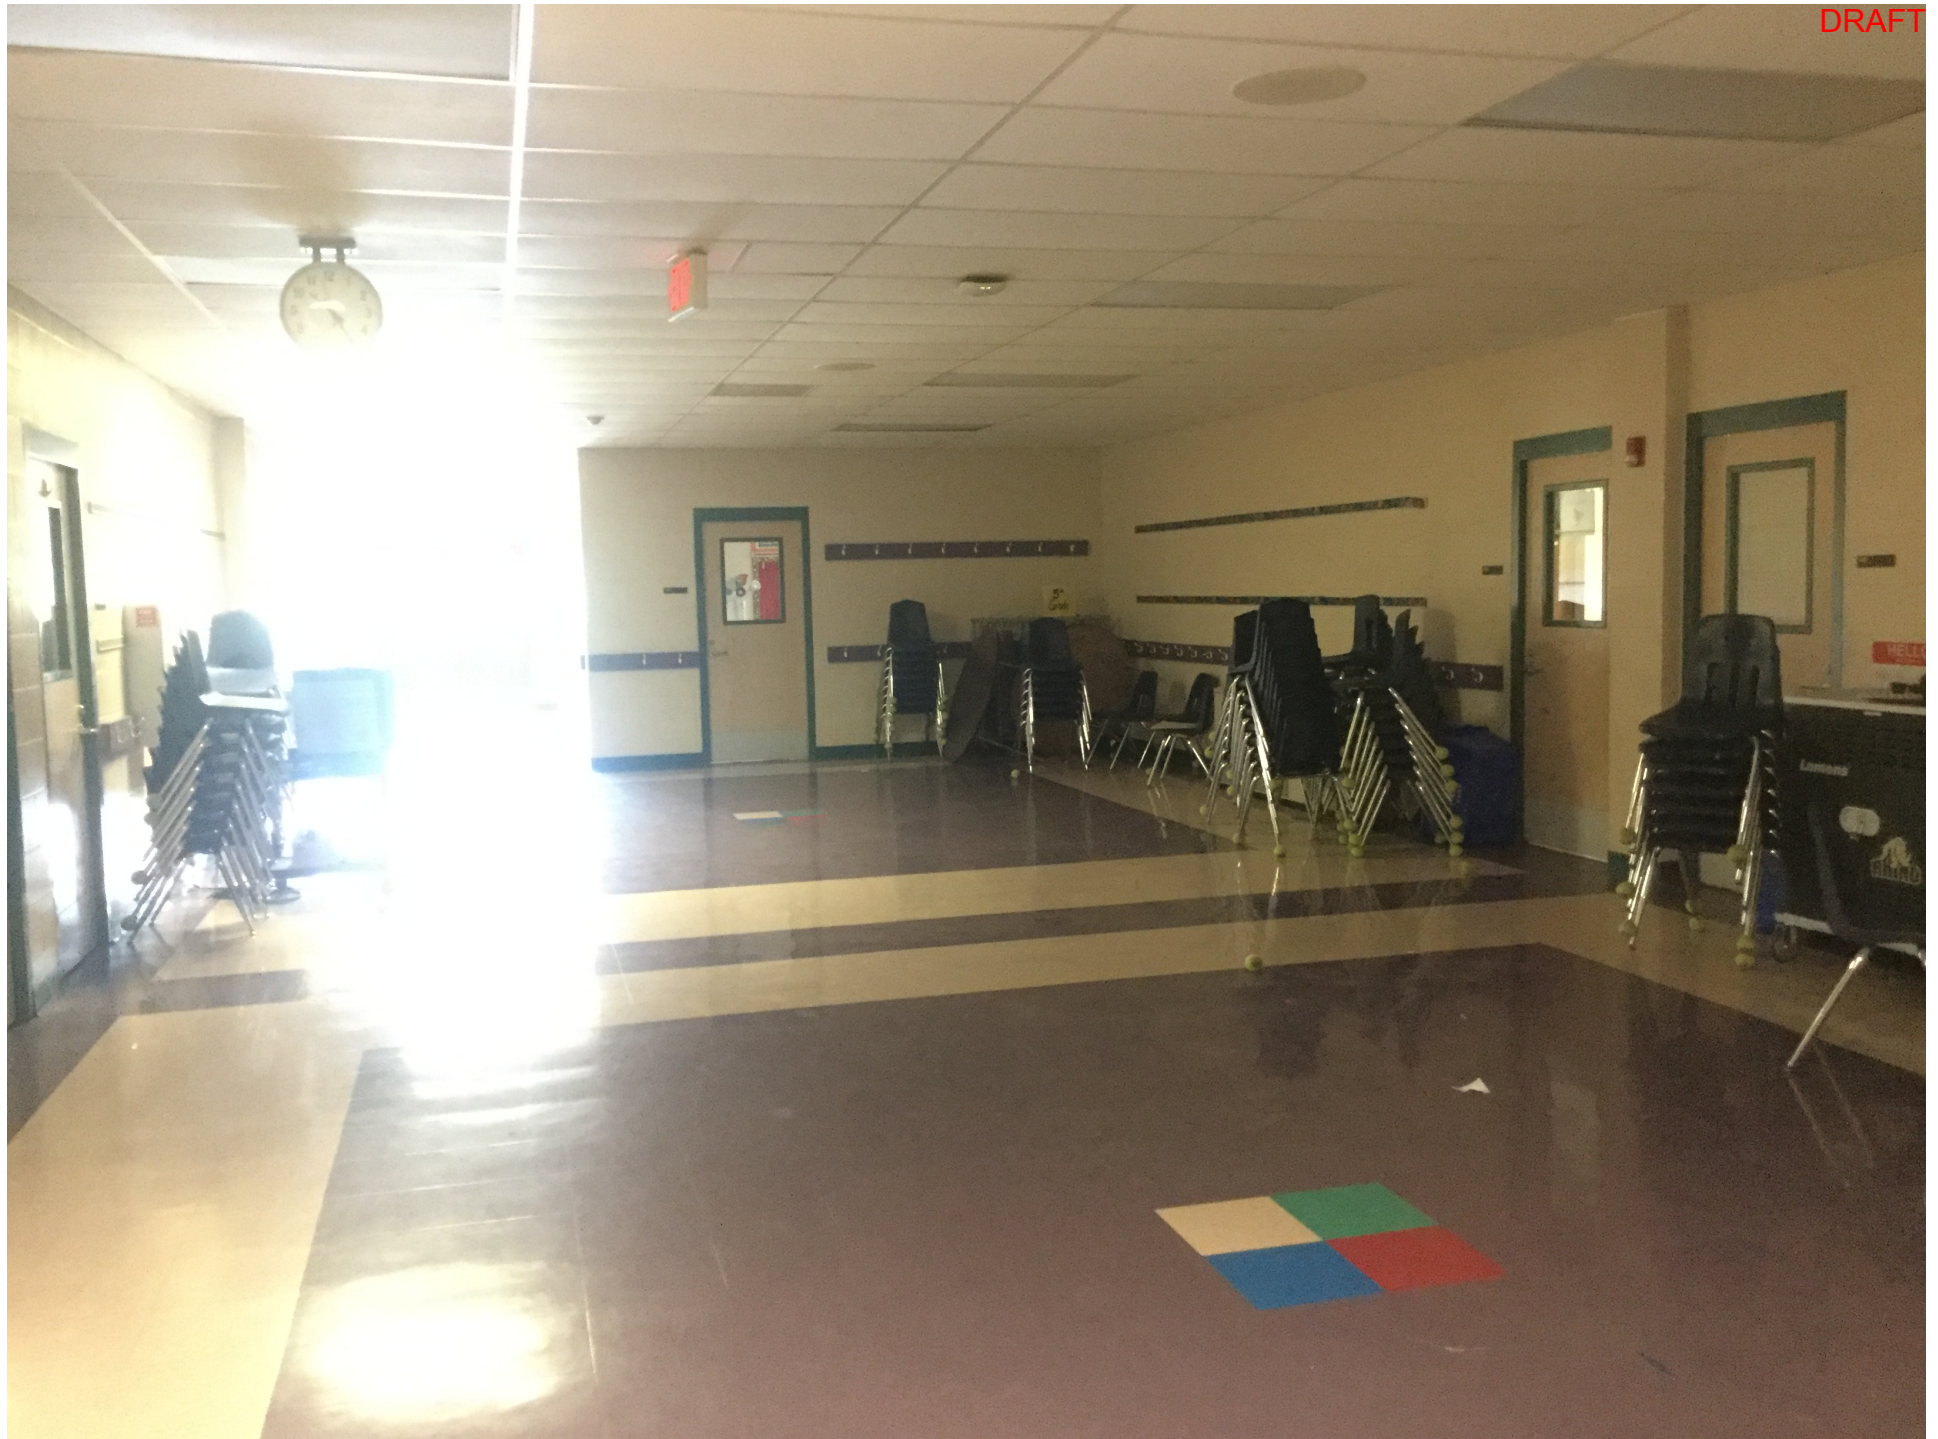
Photo 8.
4.5 Collaborative Space

1) Very unsatisfactory - no common spaces or meeting rooms or in very poor condition 2) Unsatisfactory - a few common spaces or meeting rooms in unsatisfactory condition 3) Average - a few common spaces and meeting areas needing updates 4) Good - multiple common spaces and meeting rooms in good condition 5) Very good - adequate common spaces and meeting rooms of excellent quality N/A) Does not apply.								see photo 8
