Educational Suitability Summary Report

Baranoff Elementary School

Date: 07/19/2016

Austin ISD Educational Suitability Assessment Criteria

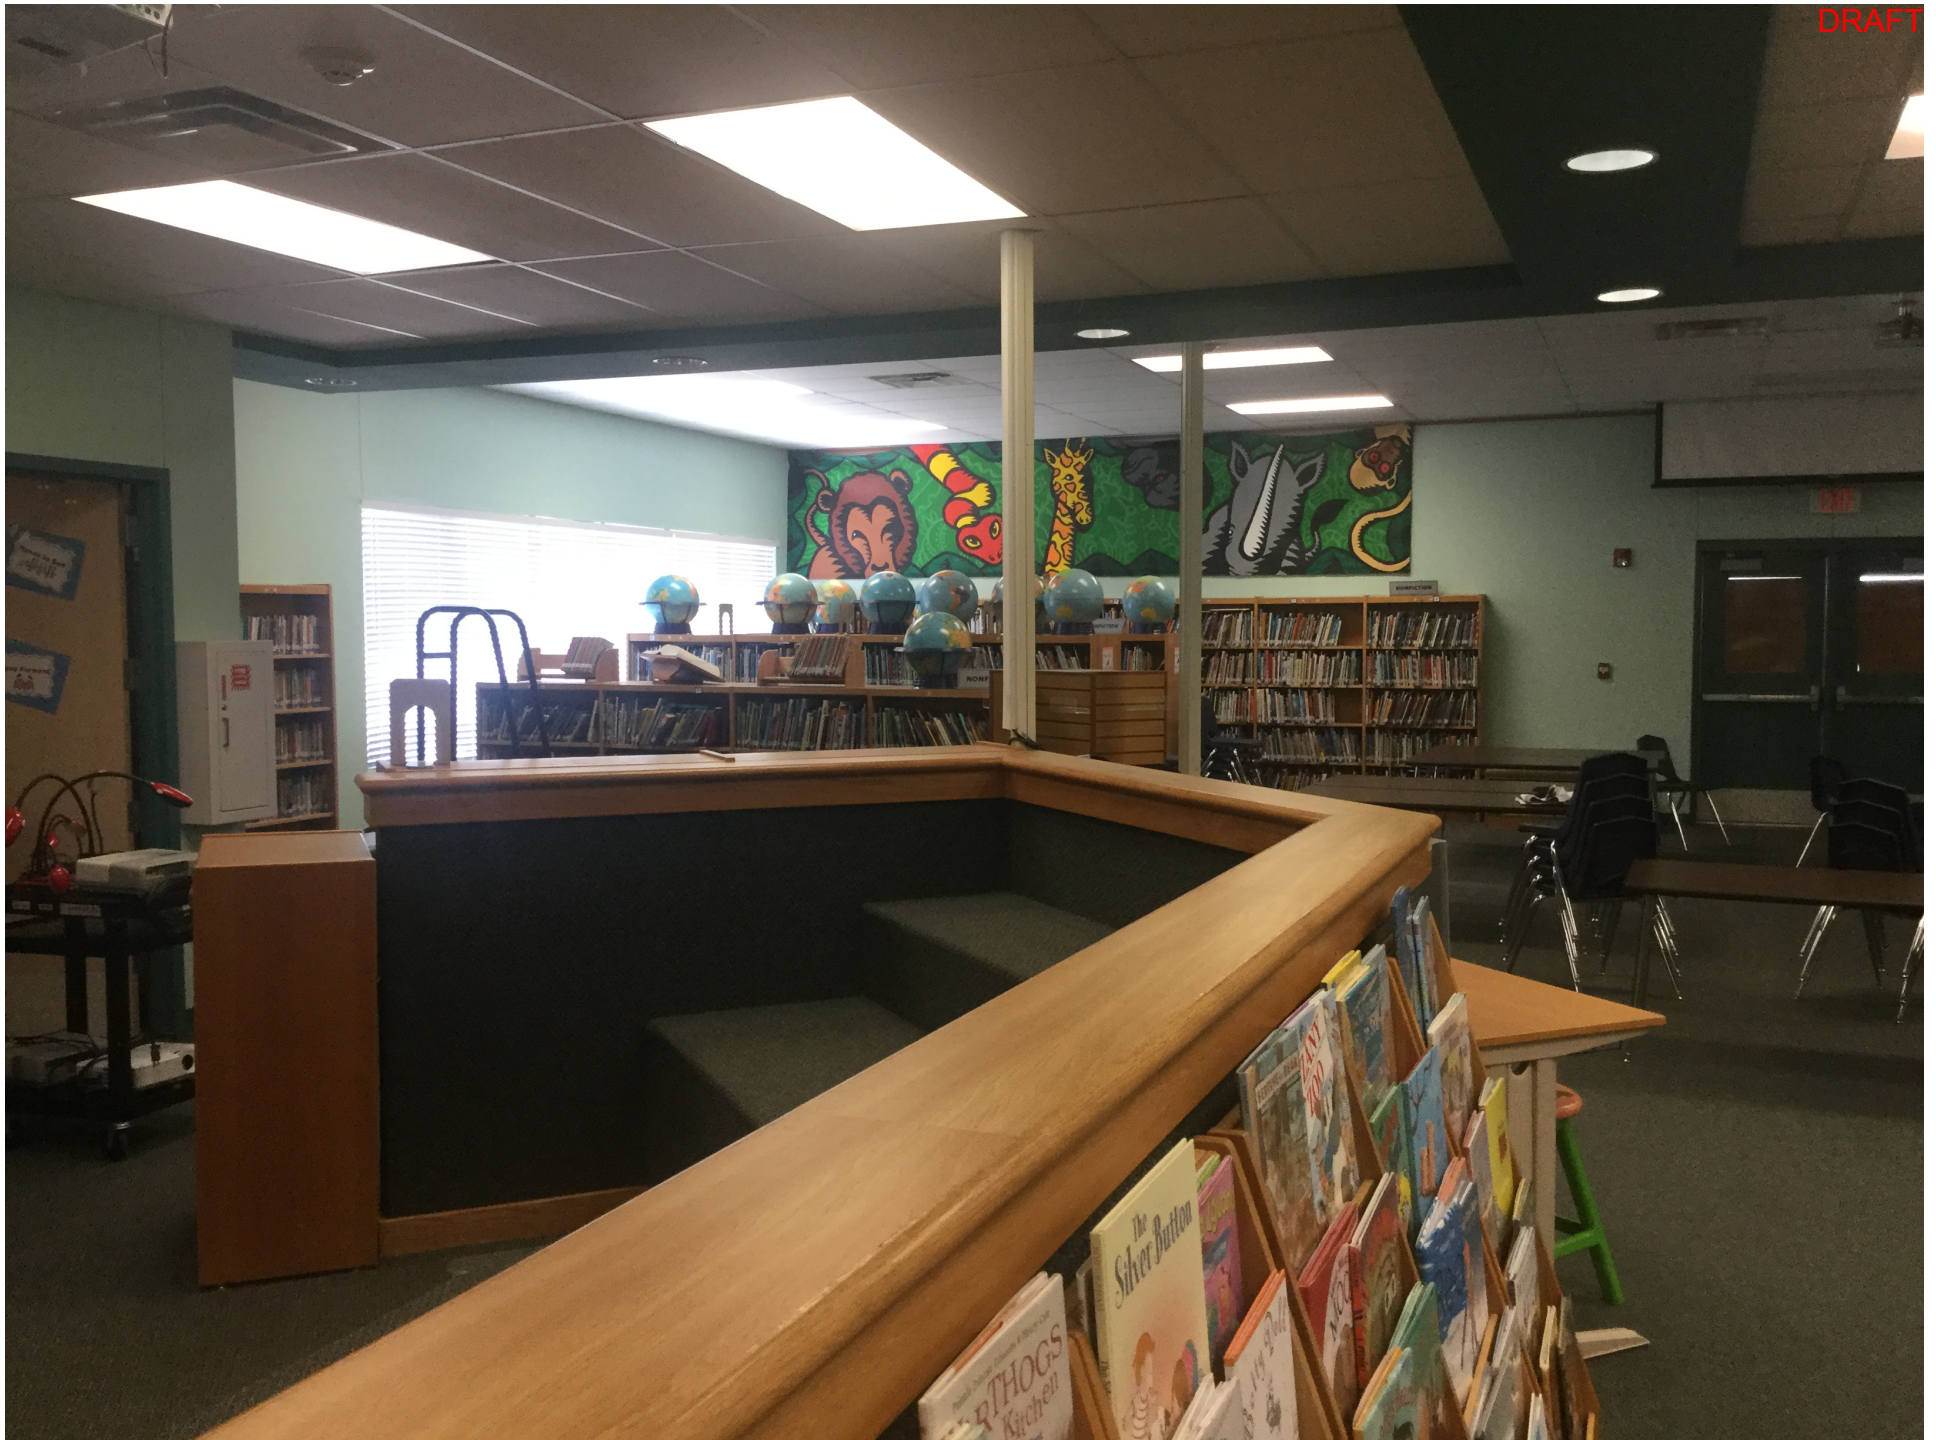
Photo 9.
5.2 Library

1) Very unsatisfactory 2) Unsatisfactory 3) Average 4) Good 5) Very good N/A) Does not apply.								There is no specialized space or furniture for independent study.	
								see photo 9

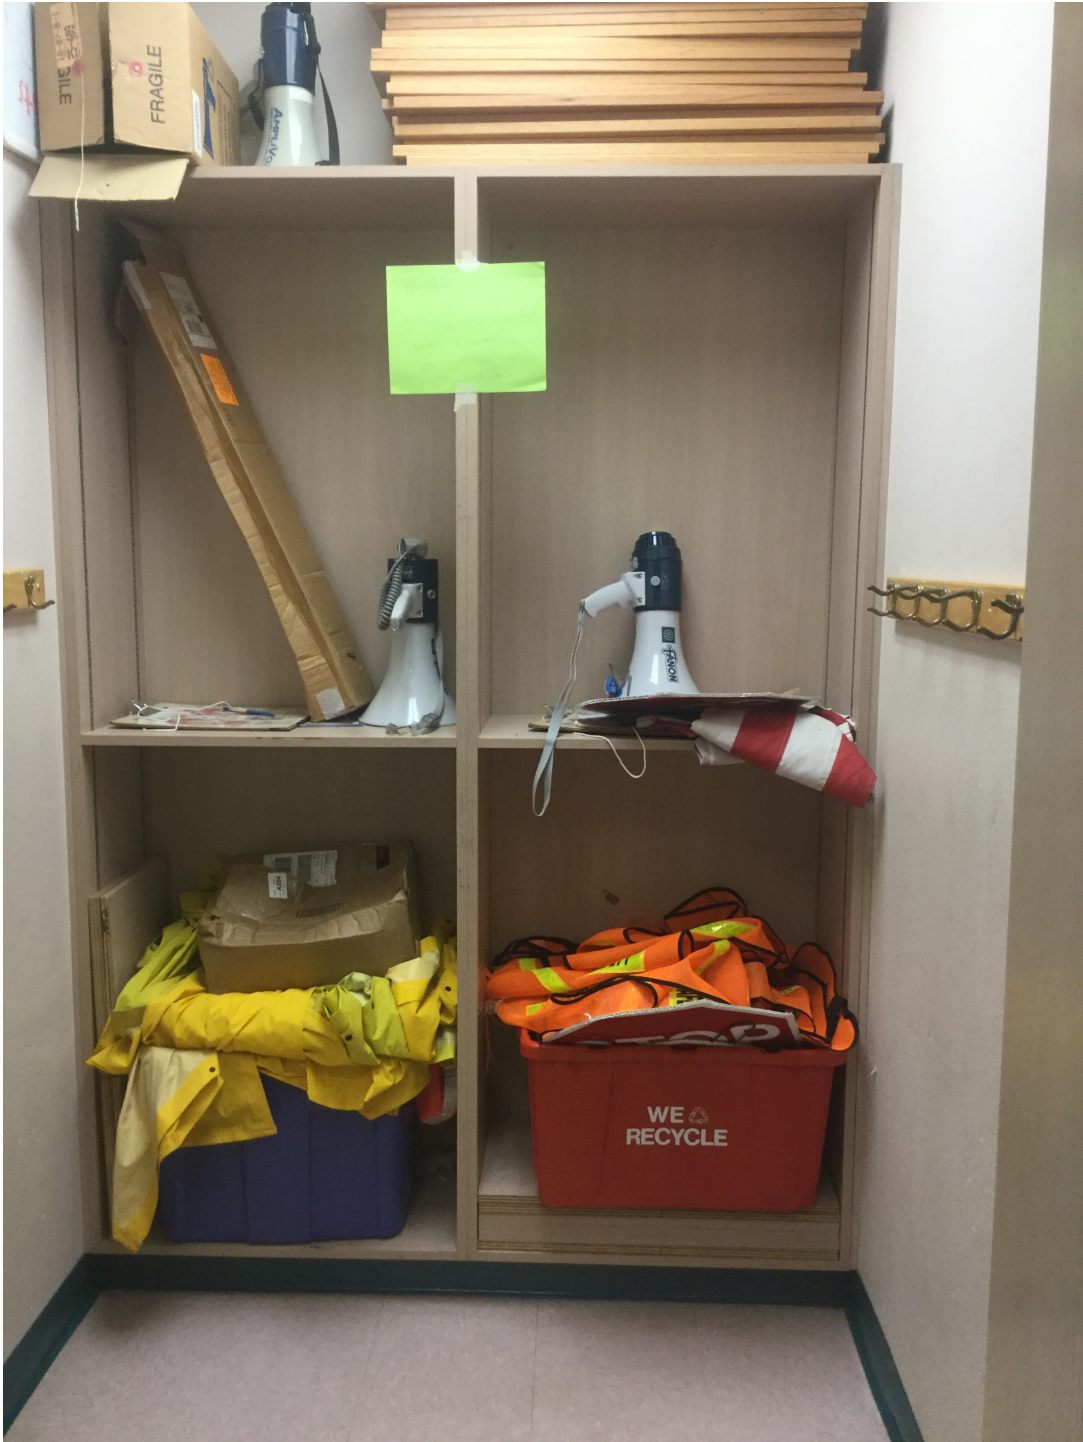
Photo 10.
8.1 Storage

8 - Storage		1	2	3	4	5	N/A	11.00	
8.1	Is there adequate general storage in the building?					5		Comments	1.00 5.00
1) Very unsatisfactory 2) Unsatisfactory 3) Average 4) Good 5) Very good N/A) Does not apply.								see photo 10	
8.2	Is there adequate classroom storage?			3				Comments	1.00 3.00
1) Very unsatisfactory 2) Unsatisfactory 3) Average 4) Good 5) Very good N/A) Does not apply.								The casework is moderate but should be improved upon.	
8.3	Is there adequate student storage?			3				Comments	1.00 3.00
1) Very unsatisfactory 2) Unsatisfactory 3) Average 4) Good 5) Very good N/A) Does not apply.								There are hooks in the hallways for students to hang their back packs.
