Educational Suitability Summary Report

House Park

Date: 08/15//2016 – (Rev. 1 – 11/7/16 – Survey Results) (Rev. 2 – 1/9/2016 – Construction Dept)

House Park Stadium

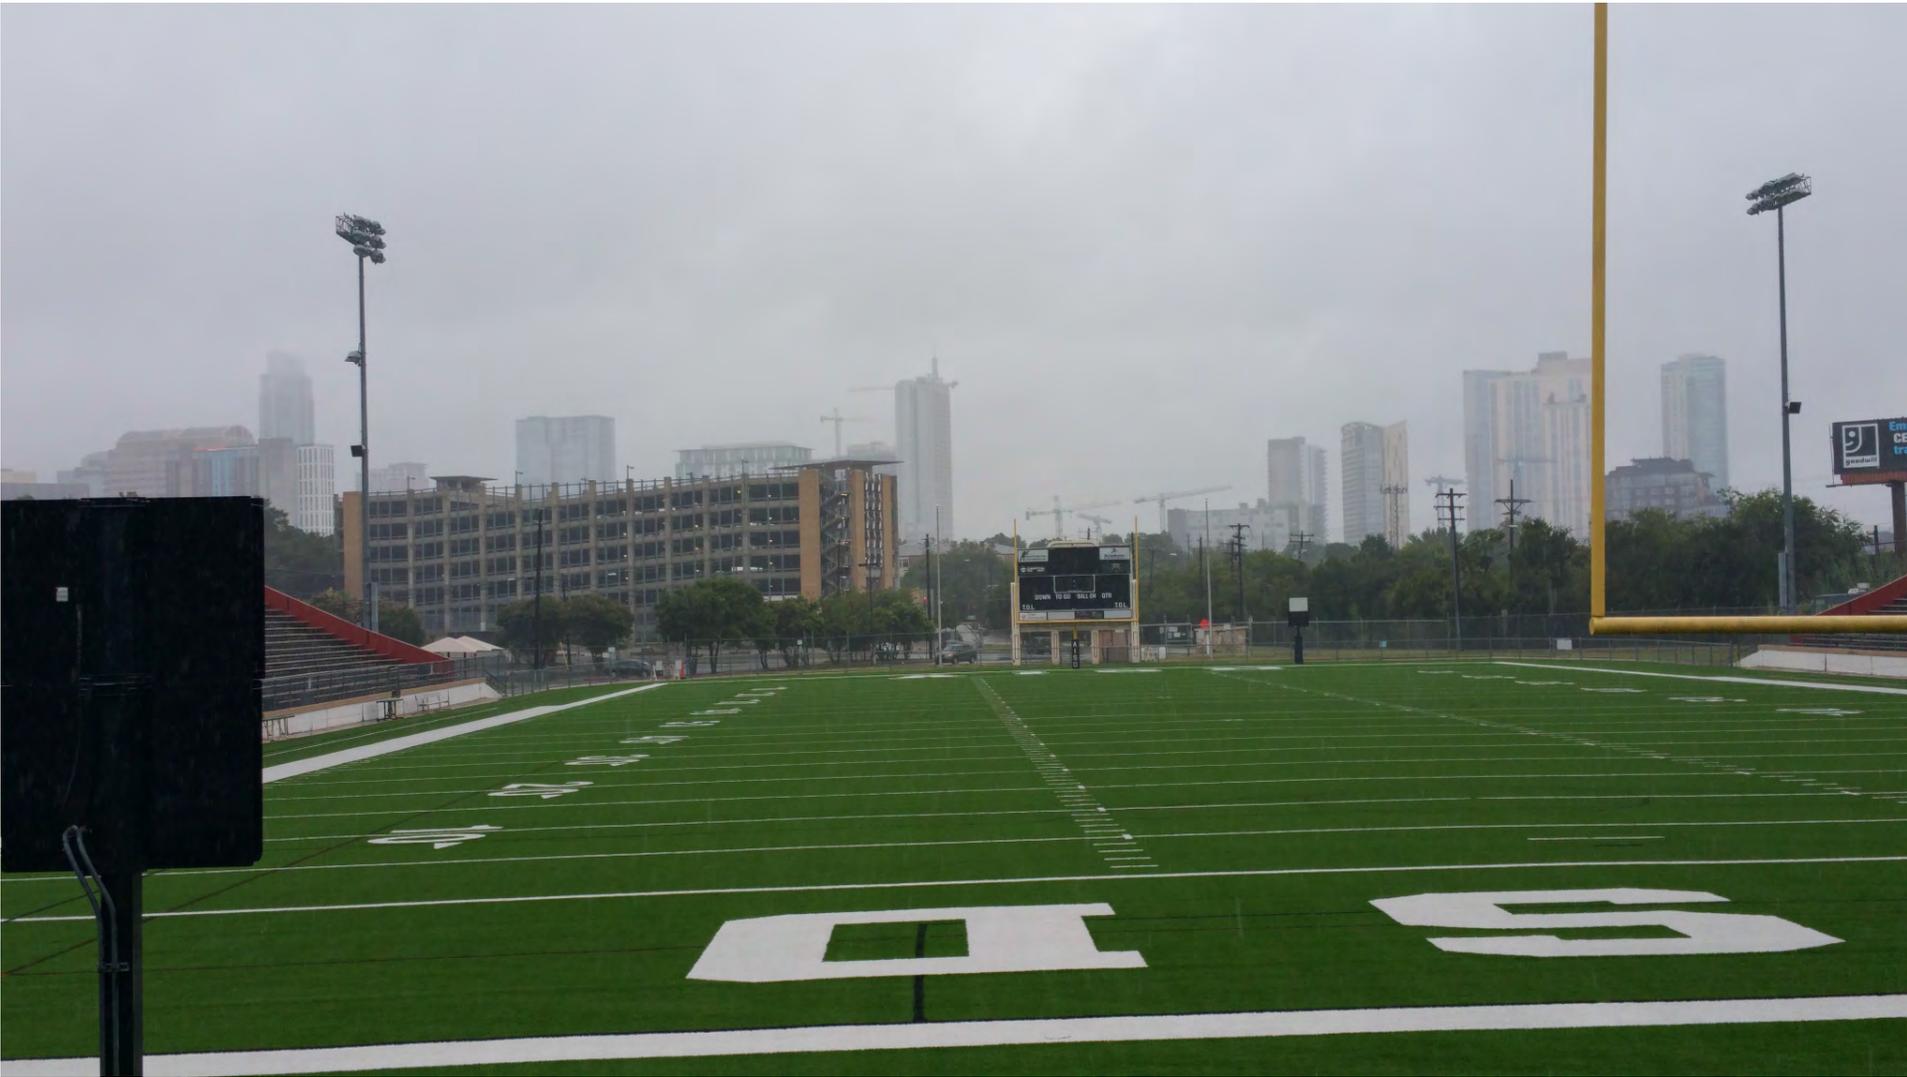
Photo 1. Stadium

The stadium has a seating capacity of approximately 6,500. The required support spaces and infrastructure are not adequate for this facility. Offices for the current staff are a converted storage room. The facilities under the stadium are showing age and are not meeting the need of the users. The press boxes are at an end of life period and are too small.

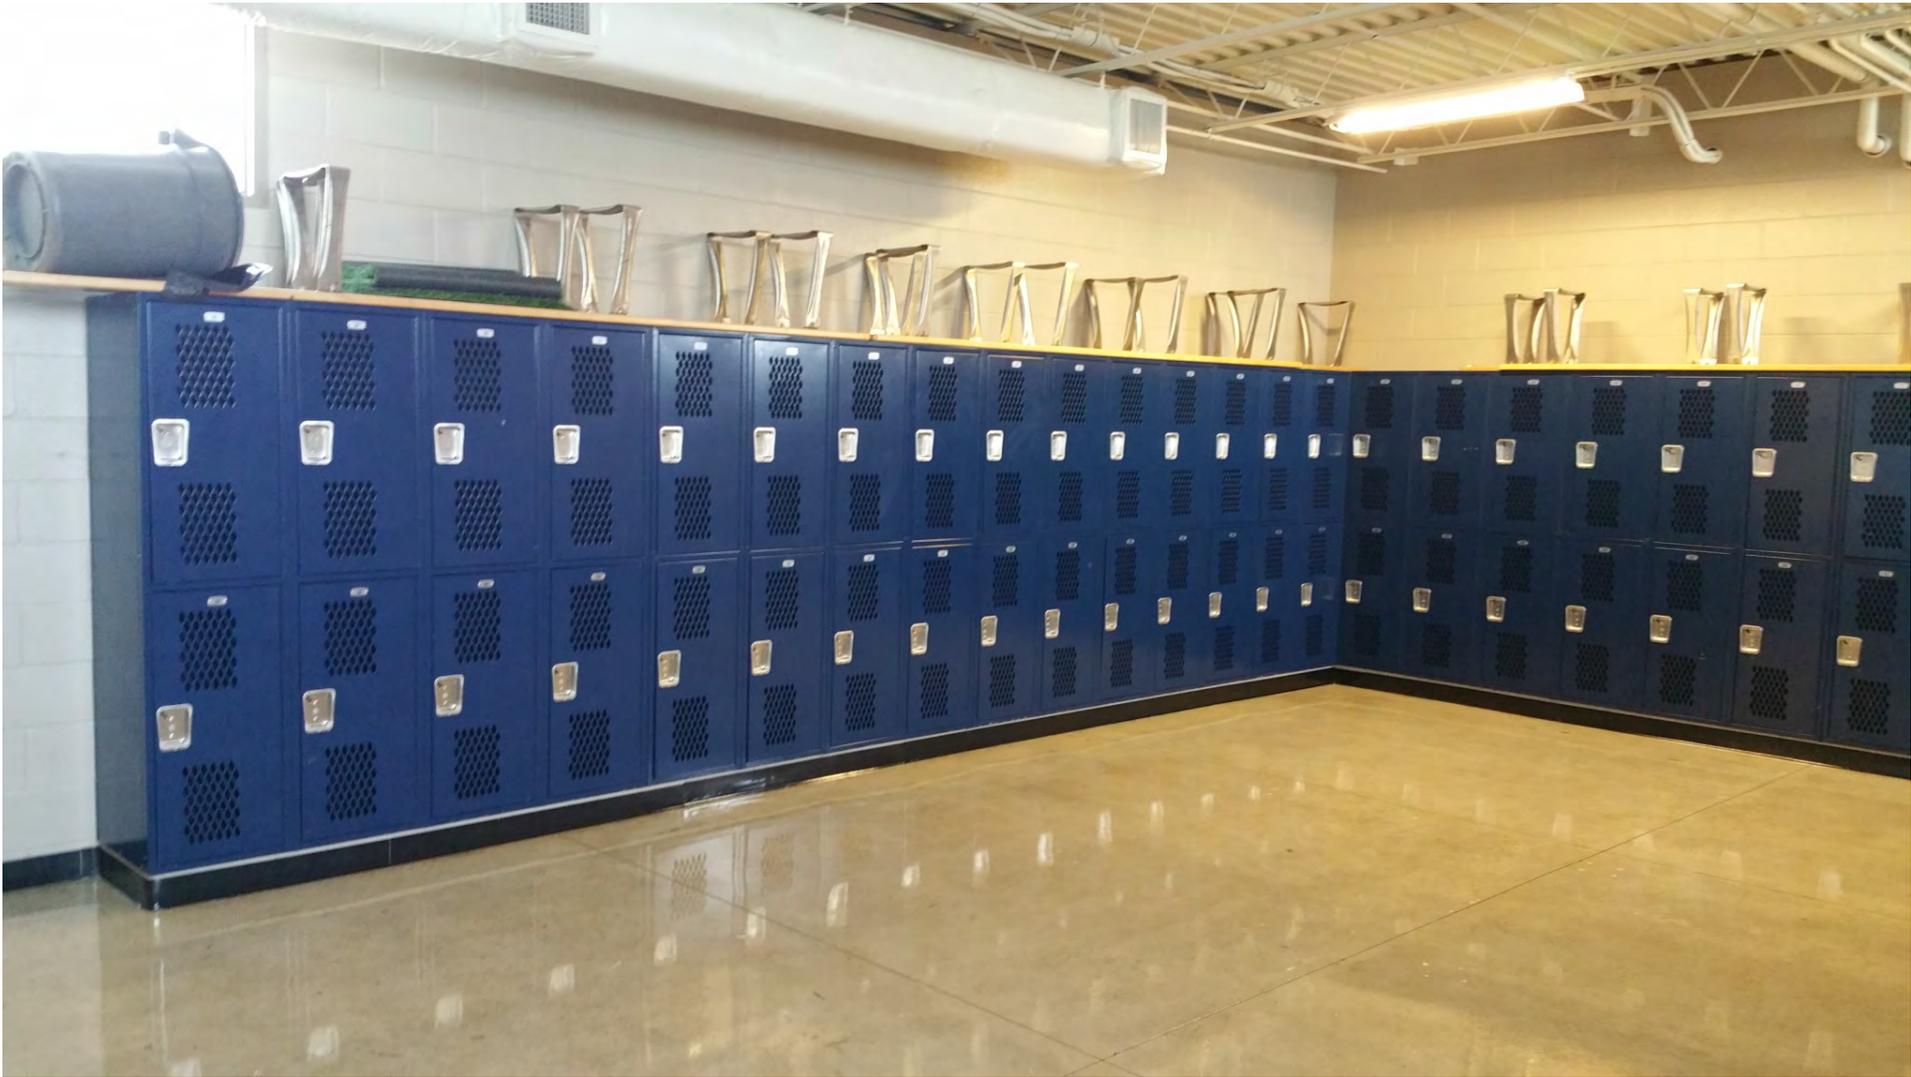
Photo 2 . Locker Room

The locker rooms are too small to serve entire varsity teams, and the competing teams must share showers. There are separate trainer rooms that are located next to the locker rooms. The sealed concrete floors, in the locker rooms and associated restrooms, is extremely slippery. There is a need to apply epoxy resin flooring in the locker rooms, and toilets to reduce the slick condition as well as fight the dangers of staff and other infections. The flooring in these rooms is a big concern for the onsite staff.

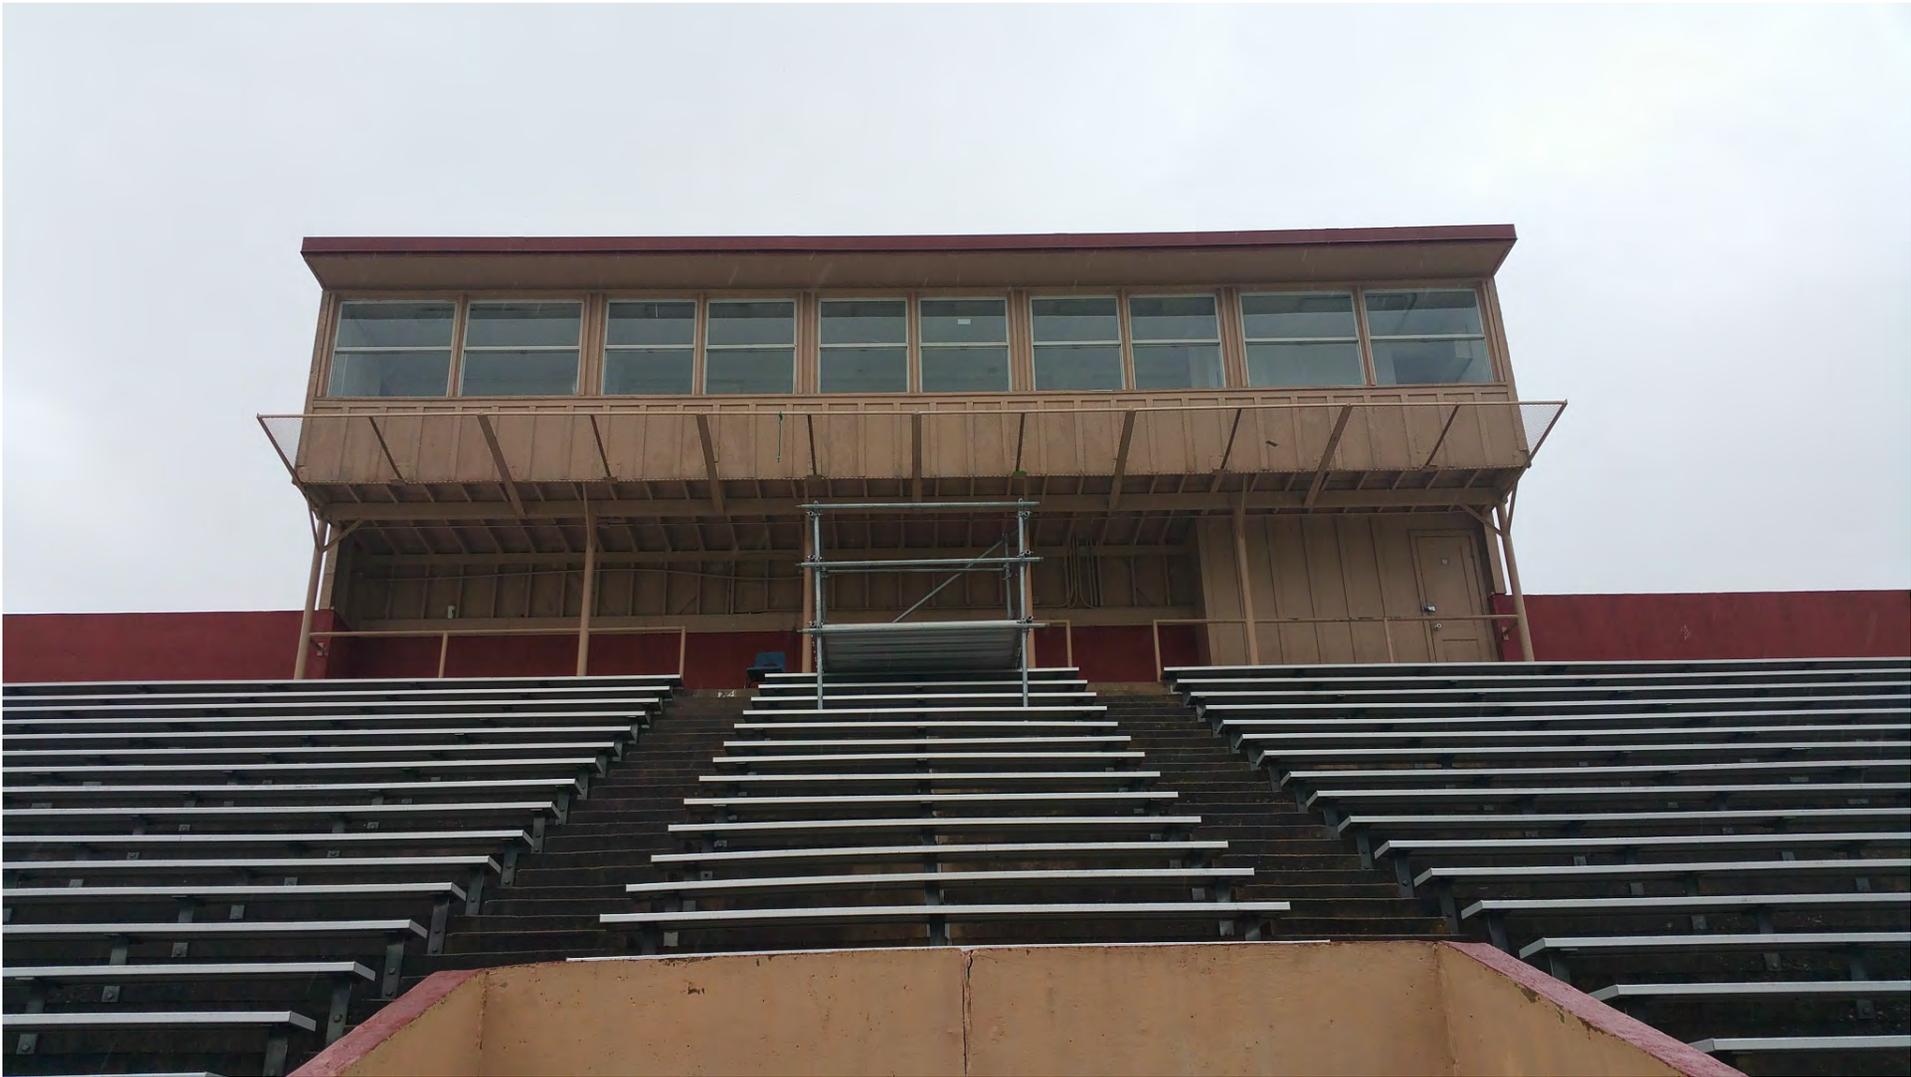
Photo 3. East Press Box

Press boxes are at end of life condition. Both press boxes are a part of original construction built in 1938. A capacity of 18 occupants are limited by code, but 18 cannot fit in the space due to size and portions of the building being condemned. Elevators are currently not serving either of the press boxes. Both press boxes cannot facilitate the staff that need to use it during the game. Media, announcers, press box supervisor, and score board controller are a just a few of the staff that would be required in

the box. Other members that would need to be seated in the press box are offensive, defensive, and special teams coaches for the home and visiting teams. No hospitality can occur in the press box, due to the design of the facility. Bringing scouts from universities is limited due to the lack of space for them as well.

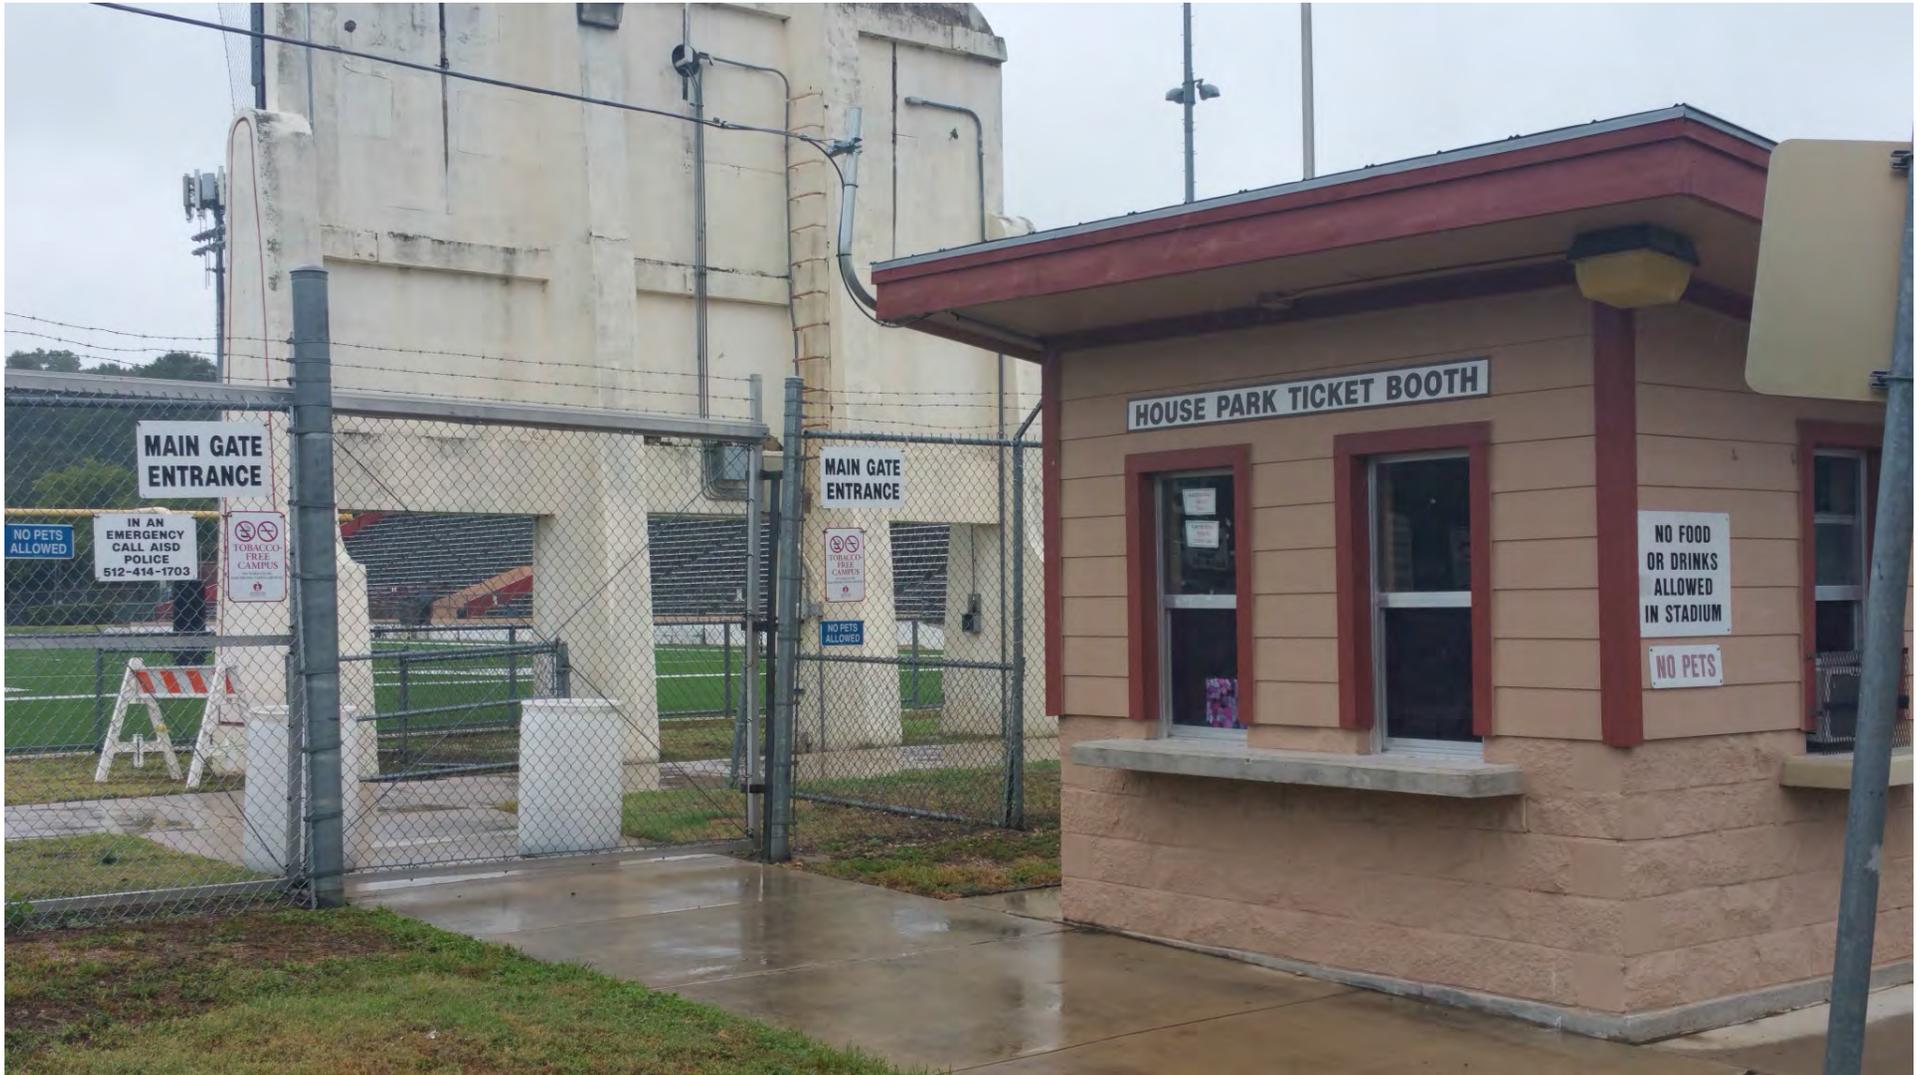
Photo 5. Ticket Booth

-Existing ticket booth does not serve capacity crowds adequately. Home and visitor patrons are not separated at ticket booth or entry. Consider construction of new booth with windows serving home and visitor fans on two different sides, and provide separated gate entries into stadium. Include restroom for workers.

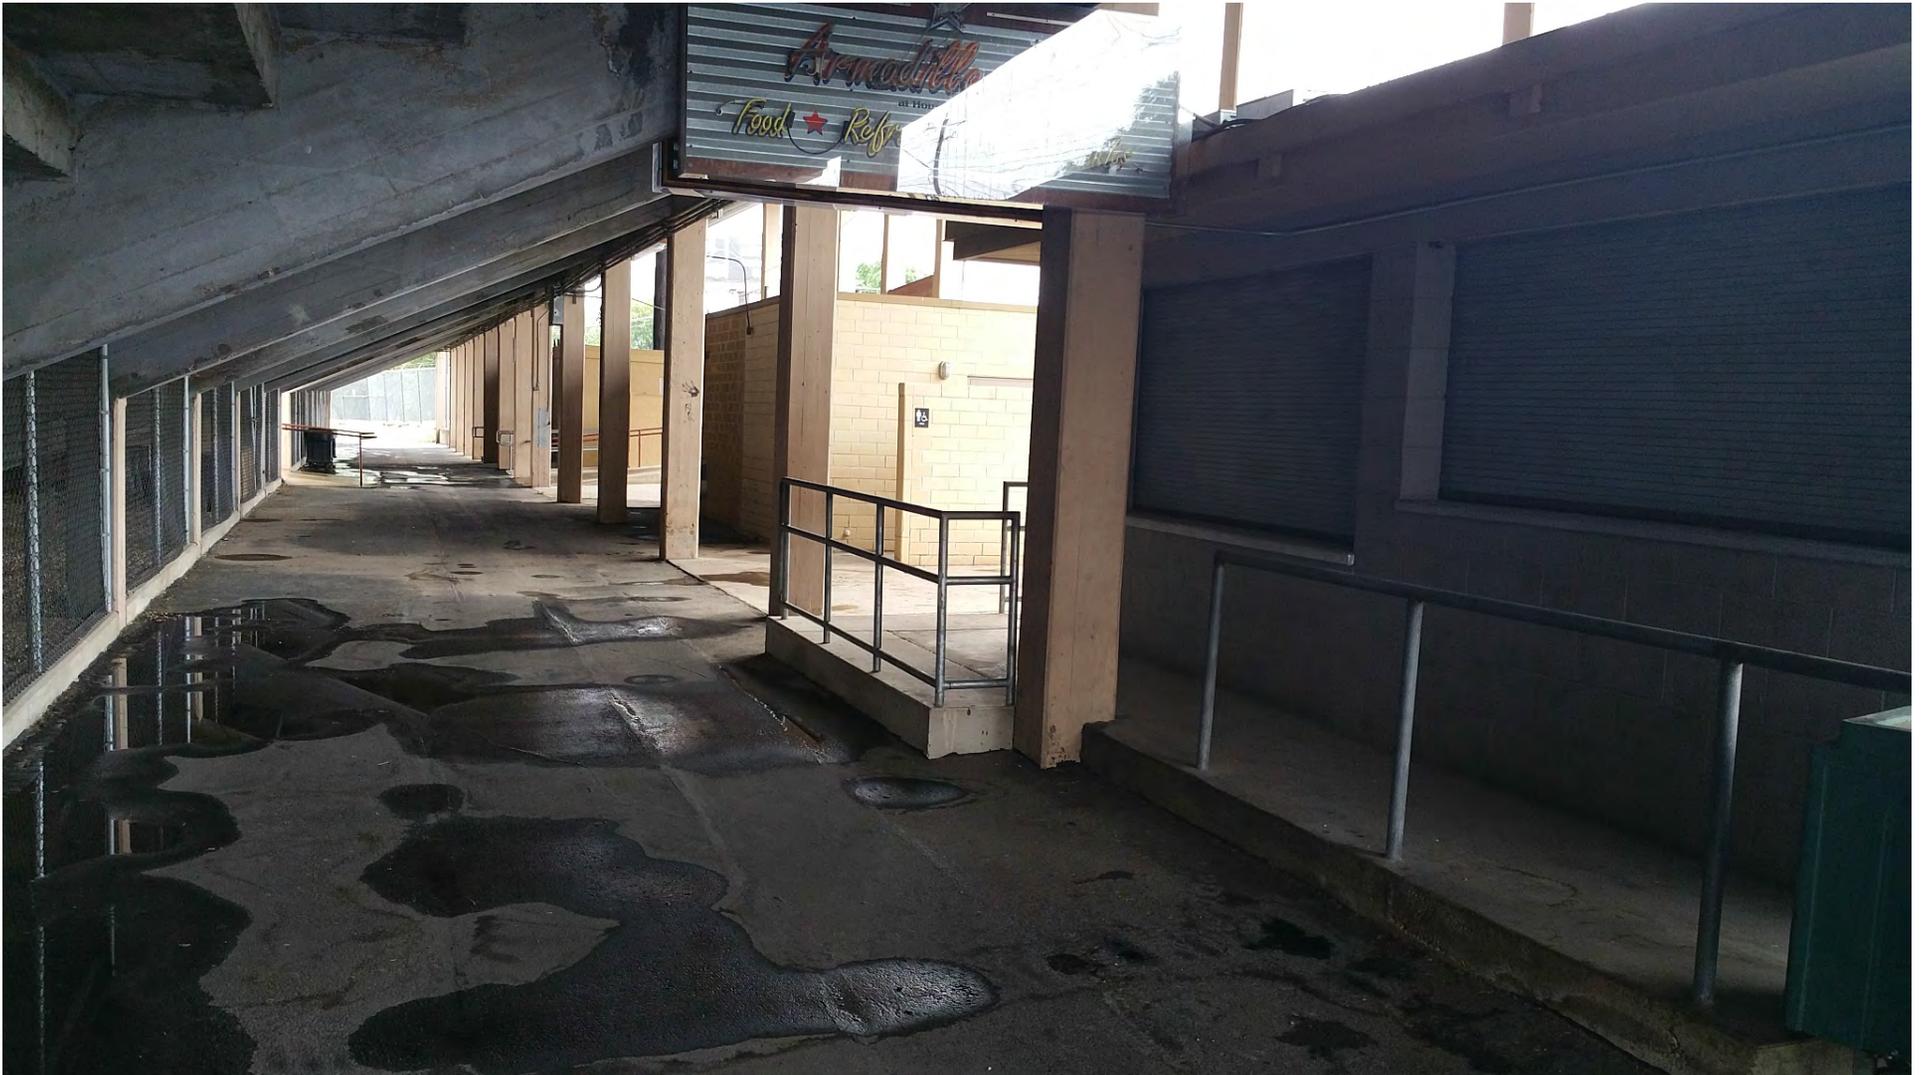
Photo 6. Concessions

-Concession equipment is not adequate.

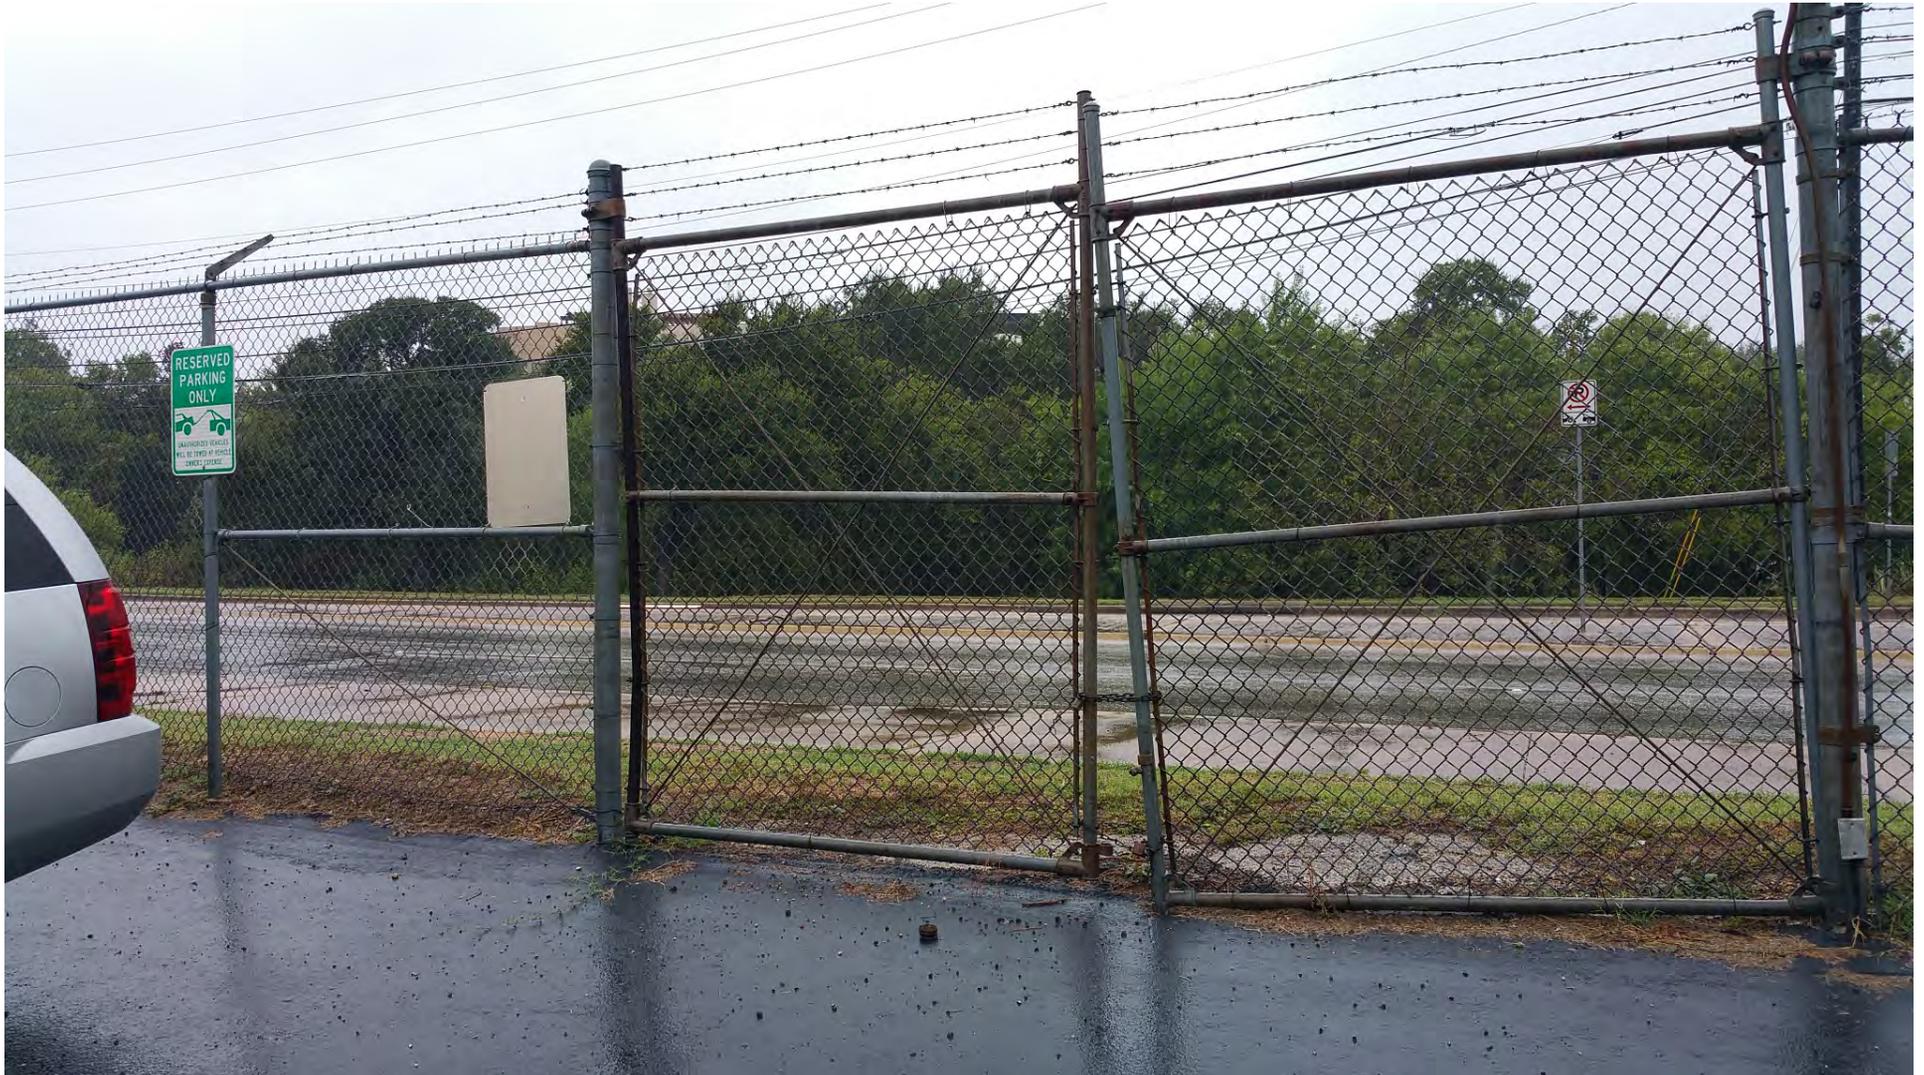
Photo 7. Fencing

Safety around the facility is a growing concern. The fencing has multiple areas where people can get onto the site. With the homeless population in the area, House Park has become a place to sleep and use the facilities. Staff have to keep the restrooms unlocked, so that the buildings are not vandalized. Due to the limited staffing and difficulty of scheduling staff it is hard to maintain the expected level of security at events. Larger events are specifically difficult to manage.
