Educational Suitability Summary Report

Gorzycki Middle School

Date: 07/26/2016

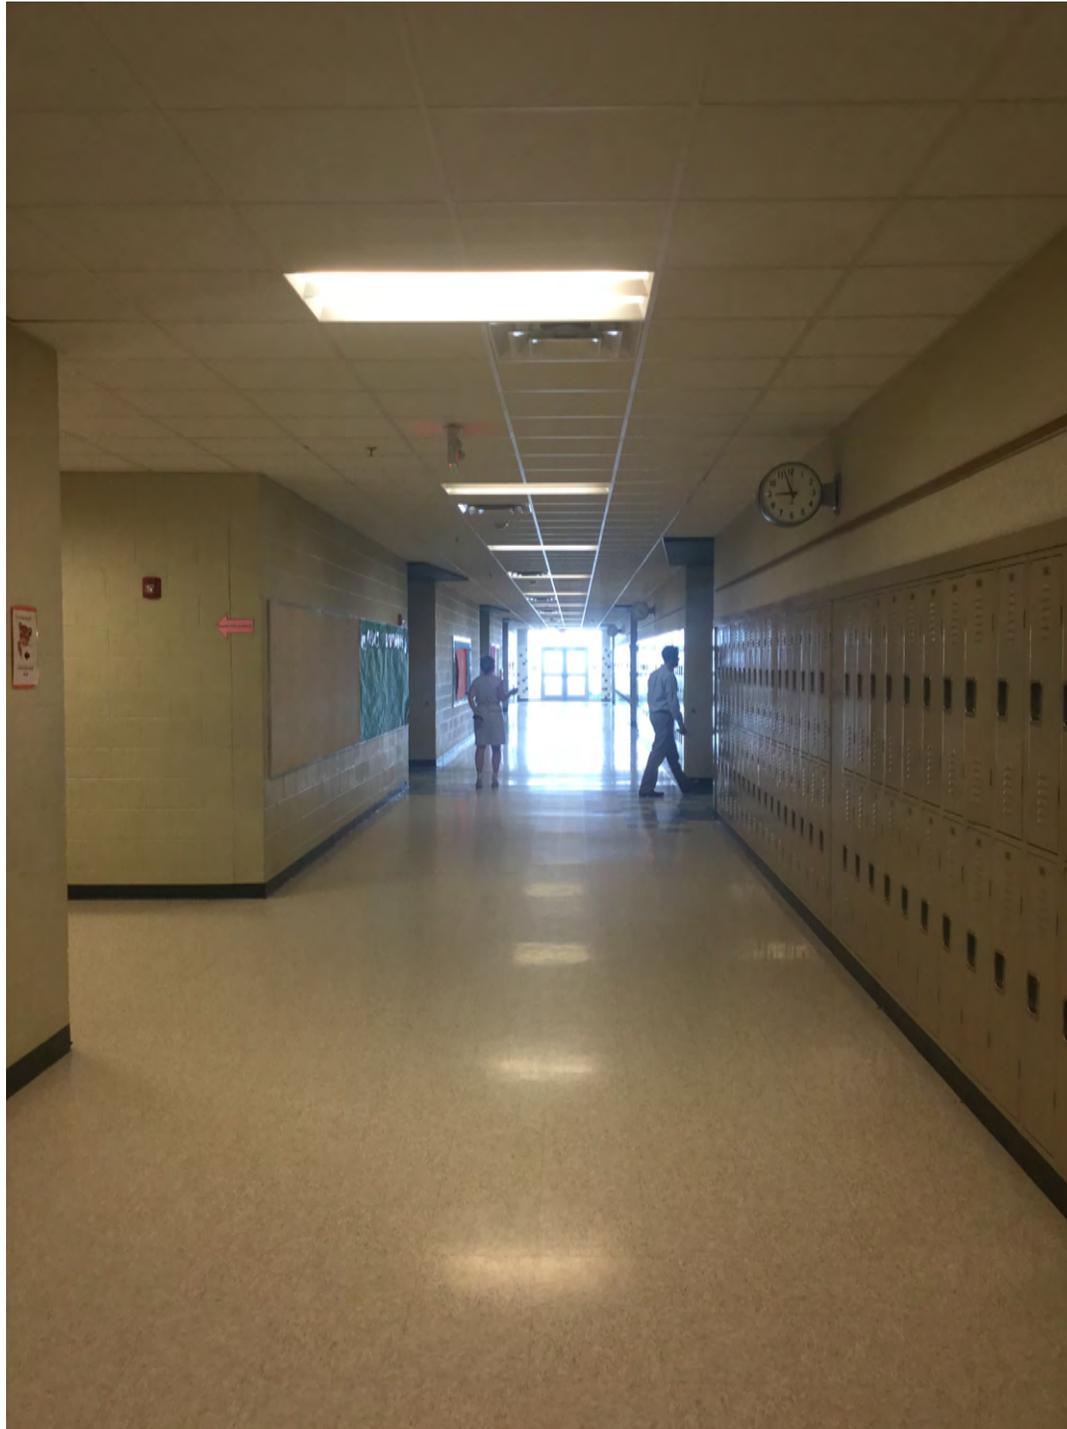
2.1 Corridor

2 - General Building		1	2	3	4	5	N/A			5.25
2.1	Are interior circulation routes wide enough to safely and effectively accommodate student movement?					5		Comments	0.50	2.50

1) Primary circulation is 5'-0" to 6'-0" wide. 2) Primary circulation is 6'-0" to 7'-0" wide 3) Primary circulation is 7'-0" to 8'-0" wide 4) Primary circulation is 8'-0"-10'-0" wide 5) Primary circulation is 10'-0"+ wide N/A) Does not apply.

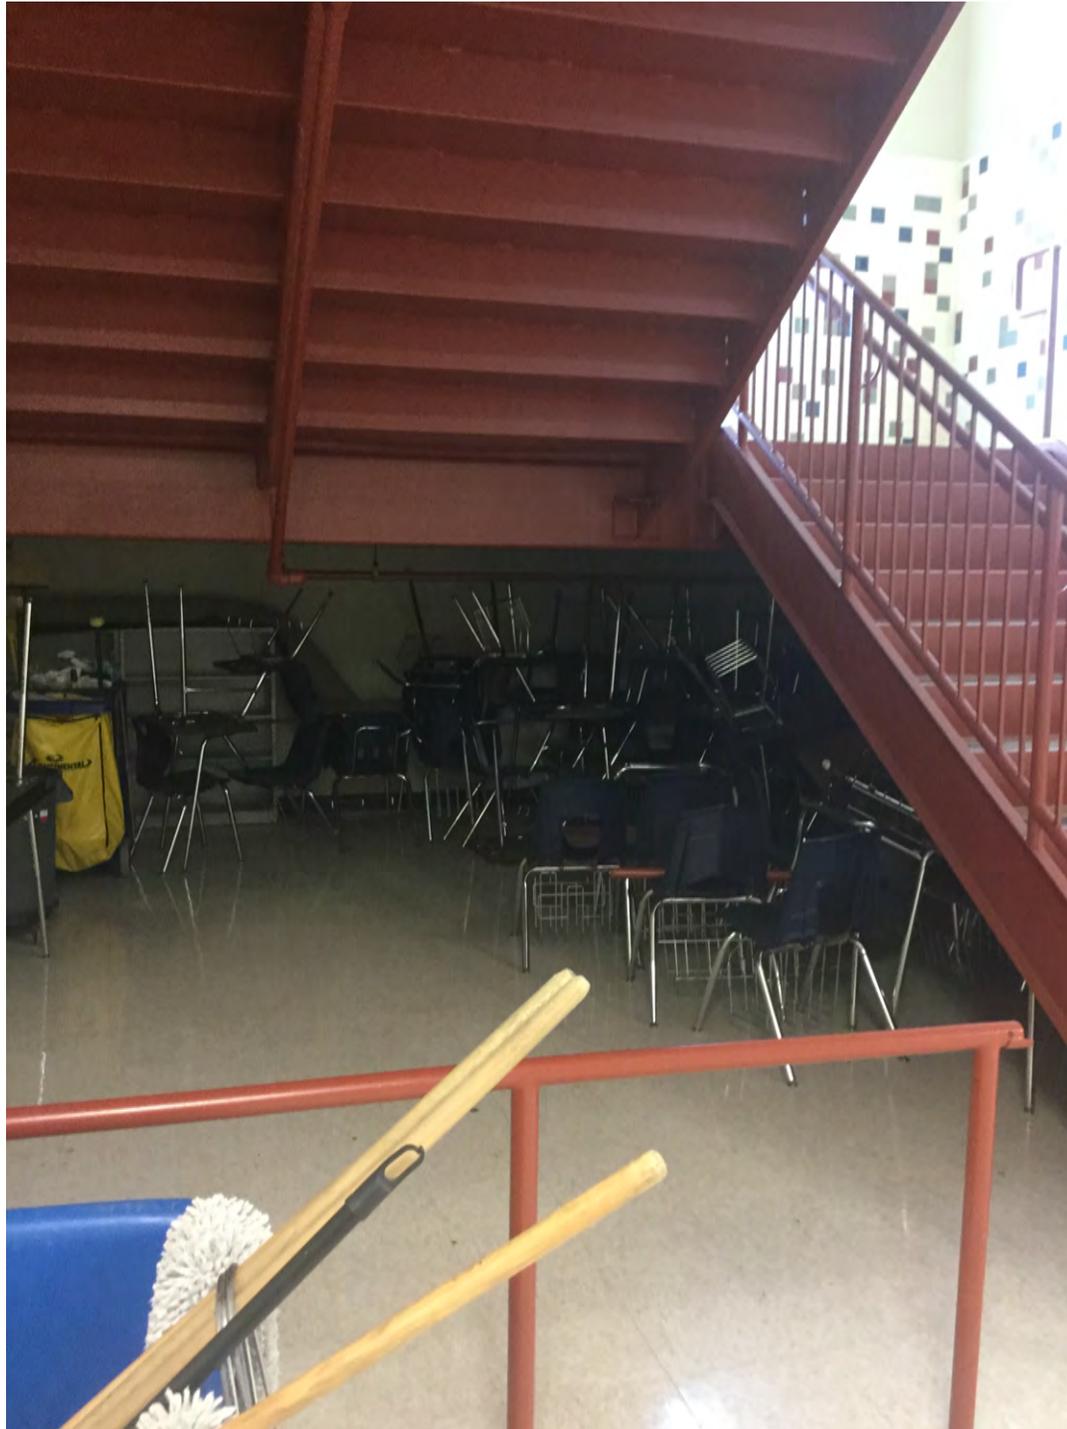
8.1 General Storage

General building storage is adequate and allocated throughout the school. A lot of storage is actually under open stair wells. Additionally, classroom storage spaces are not equipped with built-in cabinets. Purchased furniture for classroom storage is started to sag and age, and there is no lockable space for teachers. Work rooms were designed into the school, and each grade level does have a teacher work room, which works well at the campus.

8 - Storage		1	2	3	4	5	N/A			10.00
8.1	Is there adequate general storage in the building?				4			Comments	1.00	4.00
1) Very unsatisfactory 2) Unsatisfactory 3) Average 4) Good 5) Very good N/A) Does not apply.										
8.2	Is there adequate classroom storage?		2					Comments	1.00	2.00
1) Very unsatisfactory 2) Unsatisfactory 3) Average 4) Good 5) Very good N/A) Does not apply.		There is no built-in classroom storage provided. There is no lockable storage for teachers.								
8.3	Is there adequate student storage?				4			Comments	1.00	4.00
1) Very unsatisfactory 2) Unsatisfactory 3) Average 4) Good 5) Very good N/A) Does not apply.		The lockers are used at this campus.
