Ortega Elementary School

Date: 01/08/2021

Educational Suitability Summary Report

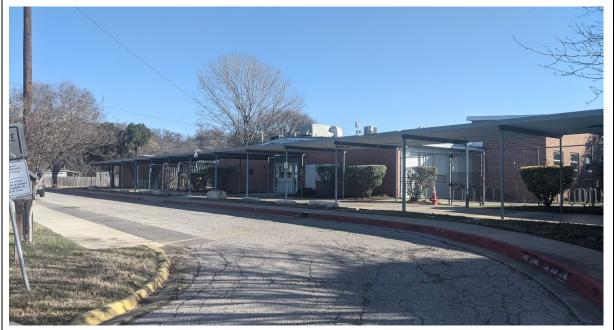
Main building entry provides covered area for pickup and drop-off, but main entry door feels unwelcoming.

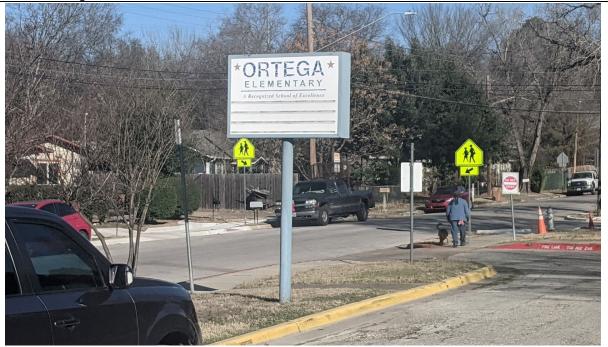
Monument sign is faded, and letters are peeling. Staff requested a digital marquee.

1.2	ls the buildir wayfinding?	ng easily identified with appropriate signage and community ?		2					Comments	0.25	0.50
		1	Very unsatisfactory - Campus has no signage / wayfinding									
		2	Unsatisfactory - Signage/wayfinding is faded/hidden									
		3	Average - Signage / wayfinding visible but not apparent									
		4	Satisfactory - Signage / wayfinding is visible but not good condition									
		5	Very satisfactory - Signage and wayfinding is visible and easy to use									
		N/A	Does not apply

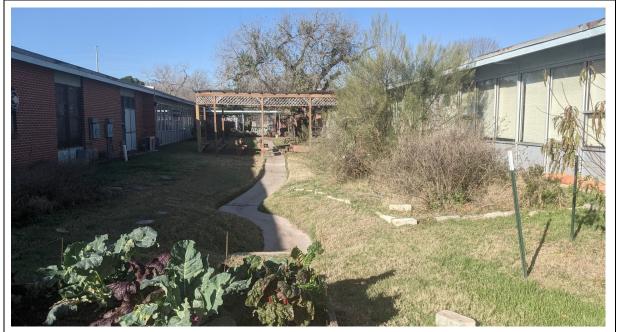
Outdoor Learning and Activity: Learning garden and shaded outdoor studio.

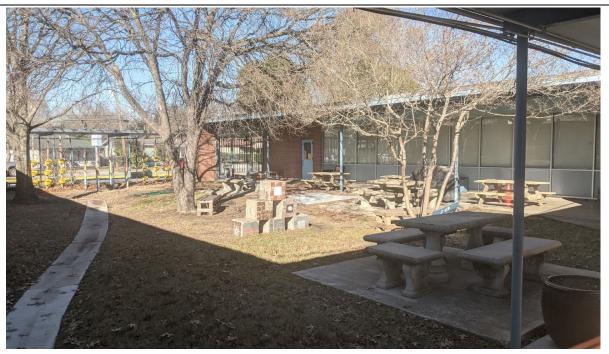
Outdoor Learning and Activity: Courtyard outside the cafeteria is partially covered. Seating is provided but is not reconfigurable.

The cafeteria is well-sized, and the school is very happy with how it functions. The space has lots of natural light with windows on both sides of the hall. A secure outdoor dining area is next to the cafeteria, providing numerous options for seating.

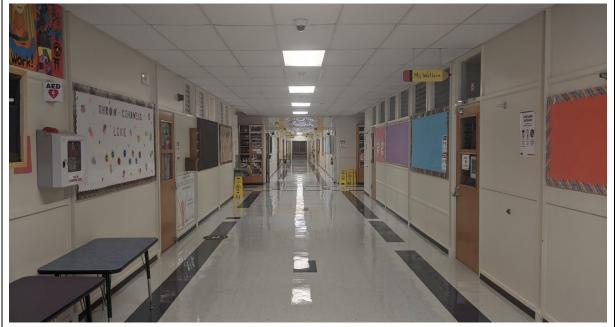
Main Entry Hallway: Library is on the right side of the photo, but there is no transparency into the space.

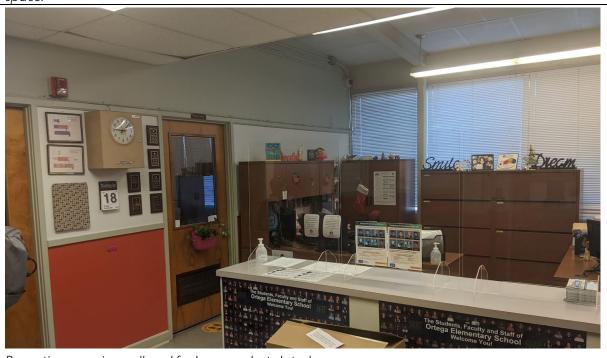
Reception area is small and feels somewhat dated.

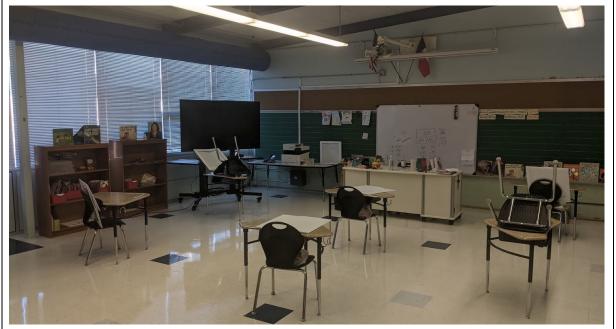
Typical studios have reconfigurable furniture, casework storage and natural light. Chalkboards are present but are not being used.

Studios are adequately sized but lack transparency and shared spaces for flexible teaching. Storage cabinets run along a full wall and are in generally good condition. Special education classes do not have access to an accessible restroom. Currently, the school does not provide a life skills program. There are limited 2D display areas and no 3D display areas.

Furniture throughout the school is in good condition and seems relatively new. Many of the studios have arrow-shaped desks and loose chairs, which can quickly switch between group and individual learning.

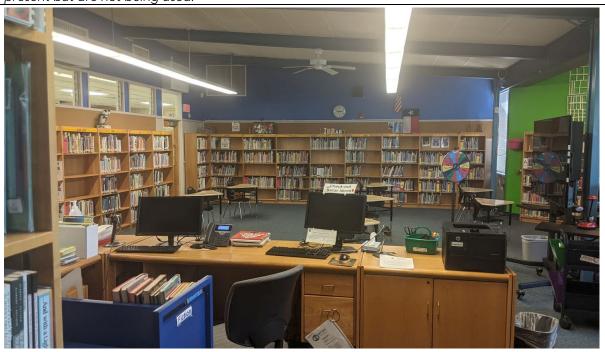
Media Center: Library is small with limited flexibility and no breakout spaces.

12.2 How well does the Library/Media Center support quiet study?	1						Comments	1.00	1.00
1 Very unsatisfactory - No quiet study spaces	•						Library is one large space and has limited flexibility. Th	e main reading	g room
 Unsatisfactory - One area in poor condition, poo privacy 	r acoustic						is 1400 square feet.		
3 Average - One or more areas provided, needing or renovations to function well	updates								
4 Satisfactory - Clusters or small rooms adjacent to center, good condition, good acoustic privacy	o media								
5 Very Satisfactory - Multiple clusters or small roon adjacent to media center, excellent condition, ex acoustic privacy									
N/A Does not apply

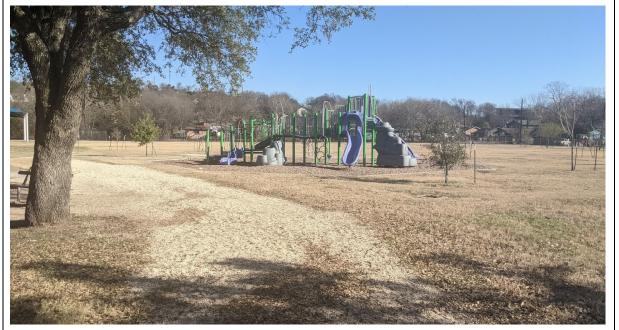
Outdoor Learning and Activity: The playscape does not have shade. A wide walking trail around the green space is provided.

1	Very unsatisfactory - No dedicated active playground								•	
2	Unsatisfactory - Too small, poor condition, no shade provided									
3	Average - Adequate size, adequate condition, needs some renovations or updates to function well, 50% or less shade coverage over play structure									
4	Satisfactory - Good size, good condition, more than 50% shade coverage over play structure									
5	Very satisfactory - Generous size, excellent condition, full									
0	shade coverage over play structure

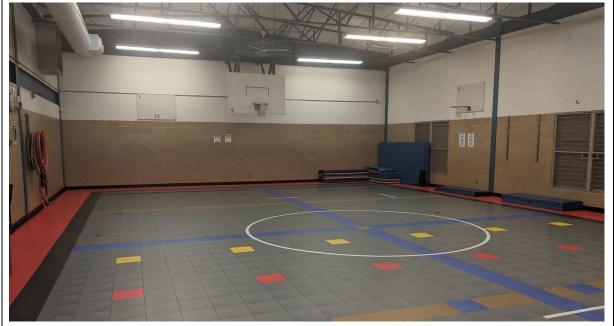
Gym is undersized (2,350 square feet) per Ed Spec. The space does not have any natural light.

The gym is very small with low ceilings and no natural light. Basketball goals are original to the school and offer no ability to raise or lower them. Gym support is limited, with a small office and inadequate storage room.

ellness	1	2	3	4	5	N/.	A	10.00	40
10.1 Does the co program sp	ampus meet the ed spec standard for physical education paces?		2					Comments	1.00	2.0
1	Very unsatisfactory - Too small, missing program spaces							No natural light, low-ceiling restrooms not connected.	Gym is small at	: 2,30
2	Unsatisfactory - Too small, poor condition							square feet.		
3	Average - Adequate size, adequate condition, needs some renovations or updates to function well									
4	Satisfactory - Good size, good condition									
5	Very Satisfactory - Generous size, excellent condition									
N/A	Does not apply			r				1		
IO.2 Are the phy the ed spec			2					Comments	1.00	2.
1	Very unsatisfactory - None provided							Small office/storage room adjacent to gym. Student re	strooms are ac	ross
2	Unsatisfactory - Too small, disconnected, poor condition							hallway.		
3	Neutral - Adequate size, average condition, needs updates or renovations to function well

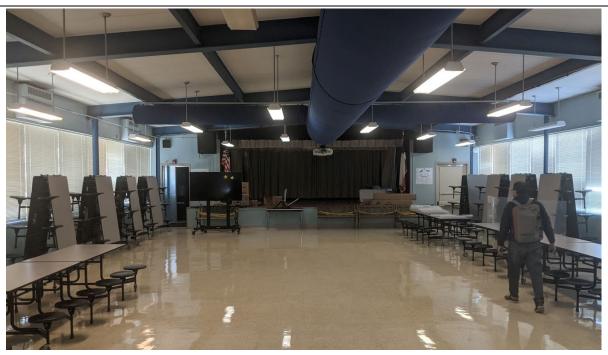
Food Services: Cafeteria has ample natural light and large stage. Functions well.

11.1 Is the Dinin	g Commons appropriately configured per the ed spec?				4			Comments	1.00	4.
1	Very unsatisfactory - Too small, missing program spaces							Cafeteria is adequately sized for current enrollment. Sp	bace has ample	•
2	Unsatisfactory - Too small, poor condition, only one option for eating space provided, inadequate circulation							daylight and functioning stage.		
3	Average - Adequate size and condition, needs updates or renovations to function well									
4	Satisfactory - Good size and condition, good circulation, multiple options for eating space (ex: connection to outdoor eating space)									
5	Very Satisfactory - Generous size, excellent condition and circulation, multiple options for eating space (ex: connection to outdoor eating space)									
N/A	Does not apply									
	od Services support spaces appropriately configured per the			3				Comments	1.00	3.
ed spec?			•	-			-		-
