Ann Richards YWLA School Site Summary

Address	2206 Prather Lane Austin, TX 78704
Number of Permanent Campus Facilities	3
Original Year of Construction	1958
Total Campus Building Area (combined)	123,686 SF

Main School Building – BLDG-028A

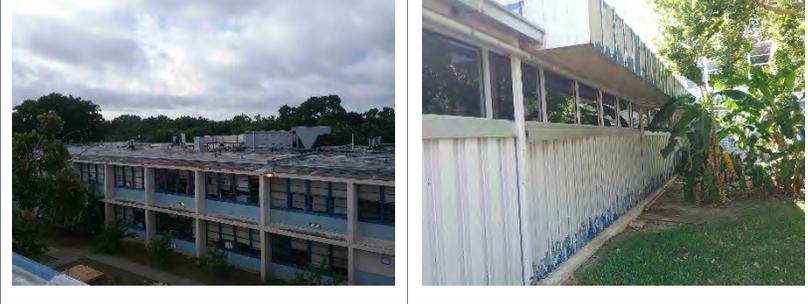
System	Subsystem	Condition and Deficiency Overview	System Condition Rating
Exterior	Exterior Walls	<p>The exterior walls of the original building are brick. There are glazed masonry units set within the exposed concrete building structure. The building's original exterior covered walkways have been enclosed and now serve as interior corridors from the Main School Building to the cafeteria and the two gymnasiums. These newer walkway enclosure walls are covered with painted metal panels. The large gymnasium's more recently constructed pre-engineered building walls are clad with brick and pre-finished metal panels. The 600-wing appears to have been abandoned, and will need to be assessed in more detail to determine how it could be renovated.</p> <p>The exterior walls were observed to be in average condition due to their age. Paint and sealants were observed to be in various stages of deterioration. Painted surfaces of metal panels, trim, and exposed concrete structure have failed and were peeling. The exterior walls of the newer gymnasium addition appeared to be in good condition. It is reported that water enters the 600-wing from the exterior through walls that are below grade. This has created a moisture problem and possibly the presence of mold in the abandoned 600-wing.</p>	Average

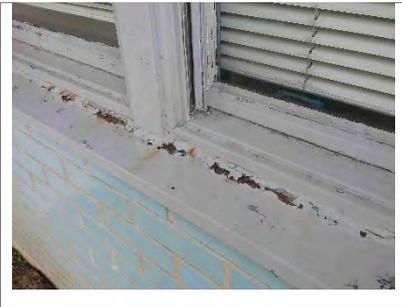
System	Subsystem	Condition and Deficiency Overview	System Condition Rating
	Exterior Windows	<p>The exterior windows are metal with single-pane glazing. Most windows are original to the building. Older windows on the main two-story building are painted, and newer building addition windows have an anodized finish.</p> <p>Older windows were observed to be in average to poor condition as paint has deteriorated significantly. Windows on the north side of the original west wing of the Main School Building were severely rusting. Several windows had broken panes. Sealants at older windows were aged and cracked. Windows at the newer classroom and large gymnasium additions appeared to be in good condition.</p>	Average
	Exterior Doors	<p>The exterior doors are metal with hollow-metal frames. Entry doors have glazed transoms and side-lites. Some service doors have louvers.</p> <p>The building entry doors were observed to be in average condition depending upon their age. Some doors on west elevations were observed to have peeling paint. The kitchen door was difficult to lock. Numerous service doors were observed to have corrosion and peeling paint.</p>	Average

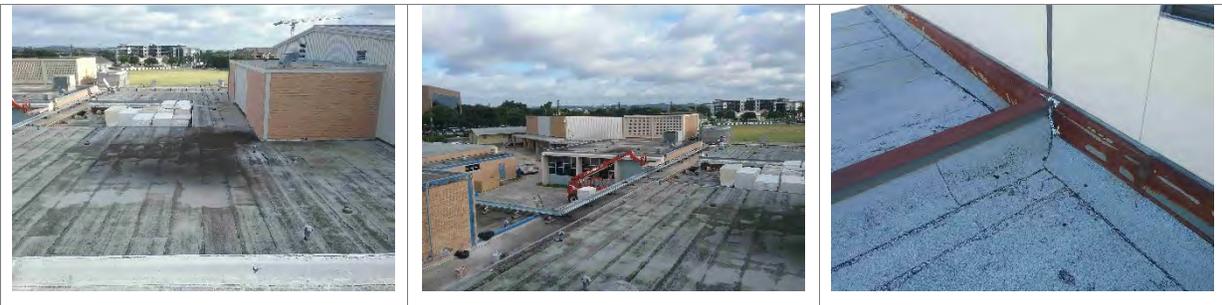
Roofing Deficiency Examples

Roofing	<p>The original 1958 building's roof appeared to have been replaced in 1998 or possibly earlier. Most of the building roof sections are modified bitumen. There are sloped standing seam metal roof sections over the library and cafeteria. The newer large gymnasium has a pre-engineered building metal panel roof. The newly constructed addition at the administration area has a modified bitumen roof. The sloped roofs were not assessed.</p> <p>The library's metal roof and adjacent corridors' modified bitumen roofs were being replaced at the time of assessment. The remaining modified bitumen roofs on the main two-story building, classroom addition, and small gymnasium were observed to be aged past their typical design service life and in poor condition. Cracking and ponding was evident and the granular surface was eroded over much of the roofing membrane. The roof areas over the kitchen and small gymnasium were reported to leak. The new administration addition roof appeared to be in good condition but was observed to have corrosion on the parapet termination bars and counter flashing. The metal roof over the larger gymnasium appears to be in good condition.</p>		Poor

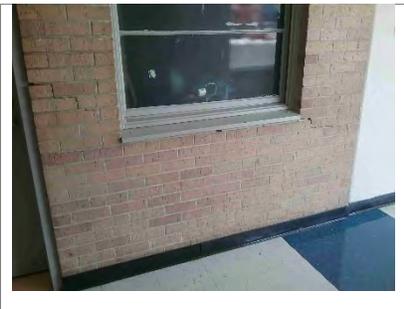
Interior Walls

System	Subsystem	Condition and Deficiency Overview	System Condition Rating
		<p>in the library are gypsum board over metal framing. Walls along enclosed walkways have their original metal windows and brick exposed. The newer classroom addition, both gymnasiums, and the shower/dressing areas have CMU walls. Newer additions have metal interior windows with fixed single glazing.</p> <p>Interior walls and windows appeared to be in good condition. Cracks in the brick mortar joints were observed along the corridor near the large gymnasium. The 600-wing has a moisture issue due to water entering through below grade exterior walls. This has led to the growth of what appears to be organic matter in the 600-wing.</p>	
	Interior Doors	<p>Areas original to construction have solid core wood doors with wood frames. The newer classroom addition, gymnasiums, and associated shower/locker areas have solid core wood doors with metal frames. In areas that have been remodeled, wood-framed doors have been replaced with metal frames.</p> <p>The doors and frames were observed to be in average condition. There were instances where individual doors had been damaged. Hardware on older doors has aged and was difficult to lock.</p>	Average

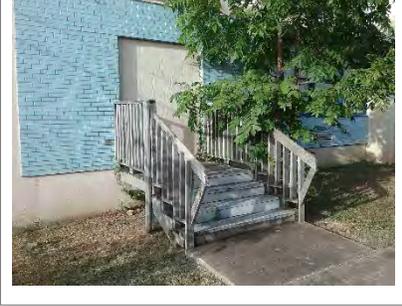
Interior Specialties	<p>There are painted metal lockers of various ages located along corridors.</p> <p>The majority of the lockers appeared to be in good condition. The lockers were observed to function adequately.</p>	Good
Stairs	Exterior Stairs	<p>There are concrete stairs at the east entrance of the main two-story building that are original to construction and a new metal ramp that is a more recent addition. The new gymnasium has two sets of exterior concrete stairs and a ramp with metal railings at its east entrance. There are concrete stairs to the basement mechanical space. There are abandoned wood stairs on the northeast corner of the two-story Main School Building classroom wing.</p> <p>Stairs and ramps were observed to be in good condition. The abandoned wood stairs appeared to be deteriorating and without a purpose.</p>	Good

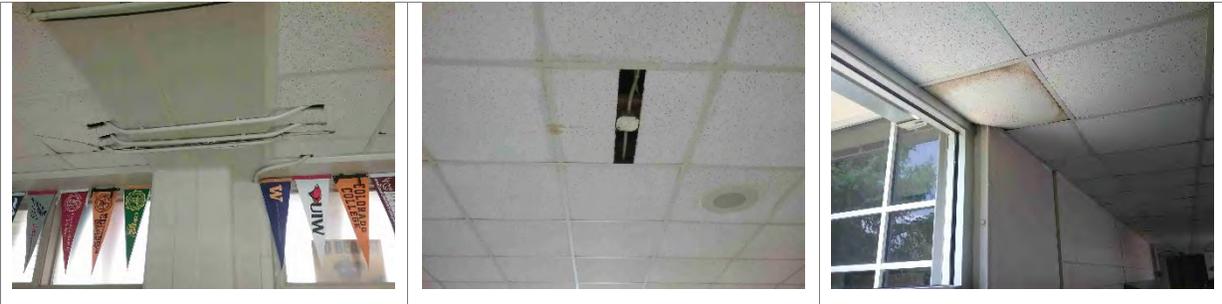
Interior Ceiling Finishes	<p>The interior ceiling is predominantly suspended 2x4 or 2x2 lay-in acoustical tile. Ceilings in both gymnasiums and some classrooms in the science-wing are exposed structure. Ceilings in locker rooms and shower areas are painted plaster.</p> <p>Ceiling conditions vary throughout the building, but much of the lay-in ceiling has been added or replaced in recent years. Ceiling tiles in the original building corridors have large gaps around conduit penetrations</p>	Average

System	Subsystem	Condition and Deficiency Overview	System Condition Rating
		<p>and have unsupported tile edges that are cracked or missing. Ceilings in classrooms and larger spaces are in good condition. There was minor staining from roof leaks observed. The library and some classrooms on the second floor were observed to have damage from mechanical equipment leaks.</p>	
Conveying		<p>The building is equipped with a hydraulic passenger elevator to service two levels. The elevator was noted as having a maximum weight capacity of 2100 lbs. There is a lift in the 600-wing that is abandoned.</p> <p>The elevator appeared to be in good condition. The required elevator inspection certificate, issued within the last year, was visible, and no operational issues were reported by the facility staff.</p>	Good
Plumbing	Plumbing Fixtures	<p>The building has public restrooms for men women, and students, and separate staff restrooms located throughout the facility. These restrooms have vitreous china hand sinks in counters with manual faucets, along with vitreous china, floor-mount toilets with manual flushing mechanisms, and vitreous china, wall-hung urinals in the male restrooms with manual flushing mechanisms. There are service sinks found in the janitorial closets, and water coolers located throughout the facility, typically near the public restrooms. The kitchen was equipped with stainless steel compartment sinks and vitreous china sinks. Stand-alone and counter-mounted eyewash stations were observed in the science classrooms.</p> <p>The facility's plumbing fixtures were observed to be in poor condition. Sink drain piping covers were missing or damaged in areas. Rust and corrosion were observed on select fixtures, primarily mop sinks. A leak was noticed at the manual flush valve on the toilet serving the gymnasium. Select sinks were observed to drain into local basins and not into the building's drainage system. Select stand-alone and counter-mounted eyewash stations were not operational. Several faucets were observed to be loose. The water coolers did not appear to be cooling at the time of the assessment. It was reported that the showers do not drain well; this was observed and confirmed during the assessment.</p>	Poor

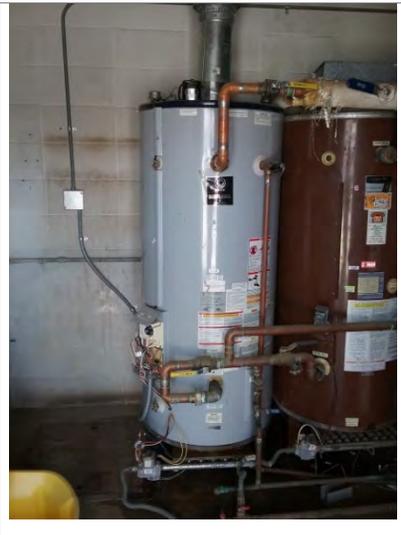
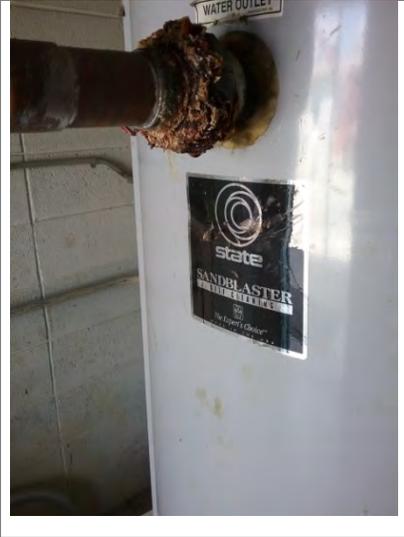
Domestic Water Distribution

System	Subsystem	Condition and Deficiency Overview	System Condition Rating
		<p>mechanical room, and one in the gymnasium basement. The hot water in the library sink is provided by a small EWH (electric water heater).</p> <p>The plumbing distribution equipment serving the facility was in poor condition, primarily due to the condition of the GWH serving the building. The heaters appeared to be aged and past their typical design service life. The hot water piping insulation associated with the water heaters was either missing or damaged. The EWH in the library was in average condition.</p>	
	Other Plumbing	<p>The roof is equipped with roof drains. The roof drains have metal grate covers to prevent debris from entering the drainage system. The plumbing system is equipped with a backflow preventer.</p> <p>The roof and floor drains serving the facility were observed to be in poor condition. Although the roof drains appeared to be in average condition; corrosion was observed in some areas. Floor drains in several areas were observed to be damaged. The sewer clean-out cap was observed to be broken on the west courtyard area of the campus.</p>	Poor

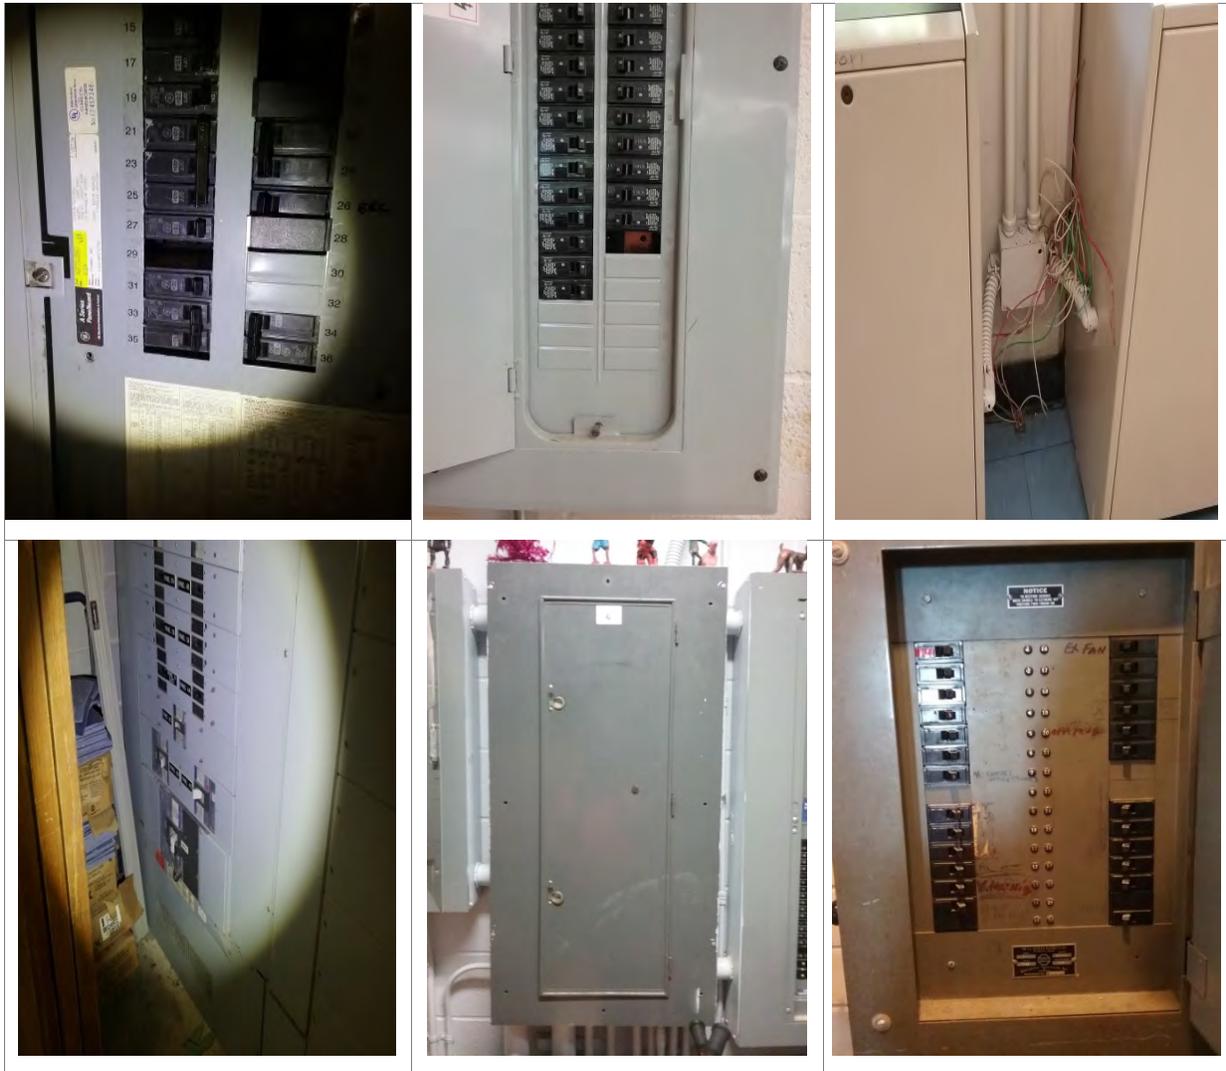
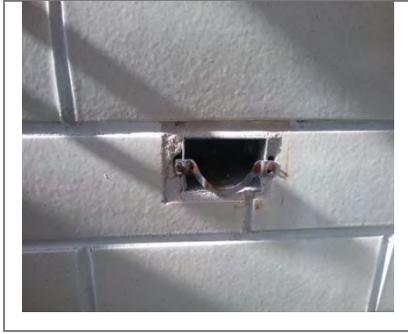
Electrical Distribution

System	Subsystem	Condition and Deficiency Overview	System Condition Rating
		<p>stacked against the switches that could be accidentally tripped or faulted. This condition could be considered a life safety hazard. Additionally, facility staff reported that in room 120, the panels were at full capacity, and in room 140, there were very few available spaces to add additional circuit breakers for expansion.</p> <p>Also, there were exterior receptacles missing the receptacle device with exposed wiring.</p> <p>Facility indicated in their interview notes that additional receptacle are requested at the stage and cafeteria areas.</p> <p>The building does not have a lightning protection system.</p>	
	Lighting	<p>The building's exterior lighting consists of downlights, HID (high-intensity discharge), and LED (light-emitting diode) fixtures that are located along the entire perimeter. The interior lighting primarily consists of T8 fluorescent light fixtures. The building is equipped with exit signs.</p> <p>The lighting for the building appeared to be in average condition. Many interior and exterior light fixtures appeared to be aged past their typical design service life, including several of the building exit signs. In addition, broken lenses and non-functional fixtures were observed.</p>	Average

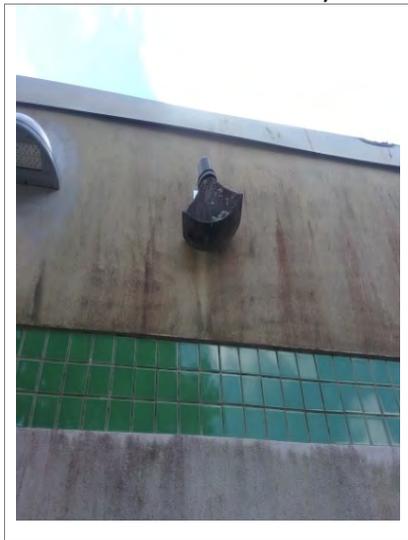
Communications & Security	<p>There is a Gemini security system including surveillance cameras installed in the building. There is a public address system inside and outside of the building. The building is also equipped with card readers at all door entries and telecommunications systems.</p> <p>The facility reported that the door card readers have issue with them not always working.</p> <p>The camera system appeared to be in average condition with both new cameras and and some older cameras in use.</p> <p>The public address system appeared to be in average condition.</p> <p>There is a security system appeared to be in average condition.</p>	Average

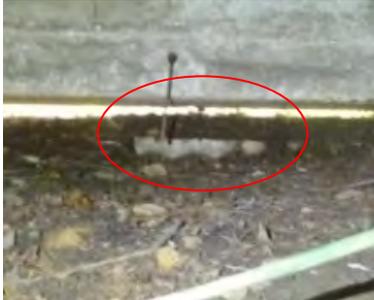
<p>Daylight visible below perimeter beam; settled soil retainers</p>

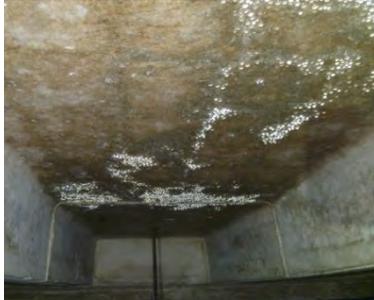
<p>Sweaty slab</p>

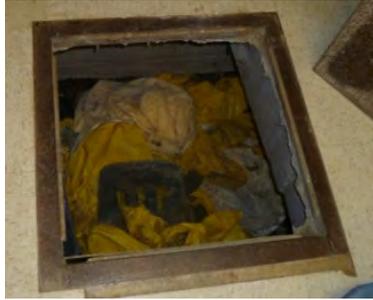
<p>Rusted hatch frame</p>

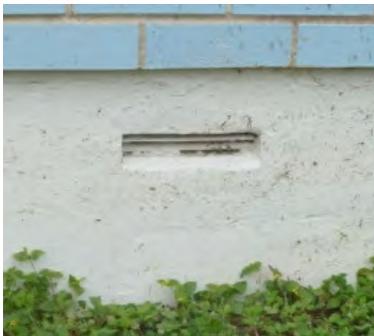
<p>Small, clogged vent in perimeter beam</p>

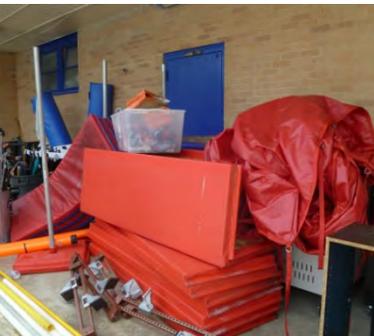
<p>Mechanical room with crawl space access blocked by stored equipment</p>

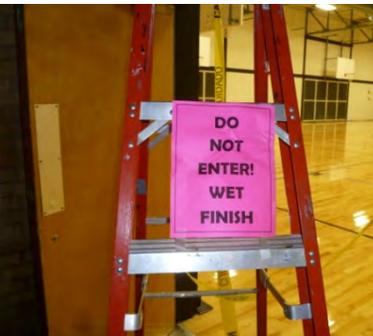
<p>Recently finished floor blocking access to hatch in room GST04</p>

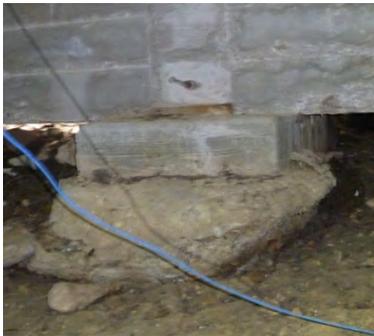
<p>Concrete mushrooming at top of pier</p>

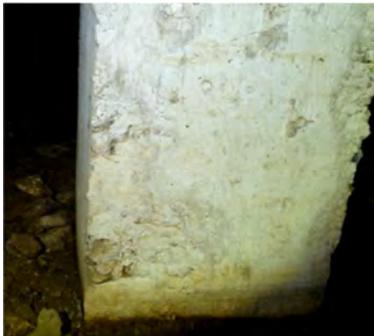
<p>Column honeycombing</p>

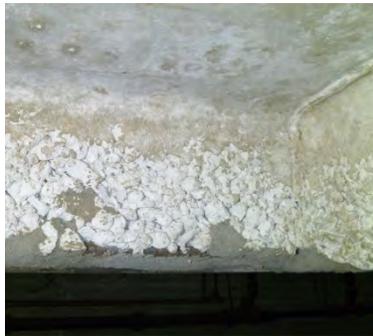
<p>Poor concrete consolidation in beam & slab joist</p>
--	--	---

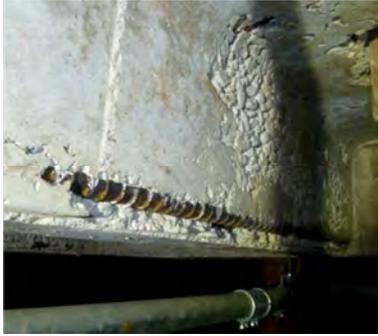
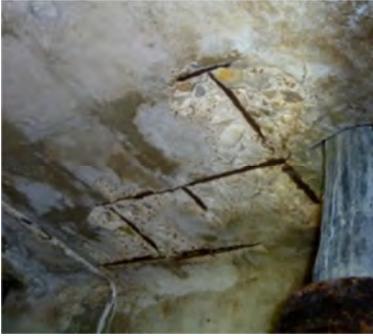
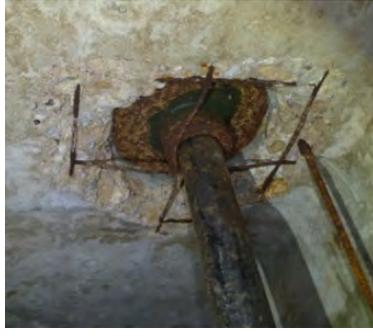
<p>Exposed/corroded longitudinal reinforcement in bottom of slab joist</p>	<p>Spalling, exposed and corroded reinforcement in slab soffit</p>	<p>Exposed reinforcement at pipe penetration through slab</p>

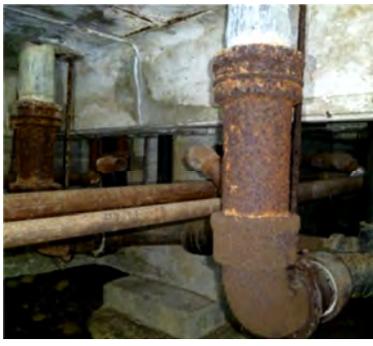
<p>Pipe leak</p>	<p>Pipe laying on soil (should be suspended)</p>	<p>Heavily rusted pipes</p>

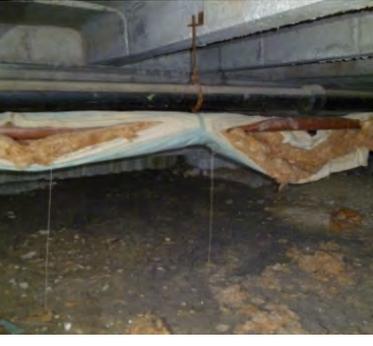
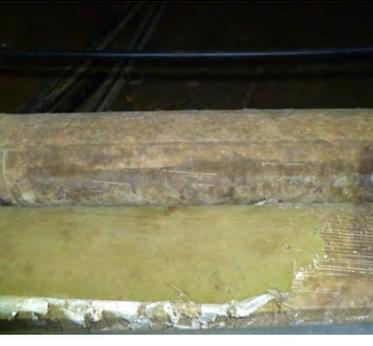
<p>Rusted pipe & pipe support</p>	<p>Failed pipe insulation</p>	<p>Moldy pipe insulation</p>

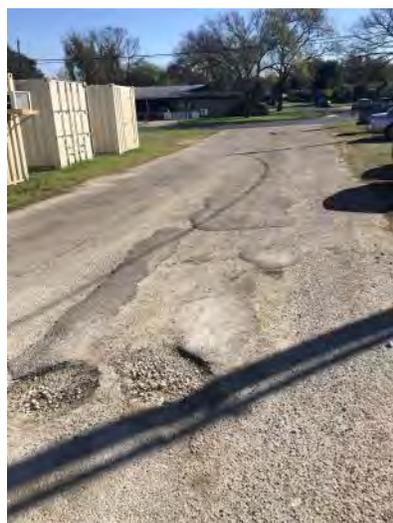
School access road from Keats Drive

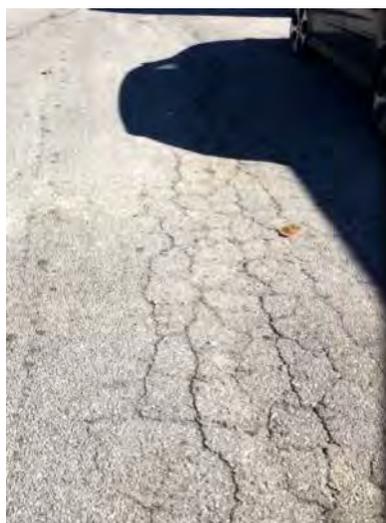
Road connecting parking to loading dock

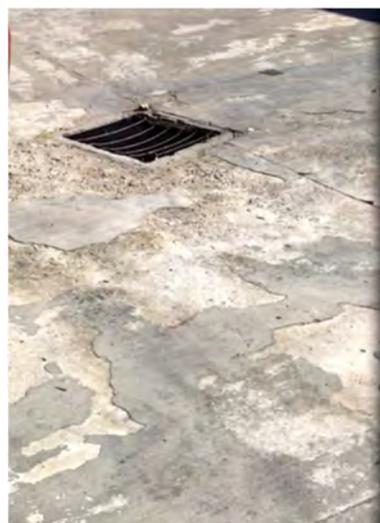
Loading dock pavement and inlet

1. Resurface asphalt roadways.
2. Repaint fire lane markings.
3. Repair inlet in the loading dock area.

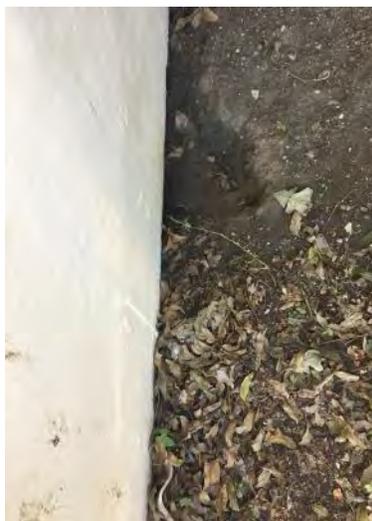
Pest hole

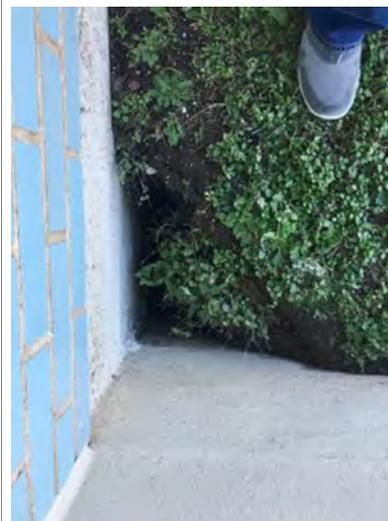
Pest hole

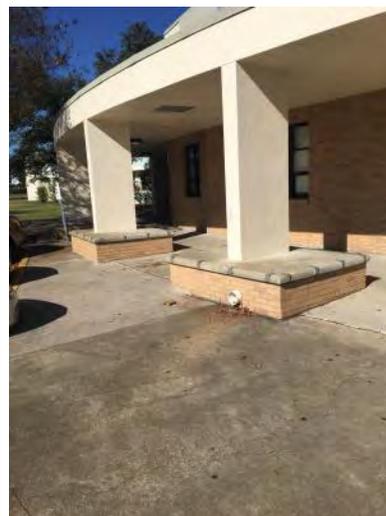
Downspouts do not flow into underground system

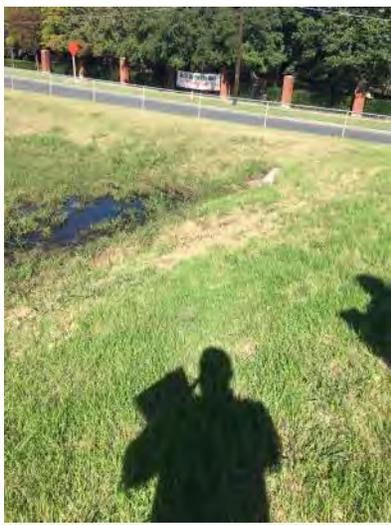
Standing water in detention pond

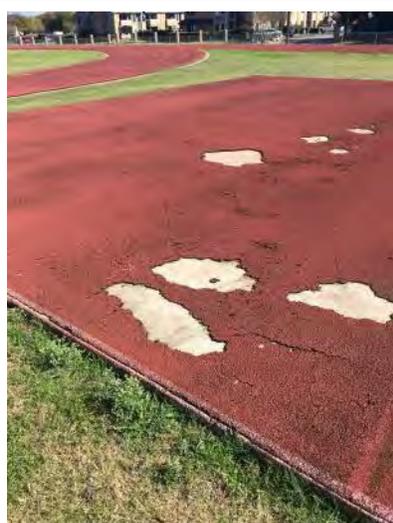
High jump area surface has peeled off

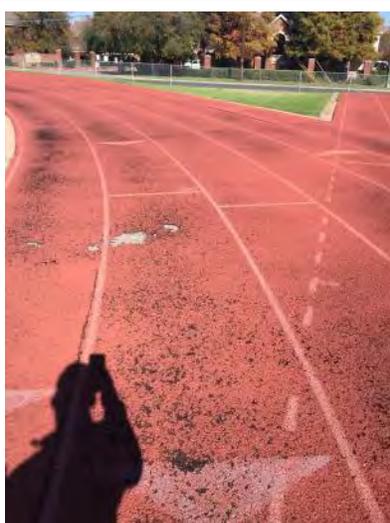
Track peeling off
