Eastside Memorial High School Site Summary

Main School Building – BLDG-019A

Theater Building – BLDG-019B

Site/Civil Assessment

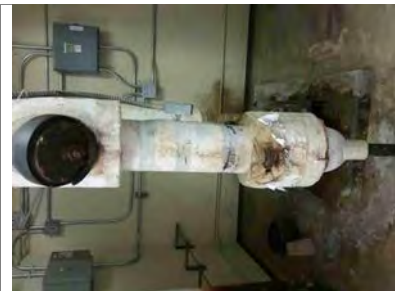
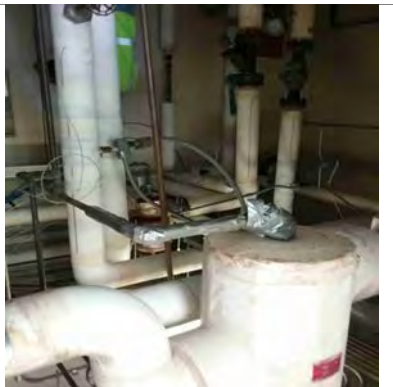
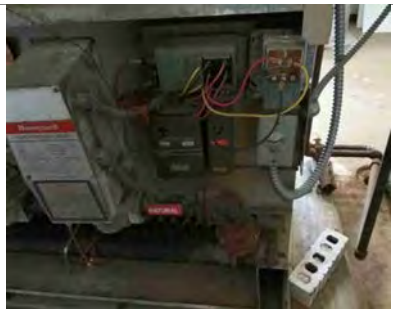
Domestic Water Distribution

Other Plumbing	The water and gas pipelines throughout the building were rusted.	Poor

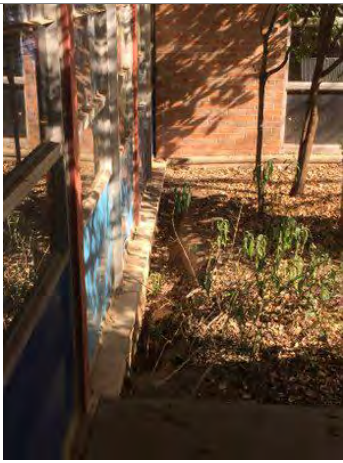
Severe erosion under sidewalk	Erosion along building	Pest Hole

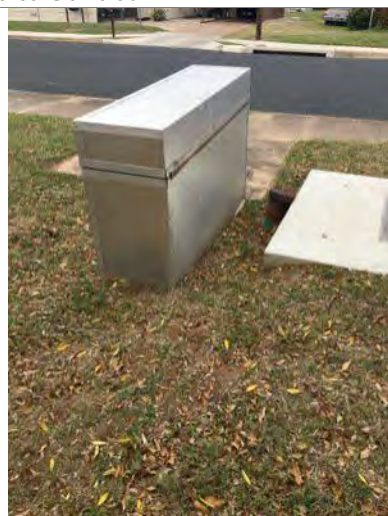
Fiberglass Grease Sampling Enclosure

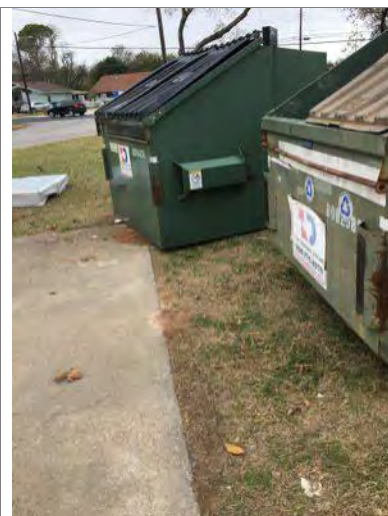
Dumpsters not on concrete pad

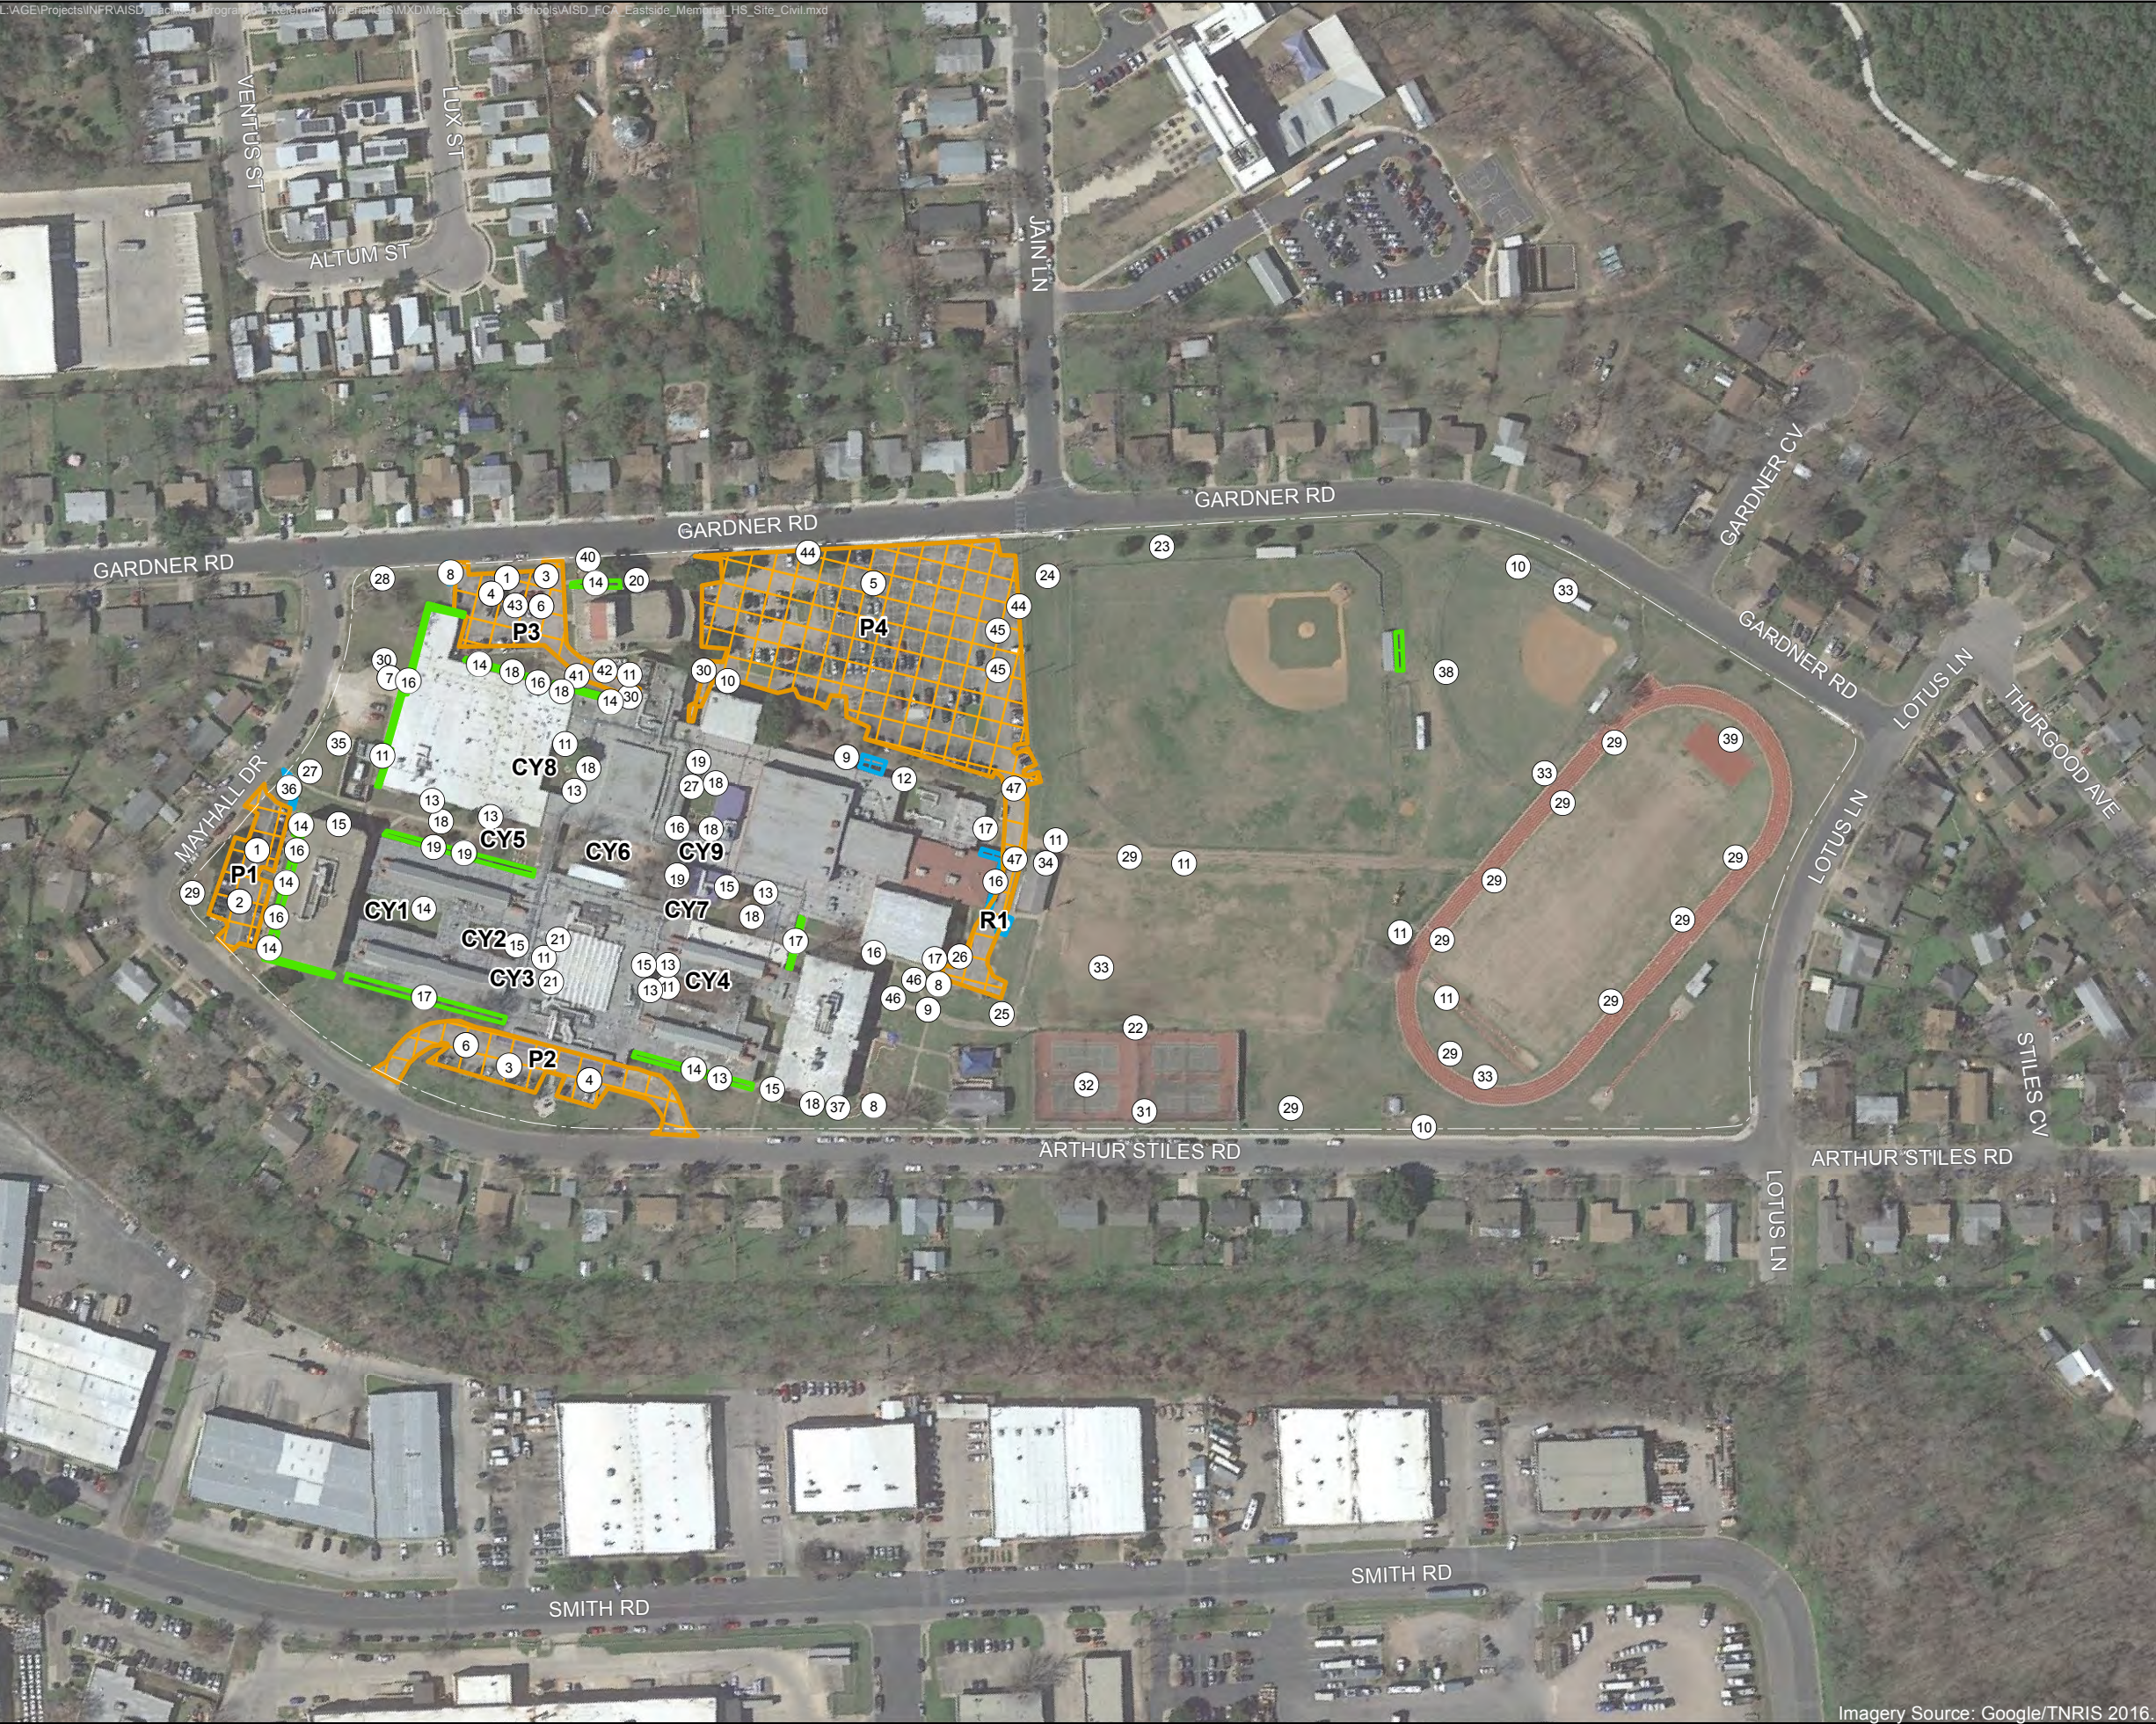
1. THERE IS RAVELING IN THIS AREA.
2. THERE ARE LONGITUDINAL CRACKS IN THIS AREA.
3. THERE IS ALLIGATOR CRACKING IN THIS AREA.
4. THERE IS A PATCH IN THIS AREA.

5. THERE IS A UTILITY PATCH IN THIS AREA.
6. THERE IS A POTHOLE IN THIS AREA.
7. THE PAVEMENT IS BROKEN.
8. THE SIDEWALK IS BROKEN/HEAVING/SUNKEN IN.
9. THERE IS EROSION UNDER AND/OR ADJACENT TO THE SIDEWALK.

10. THE FENCE IS BENT AND/OR BROKEN IN NEED OF REPAIR.
11. AREAS OF MATERIAL/DEBRIS/CONCRETE NEED TO BE REMOVED.
12. THE FENCE NEEDS TO BE LOCKED.
13. THERE IS EVIDENCE OF PEST HOLES.

22. THERE IS OVERGROWN LANDSCAPING THAT NEEDS TRIMMING/PRUNING.
23. THE IRRIGATION BOX IS MISSING A COVER.
24. THE AREA AROUND THE IRRIGATION BOX NEEDS TO BE BACKFILLED.

32. THE TENNIS NETS ARE IN BAD CONDITION OR NON EXISTENT.
33. THERE ARE LOW SPOTS IN THE FIELD THAT NEED TO BE FILLED.
34. WATER PONDS ON THE FIELD.
35. DAMAGES & LOW SPOTS FOM OVERFLOW PARKING

36. SIDEWALK NEEDED IN THIS AREA
37. REWINTERIZE PIPES
38. TIRE TRACKS CAUSING PONDING
39. INLET NEEDS TO BE COVERED. SAFETY HAZARD
40. BROKEN PLASTIC FENCING AROUND MANHOLE

41. DROP OFF FROM CONCRETE. NEEDS BACKFILL
42. TIRE TRACKING
43. 5 POST HOLES IN PAVEMENT
44. BROKEN CURB
45. SPEED BUMPS NEED TO BE REPLACED.
46. CONNECT SIDEWALK

47. PATCH OF PAVEMENT MISSING

1. Repair cracking, mill and overlay.
2. Fill potholes, repair cracking, resurface.
3. Remove post bases and patch.
4. Fix broken curb.
5. Replace speed bumps.

1. Repair cracking sidewalk, replace section if needed.
2. Fill in eroded area around sidewalk.

1. Repair fencing.
2. Remove debris.
3. Add lock to fence gate.

1. Regrade areas away from the buildings.
2. Repair areas of severe erosion along the buildings.
3. Add gutters to areas with erosion damage.
4. Fill pest holes.
5. Remove and replace damaged sidewalk with severe erosion underneath.
6. Backfill area around manhole.
7. Remove debris from all courtyards.

1. Replace or fix irrigation box covers.
2. Backfill area around irrigation box.
3. Fill erosion holes and low spots.

1. Fill in low spots.
2. Repair the fence area that has been damaged.
