Travis High School Site Summary

Address	1211 E Oltorf Street Austin, TX 78704
Number of Permanent Campus Facilities	6
Original Year of Construction	1953
Total Campus Building Area (combined)	285,468 SF

Main School Building – BLDG-007A

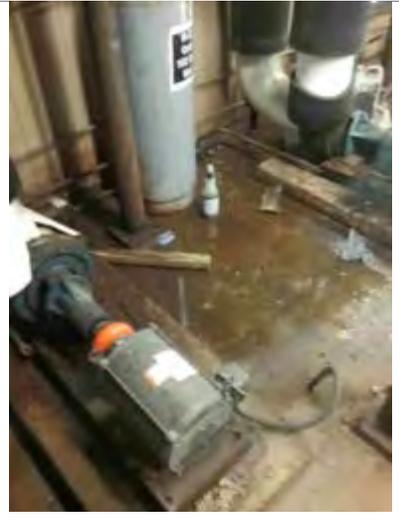
Interior Stairs	System not present.	N/A
Interior Finishes	Interior Wall Finishes	The interior face is unfinished. There are no other finishes present.	N/A
	Interior Floor Finishes	The interior floor is an unfinished concrete slab on grade. Ponding water was observed in one area and water intrusion was evident at the entry doors.	Average
	Interior Ceiling Finishes	System not present.	N/A
Conveying	System not present.		N/A

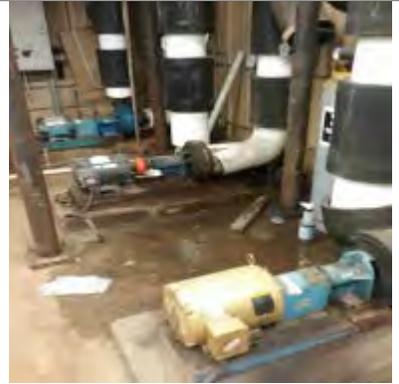
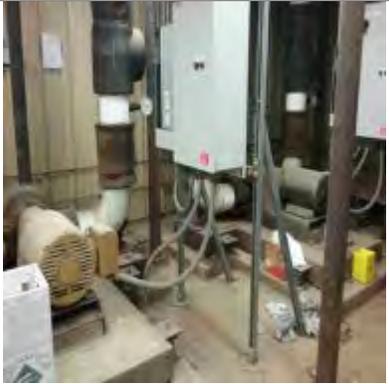
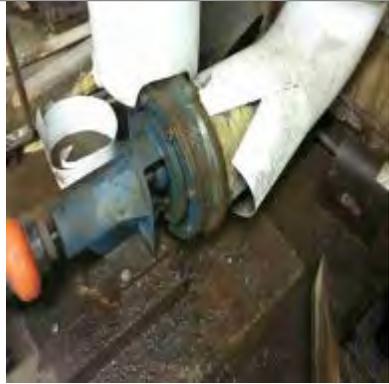
Mechanical/HVAC System Deficiency Examples

System	Subsystem	Condition and Deficiency Overview	System Condition Rating
Plumbing	Plumbing Fixtures	System not present.	N/A
	Domestic Water Distribution	System not present.	N/A
	Other Plumbing	The only plumbing assets that were observed in the Pump Room were the floor drains. These were assumed to be in average condition as no standing water was observed around the floor drains but the covers appeared to be corroded.	Average
Mechanical/ HVAC	<p>The major mechanical equipment consists of five chilled water distribution pumps that were assumed to pump chilled water for the Gymnasium facility from the chillers to the AHUs and package units at that facility.</p> <p>These five chilled water distribution pumps are all located in the small, open interior space of the building. They were observed to be in poor condition with all five of the pumps exhibiting damaged or missing insulation, corroded and rusted piping connections and housing, and significant condensation or possible leaks.</p> <p>Supplemental mechanical equipment for the HVAC system also includes one thru-wall EF and a unit heater. Both of these units were observed to be in average condition as they appeared aged and outdated, but no operational issues were reported or observed. The HVAC system at the Pump House was generally observed to be in poor condition with all of the prior mentioned deficiencies.</p>		Poor

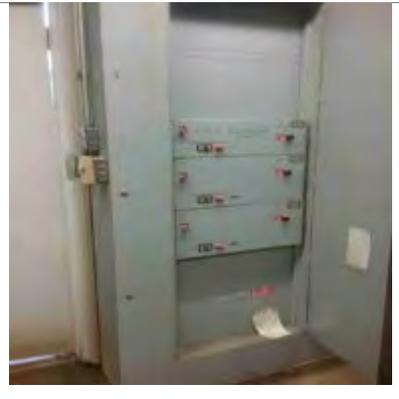
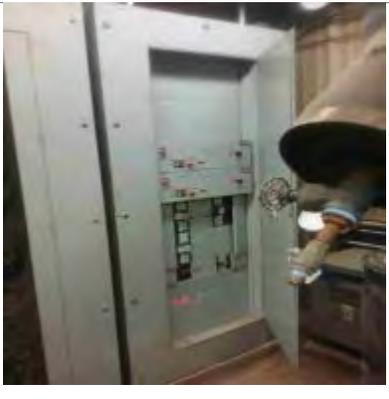
Fire Protection	Fire Alarm	System not present.	N/A
	Fire Protection/ Suppression	The facility is solely protected by portable fire extinguishers. All portable fire extinguishers observed had inspection tags dated within the last year.	Good
Electrical	Electrical Distribution	<p>The electrical utility service enters the building at two 277/480-volt 1200-amp switchboards which are located in the open interior space. The switchboards primarily deliver power to mechanical assets in the building and other neighboring areas around the campus including the chillers at the Gymnasium facility. There is one distribution transformer rated at 480-volt primary that step-downs to 120/208-volt secondary, which feeds power to 120/208-volt panelboards. The building is not equipped with a lightning protection system.</p> <p>The electrical distribution equipment was observed to be in poor condition. The assets appeared to be past their design life. Additional deficiencies observed include assets with corrosion/rust, missing screws from housing enclosures, and areas where electrical wiring was exposed.</p>	Poor

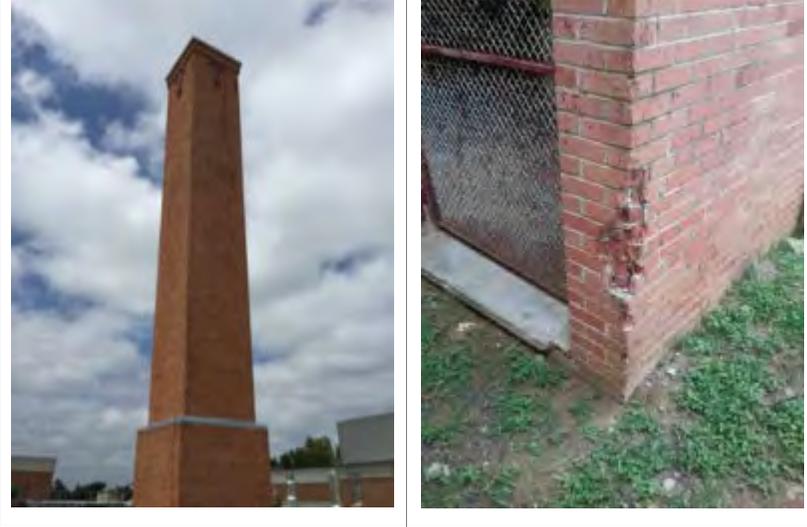
System	Subsystem	Condition and Deficiency Overview	System Condition Rating
Exterior	Exterior Walls	The building is constructed with a concrete slab on grade and brick exterior walls. Several portions of the brick wall were observed to be cracked and damaged. The old tower for the boiler system shows cracking on the upper 30 feet on all sides.	Average
	Exterior Windows	The window system consists of single pane glazing in metal a metal frame assembly. The exterior window system was observed to be aged beyond its useful life. The windows are original to construction and the frames are deteriorated. The glazing is cracked and broken.	Poor
	Exterior Doors	The exterior doors of the building are metal with wood frame. The left door appears to have been recently replaced, and the right door is aged. There was a metal louvered opening above the doors, which was dented and aged.	Poor
Roofing	The roof was not accessible at the time of assessment, but is reported to be modified bitumen . There were no signs of water intrusion on the interior of the building.		Average

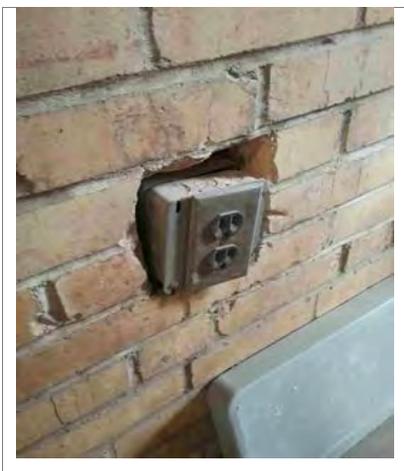
Interior Construction	Interior Walls	The interior consists of unpainted brick walls and CMU walls. They appeared to be in average condition. A minor deficiency was unsealed space surrounding an electrical outlet.	Average
	Interior Doors	The interior doors are wood with wood frames. They have experienced wear and appeared to be in average condition.	Average
	Interior Specialties	System not present.	N/A

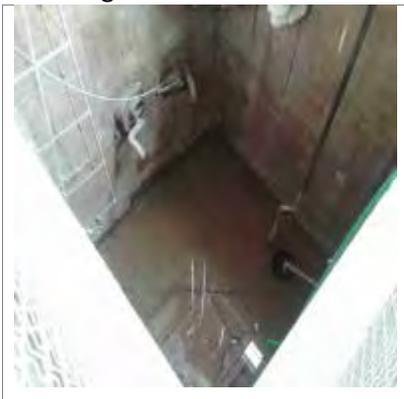
System	Subsystem	Condition and Deficiency Overview	System Condition Rating
Stairs	Exterior Stairs	System not present.	N/A
	Interior Stairs	System not present.	N/A
Interior Finishes	Interior Wall Finishes	The interior walls are unfinished.	N/A
	Interior Floor Finishes	The floor of the building is an unfinished concrete slab on grade. It appeared to be in average condition.	Average
	Interior Ceiling Finishes	The interior ceiling is open to the exposed structure above. It appeared to be in average condition.	Average
Conveying	System not present.		N/A
Plumbing	Plumbing Fixtures	<p>The building has one restroom for staff. The restroom has a vitreous china hand sink that is a stand-alone wall-mounted with manual knob faucets, along with a vitreous china, floor-mount toilet with manual flushing mechanisms.</p> <p>The restroom plumbing fixtures were observed to be in average condition. The fixtures were typically aged but still operational. It did not appear that the restroom was frequently used.</p>	Average

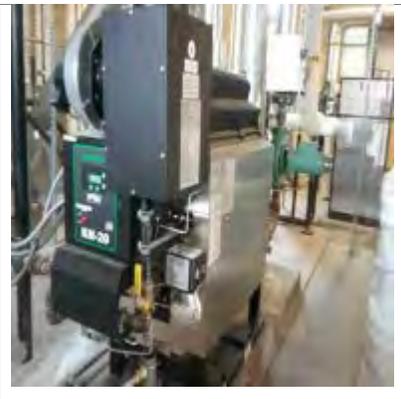
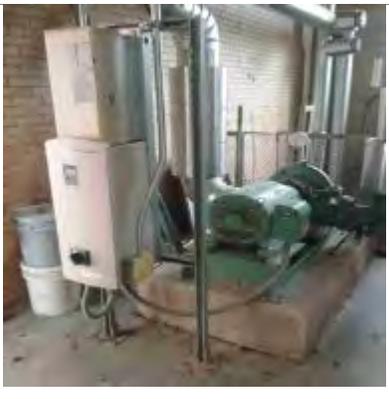
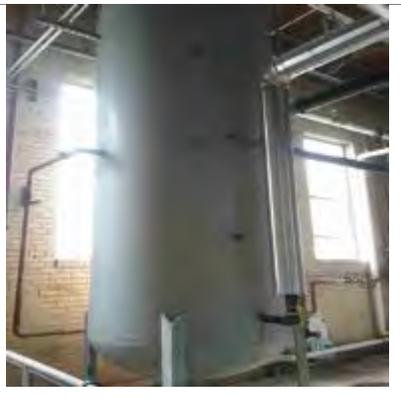
Mechanical/HVAC System Deficiency Examples

System	Subsystem	Condition and Deficiency Overview	System Condition Rating
		<p>housing enclosures.</p> <p>Supplemental mechanical equipment for the HVAC system also includes an EF and a unit heater. Both of these units were in average as they appeared aged and outdated, but no operational issues were reported or observed.</p> <p>Additionally there was a large storage tank for hot water in the open interior. No nameplate information was seen for the storage tank but it estimated to be approximately 250 gallons. The storage tank was in good condition as it was assumed to have been installed or refurbished at the time of the new boilers installation.</p> <p>The HVAC system at the boiler plant is in good condition.</p>	
Fire Protection	Fire Alarm	System not present.	N/A
	Fire Protection/ Suppression	The facility is solely protected by portable fire extinguishers. All portable fire extinguishers observed had inspection tags dated within the last year as required.	Good

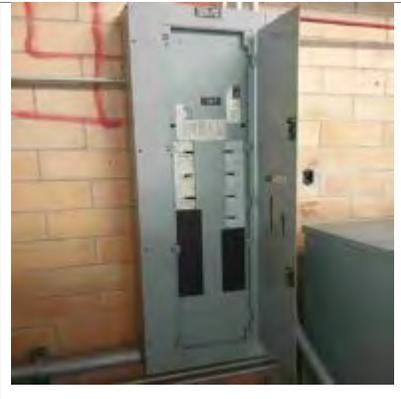
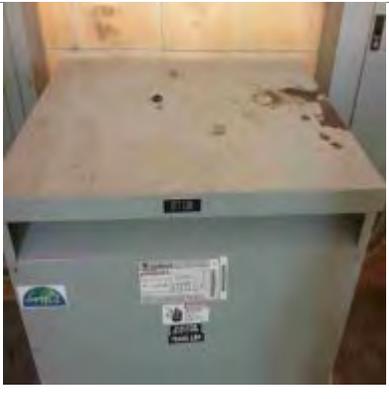
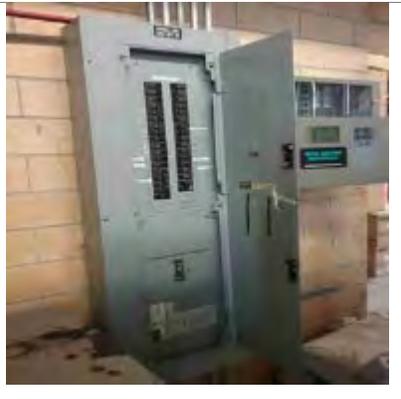
Electrical	Electrical Distribution	<p>The electrical service enters the building at a 277/480-volt 225-amp panelboard, which is located in the large, open interior space and delivers power primarily to mechanical units and a distribution transformer. The transformer is rated at 480-volt primary that step-downs to 120/208-volt secondary, which feeds power to the 120/208-volt panelboard. The building does not have lightning protection system.</p> <p>The electrical distribution equipment was observed to be in average condition. The assets were observed with some corrosion/rust. There were missing screws in the housing enclosures.</p>	Average
	Lighting	<p>The building does not have exterior lighting. The interior lighting is primarily T8 fluorescent with several incandescent luminaires. The building does not have exit signs or egress lighting.</p> <p>The lighting for the building was observed to be in poor condition. Luminaires appeared to be past their design life.</p>	Poor

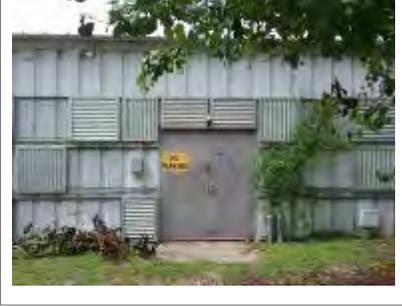
System	Subsystem	Condition and Deficiency Overview	System Condition Rating
Exterior	Exterior Walls	The building is constructed with a concrete slab on grade and corrugated metal exterior walls. There are metal louver openings on the building façade. Vines have penetrated through seams in wall panels, under gutters, and reportedly under the roof panels. The walls do not properly protect from water intrusion and are in poor condition.	Poor
	Exterior Windows	System not present.	N/A
	Exterior Doors	The exterior doors of the building are metal with metal frame. They appeared to be in average condition and were functioning; however, the paint is extremely faded.	Average
Roofing	The building has a metal roof. It was observed to be aged beyond its useful life and in poor condition.		Poor
Interior Construction	Interior Walls	The interior face of the exterior walls is unfinished metal. Corrosion and holes were observed throughout the wall surfaces.	Poor

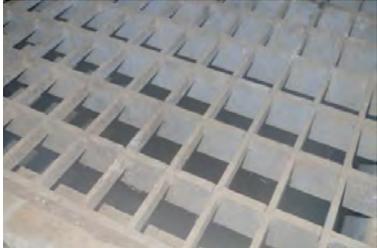
<p>Drain Basin in standing water</p>

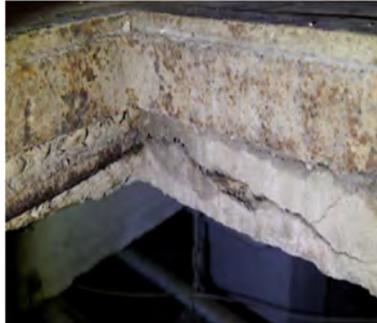
<p>Slab splitting at access hatch</p>

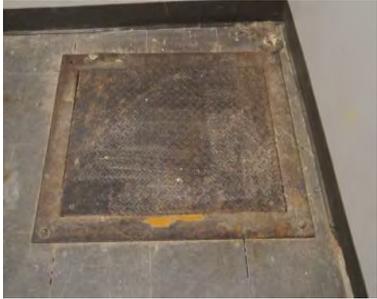
<p>Access hatch with no handle</p>

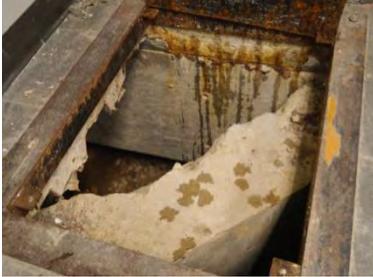
<p>Interior beam restricting access to crawl space</p>

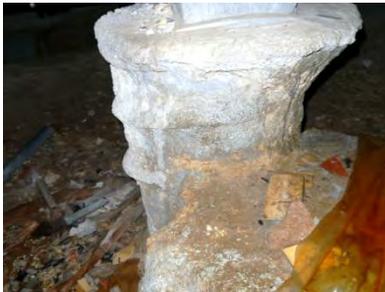
<p>Pier with mushroom top and concrete mass (presumably filling a void near surface) behind library</p>

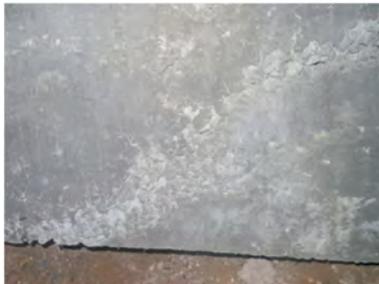
<p>Honeycombing in basement wall</p>

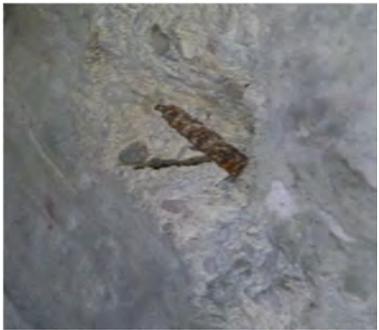
<p>Spalling & exposed/corroded rebar in beam</p>
---	--	--

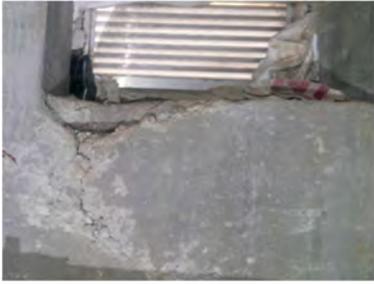
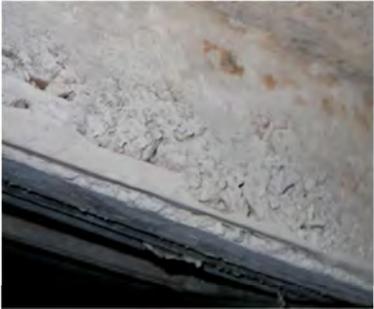
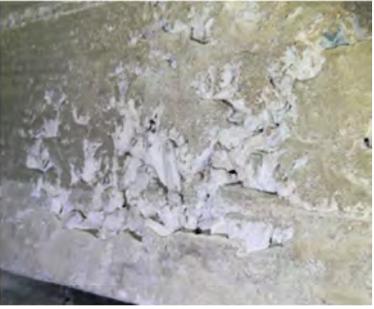
Exposed rebar in wall at ventilation louver, spalling & honeycombing	Typical honeycombing in pan joist webs	Major honeycombing in beam

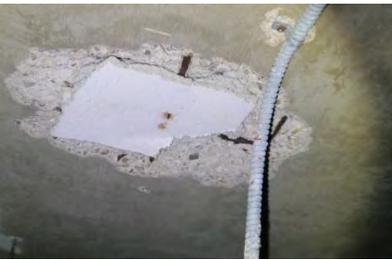
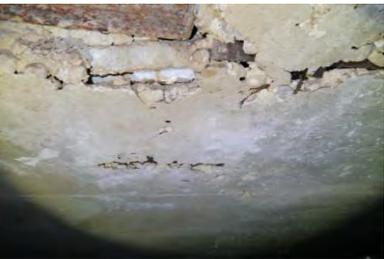
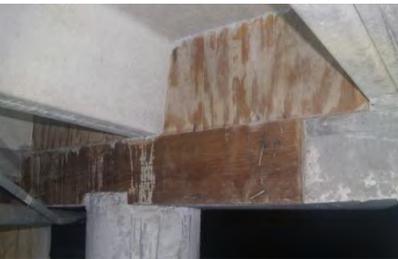
Exposed rebar, spalled slab	Honeycombing and exposed rebar in slab	Formwork left in place

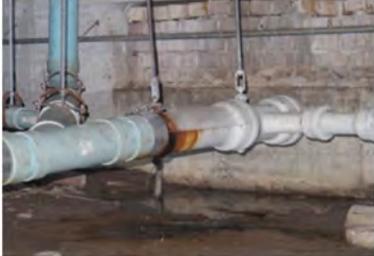
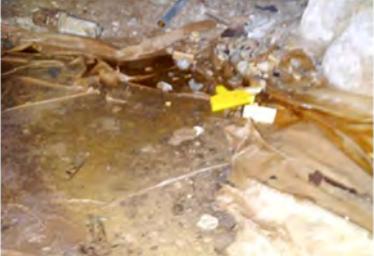
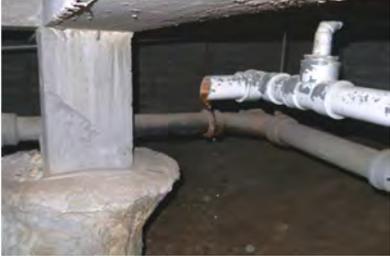
Leaking pipe near exterior wall	Water pooling on tarp under broken pipe	Leaking pipe behind library

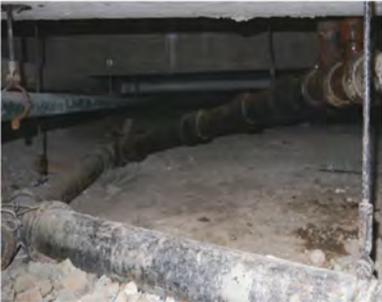
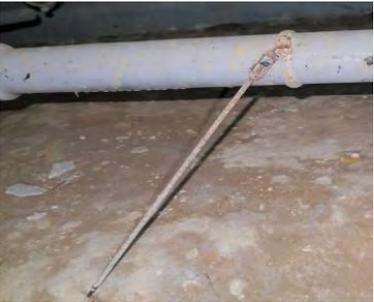
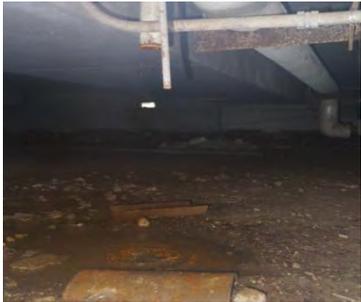
Suspended pipe resting on grade	Broken hanger rod	Constantly leaking pipe

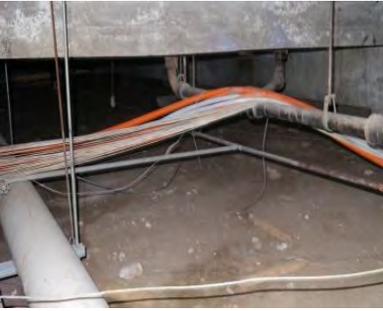
Wires draped over pipes

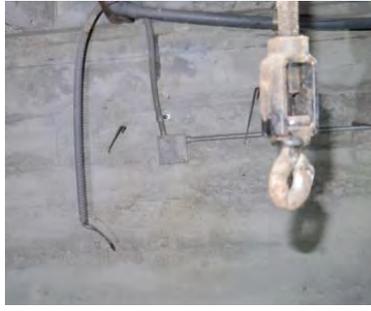
Broken Wiring

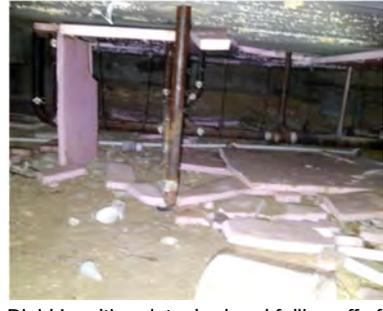
Rigid Insulation detached and falling off of underside of slab

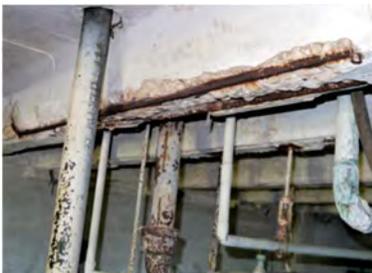
<p>Exposed, corroded longitudinal bars in pan joists</p>

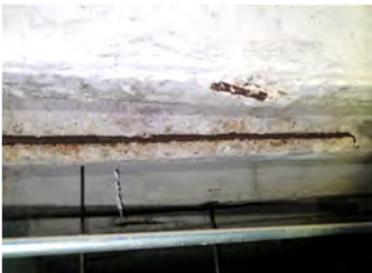
<p>Exposed, corroded longitudinal bars in pan joist webs</p>

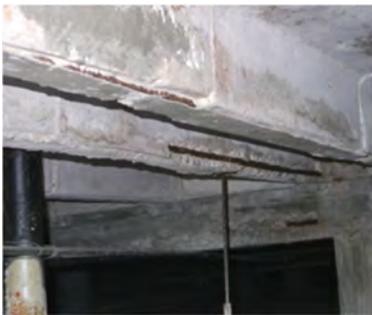
<p>Exposed, corroded longitudinal bars in pan joists and exposed longitudinal bars in beam beyond</p>

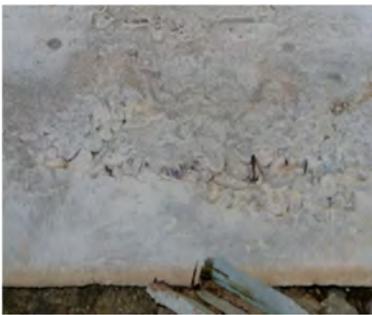
<p>Honeycombing in walls</p>

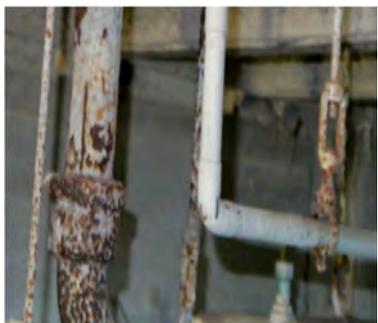
Minor rusting in pipes

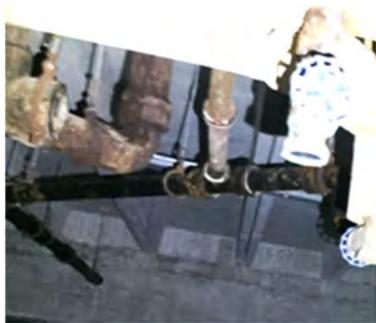
Severely Rusted Pipes

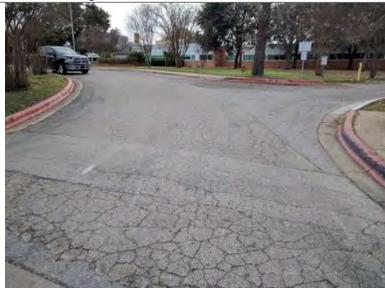
West Entrance from Oltorf R1

1. Resurface asphalt roadways.
2. Repair curb & gutter sections that have cracks.
3. Repaint fire lane markings.
4. [Replace east driveways and culinary parking \(requested by PM Deborah James\).](#)

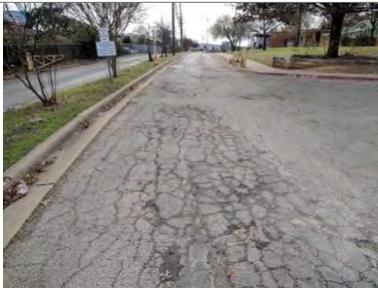
East Entrance from Oltorf R3

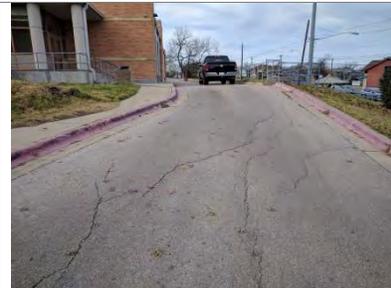
Longitudinal Cracking East end of R1

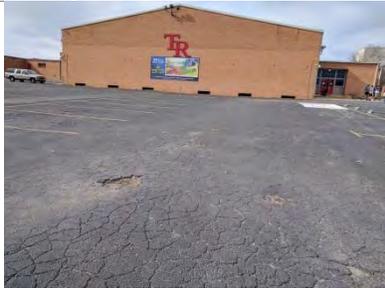
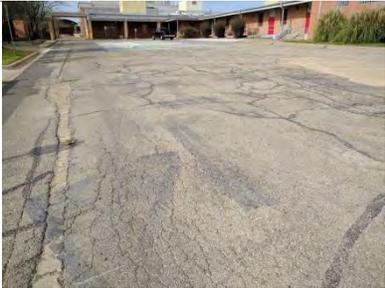
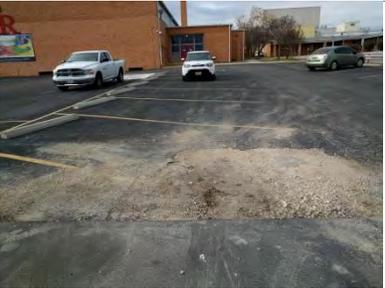
Alligator Cracking P5	Heavy Cracking at failing utility cut P4	Pothole with base exposure P5

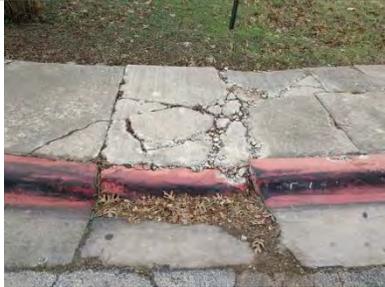
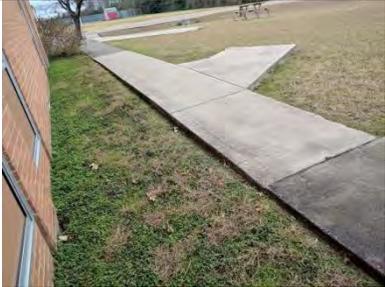
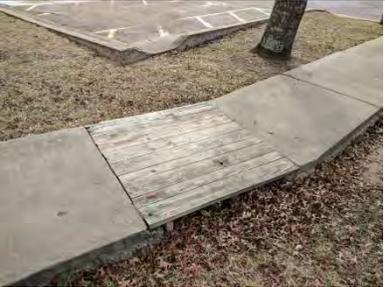
Broken Sidewalk, West Ent. of R1	Level-up along entire sidewalk with removal	Wooden Sidewalk Bridge

1. Replace pedestrian paving that is heaving [or level changes greater than 1/2 -inch \(requested by PM Deborah James\).](#)
2. Add topsoil to level-up sidewalks
3. Construct sidewalk where foot traffic is apparent
4. Remove random sidewalk leading to nowhere
5. Replace wooden bridges with metal plates.

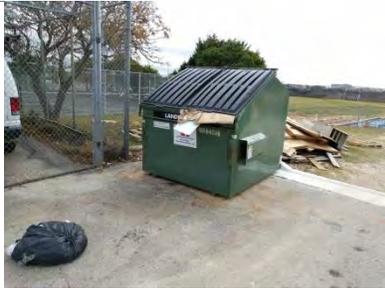
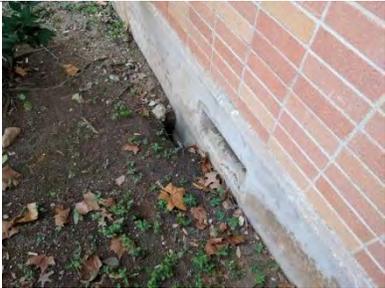
Dumpster without concrete approach P3	Pest hole

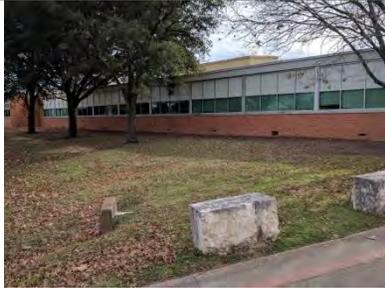
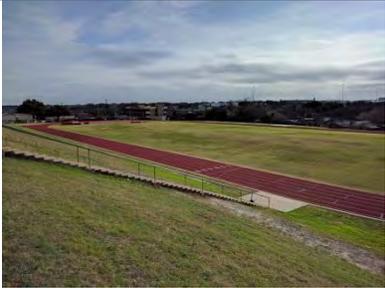
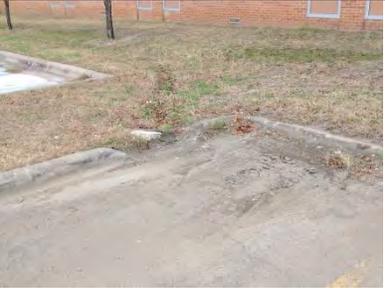
Flat Drainage at Building Foundation	Erosion of Topsoil	Ponding issue at corner of P2

1. Regrade topsoil away from foundation
2. Replace topsoil as necessary
3. Regrade at curb cut to allow water to leave parking area
4. Add underground drainage system as necessary to contain building runoff
5. Add/Replace downspout and connect to underground drainage

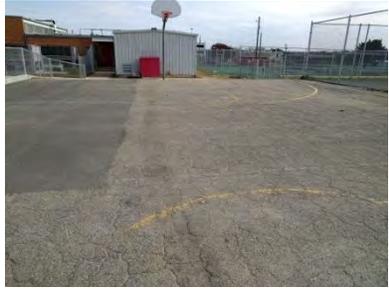
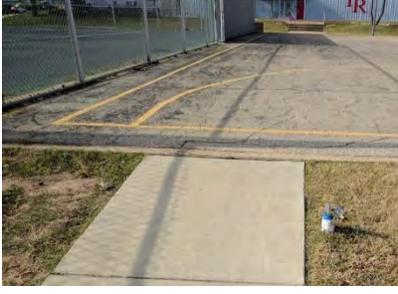
System	Subsystem	Condition and Deficiency Overview	System Condition Rating
Playfields	Basketball Courts	<p>The basketball court is asphalt pavement and has alligator cracking throughout a majority of the court. The goals are rusted and have no nets. There is no lighting for any of the courts.</p> <p>Basketball Court Deficiencies:</p> <ul style="list-style-type: none"> • Alligator cracking and worn surface • Missing nets • No lighting 	Poor
	Tennis Courts	<p>There are 2 tennis court areas with 2 individual courts each. Court 1 has heavy dark patches and minor cracking while Court 2 has larger cracks. Fencing seems to be in average condition around both courts.</p> <p>PM Deborah James reported that the east court was replaced in 2013 and that the west court is in need of replacement.</p> <p>Tennis Court Deficiencies:</p>	Poor

Alligator cracking and worn surface on Court	Alligator cracking and worn surface

1. Resurface basketball court
2. Replace missing nets
3. Add lighting

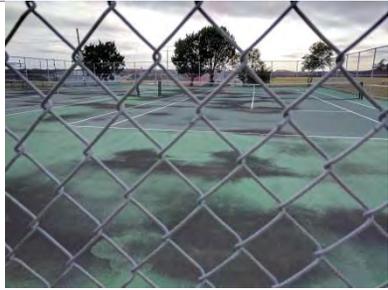
<ul style="list-style-type: none"> Dark patches and cracking at Court 1 (tennis) Large Cracks at Court 2 (tennis) 	
	Track	<p>The track and field event surfaces are in good condition. Pole vault concrete runway has recently been repaired but no topsoil leveled up at edges. There is no lighting on the track.</p> <p>Track Deficiencies:</p> <ul style="list-style-type: none"> Lacking topsoil at Pole Vault Runway 	Good
	Soccer/ Football Field	<p>The soccer / football field seems to be in good condition. No evidence of standing water and/or erosion issues was observed. There is no lighting on the Soccer/Football field..</p> <p>Soccer/Football Field Deficiencies:</p> <ul style="list-style-type: none"> N/A 	Good
	Multi-Purpose Field	<p>The multi-use field seems to be in average condition with no visible erosion conditions. The vegetation seems to be sufficient given the time of the year. There is no lighting on the multi-purpose field.</p> <p>Multi-Purpose Fields</p> <ul style="list-style-type: none"> N/A 	Average

Dark patches with cracks	Tennis court cracks

1. Replace west-side tennis court (requested by PM Deborah James).
2. Add lighting

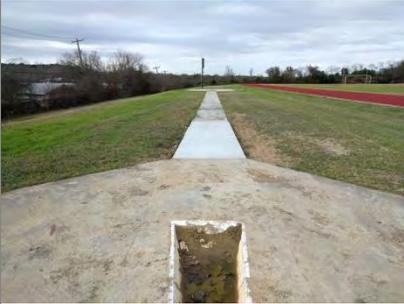
Pole vault drop-off	Pole vault drop-off

1. Add fill topsoil material to account for pole vault track drop-off
